**FAST/HAL TURNOUT AND
FROG PERFORMANCE**

**REPORT NO. R-798
FRA/ORD-91/25**

***Facility for Accelerated Service Testing
Heavy Axle Load Program***

November 1991

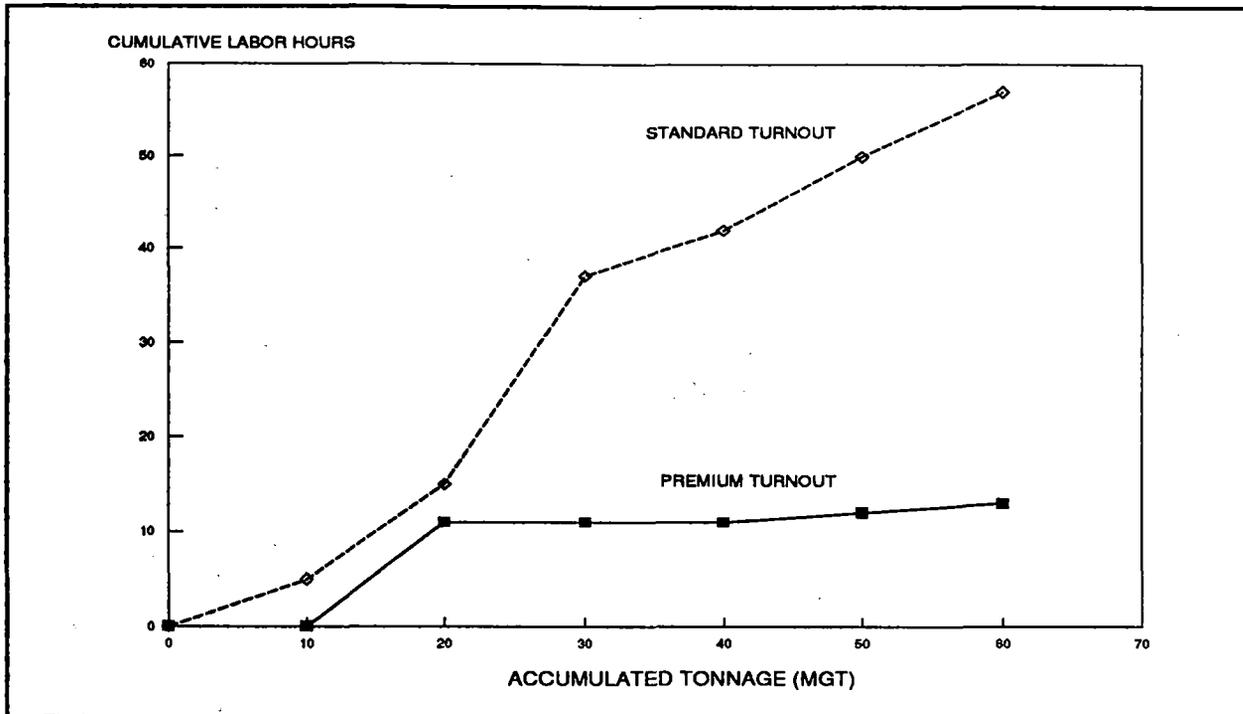
Figure 13. Comparison of Premium and Standard Component Turnout Maintenance Hours

The labor hours required to maintain the standard and premium component No. 20 turnouts were compared for the first 60 MGT on each turnout. As shown in Figure 13, the premium materials required about 77 percent less maintenance effort than the standard components. During the initial 60 MGT of operation, the standard turnout required repair of a cracked switch point, grinding to remove metal flow on the stock rails, grinding to reshape the manganese casting due to metal flow, and grinding to remove metal flow and surface defects on the wing and heel rails of the frog. Maintenance of the premium turnout included grinding of metal flow on the straight switch point and stock rail at 12.5 MGT, grinding of metal flow on the manganese casting at 16 MGT, and replacement of four fractured rail fasteners.

4. Comparing the maintenance effort after 60 MGT of traffic, the premium component No. 20 turnout required 77 percent less maintenance than the standard component turnout installed earlier at the same location. In addition to repair of a cracked switch point, grinding of rail surface defects, such as head checking and spalling, which were observed on the 300 Bhn rails starting at 20 MGT, accounted for most of the increase.

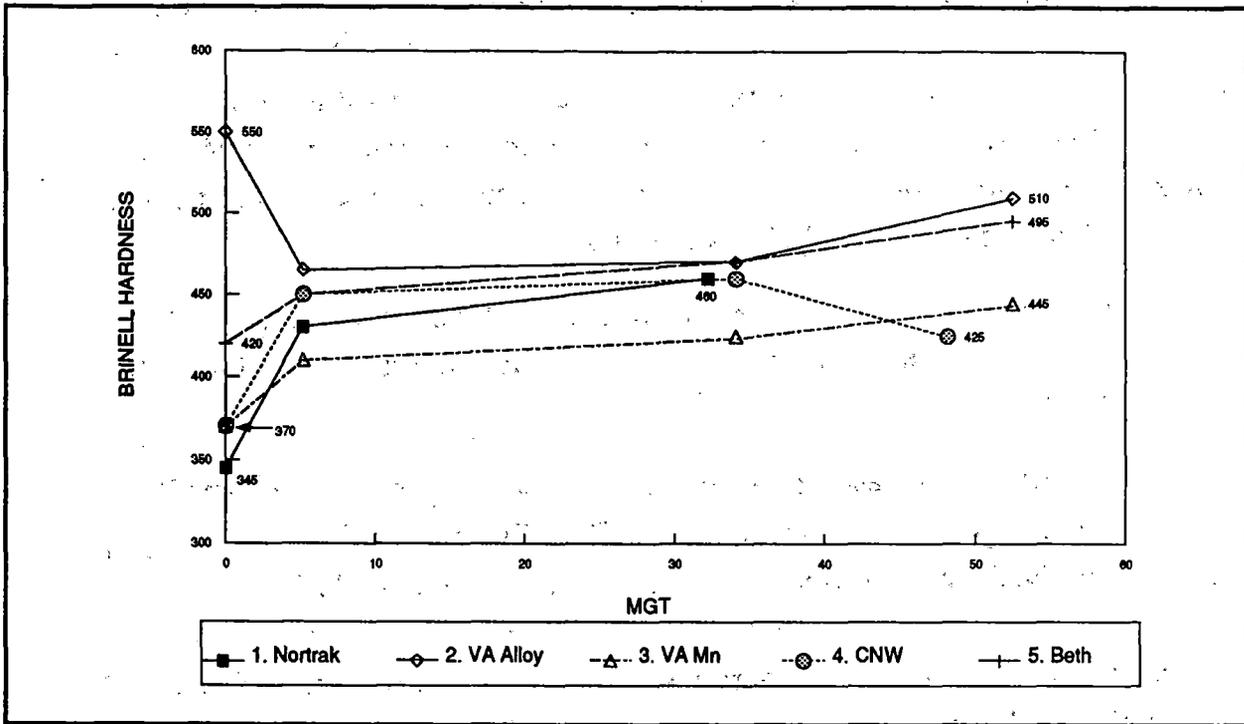
Figure 4. Average Brinell Hardness of Frogs

One of the main characteristics affecting frog performance may lie in the hardness of the point. The hardness data collected on the point of each frog throughout the test was averaged and plotted against MGT in Figure 4. As expected, the hardness in most cases has continually risen throughout the test. The Voest-Alpine alloy frog had a very high initial hardness of 550 Bhn, which subsequently came down to 465 Bhn at 5 MGT. These inconsistent readings were probably due to measurement error. Nevertheless, this frog has had the highest Bhn readings throughout the test and currently has a Bhn of 510. The next highest Bhn was on the Bethlehem frog whose initial hardness of 420 Bhn had risen to 495 Bhn. The Voest-Alpine manganese frog with an original hardness of 370 Bhn, has continually hardened to its current hardness of 445 Bhn. The CNW control frog surprisingly had a hardness as high or higher than two of the EDH frogs at 370 Bhn. The last test on this frog showed a drop in hardness, probably due to measurement error. Finally, the Nortrak frog with the lowest original hardness, hardened to 460 Bhn, second only to Voest-Alpine alloy frog and the Bethlehem frog, and after only 32 MGT.

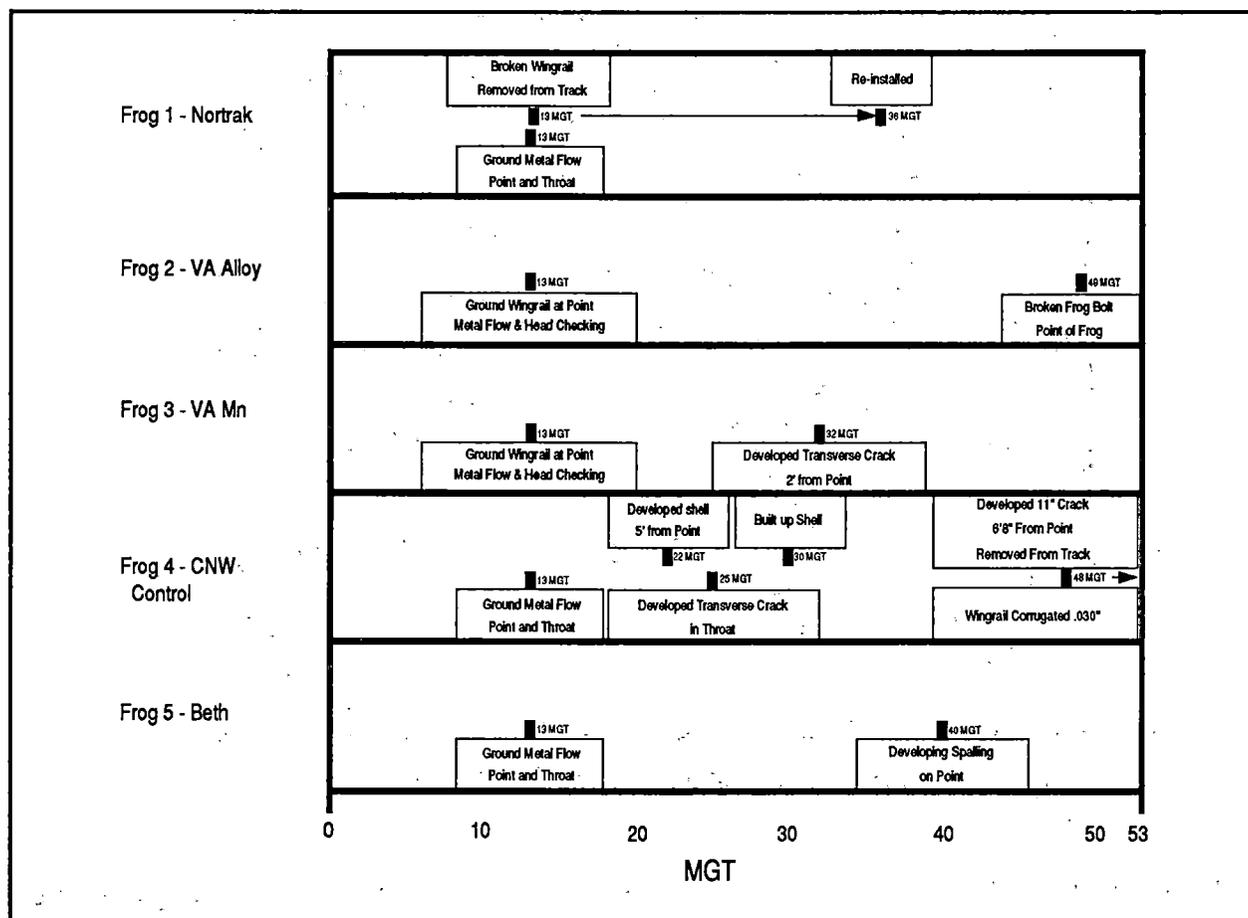
Figure 5. Highlights of Frog Farm Test

Figure 5 denotes the highlights of the performance of each frog throughout the test. This figure shows milestone developments for each frog and at what MGT they occurred. All five frogs required grinding at 13 MGT. The AREA frogs required grinding along the point and in the throat of the insert, while the Voest-Alpine wing rails required grinding along the wing rails. The grinding will be described in more detail in the section on profiles.

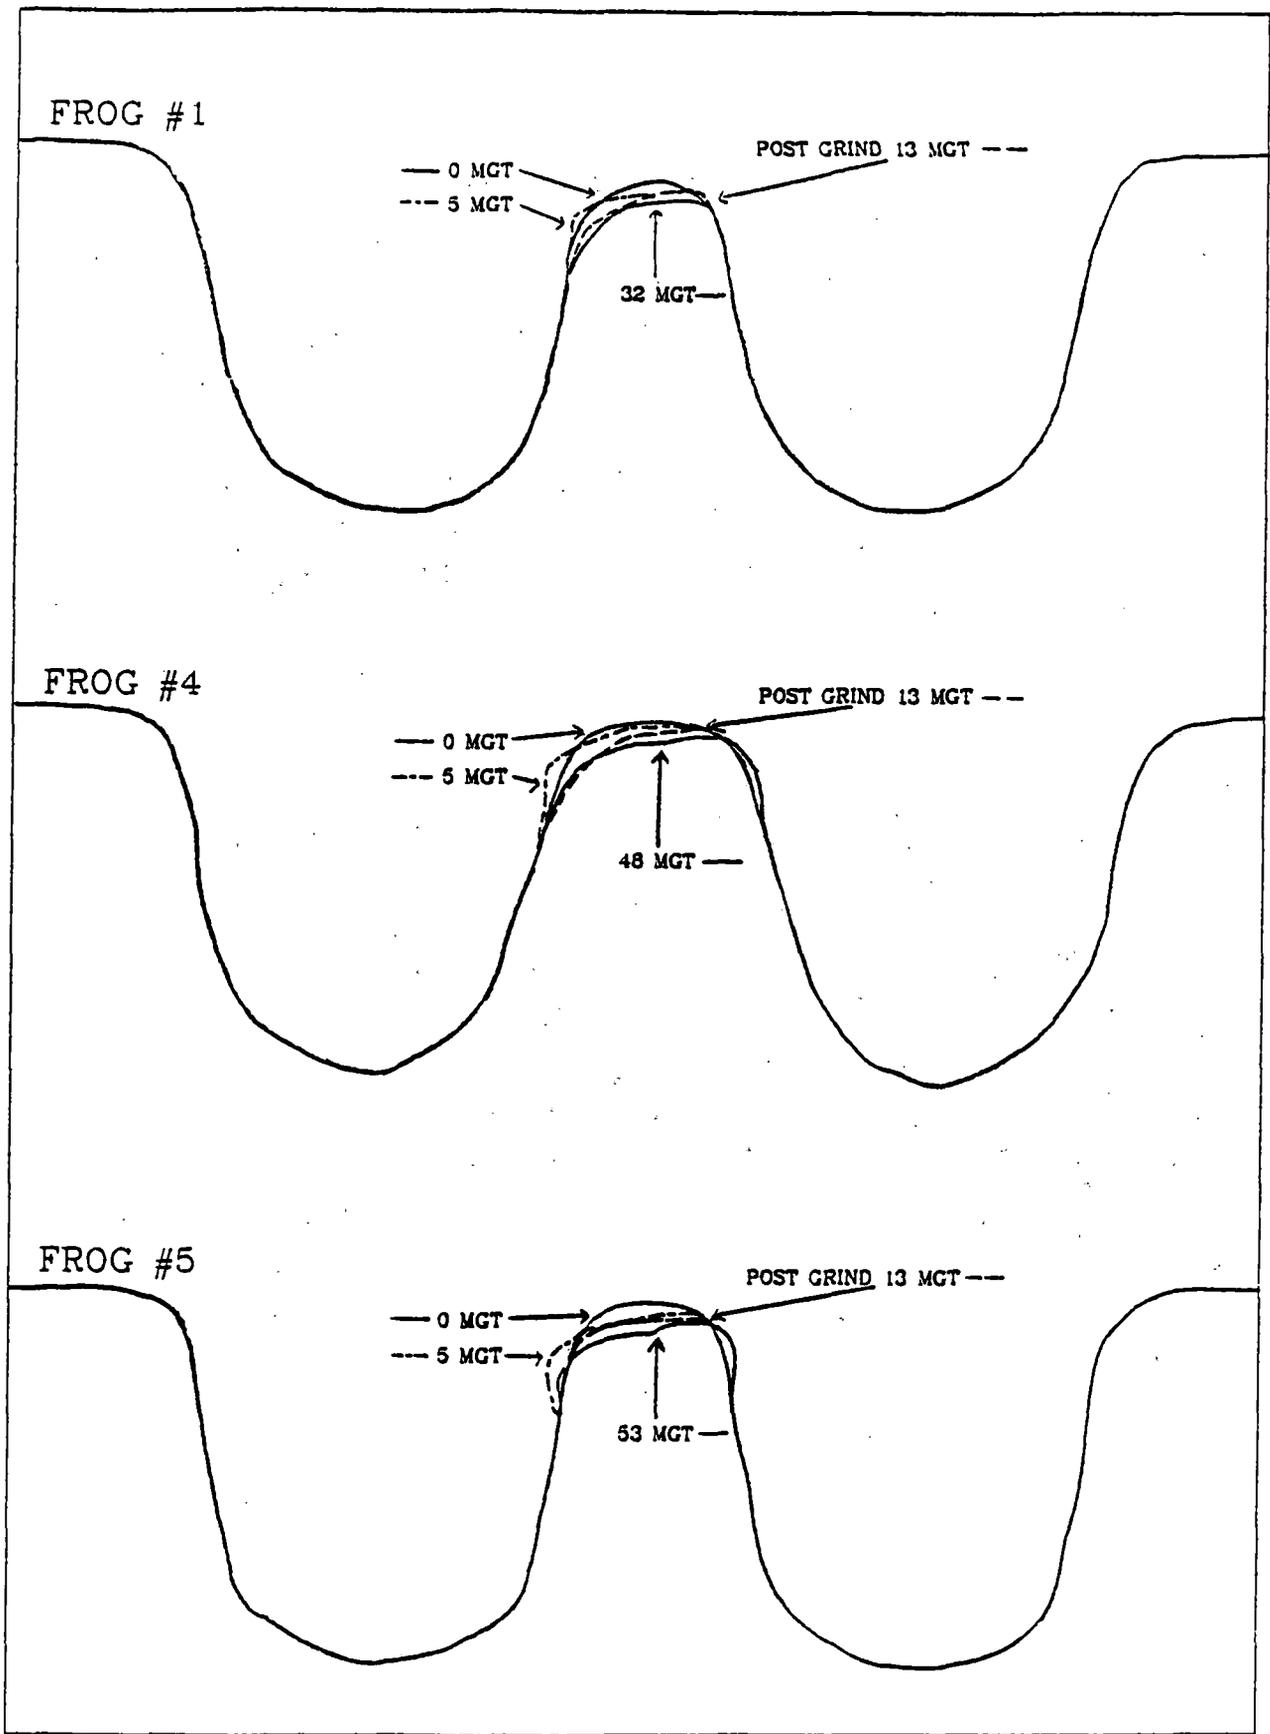
Figure 9. Overlaid Profiles of AREA Frogs

Metal flow on the frog points was very similar for all three AREA frogs. At 5 MGT, the CNW (#4) and Bethlehem (#5) frogs had more metal flow than the Nortrak frog but in a similar pattern. This was due to the different design height of the point at the measurement location, 5 inches behind the 1/2 inch POF. At this location, the CNW and Bethlehem frog points were slightly taller in relation to the wing rails than the Nortrak frog point. The taller points initially supported the brunt of the vertical wheel load, while the shorter point shared the load more with the wing rail. After 13 MGT, the metal flow on all three points was only slightly more than it was at 5 MGT. At this time the frogs were all ground to reduce the incidence of surface fatigue. The post-grind profiles, which were checked with an AREA frog contour gage, can be seen in Figure 9. Subsequently, the metal flow rate has slowed down and will probably continue to do so as the wing rail absorbs more of the vertical loads.
