# **REPORT NO. FRA/ORD-79/09.1**

# **POSTMORTEM INVESTIGATION OF** THE KANSAS TEST TRACK

**NOVEMBER 1979** FINAL REPORT

**U.S. DEPARTMENT OF TRANSPORTATION** FEDERAL RAILROAD ADMINISTRATION Office of Research and Development Washington, D.C. 20590

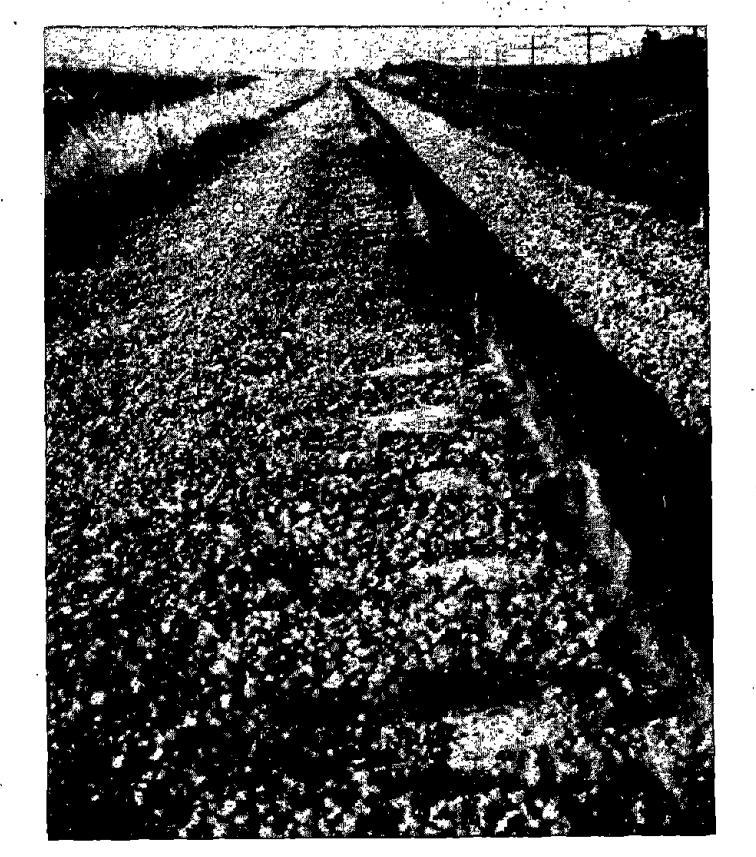
conditions were in evidence at many locations, being particularly severe in Track Sections 1, 4, 6, and 7 after heavy downpours. Typical conditions in the conventional track structures are illustrated in Figure 3. Two kinks in the KTT track occurred on 6 June 1975; these kinks were located in Track Sections 1 and 2, respectively, and were attributed to loss of lateral tie support in the mud-fouled ballast. These and other operational problems prompted FRA to close the KTT permanently on 11 June 1975.

FIGURE 3. TYPICAL EXAMPLES OF PUMPING IN THE CONVENTIONAL TRACK STRUCTURES

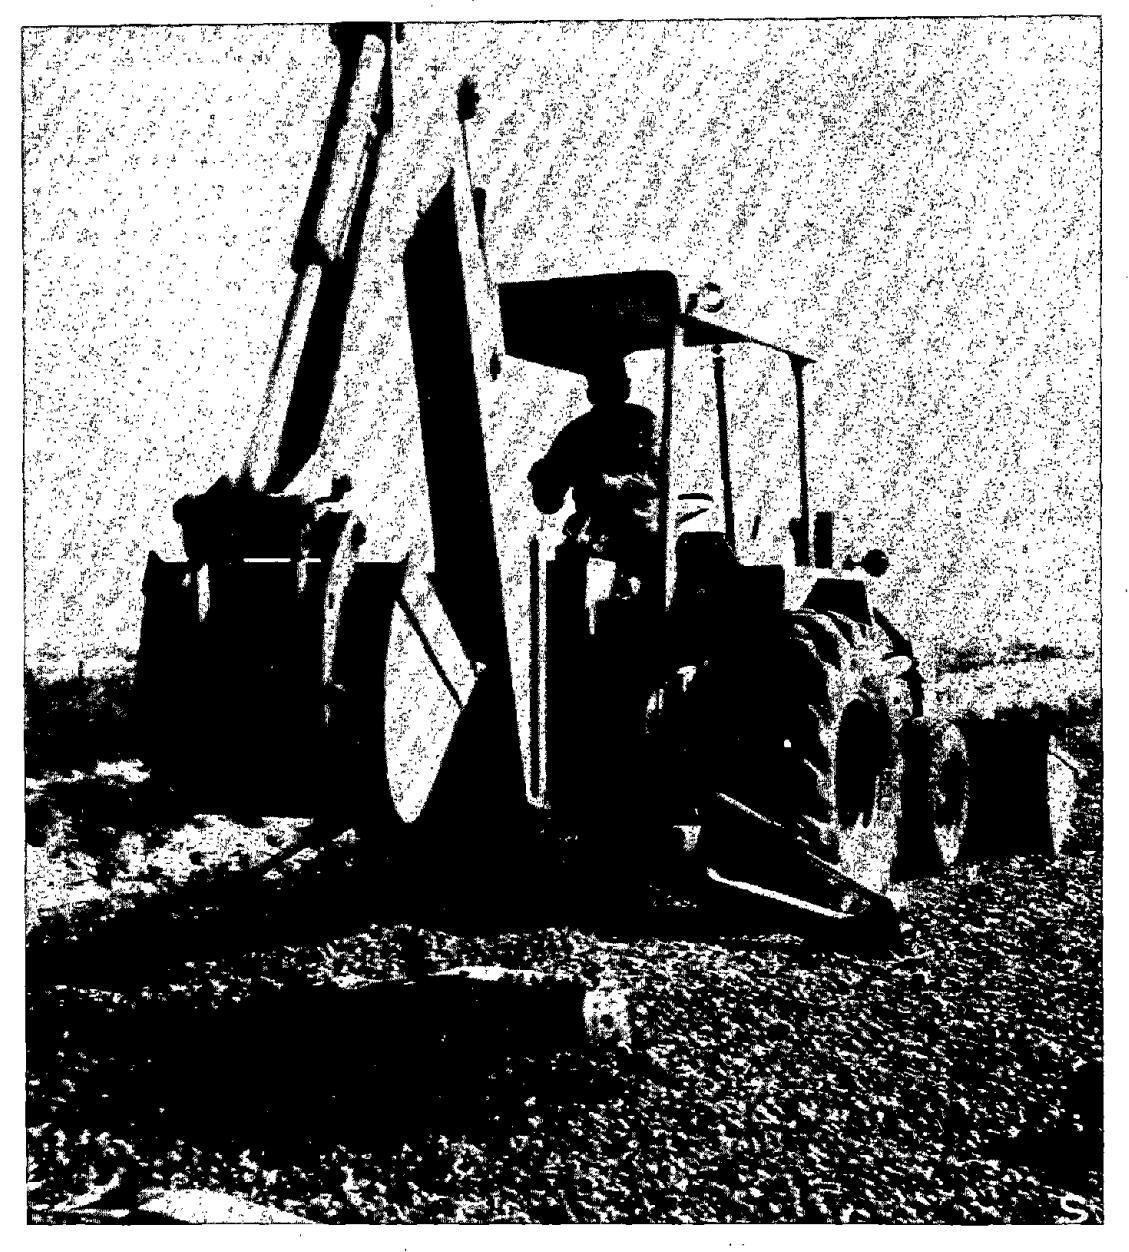
FIGURE 37. REMOVAL OF CONVENTIONAL TRACK STRUCTURES FROM TEST LOCATION 2A (TRACK SECTION 2)

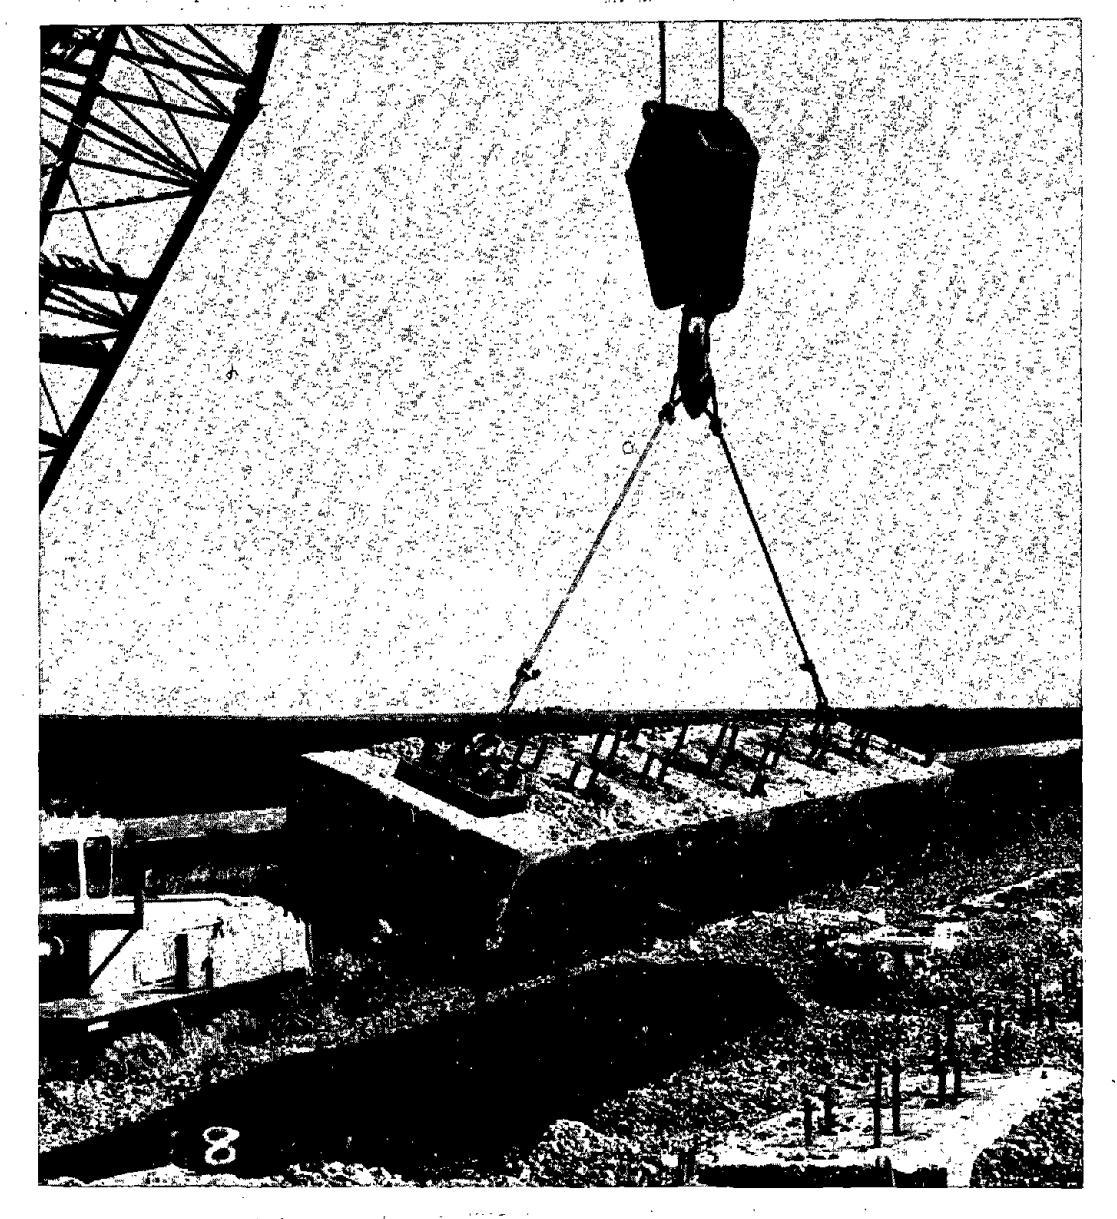
FIGURE 38. REMOVAL OF NONCONVENTIONAL TRACK STRUCTURES FROM TEST LOCATION (TRACK SECTION 7)

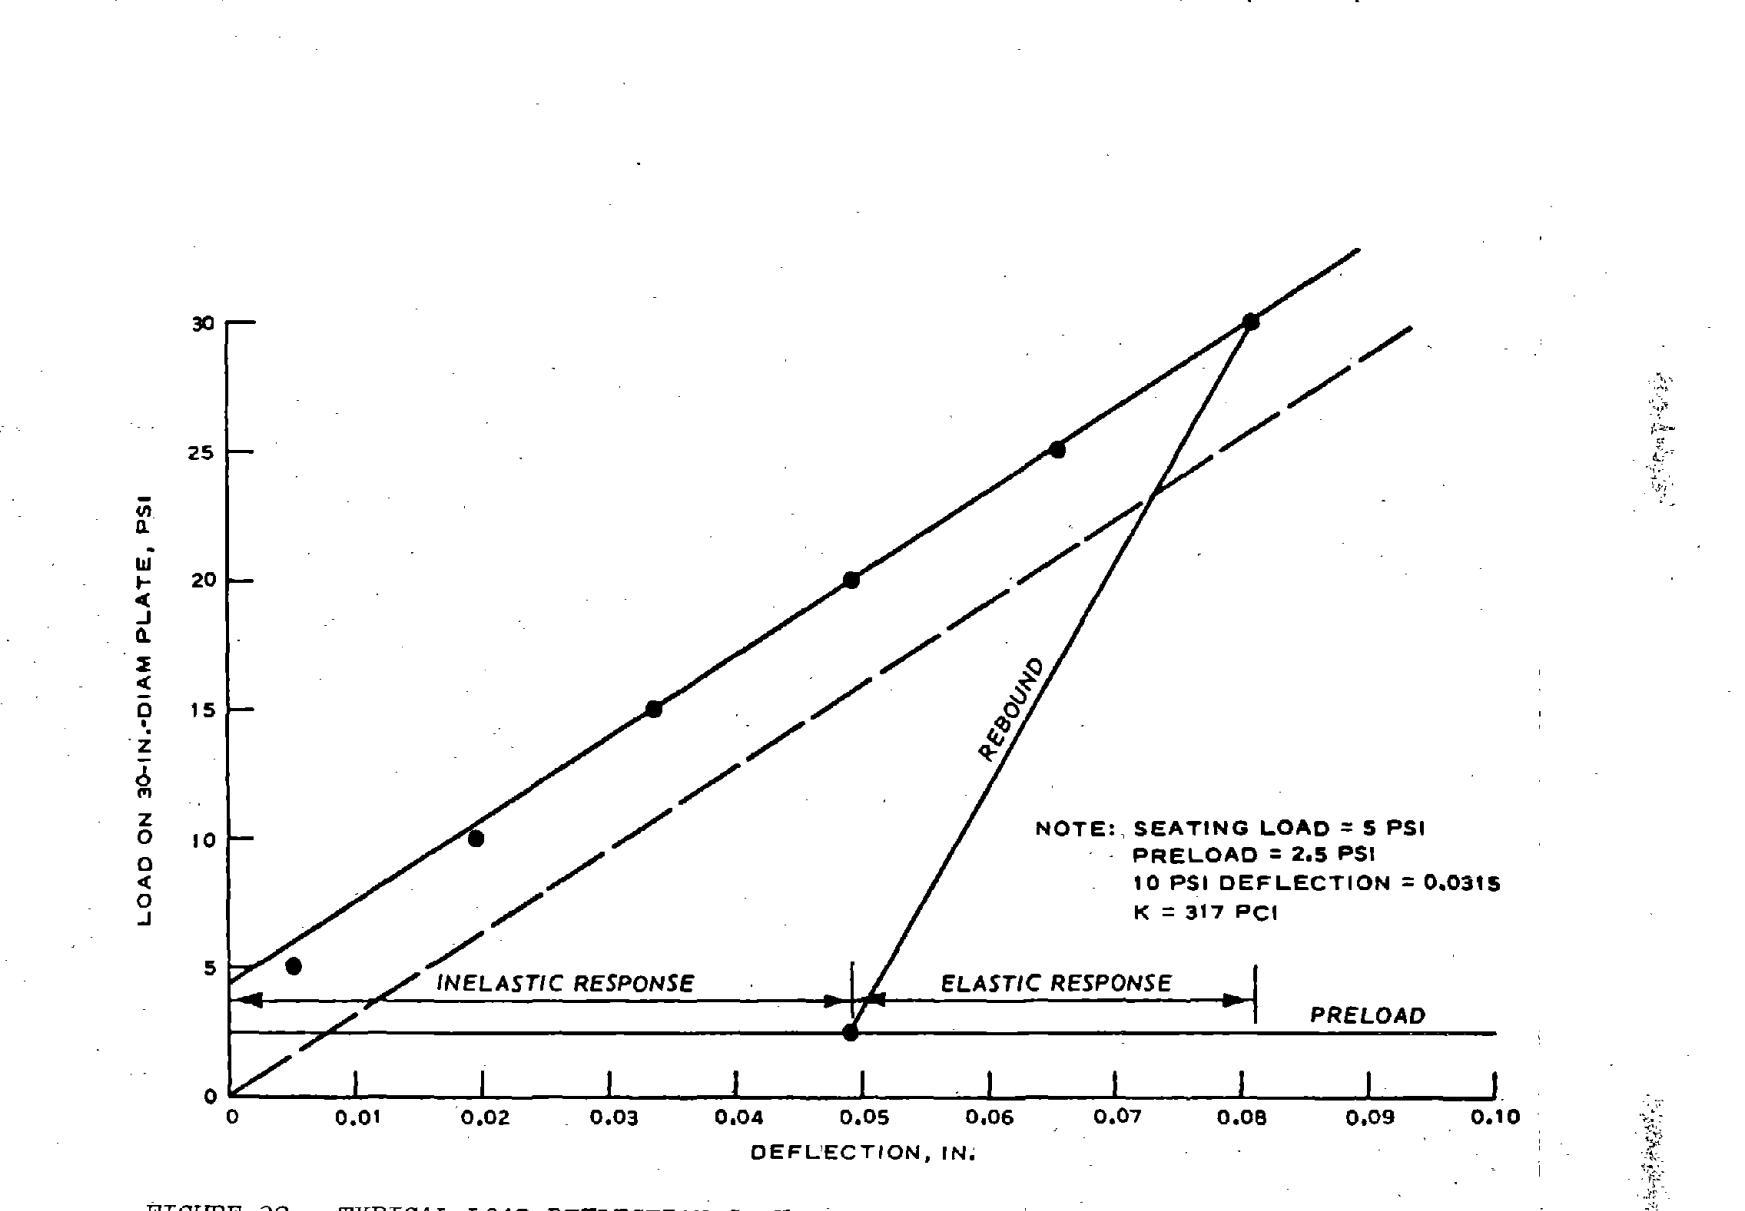
At each pit location the track structure was first removed by lifting vertically with either a backhoe (Figure 37) or a crane (Figure 38) to minimize disturbance of the ballast beneath. Next, 30-in.diam plate bearing tests were run at the structure-ballast interface, as described in ASTM Method D1196-64.<sup>12</sup> Results of these tests are summarized in Table 2. A typical load deflection curve for the plate bearing test is shown in Figure 39. It can be seen from Figure 39 that a large part of the total deflection was not recoverable.

FIGURE 39. TYPICAL LOAD-DEFLECTION CURVE FROM 30-IN.-DIAM PLATE BEARING TESTS ON THE BALLAST BENEATH THE TRACK STRUCTURES, KANSAS TEST TRACK SECTION 2B, CROSSTIE NORTH RAIL

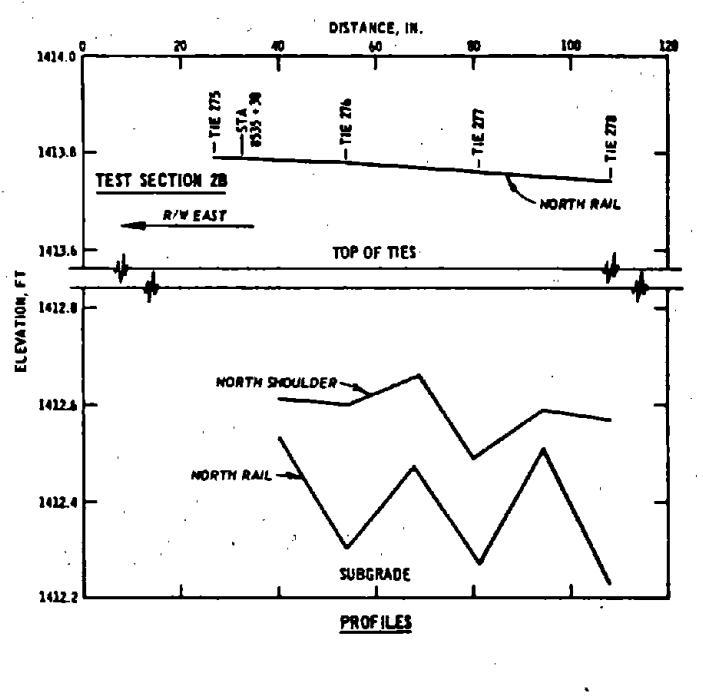
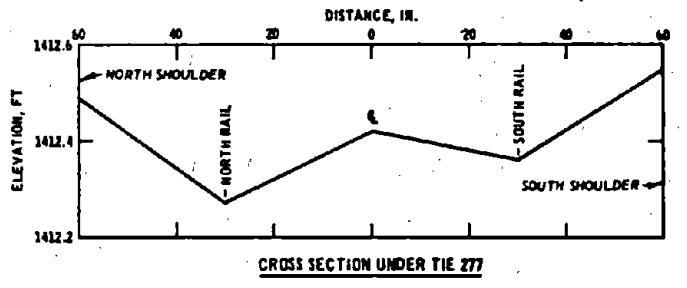
rail seats of the ties. An example of the profiles and cross-section data taken at the subgrade surface is shown in Figure 41; these data were obtained in Test Pit 2B, Track Section 2. Maximum absolute and relative deformations of the subgrade in each test pit, from construction and postmortem survey data, are summarized in Table 3. Both absolute (survey) and differential (pit cross section or profile maximum) deformations are shown in Table 3. However, the absolute deformations shown in Table 3 are not believed to be accurate because (1) finished subgrade elevations were established only at four points over the length of the KTT, none of which corresponded with any pit location,<sup>9</sup> and (2) the embankment heaved differentially between 1971 and 1974 and settled differentially under traffic in the period October 1974 through April 1975.6 Consequently, the beginning subgrade elevation at each test pit is not well defined. The accuracy of vertical deformation measurements is questionable when main array deformations exceeded +1 in. from mechanical zero, and only the postmortem survey measurements provide detailed profile and cross-section elevations within each test pit area. The postmortem data are presented in more detail in Volume II.

FIGURE 41. SURVEY CROSS SECTION AND PROFILES OBTAINED AT THE BALLAST-SUBGRADE INTERFACE, TEST PIT 2A (TRACK SECTION 2)

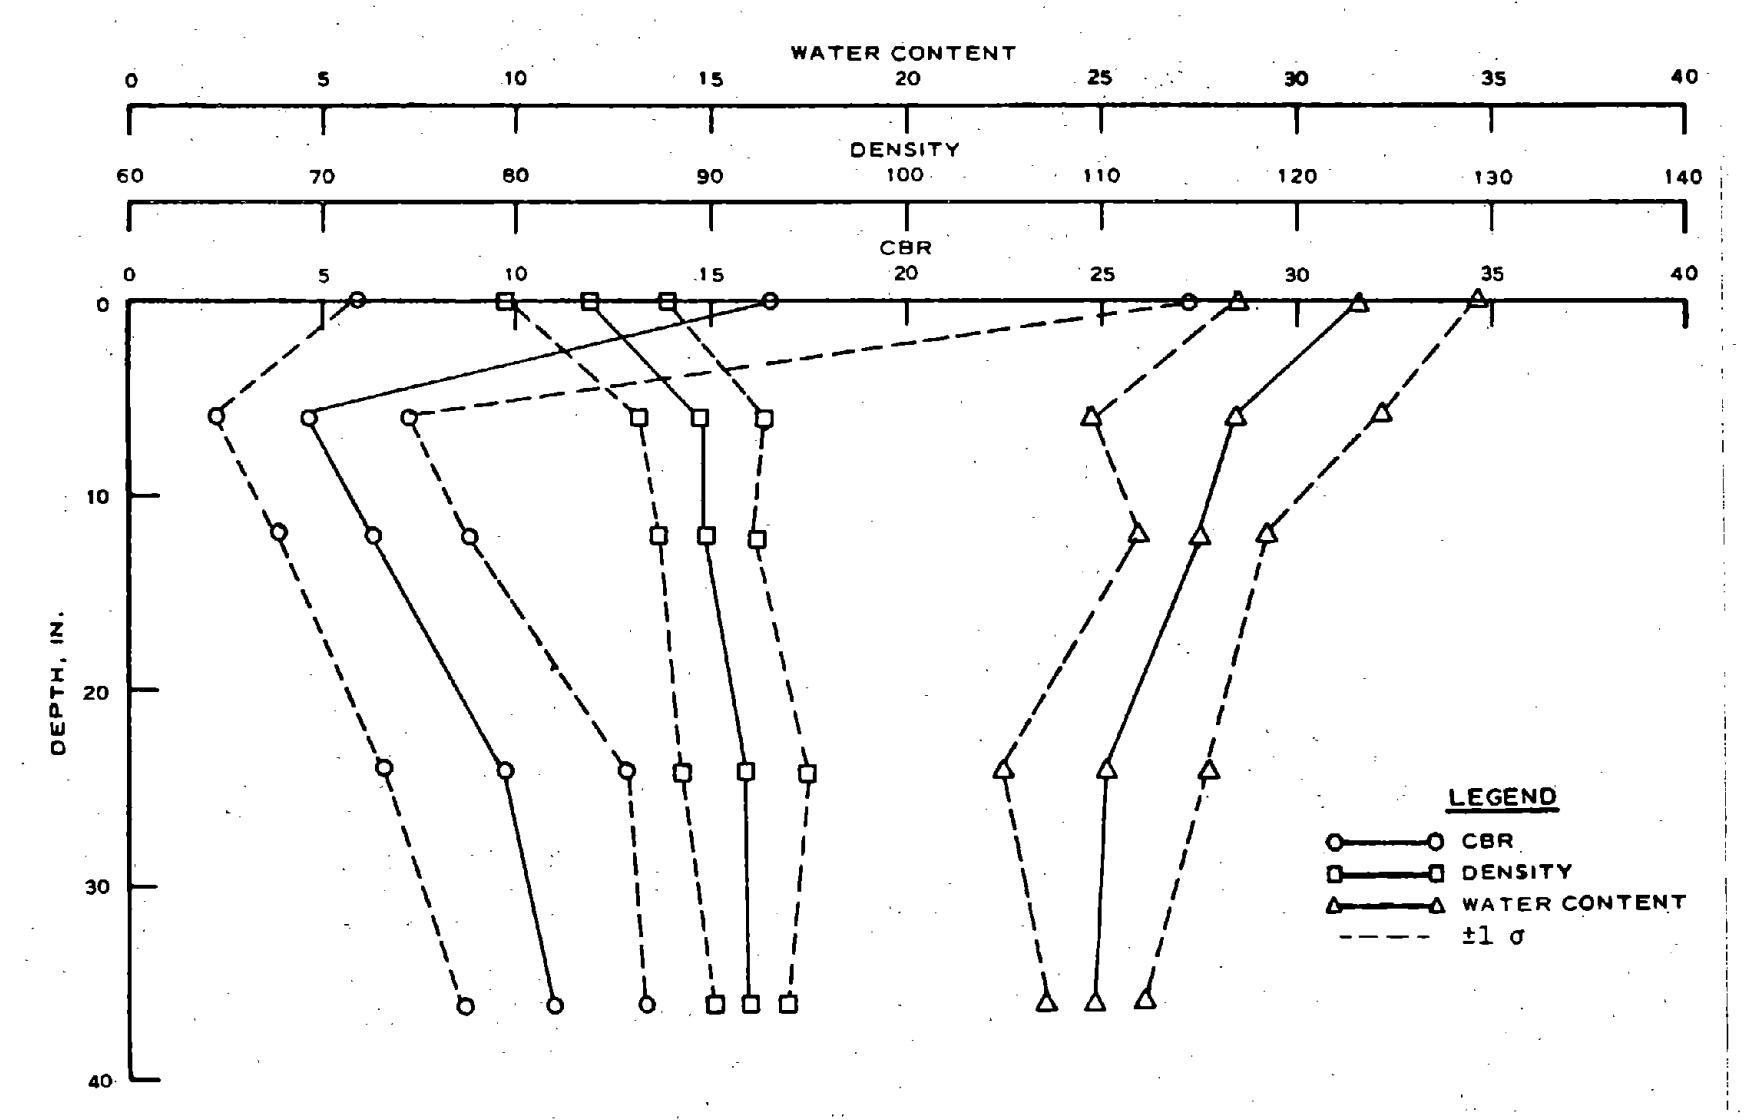
FIGURE 52. MEAN AND STANDARD DEVIATION CURVES FOR AVERAGE WATER CONTENT, DRY DENSITY, AND CBR DATA FROM ALL TEST PITS VERSUS DEPTH IN THE EMBANKMENT

Based on the average postmortem field moisture content, density, and CBR test results presented in Figure 52, the embankment is also characterized as having high-surface and near-surface moisture contents which tend to decrease with depth. The postmortem (1976) average moisture contents to a depth of 3 ft exceed the average (1971) embankment construction moisture content of 24.3 percent.<sup>6</sup> The CBR curves in Figures 52 and 61 illustrate that strength decreases in the embankment clay as water content increases. However, and as expected, the remanent lime-stabilized surface layer provided higher CBR values than the underlying clay. The CBR test locations, which were patterned to typify conditions at points of interest beneath the structures, were statistically analyzed with the results shown in Table 11. The "F" (variance) and Student "t" (mean) statistical tests were used to assess the CBR results. At the 90 percent confidence level, the means were not equal in only two statistical cases. There is then a 90 percent probability that:

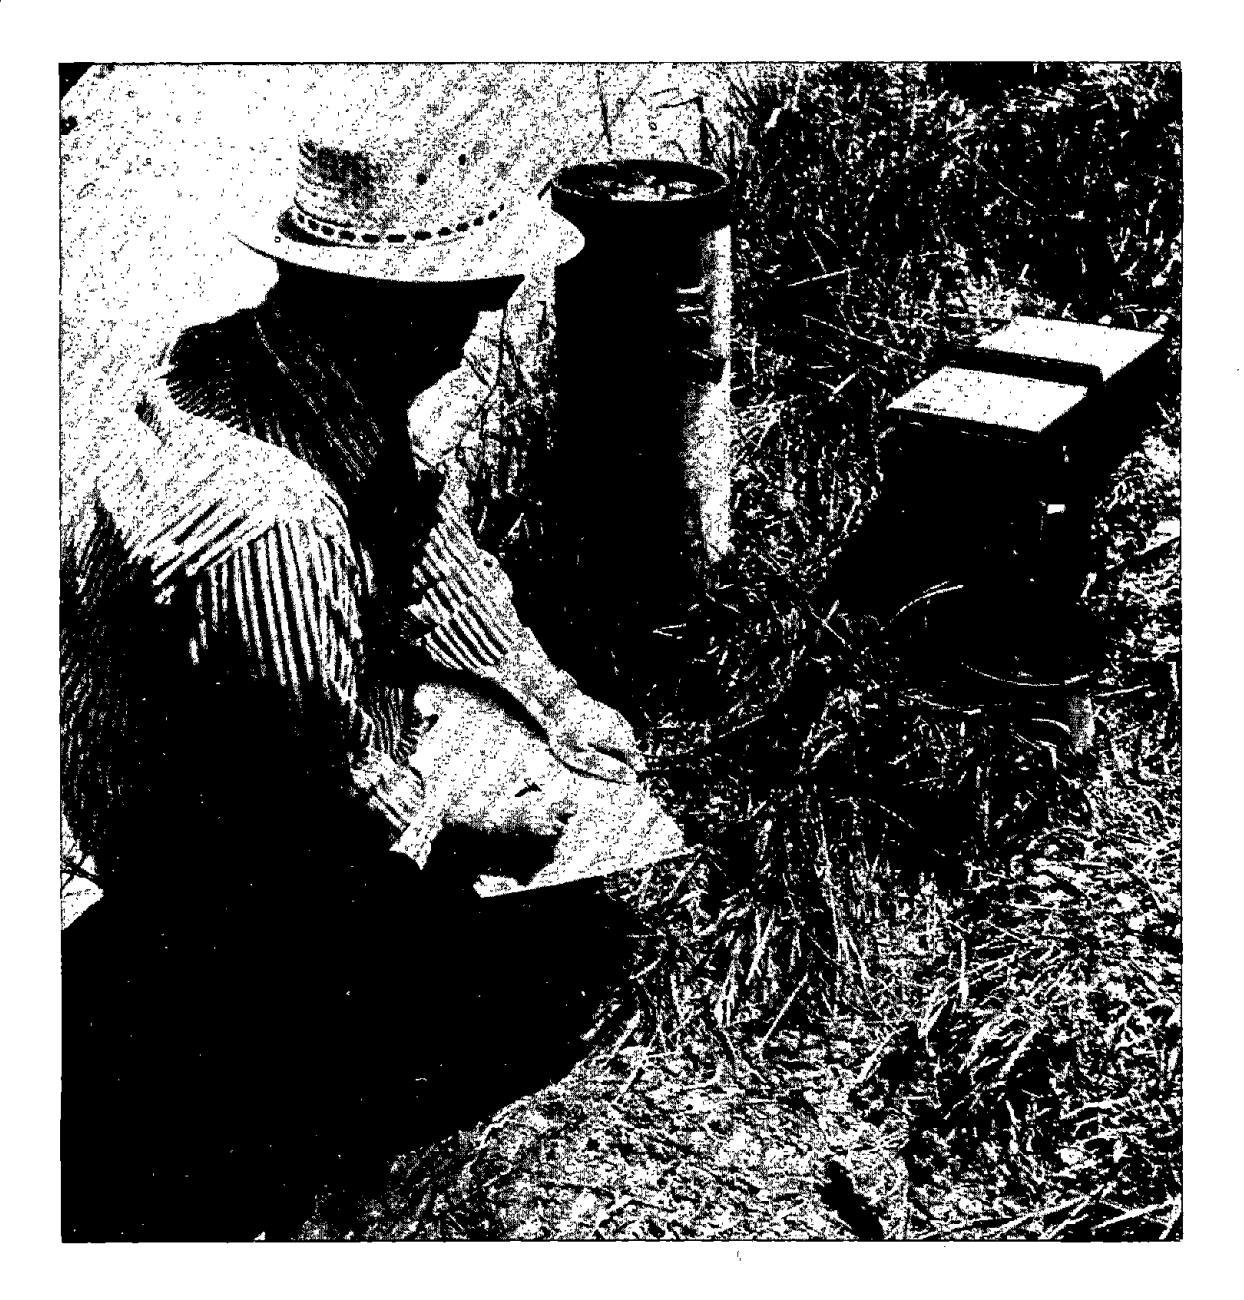
The embankment instrumentation investigation was carried out by an electronics engineer. In the first phase of this work, a field check was made to determine insulation values for the pressure, moisture, temperature, and main array vertical extensometer circuitry. Figure 53 shows this work in progress. Typical results of the field insulation checks are summarized in Table 4. In general, 100 megohms or higher values of insulation resistance to ground are desired for relatively noise-free electrical measurements. Usable electronic signals can, of course, be obtained with insulation values less than optimum; but below 10 megohms insulation resistance, the signal to noise ratio decreases rapidly and noise levels tend to affect measurement precision. Approximately 50 percent of the insulation values recorded for the vertical extensometers and pressure cells in Track Section 2 were less than 10 megohms, as shown in Table 4. Circuits of the moisture-temperature cells connect through the sensor to ground, so relatively low values of insulation are to be expected when readings are made at the cable terminals. Final readings of the vertical extensometers were also made, and these readings are tabulated in Table 5.

FIGURE 53. FIELD CHECK OF MAIN ARRAY INSTRUMENTATION READOUTS

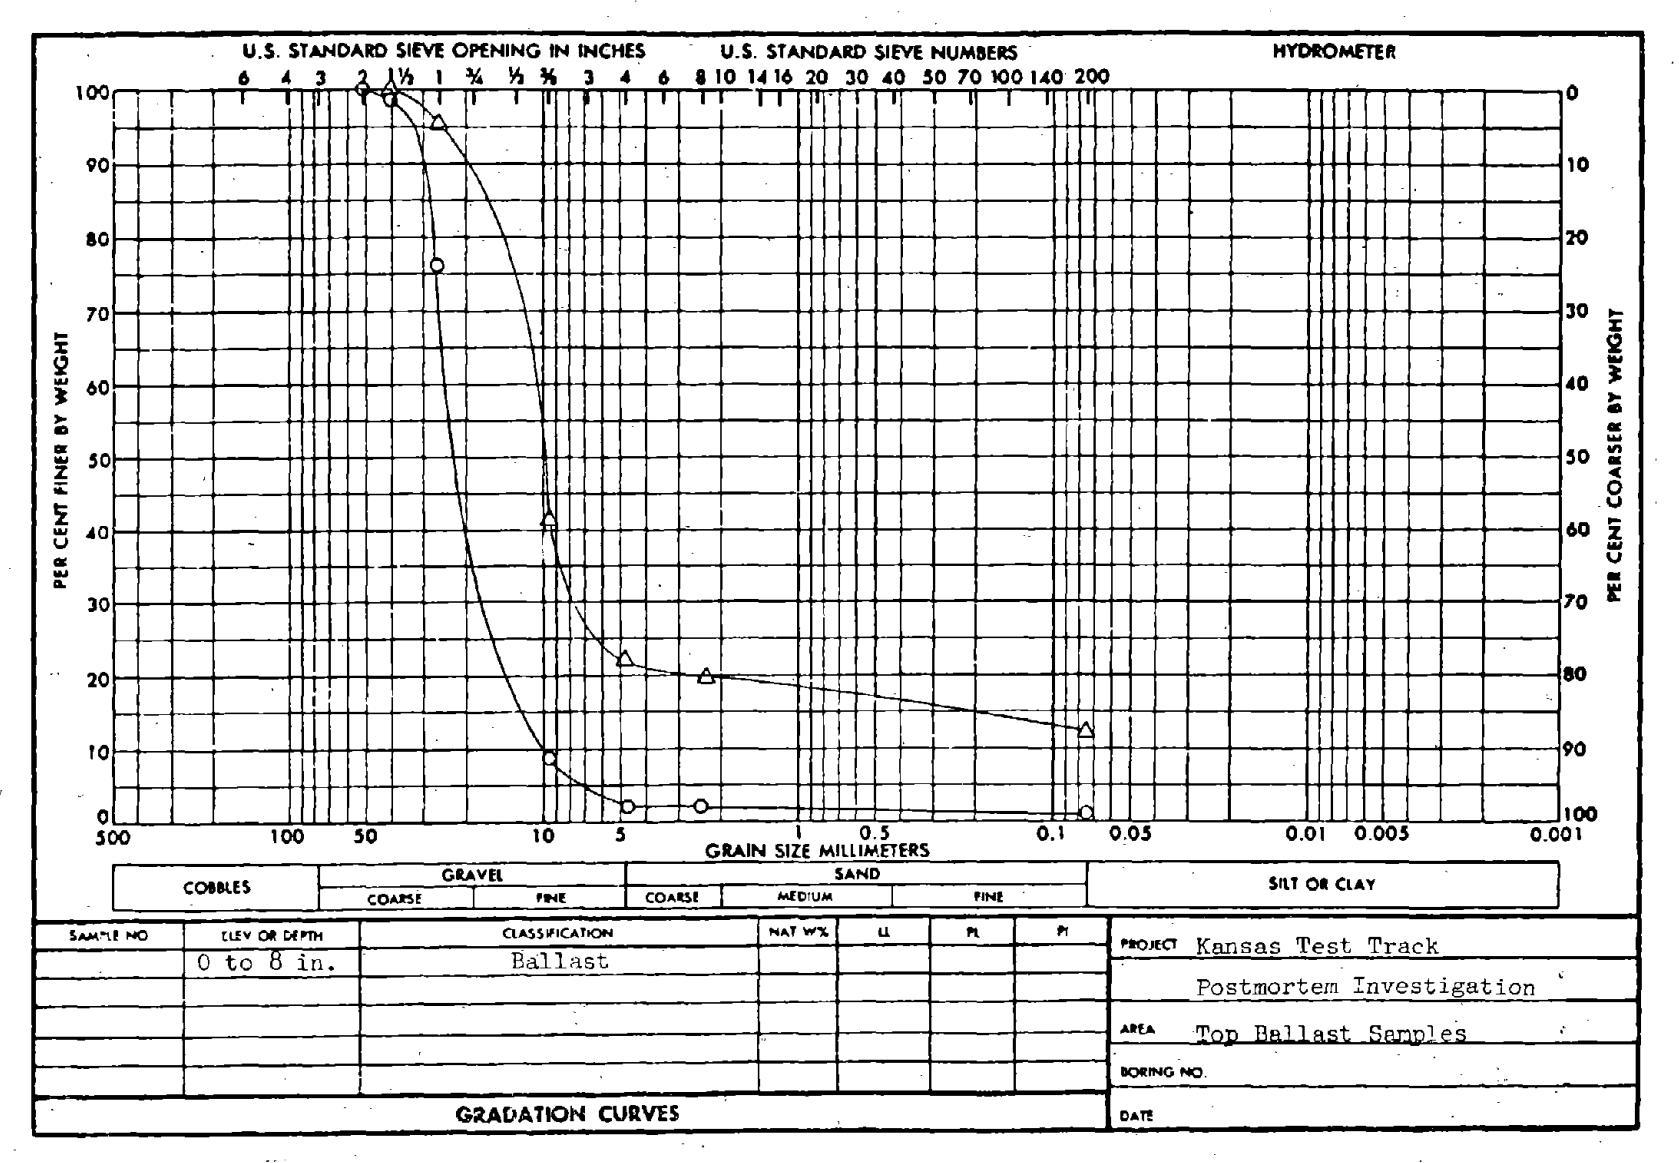
FIGURE 58. RANGE IN GRADATION OF "TOP" BALLAST SAMPLES

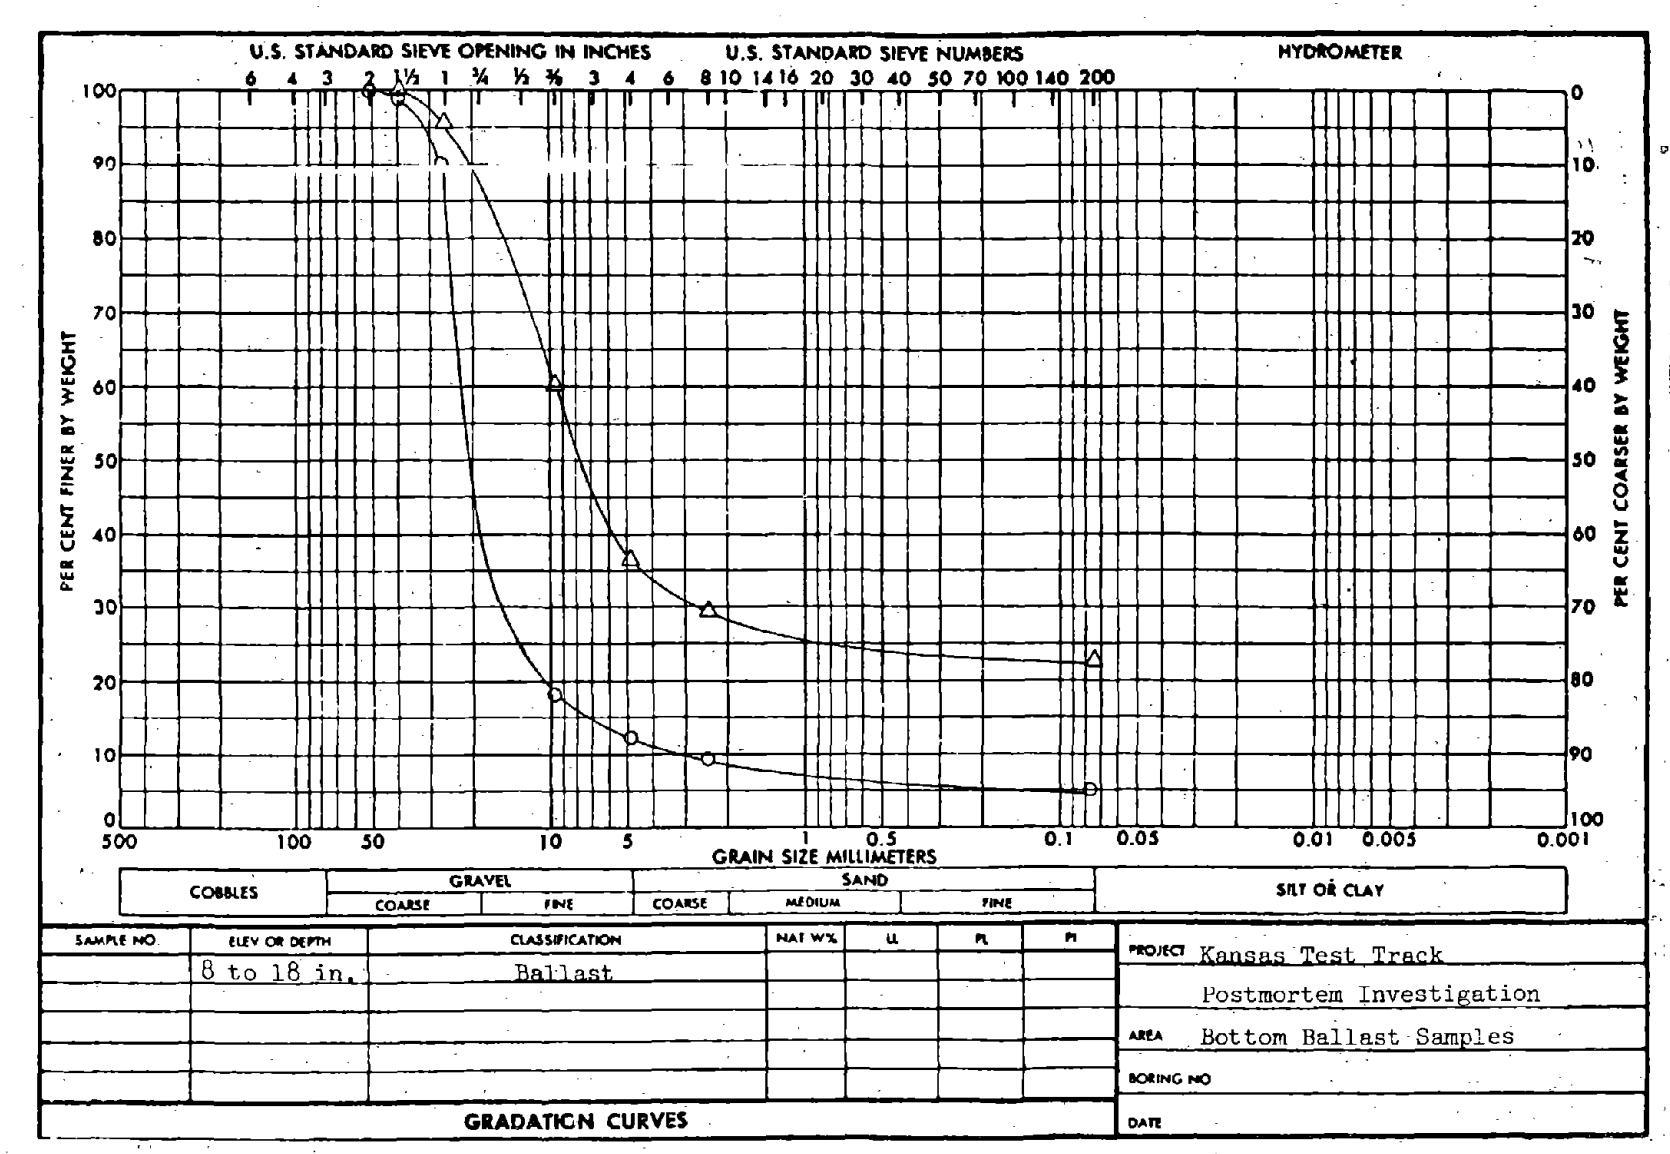
FIGURE 59. RANGE IN GRADATION OF "BOTTOM" BALLAST SAMPLES

amount of fines (15 or more percent by weight passing the 200 sieve) in the lower ballast level. The control (shoulder) sample gradation tests indicated less than 7 percent passing the 200 sieve. Atterberg limit tests were performed on the lower ballast fines; however, these test results were inconclusive because of small rock particles which were present in the material. These particles probably originated as (1) fines originally present in the ballast, (2) the products of ballast abrasion, (3) concrete particles resulting from ballast-tie abrasion, or, more likely, (4) a combination of all of these processes. The raw data and statistical analyses indicated that a slightly greater amount of fines was typically present under the north rail than under the south rail. While this difference was not statistically significant, the raw data do support the argument that pumping conditions were probably worse under the north rail.

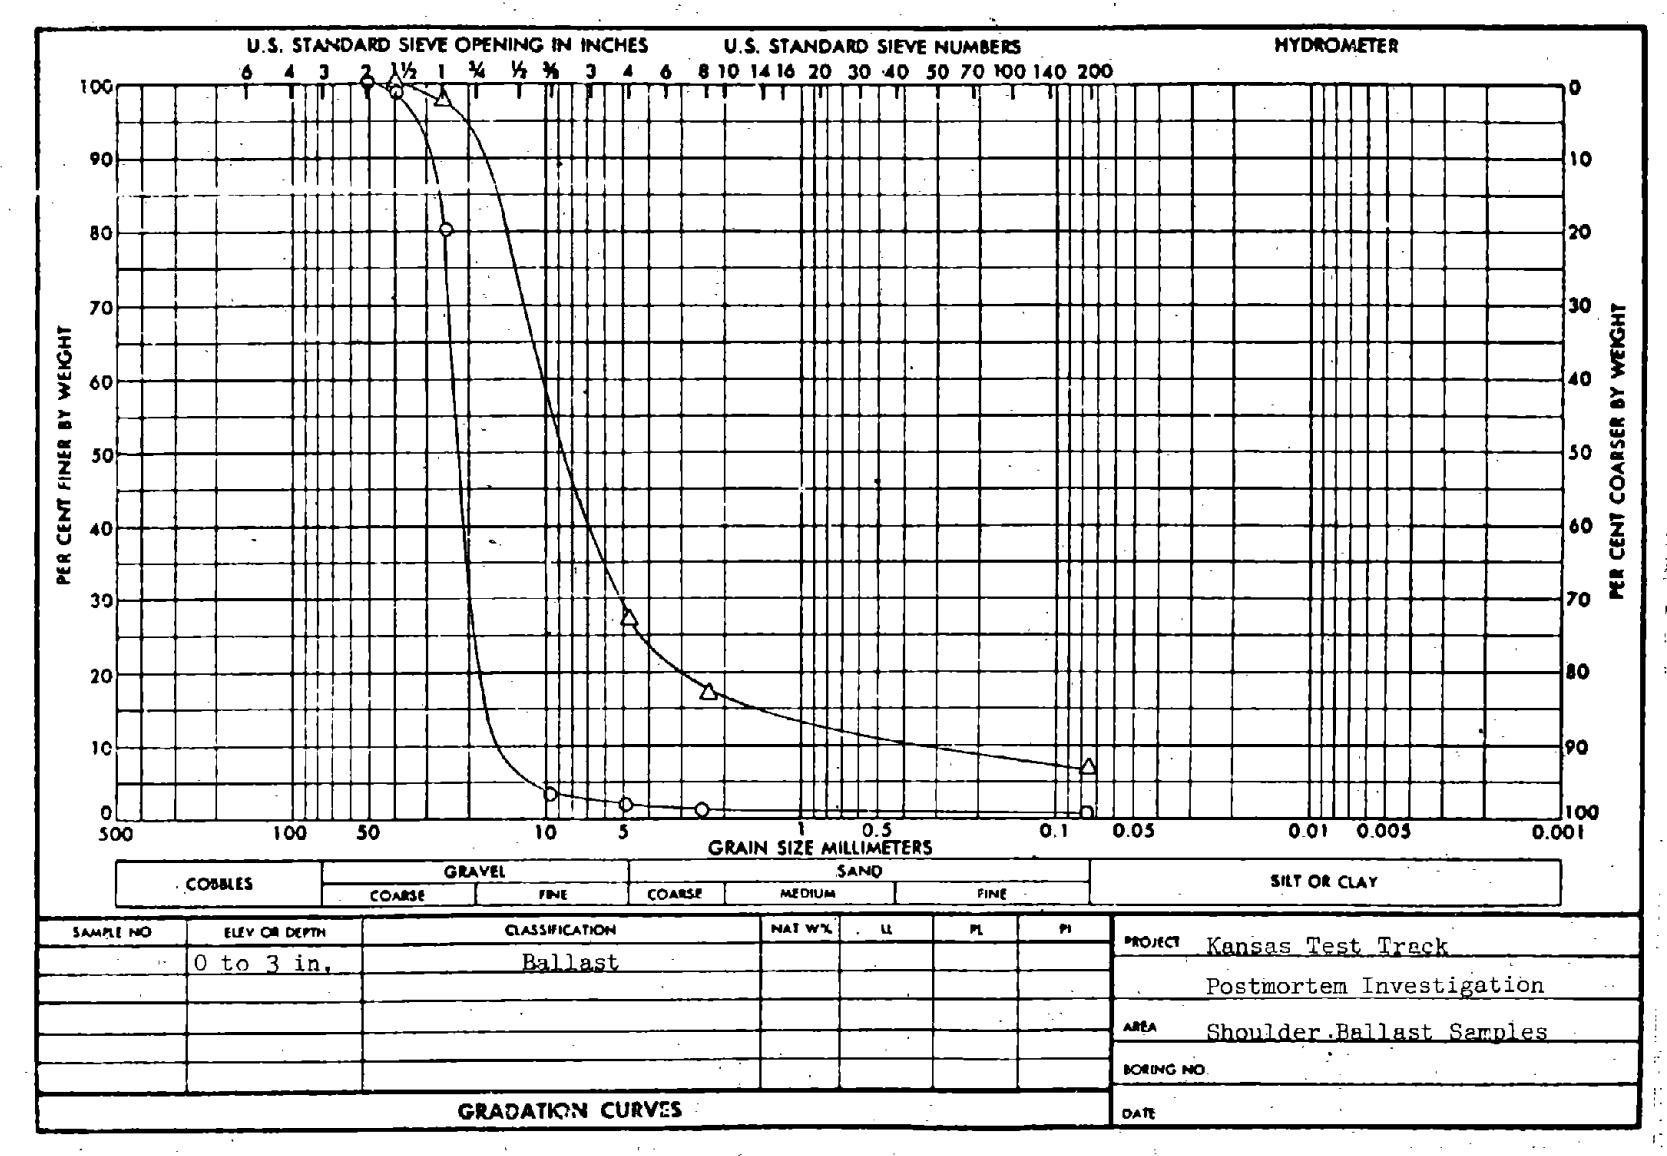
FIGURE 60. RANGE IN GRADATION OF "SHOULDER" BALLAST SAMPLES

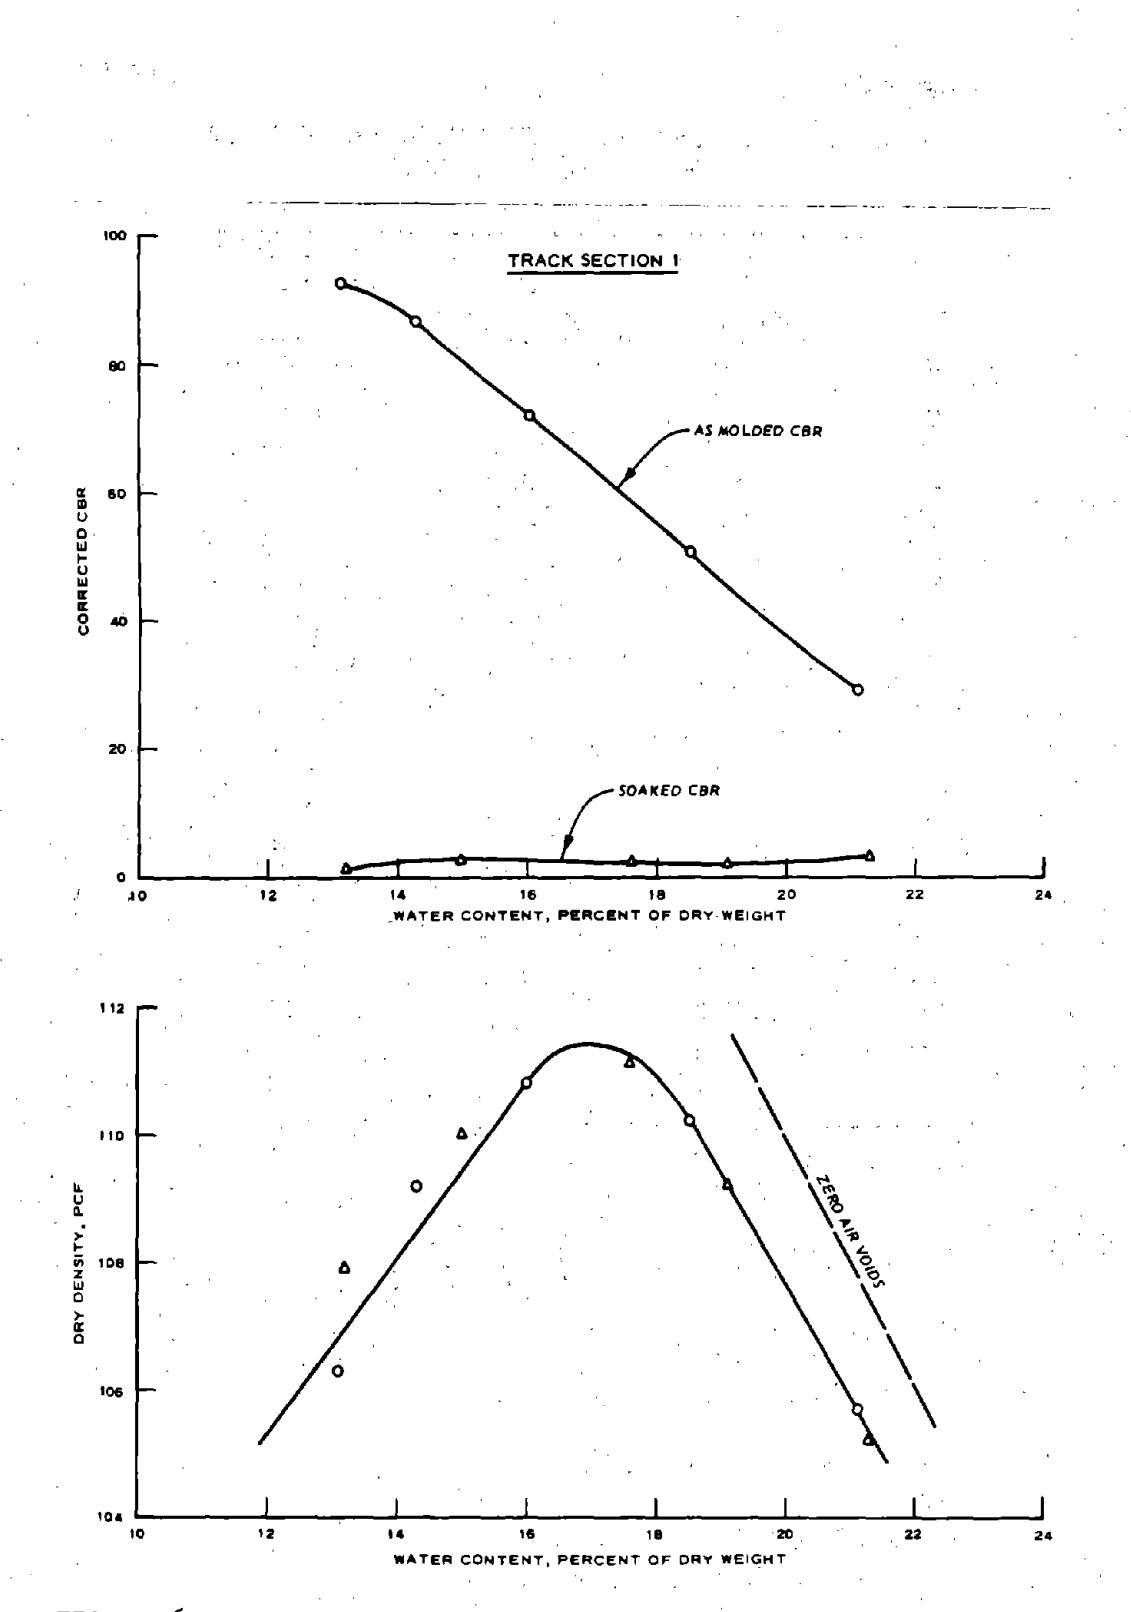
specimens and on specimens which had soaked in water for 4 days. Typical CBR and compaction test results from Track Section 1 are shown in Figure 61. By averaging all the compaction test results, an optimum water content of 16.6 percent and a maximum dry density of 111.7 pcf were determined to be representative values for the embankment clay.

It should be noted for future reference (Figure 61) that the soaked specimens had little strength.

FIGURE 61. TYPICAL LABORATORY CBR AND COMPACTION TEST RESULTS (ON SPECIMENS REMOLDED FROM BAG SAMPLE OBTAINED IN TEST PIT 1, TRACK SECTION 1)

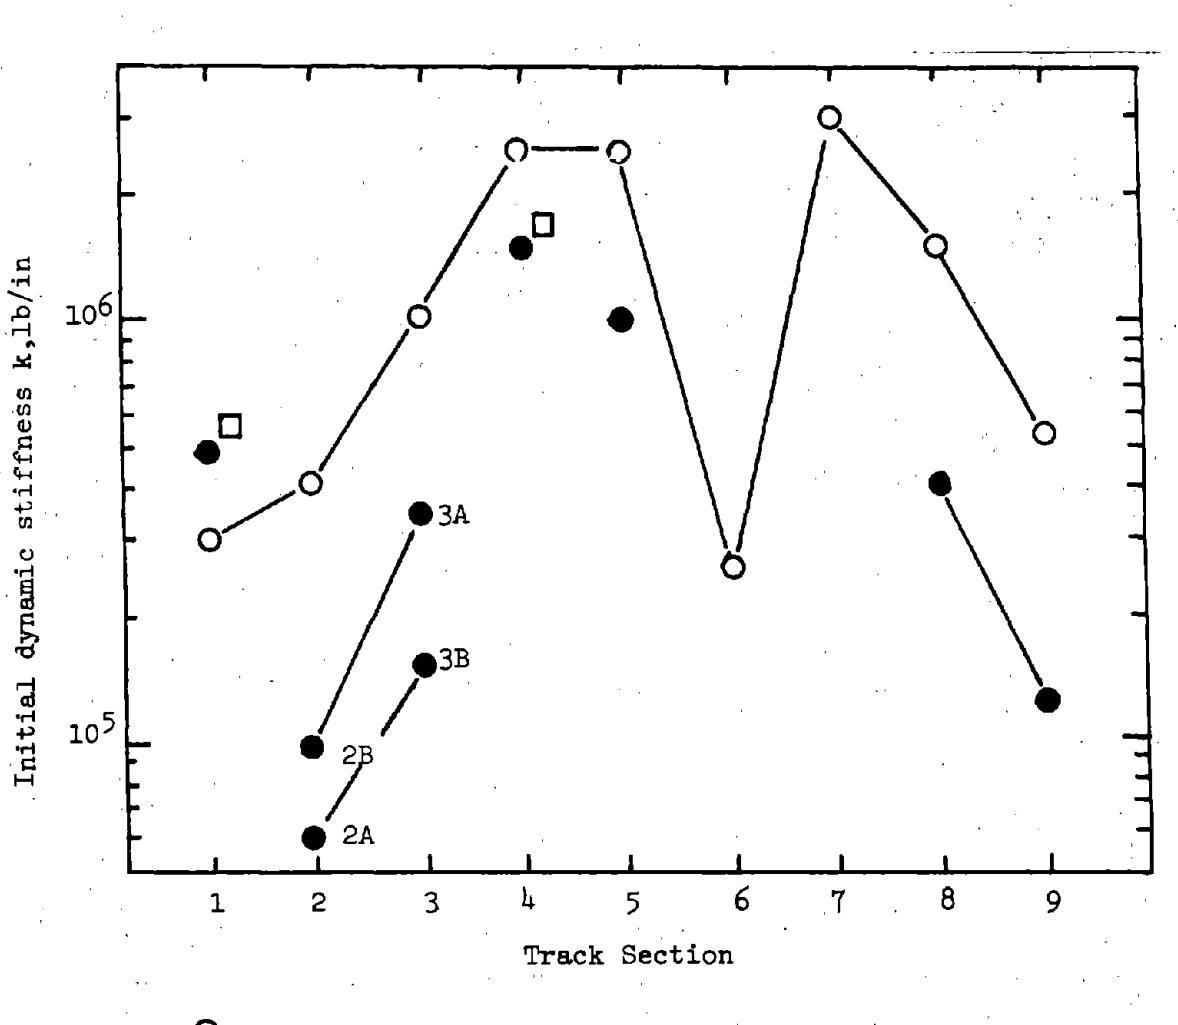
Impedance test results provide a means for ranking KTT track sections according to their initial dynamic stiffness for both pretraffic and posttraffic conditions. Such a ranking is shown in Figure 62. A precondition for the posttraffic (October 1975) testing was the recreation of pumping conditions (December 1974 through April 1975) at each test location. To that end, up to 16,000 gal of water and 600 passes of a captive train were applied to some test locations. Surface indications of pumping were achieved only in Track Sections 1, 2, and 3. The impedance results in Figure 62 show that this approach resulted in a

FIGURE 62. RANKING OF THE KTT TRACK SECTIONS ACCORDING TO THEIR INITIAL DYNAMIC STIFFNESS IN PRETRAFFIC AND POSTTRAFFIC IM-PEDANCE TESTS

reduction of stiffness (posttraffic) of Track Sections 2, 3, 4, 5, 8, and 9. Track Sections 6 and 7 were not tested for reasons given earlier. However, the attempt to re-create pumping did not succeed in all instances, because Track Section 1 actually exhibited an increase in stiffness and Track Section 4 did not exhibit the degree of softening expected from pretest judgments of performance under traffic.<sup>8</sup> A relative stiffness ranking of KTT track sections was developed by other investigators<sup>14</sup> from tests conducted in December 1974 (when the KTT subgrade was in distress and pumping under traffic). Results of this testing are shown in Figure 63 and are believed to accurately reflect structure, ballast, and, most important, subgrade conditions existing in December 1974.

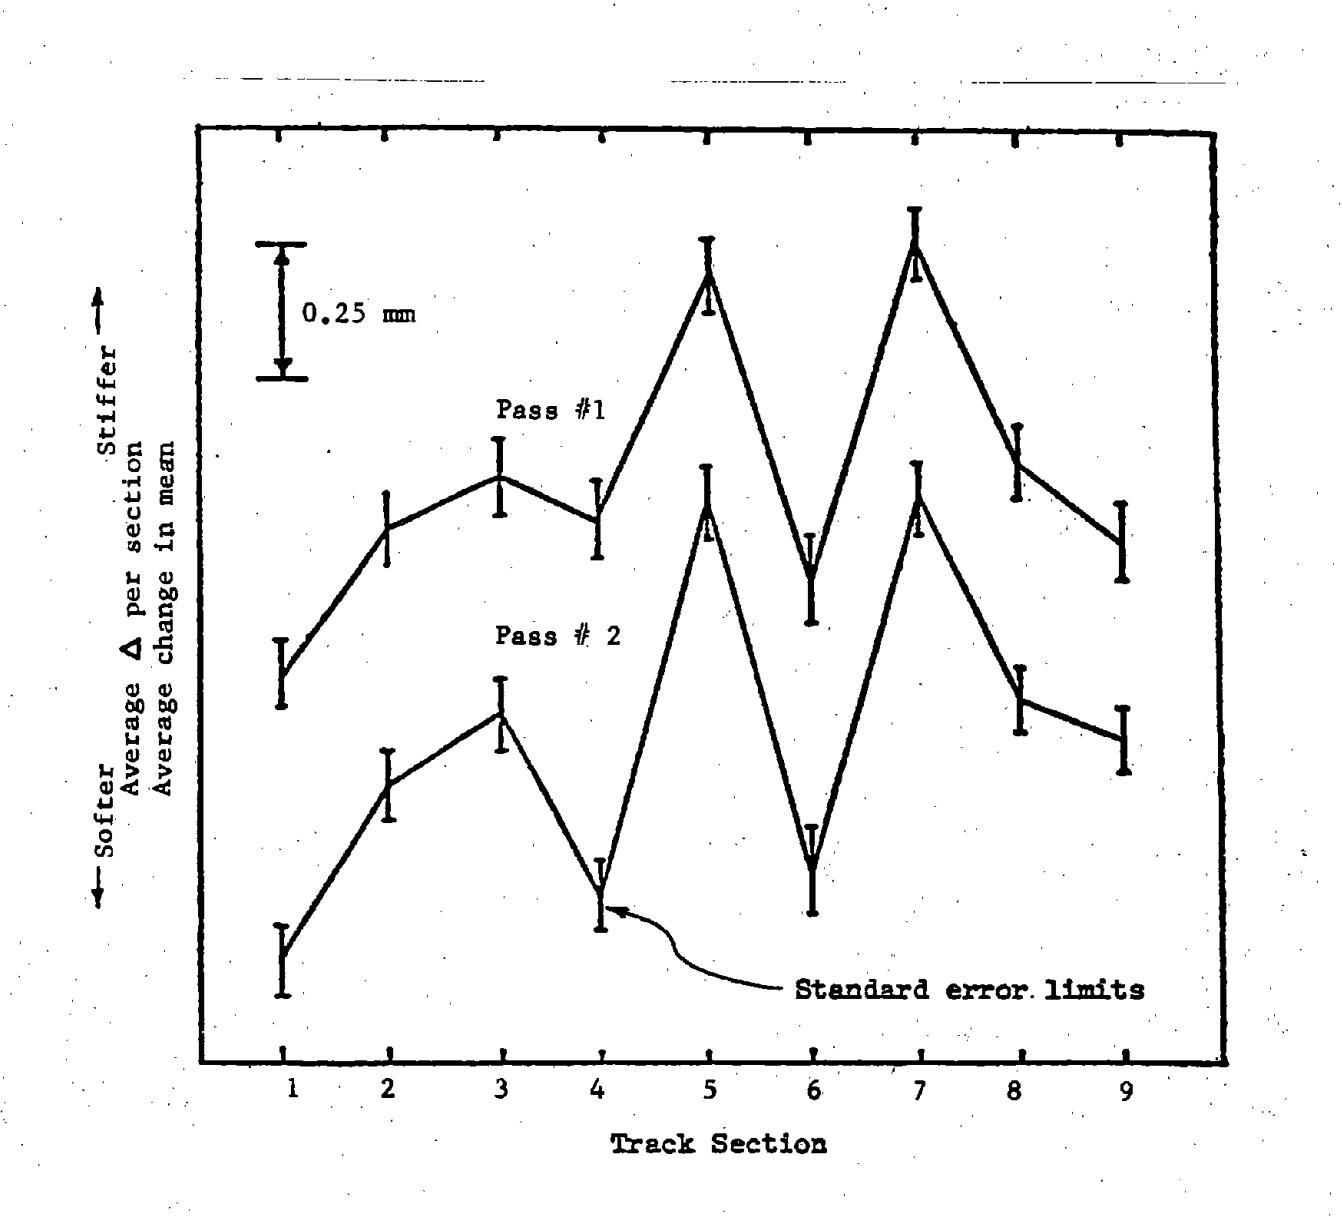
FIGURE 63. RANKING OF THE KTT TRACK SECTIONS ACCORDING TO THEIR REL-ATIVE STIFFNESS UNDER TRAFFIC (FROM TRACK GEOMETRY CAR MEASUREMENTS BY ENSCO, DECEMBER 1974)
