# **REPORT NO. FRA/ORD-79/09.1**

# **POSTMORTEM INVESTIGATION OF** THE KANSAS TEST TRACK

**NOVEMBER 1979** FINAL REPORT

**U.S. DEPARTMENT OF TRANSPORTATION** FEDERAL RAILROAD ADMINISTRATION Office of Research and Development Washington, D.C. 20590

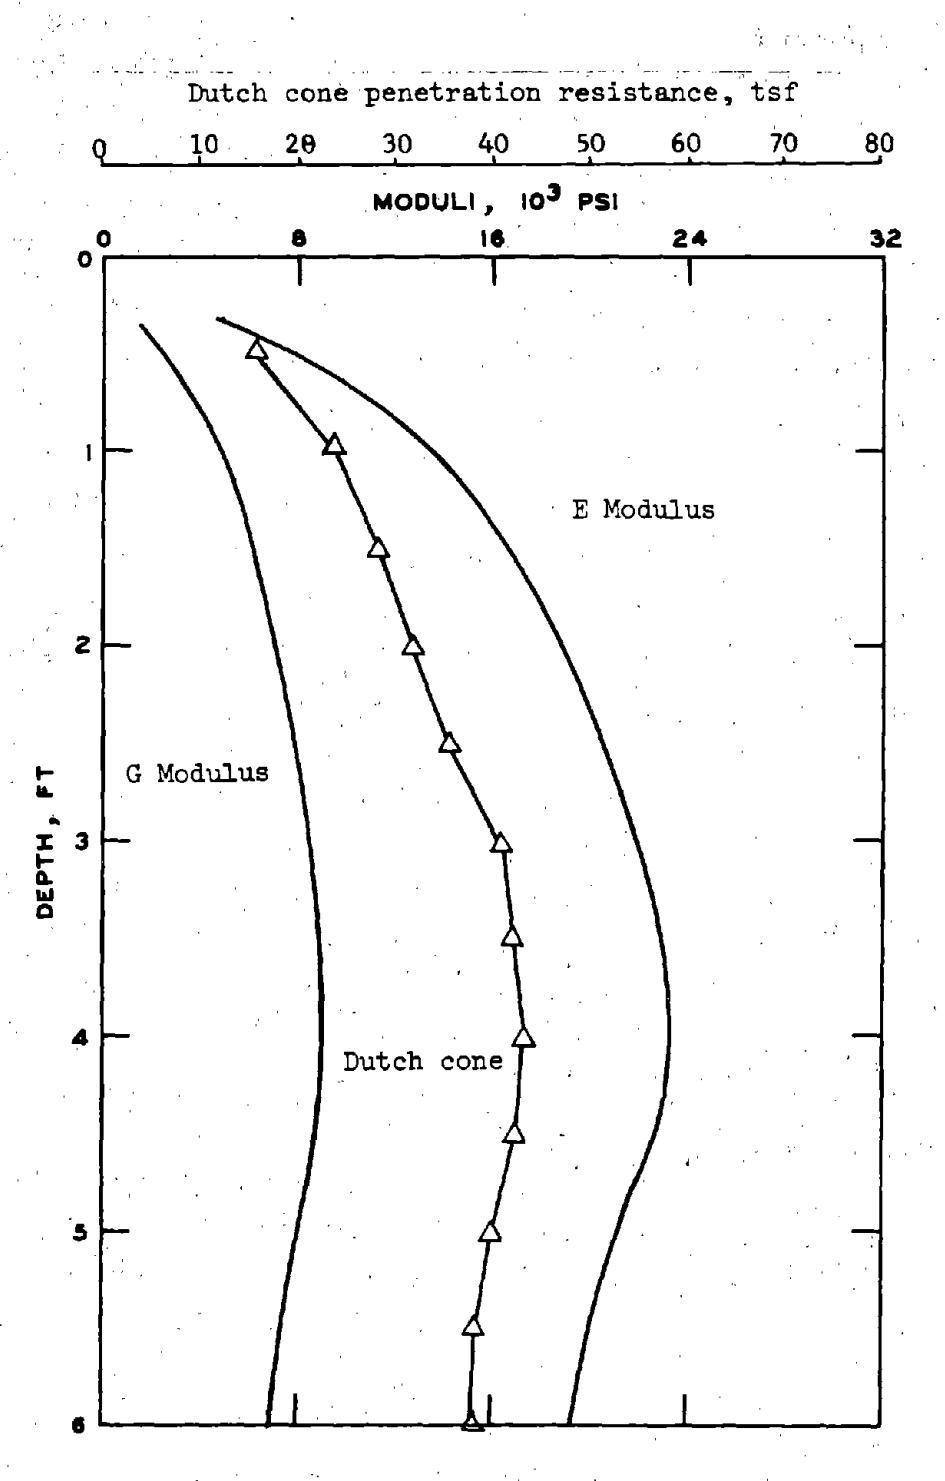
The postmortem vibroseismic and penetrometer results show very similar trends, as illustrated by the summary plots of vibroseismic and penetrometer data presented in Figure 66. Figure 66 demonstrates a particularly good correlation between modulus (derived from vibroseismic tests) and cone point penetration resistance as a function of depth in the embankment. Since the cone penetrometer direct index of strength and the vibroseismic (indirect index of strength) results are in excellent agreement for the posttraffic test condition, it is also instructive to compare the pretraffic and posttraffic vibroseismic results to identify time-induced and/or traffic-induced changes in response. This

FIGURE 66. AVERAGE CURVES FOR ELASTIC MODULI AND PENETRATION RESISTANCE VERSUS DEPTH IN THE EMBANK-MENT FROM ALL VIBROSEISMIC AND PENETROMETER DATA, RESPECTIVELY

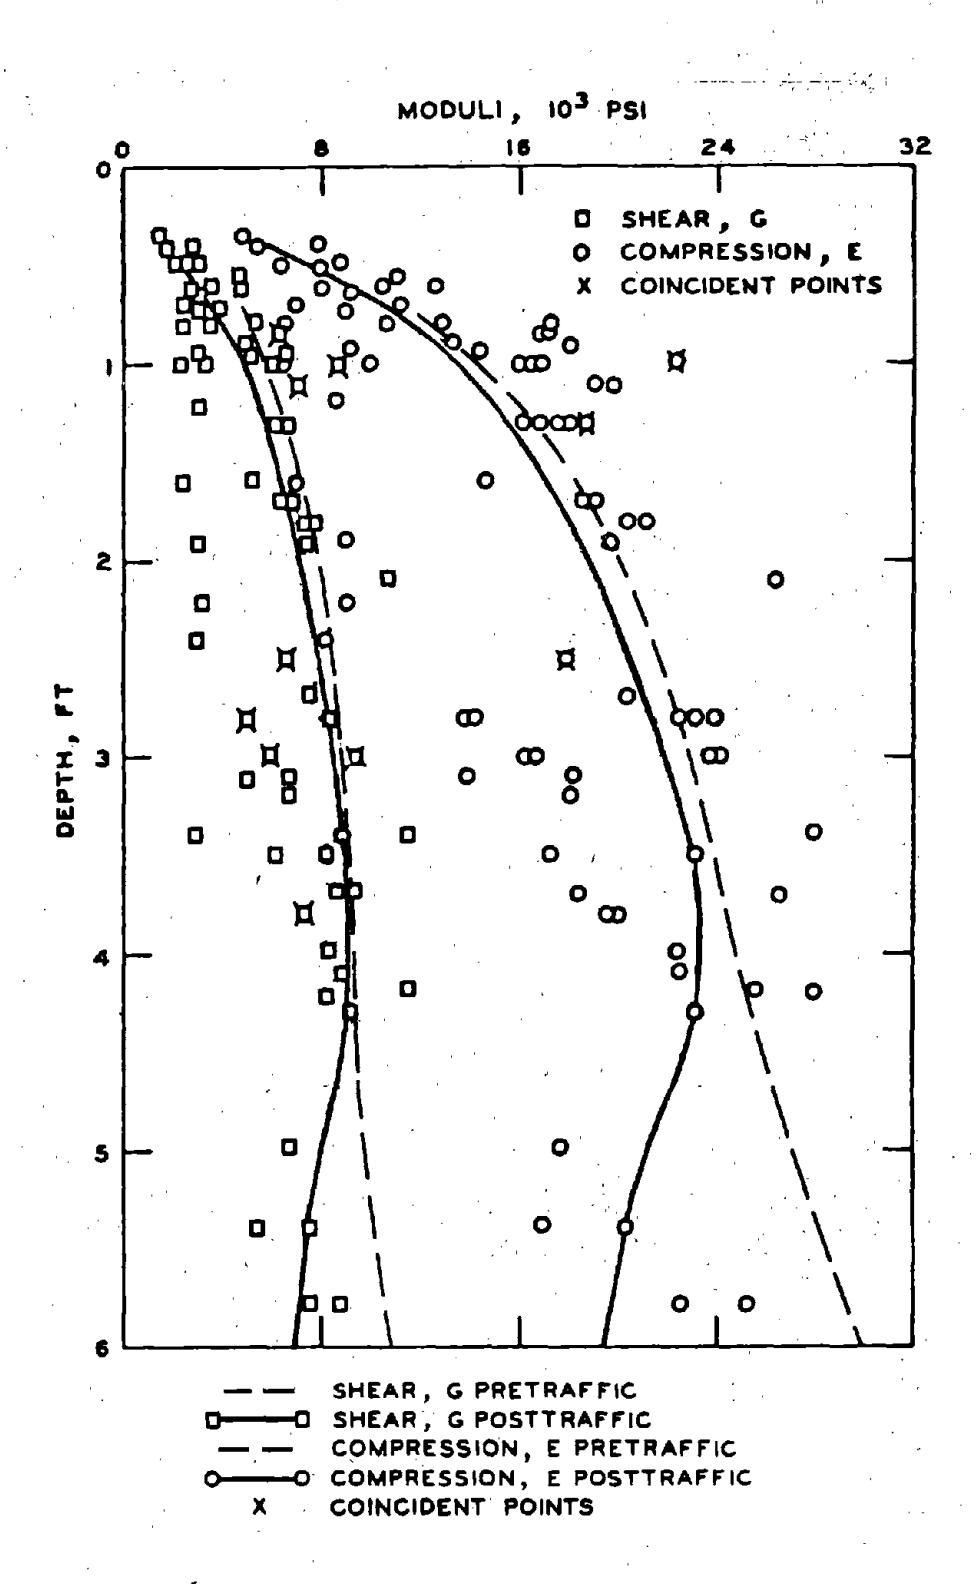
comparison is presented in Figure 67. Both the E and G moduli plots in this figure indicate a softening in the upper and lower 1.5 to 2 ft of the embankment in the time interval (1972-1975) between pretraffic and posttraffic tests. These trends, i.e., softening in the upper and lower levels of the embankment, are also confirmed by the main array (builtin) instrumentation results which have been analyzed by other investigators.<sup>9</sup> Embankment vertical deformation as a function of time, from Reference 9, is summarized in Figure 68. Figure 68 shows that embankment heave occurred from 1971 until October 1974 when, under traffic, rapid settlement took place. The initial heave was attributed to an increase in moisture content above construction levels, and the heave occurred primarily in the upper 1.5 ft of the embankment.<sup>6</sup> The increase in moisture content (with attendant heave) is stressed as an important factor in assessing embankment behavior and performance.

FIGURE 67. COMPARISON OF PRETRAFFIC AND POSTTRAFFIC VIBROSEISMIC DATA TO DETERMINE TIME AND TRAFFIC-RELATED CHANGES IN STRENGTH AS A FUNCTION OF DEPTH IN THE EMBANKMENT

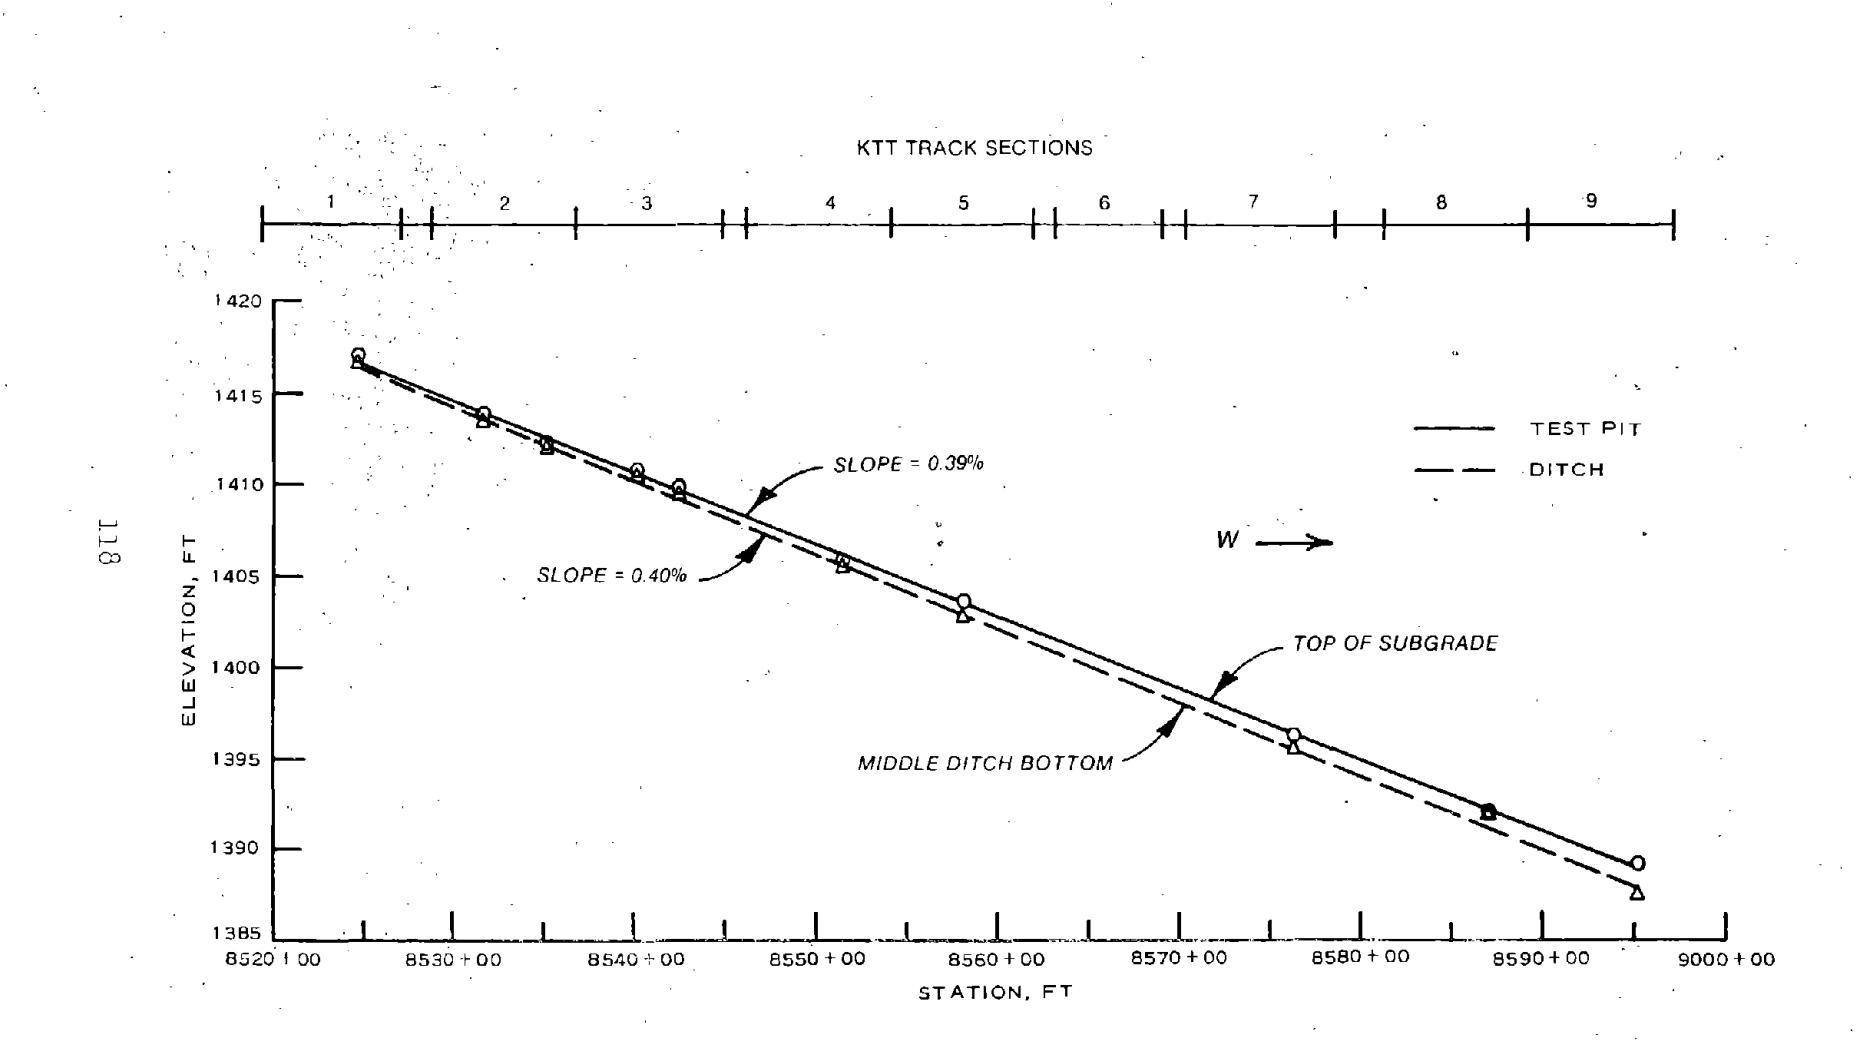
FIGURE 75. TOP OF SUBGRADE AND DITCH BOTTOM (BETWEEN TRACKS) PROFILES ALONG THE LENGTH OF THE KTT

about 6 in. below the top of the KTT embankment and dipped toward the west with a 0.4 percent slope. It should be stressed that any water present in the ditch was thus in direct contact with the top of the KTT subgrade along its southern flank, and that overflow conditions (easily achieved in the upper reaches of the ditches) would flood water over the top of the KTT embankment. Either condition was most undesirable and would have been aggravated by the ponding (channel storage) conditions which are obvious in Figures 72 through 74. It is also likely that the preventive measures taken during construction, i.e., the thin (sprayed) asphalt membrane and the (nominally) 6-in.-thick lime-stabilized layer, did not provide an effective barrier to water migration. Lime-stabilized soil typically develops tensile cracks upon curing, and the KTT asphaltic membrane appeared to be no more than 1/16 in. thick from field observations. Also, the lime-stabilized material would have a higher permeability than the intact clay.
