***Federal Railroad Administration
Office of Railroad Safety
Accident and Analysis Branch***

***Accident Investigation Report
HQ-2016-1165***

***CSX Transportation (CSX)
Chester, PA
October 28, 2016***

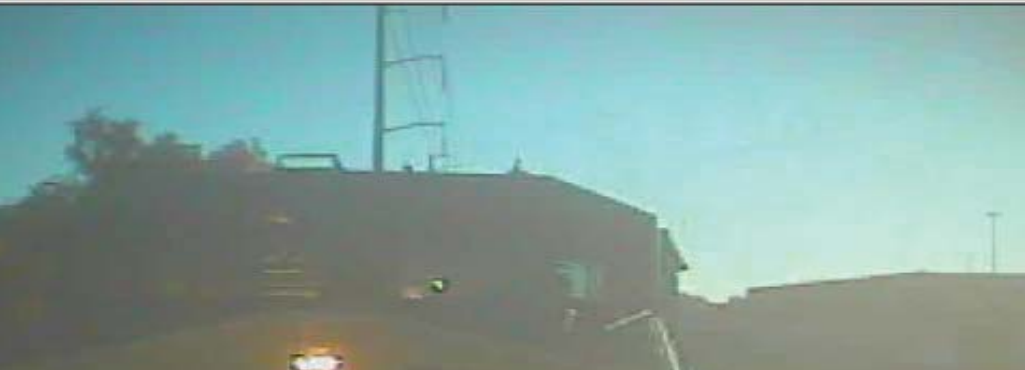
Session Details		GMT: 2016/10/28, 12:22:30	Wheel Diameter : 40.00
Current File: 58134303.VAM		EDT: 2016/10/28, 08:22:30	
Road#: CSX # 4402

As a result of the collision with the striking train, the struck train's lead locomotive (CSXT 4402) leading truck was raised up, above, and off the rail. There were no hazardous materials released, however, Locomotive CSXT 4402 sustained damage to the fuel tank, which resulted in a minor fuel (diesel) leak of unknown quantity, that did not affect any waterways and was contained by first responders. The collision occurred at Milepost (MP) BAK 14.0, 548 feet west of the interlocking at Control Point (CP) East Feltonville.
