U.S. Department of
Transportation

**Federal Railroad
Administration**

Rail Base Corrosion and Cracking Prevention: Phase 2

1. AGENCY USE ONLY (Leave blank)		2. REPORT DATE April 2018		3. REPORT TYPE AND DATES COVERED Technical Report – July 2014 - April 2017
4. TITLE AND SUBTITLE Rail Base Corrosion and Cracking Prevention: Phase 2			5. FUNDING NUMBERS DTFR53 14-C-00007

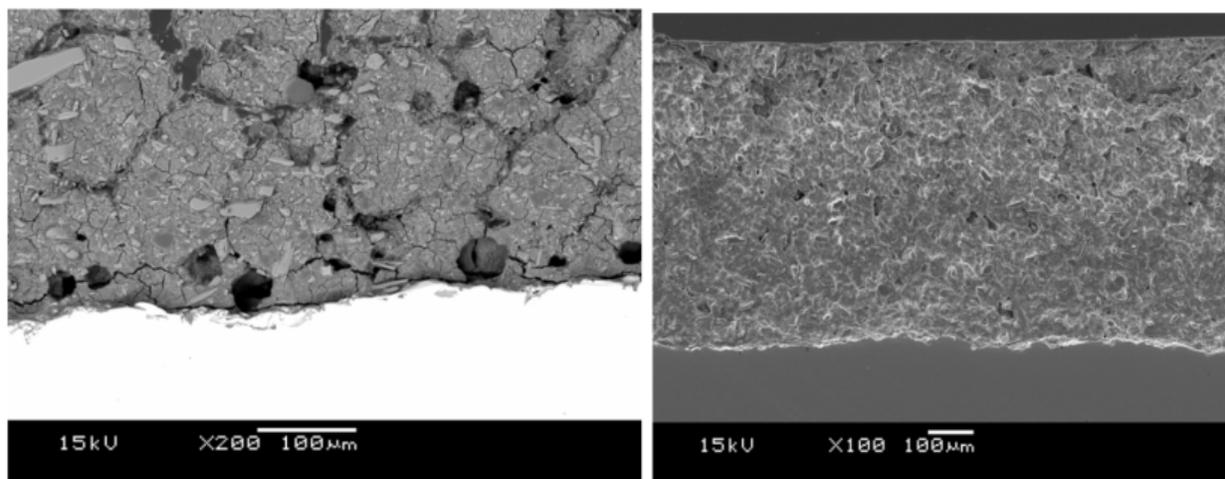
Figure 10. Micrographs of Original EonCoat® (left) and Modified EonCoat® V (right)

In developing a new coating for better protection against corrosion, EC made formulation changes to balance the steel reaction speed with the coating curing speed such that gas formation would be retarded or eliminated. This goal was achieved as indicated in the micrographs of the interfacial regions shown in Figure 10. The new formulation was identified as EonCoat® V.

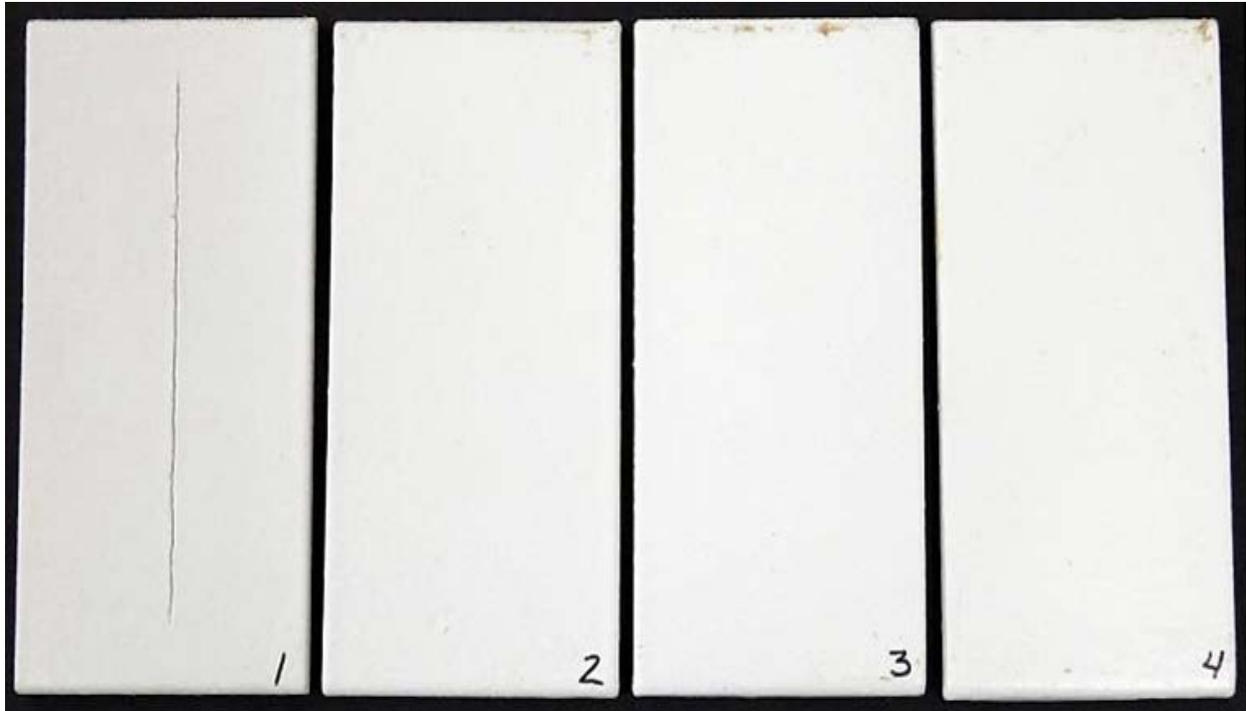
Figure 14. EonCoat® V – Macro of Panels Before Testing

Figure 14 and Figure 15 show the before and after pictorial record from the DNV exposures. There are penetrations to metal on the plates that were initially undamaged. On the scribed plate, there is obvious pulling back of the coating from the scribe region, however, there is still rust protection outside the region. That is a trait of the EonCoat® V system. It converts the surface, not just coats it, so there is additional resistance to corrosion with time in regions where coating has been lost physically.

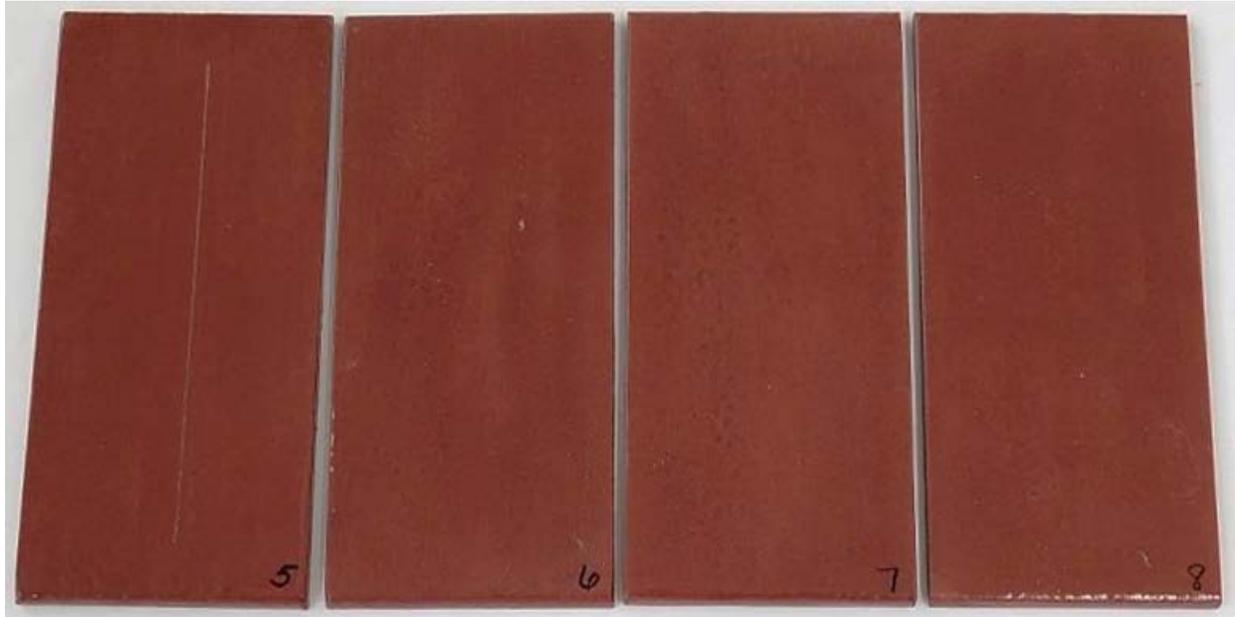
Figure 20. Rutgers Coating – Macro of Panels Before Testing

This is an experimental coating and not commercially available. Figure 20 through Figure 23 show that the coating has remained substantially intact. However, moisture and possibly salt have transgressed its protection to reach the surface and begin corrosion. In Figure 23, the development of a blister is evident.

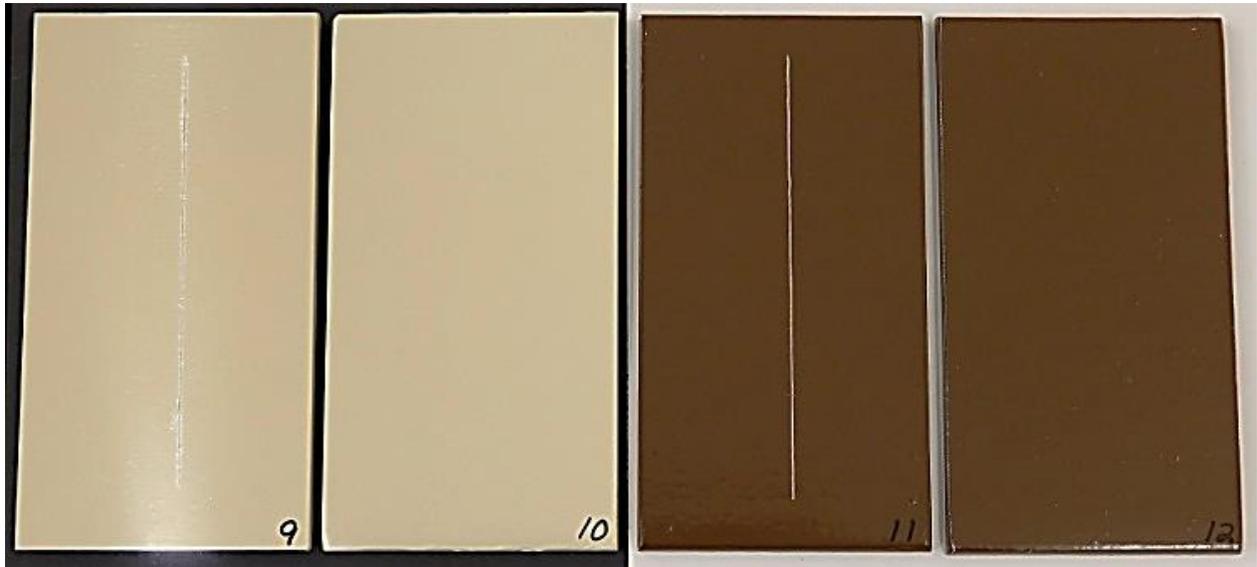
Figure 24. PCI-3000 (left) and PCI-5000 (right) Panels Before Testing

Both the PCI-3000 and PCI-5000 coatings performed well, with the PCI-5000 appearing to perform better of the two (and the best of the set of four) coatings. The plate coated with PCI-5000 had good resistance to blistering and peeling in the scribe region. All the coatings showed incursion from the edges, which is common in this type of testing. However, the PCI coatings showed good resistance to creeping corrosion from the edges, much as they had done in the scribe region. Based on the results of this testing (Figure 24 through Figure 29), the PCI-5000 coating is a good candidate for field testing.

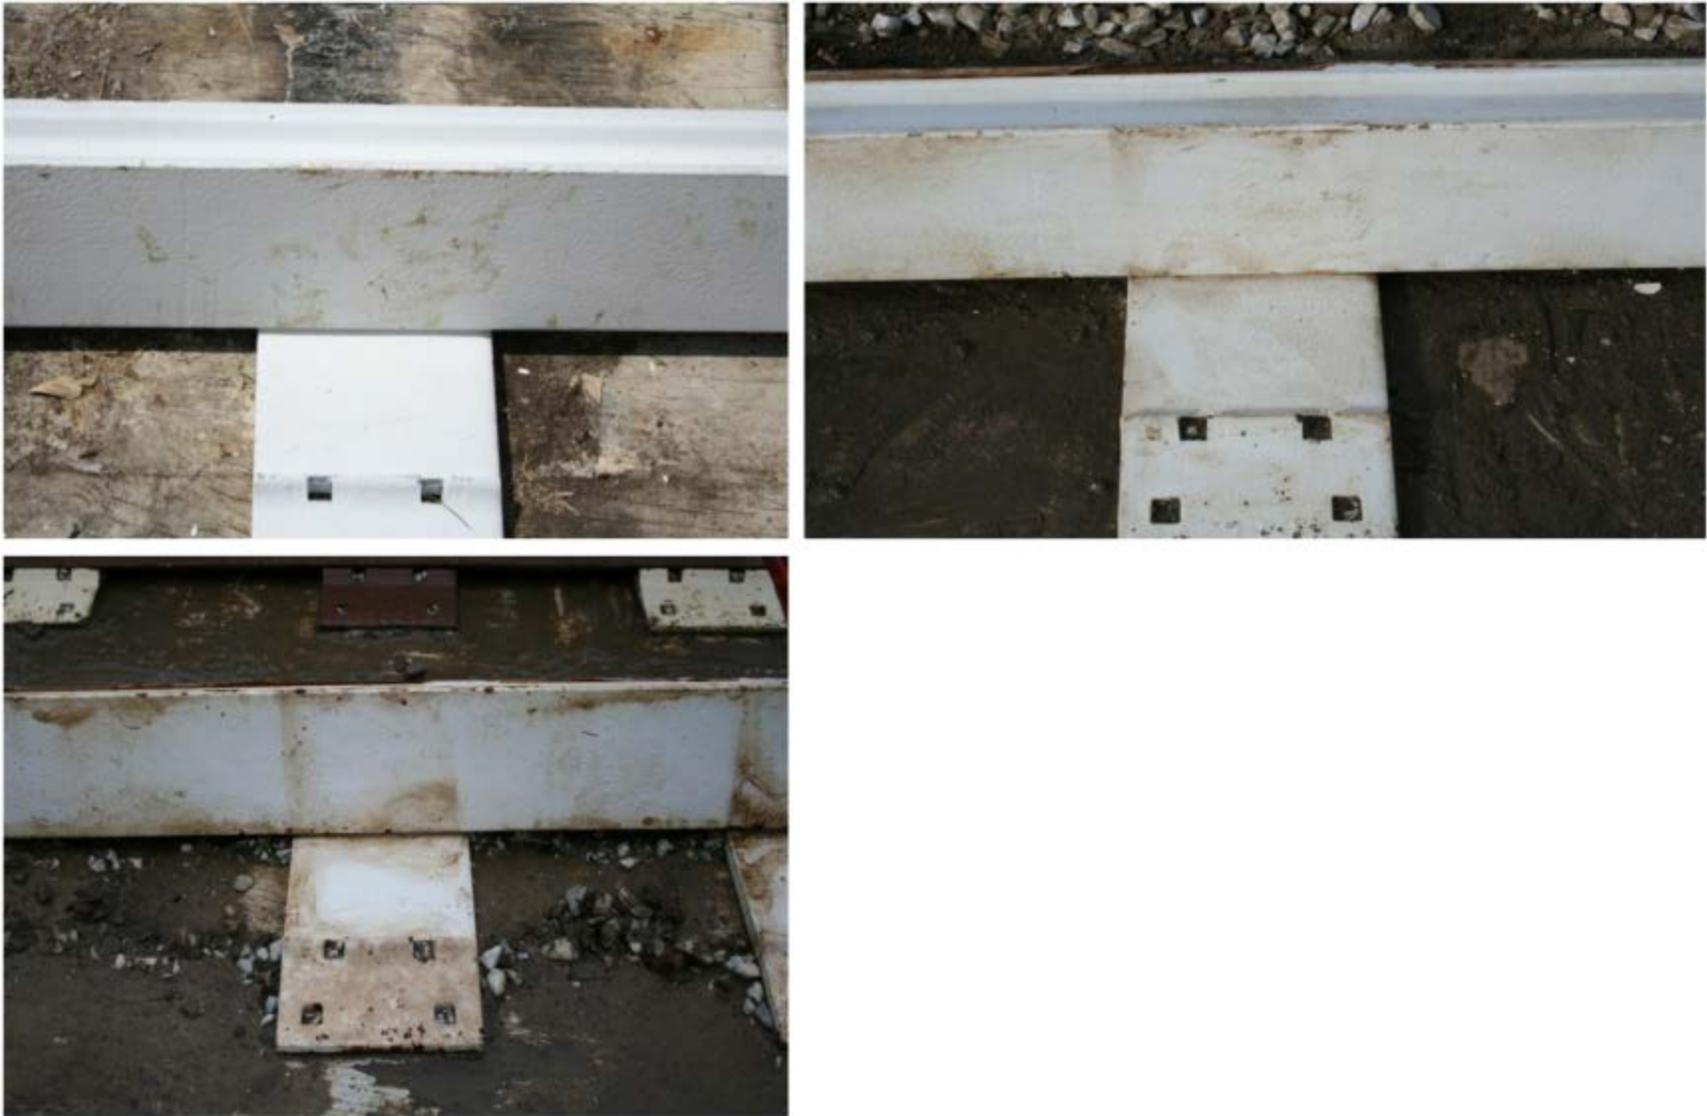
Figure 31. EonCoat® V (Clockwise: UL – Start, UR – 2 Months, LR – 4 Months, LL – 6 Months)

The EonCoat® V coating held up fairly well (Figure 31). However, at the end of the 6-month exposure, it was beginning to show the same types of penetration and incursion that were seen in the DNV exposure sequence. This was evident not only at the rail-tie plate interface, but also in the built-up regions where dirt-gravel-salt had been piled up against the web.
