**Federal Railroad
Administration**

Joint Bar Failure Study—Field Investigation

1. AGENCY USE ONLY (Leave blank)		2. REPORT DATE June 2019		3. REPORT TYPE AND DATES COVERED Technical Report April 2016
4. TITLE AND SUBTITLE Joint Bar Failure Study—Field Investigation			5. FUNDING NUMBERS DTFR53-10-D-00002 Task Order 18

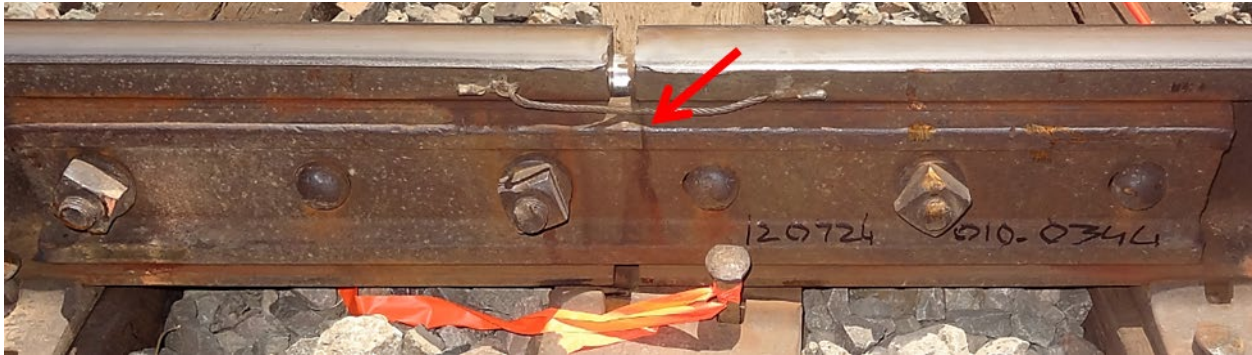
Figure 2. Top Center Defect on a Standard Design Head-Free Bar

On standard design head-free joint bars the overwhelming majority of the failures were center defects and 59 percent of the center defects were top center cracks.

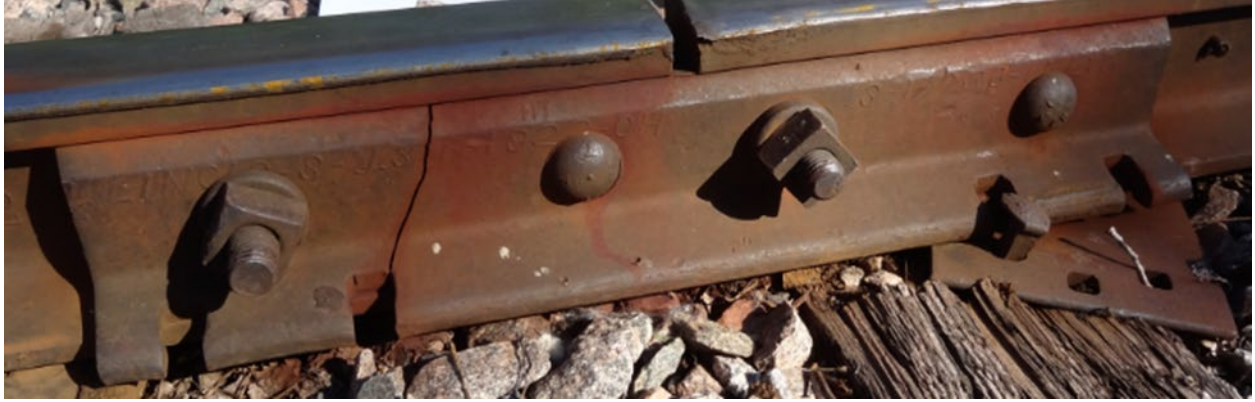
Figure 3. Full Quarter Break on a Long Toe (Angle) Bar

On long toe (angle) type bars the predominant failure was a quarter defect, most often a full quarter break—almost 70 percent. Surprisingly, three out of eight partial quarter cracks on the long toe (angle) bars were initiated from the top of the bars and not from the spike hole on the bottom of the bar as expected. When center defects occurred on long toe (angle) type bars, the majority were top cracks (77 percent).

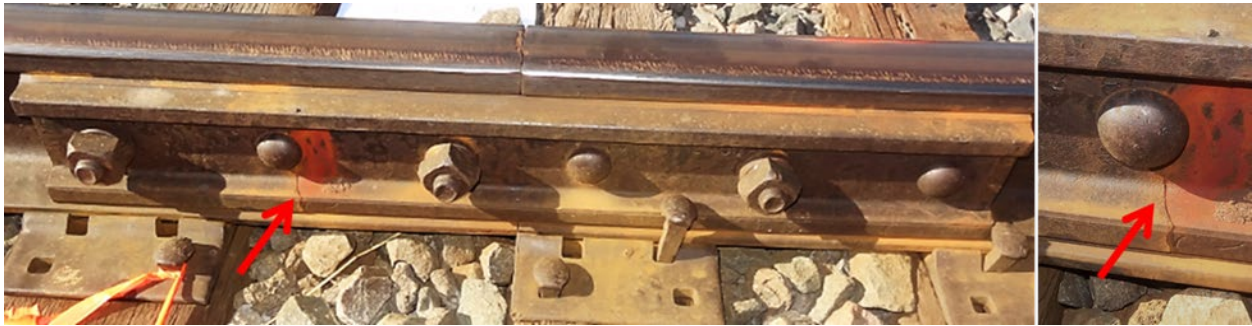
Figure 6. Bolt Hole Defect on a Standard Design Bar

All the head-contact bars in the sample but one failed through the center. One head-contact bar contained a bolt-hole defect. Overall bolt-hole defects were only a marginally occurring defect

type on all bar designs. In general, bar defects were evenly distributed between field and gage side bars.

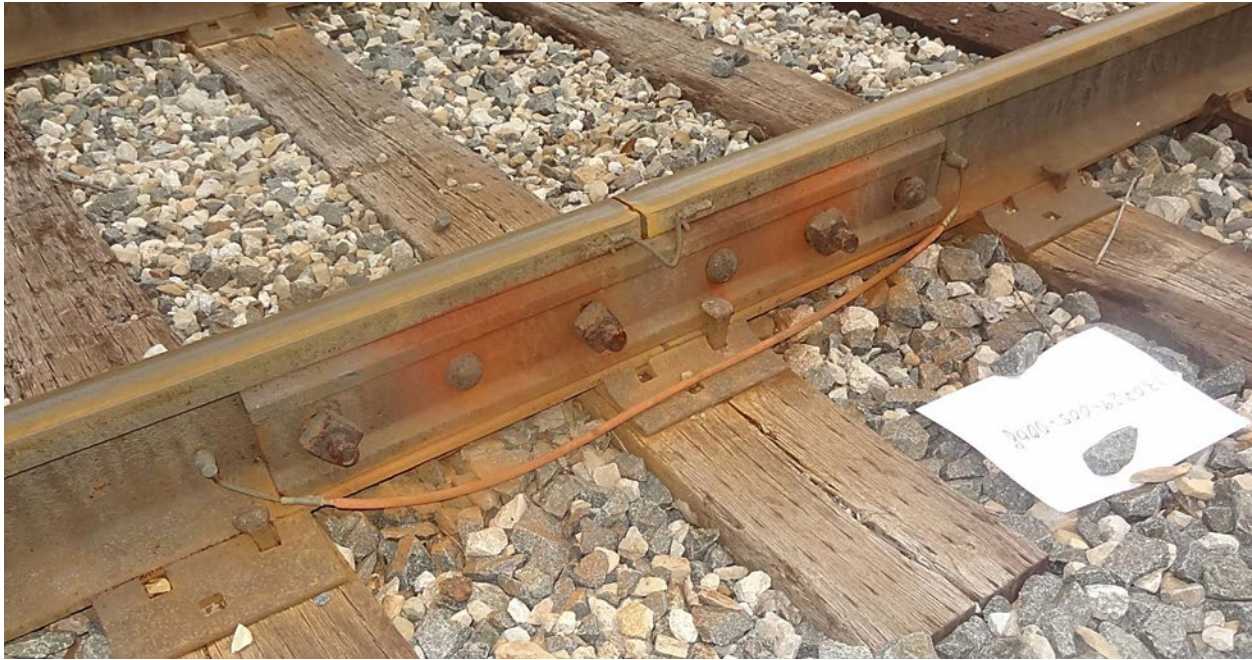
Figure 13. Intact Rail Joint Location

Investigated intact rail joints were overwhelmingly present in locations with very good track support and rail end conditions. A typical intact rail joint (from test zone F1) is shown in [Figure 13](#).

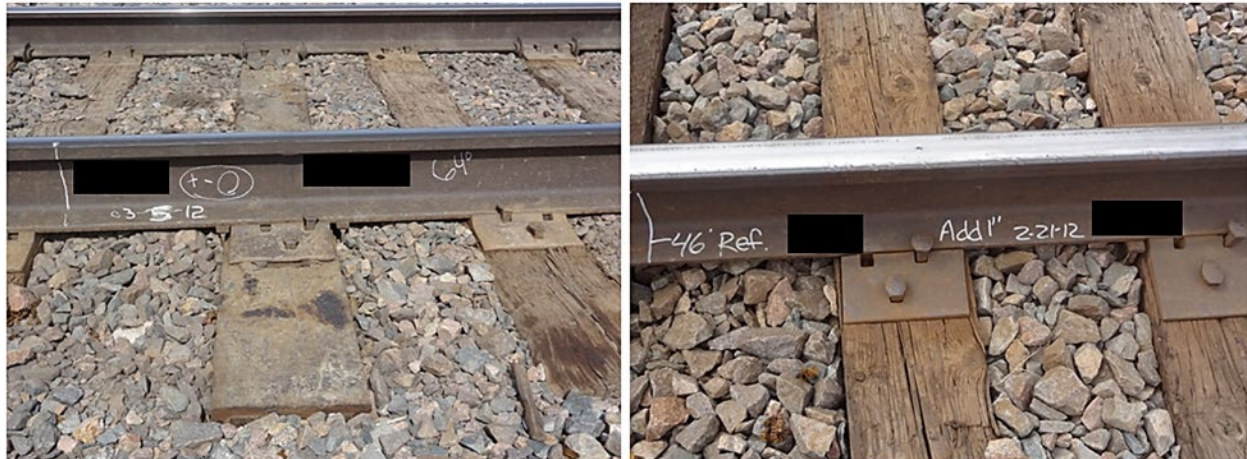
Figure 18. Examples of Welder Reference Marks at Temporary Joints on Wooden CWR Track

Reference marks located on the rail next to the temporary joints made by railroad personnel were documented to get an estimate of how long ago the temporary joints were cut in. The marks are used to keep track of added and subtracted rail whenever a cut is made in CWR (see [Appendix F](#) for details). Two welder's reference marks at recently installed temporary joints can be seen in [Figure 18](#). This information confirmed that the intact locations with the large values of joint movements and rail end misalignments were cut in the rail only several weeks or few months prior to the joint bar survey and had not accumulated more than 10 MGT.

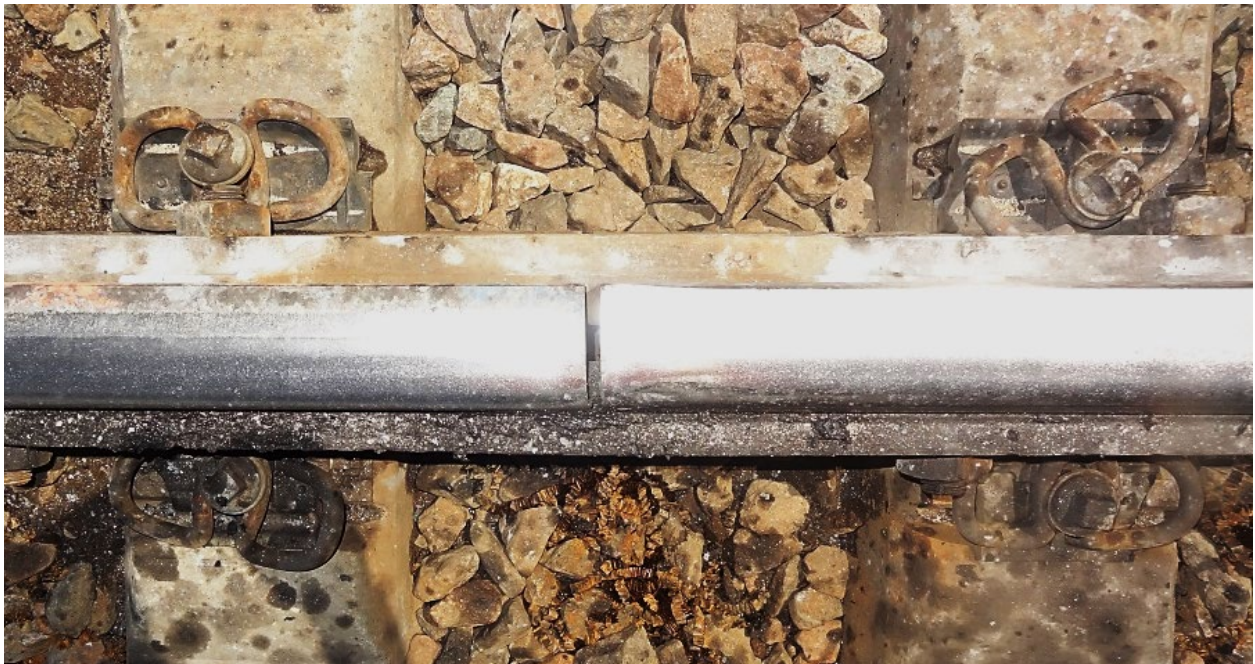
Figure 20. Temporary Joint on Concrete Ties Fully Equipped with VOSSLOH Fasteners

equipped with Vossloh fasteners were fully configured with two fasteners per rail. See [Figure 19](#) and [Figure 20](#) for illustrations.

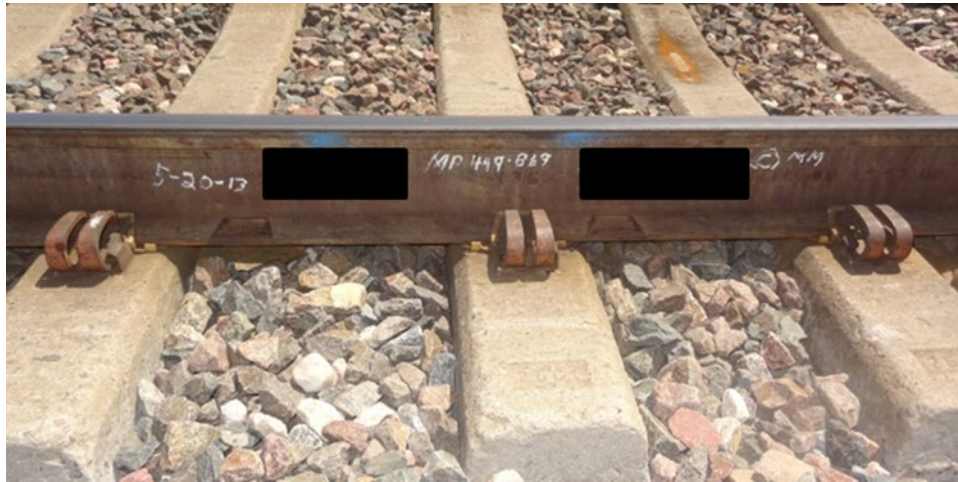
Figure 21. Example of Welder Reference Marks at Temporary Joint on Concrete Tie CWR Track

To estimate when temporary joints were installed, reference marks located on the rail next to the temporary joints were also documented on concrete tie track. An example of observed welder's reference marks at recently installed temporary joints on concrete tie track can be found in [Figure 21](#).

The reference marks revealed that most of the temporary joints were cut in the track very recently, 1 to 2 months prior to the survey date, but in that time accumulated up to 27 MGT because of the high tonnage on that particular test zone.

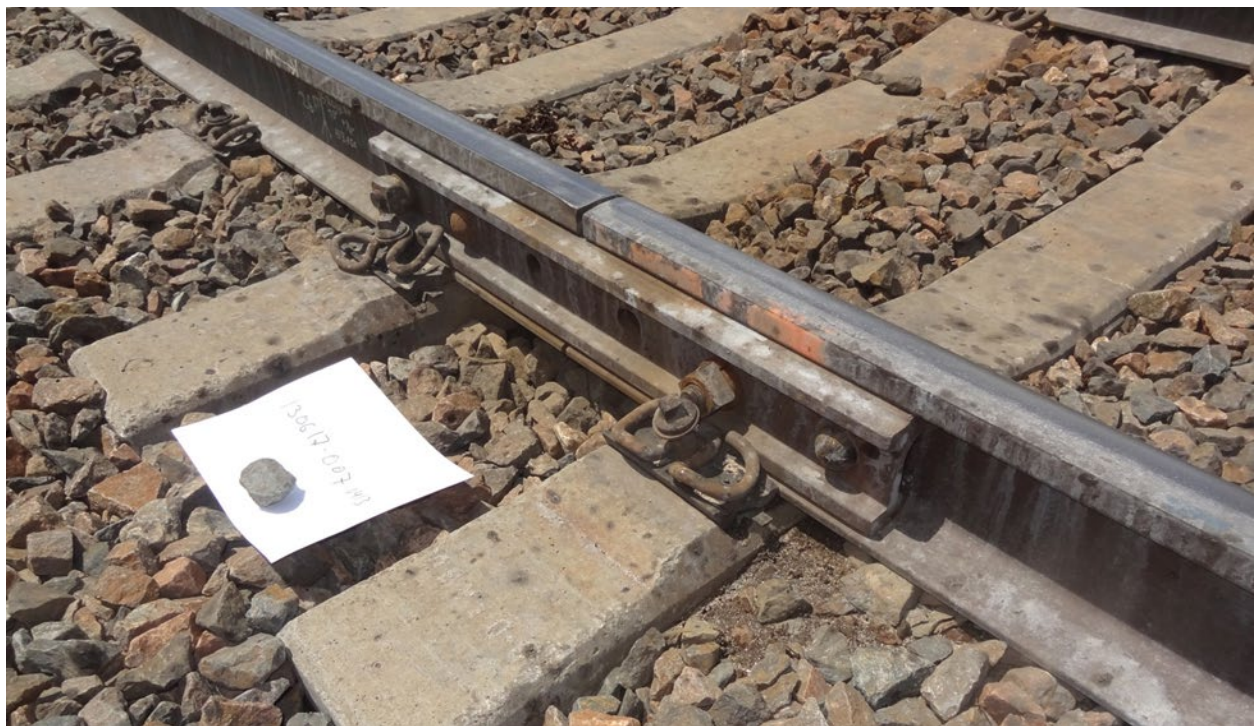
Figure 22. Example of Rail Joint Location on Concrete Tie Track with Good Support Conditions

Even though no defects were found on the concrete tie CWR territory, the field survey showed that well supported rail joints with minimal rail end misalignments can survive for months in high tonnage Class 4 track. An example of a well-supported temporary rail joint on concrete track territory is shown in [Figure 22](#).

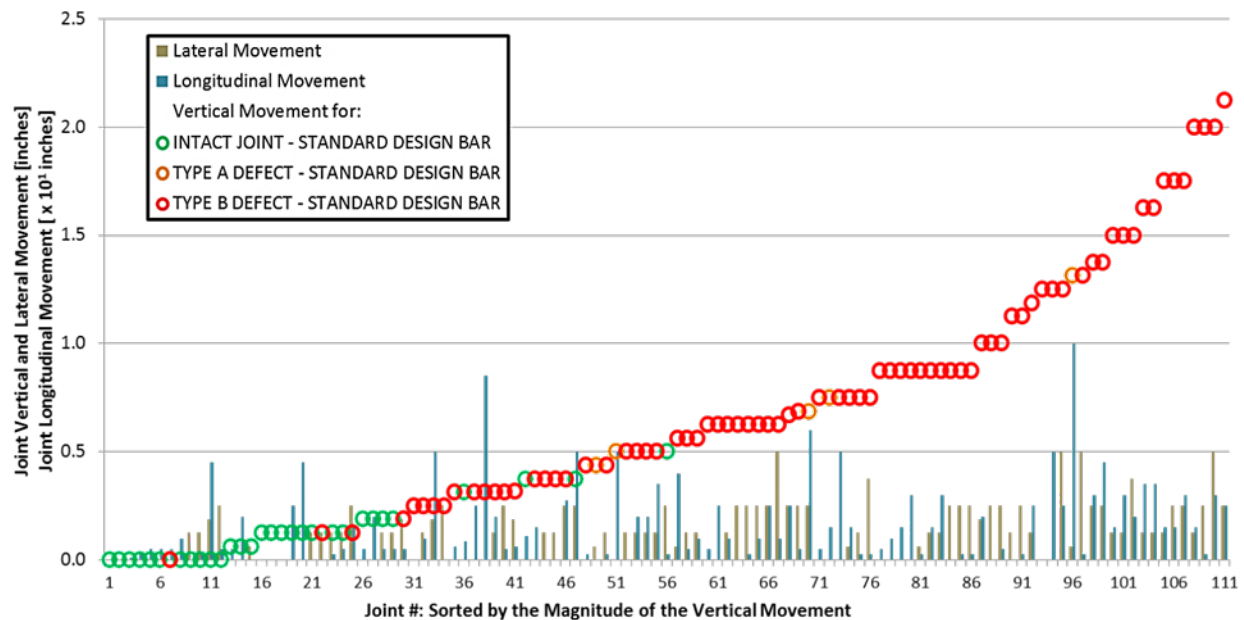
Figure 32. JNT Sample Track Class 3—Overview of Joint Movements

The chart in [Figure 32](#) contains an overview of vertical, lateral and longitudinal movements recorded at the investigated rail joint locations on Class 3 JNT. The locations are displayed in same format as the low track class JNT samples. Again, we can observe that the locations with failed joint bars exhibit much larger vertical movement measurements than the evaluated intact locations.

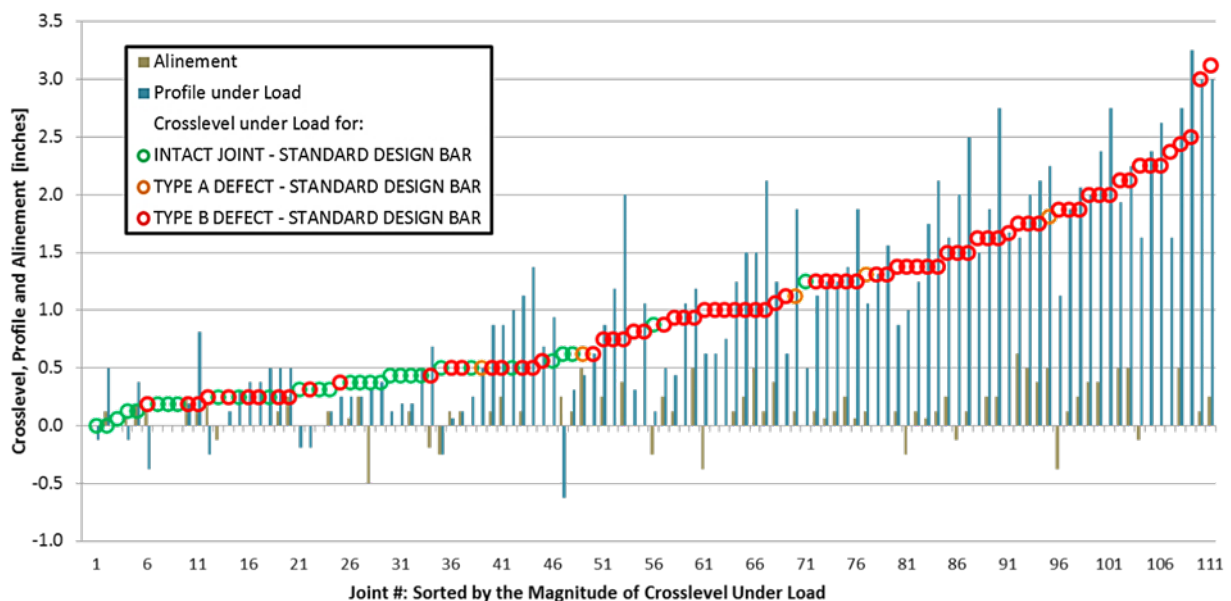
Figure 33. JNT Sample Track Class 3—Overview of Selected Track Geometry Parameters

[Figure 33](#) presents an overview of three track geometry measurements: crosslevel under load, profile under load and alinement. The chart shows that the locations with failed joint bars exhibit much larger crosslevel under load and profile under load measurements than intact locations. We can also notice a trend in increasing profile under load values with growing crosslevel under

load. This trend is very pronounced compared to the Class X, 1 and 2 data where such a trend was not as discernible (see Figure 24).

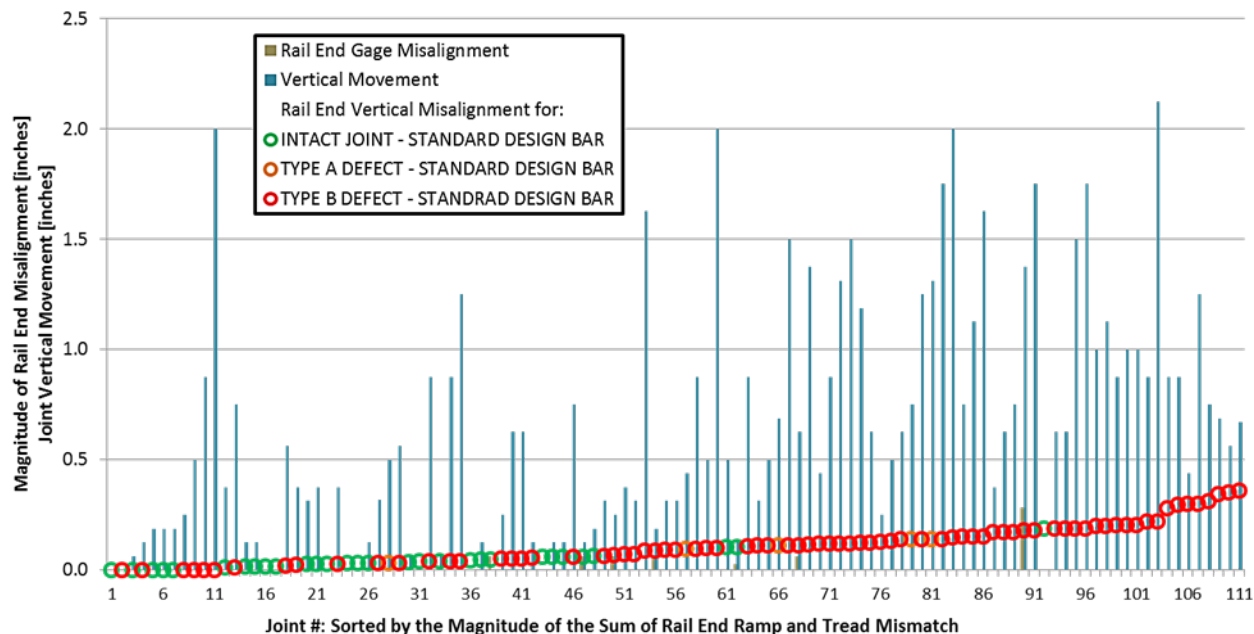
Figure 34. JNT Sample Track Class 3—Overview of Rail End Conditions

During the field surveys, it was observed that Class 3 track, unlike lower track classes, had many failed rail joint locations that contained much more deteriorated rail end conditions than investigated intact rail joint locations. The following chart in Figure 34 gives an overview of the rail conditions with overlaid vertical joint movement confirming the observation. The locations are sorted by the value of rail end vertical misalignment. This value is defined as a sum of tread

mismatch and rail end ramp and it is a calculated parameter used to evaluate the overall conditions of the rail ends in vertical direction. Most locations with significant rail end misalignments were also accompanied by large vertical movement. The magnitude of the movement, however, did not grow with the magnitude of the rail end misalignment and many locations with no rail end conditions also contain vertical movement.

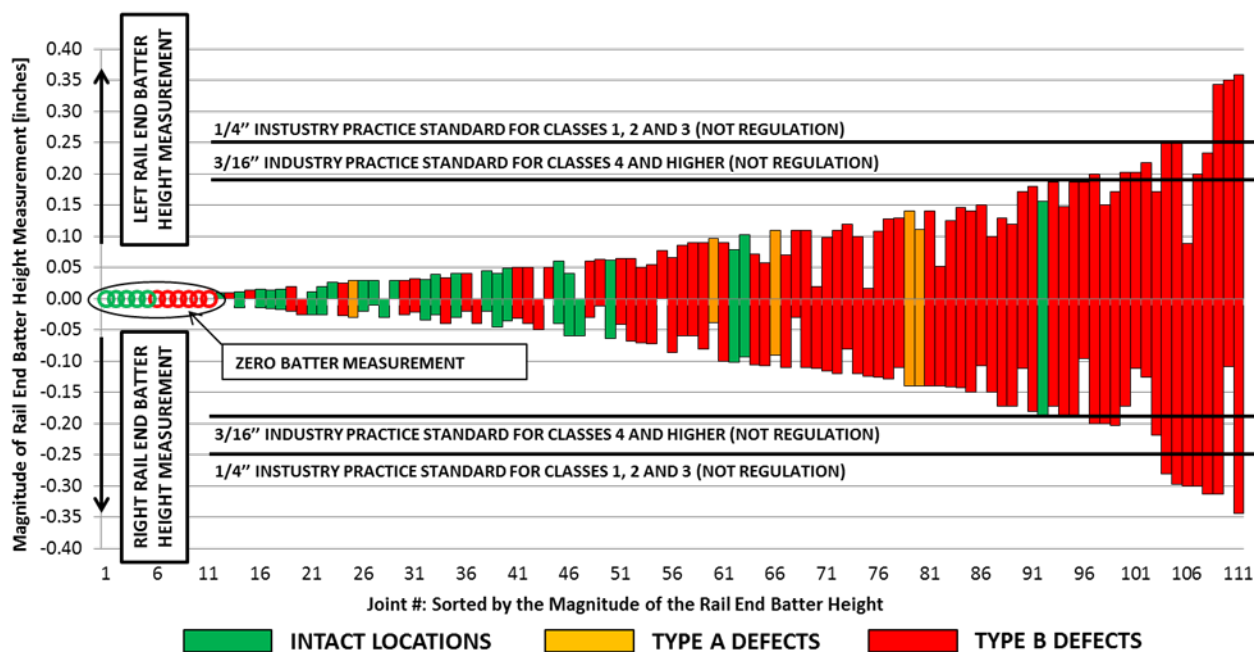
Figure 35. JNT Sample Track Class 3—Overview of Rail End Conditions

Most cases of adverse rail end conditions encountered on Class 3 JNT consisted of moderate or even significant rail end batter of fairly even magnitudes at the opposite rail ends as illustrated in Figure 35. The chart shows that the left and right rail end ramp height measurements are very consistent and that their magnitudes do not exceed the industry practice recommendations, except for several of the most adverse instances of rail end conditions. There were very few cases of tread or gage mismatches encountered on JNT.

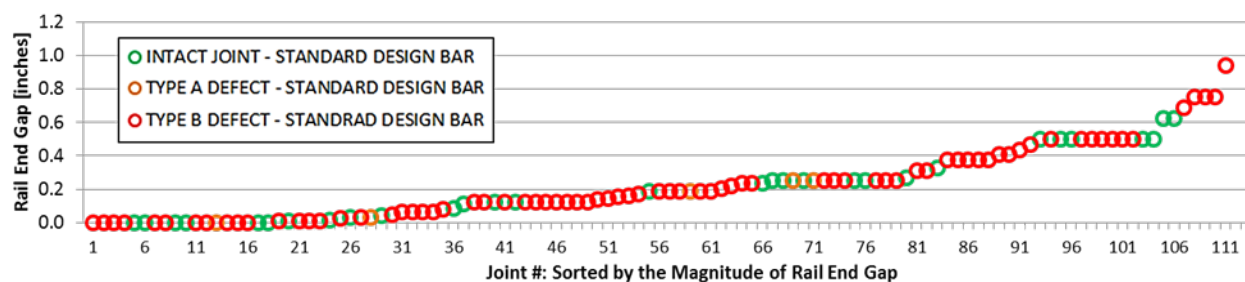
Figure 36. JNT Sample Track Class 3—Overview of Rail End Gaps

Figure 36 and Figure 37 illustrate the distribution of rail end gaps and the measured distance to the first effective tie. Locations with defects do not seem to have different magnitudes of rail end gaps than evaluated intact joint locations. The distance to the first effective tie does not seem to be significantly different between the intact and failed locations (up to around 12 inches). In this sample, distances larger than 12 inches indicate a defective tie at the rail joint location. All such locations contained a failed joint bar.

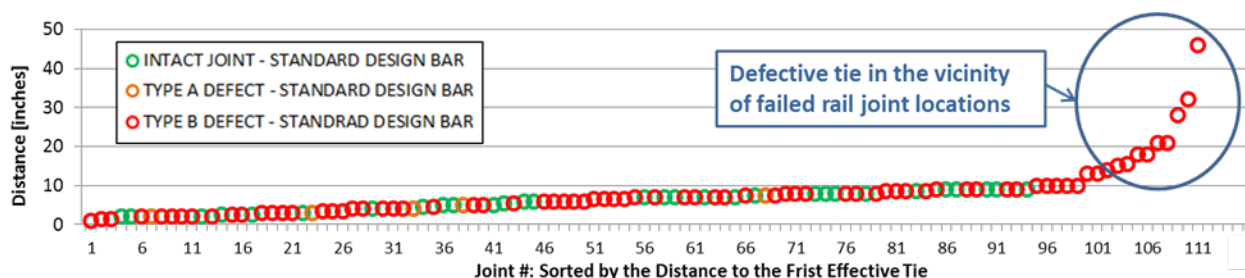
Figure 37. JNT Sample Track Class 3—Overview of Distance to First Effective Tie

The distance to first effective ties was identified by the T-test as a factor that had significant differences when intact locations were compared to defect locations. The sample contains multiple failed rail joint locations with a distance to first effective tie larger than 12 inches (see [Figure 37](#)). Within this sample, this represents locations where there was another tie closer to the joint centerline which was deemed ineffective due to its deteriorated condition as defined in [Appendix E](#). When we repeat the T-test and reconstruct the confidence intervals for a sample with those locations removed, the statistical significance disappears as illustrated in [Figure 41](#). In this case four locations with a distance to first effective tie of 20 inches or larger were removed from the Type B defect sample group.

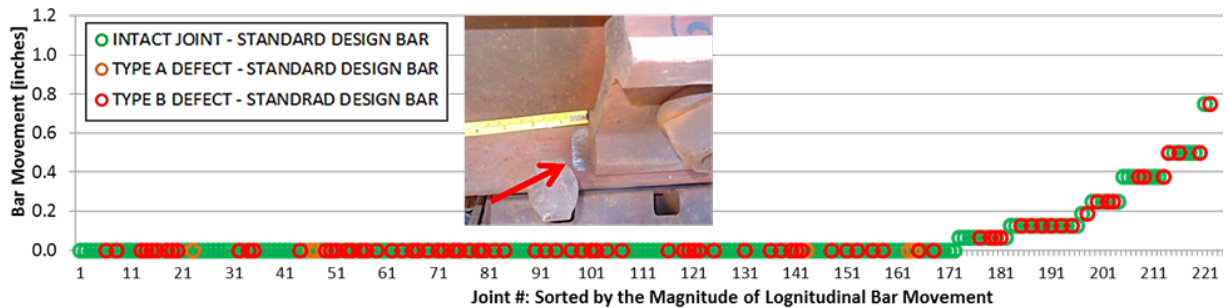
Figure 38. JNT Sample Track Class 3—Overview of Longitudinal Bar Movement

Figure 38 displays encountered longitudinal bar movement. This parameter represents a relative motion between the joint bar and the rail ends and it is an indirect sign of the effectiveness longitudinal restraint, rail stresses and response of the joint to rail temperature fluctuations. In this plot, each entry represents an individual joint bar. Both intact and failed joint bars show comparable values of longitudinal bar movements.

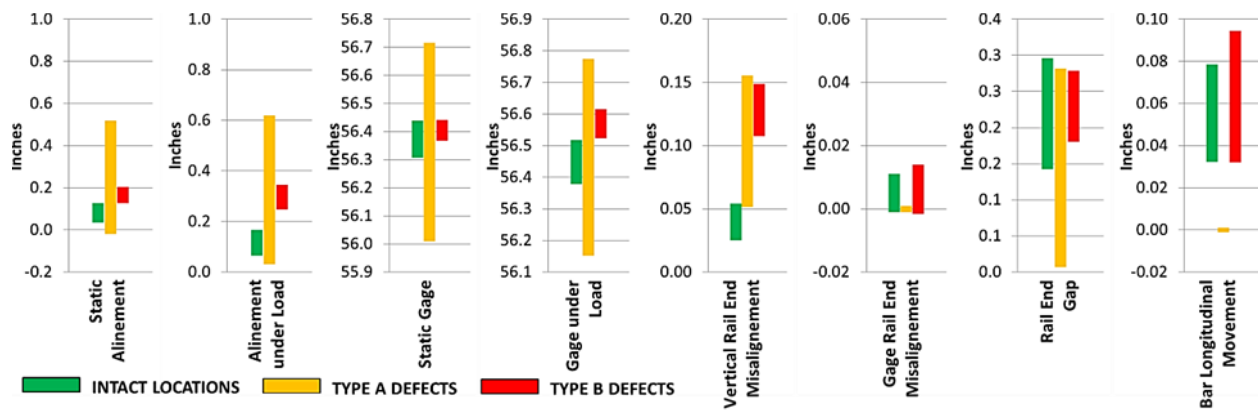
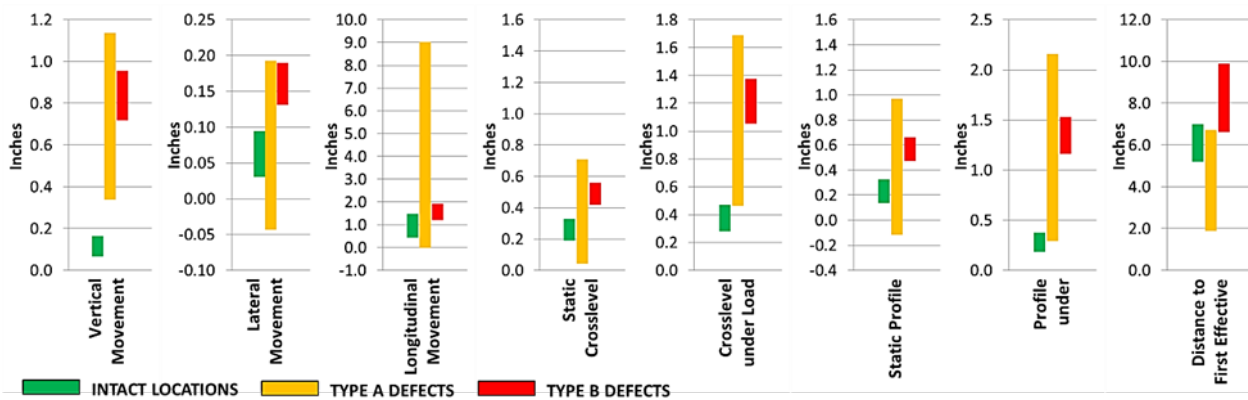
Figure 39 and Figure 40 show the 95 percent confidence intervals for the parameters summarized in Table 9. The charts can be also viewed as a graphical interpretation of the T-test.

It is important to note that the Class 3 track sample only has five locations with Type A defects. The T-test becomes much more restrictive for smaller sample sizes because more uncertainty exists in estimations of the populations mean and variance and the tails of t-distribution become heavier. This is also reflected in the very large confidence intervals for defect Type A in Figure 39 and Figure 40.

Most the parameters (with few exceptions) do not show significant difference between the intact and the Type A defect locations, even where the difference between intact group and Type B defects is very large. Notably, two exceptions are vertical joint movement and vertical rail end

misalignments. For those two parameters, the difference is significant for both defect groups despite the small sample size of defect group A. This confirms two most important observations from the field: 1) Vertical movement at all track classes is a very significant factor that distinguishes intact rail joint locations from failed rail joint locations and 2) Rail end conditions, specifically in the vertical direction, are a contributing factor at Class 3 track, unlike rail end conditions on lower track classes.

Based on the results of the Type B defect group, lateral movement is also shown as a significant factor, even though it is not as large as vertical movement. Longitudinal movement does not show a statistically significant difference between the intact and failed locations for both defect type groups.

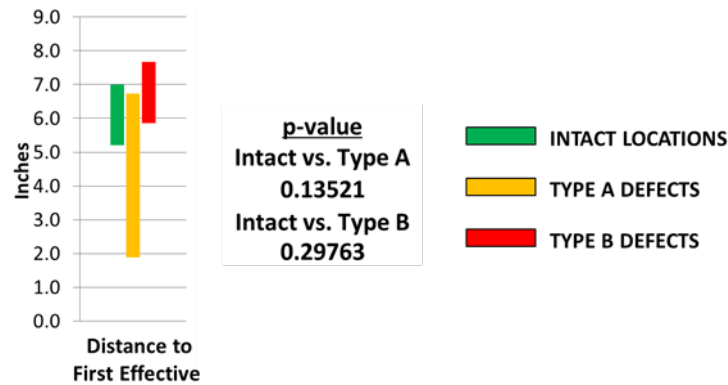
Figure 41. JNT Sample Track Class 3—95% Confidence and T-Test Results for Locations with Distance to First Effective Tie of 20 Inches or Smaller

The result supports the important observation that rail joint failure appeared to affect both suspended and supported rail joint configurations evenly. However, the presence of defective ties contributes to deteriorated overall vertical support condition of the rail joint, regardless of the original tie configuration under the rail joint.

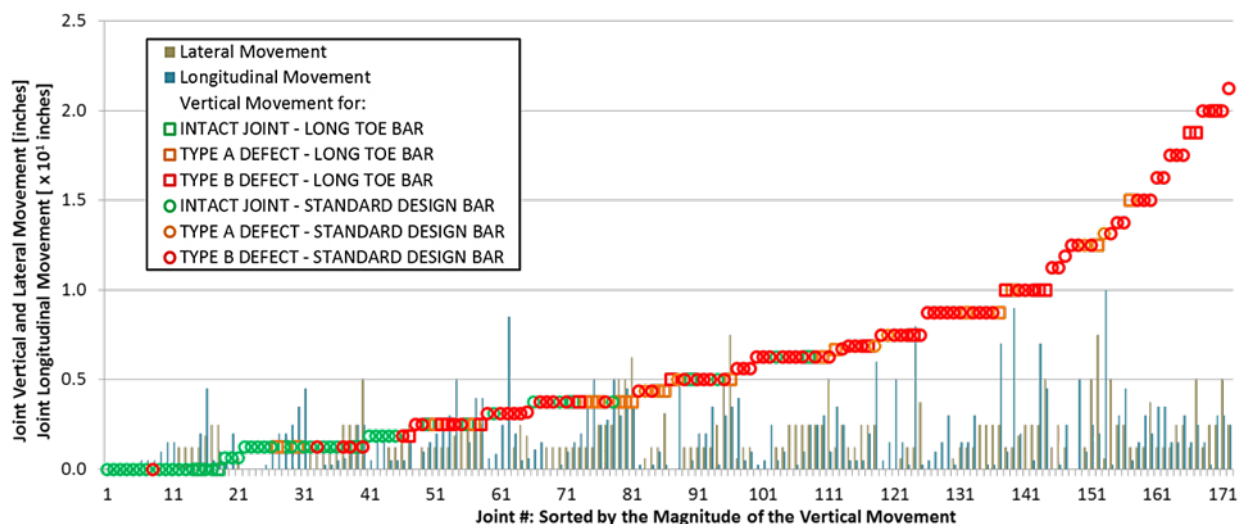
Figure 42. Combined JNT Sample—Overview of Joint Movements

Again, the locations with failed joint bars exhibit much larger vertical movement measurements than the evaluated intact locations (see [Figure 42](#)). They also exhibit much larger crosslevel under load and profile under load measurements than intact locations. We can also notice a

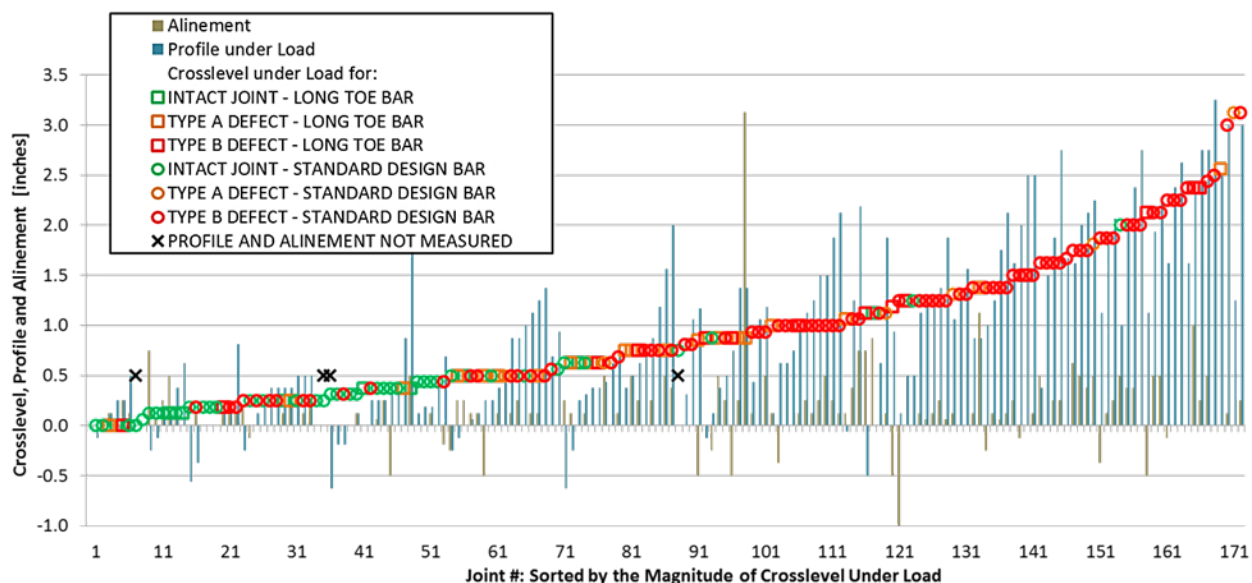
Figure 43. Combined JNT Sample—Overview of Selected Track Geometry Parameters

Joint movements and track three track geometry measurements—crosslevel under load, profile under load and alinement follow the same trends in the combined sample as they did separately in the lower and higher track class samples.

similar trend as in Class 3 track sample regarding increasing profile under load values with growing crosslevel under load (see Figure 43).

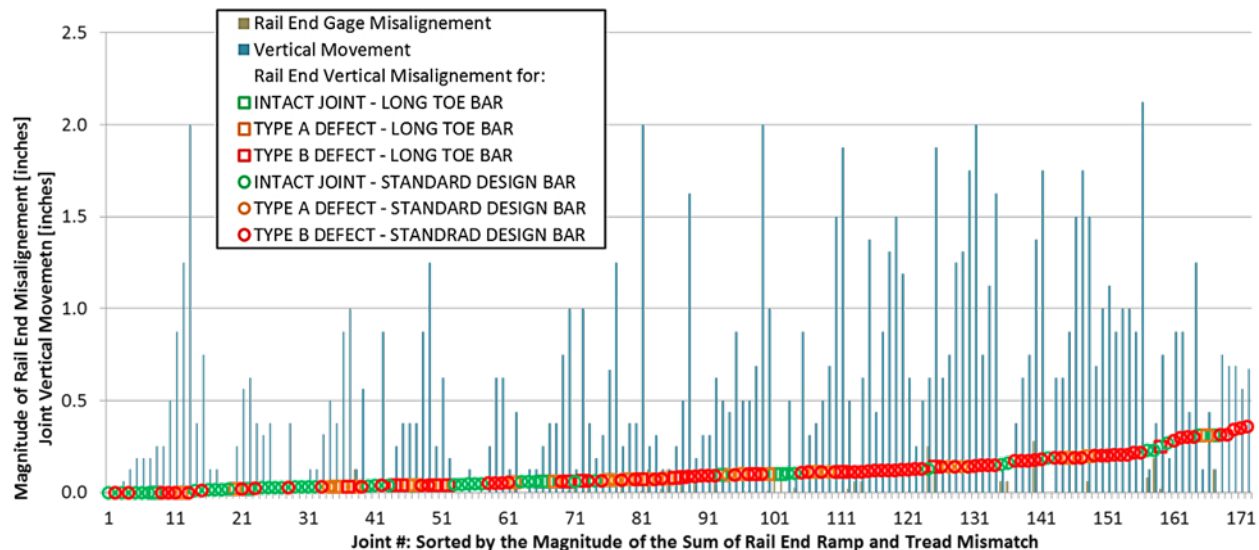
Figure 44. Combined JNT Sample—Overview of Rail End Conditions

Rail end conditions at intact and failed locations are comparable on Combined JNT Sample – Overview of Rail End Conditions the combined JNT sample as seen in Figure 44. The difference in rail end conditions between intact and failed rail end locations was specific to data from Class 3 track.

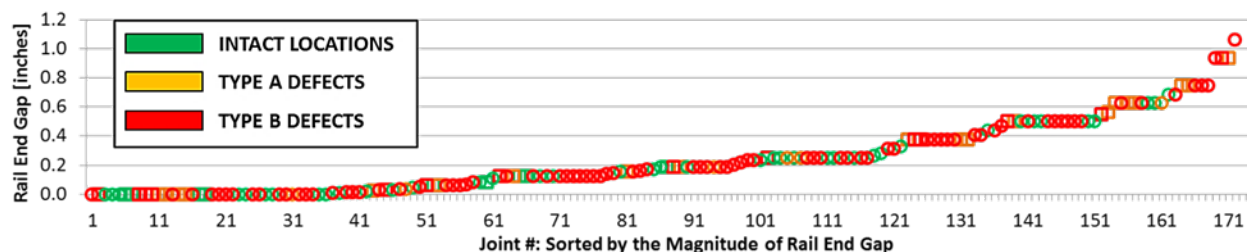
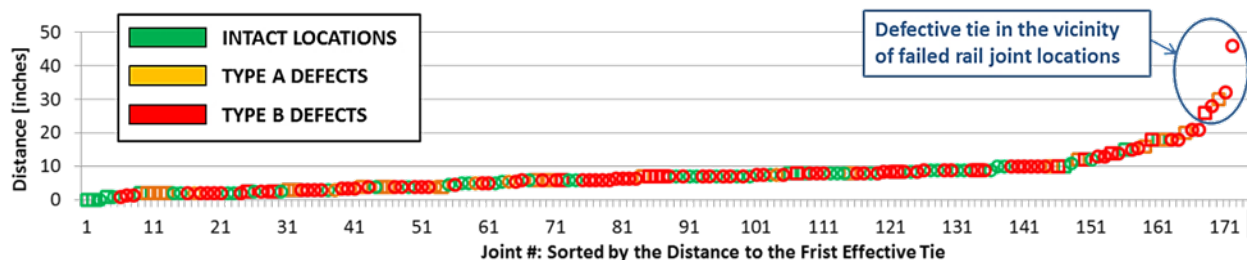
Locations with defects do not seem to have magnitudes of rail end gaps than evaluated intact joint locations. The distance to the first effective tie doesn't seem to be significantly different

between the intact and failed locations up to distances around 12 inches, see [Figure 45](#) and [Figure 46](#) respectively. This is consistent with the trends on data separated by track class.

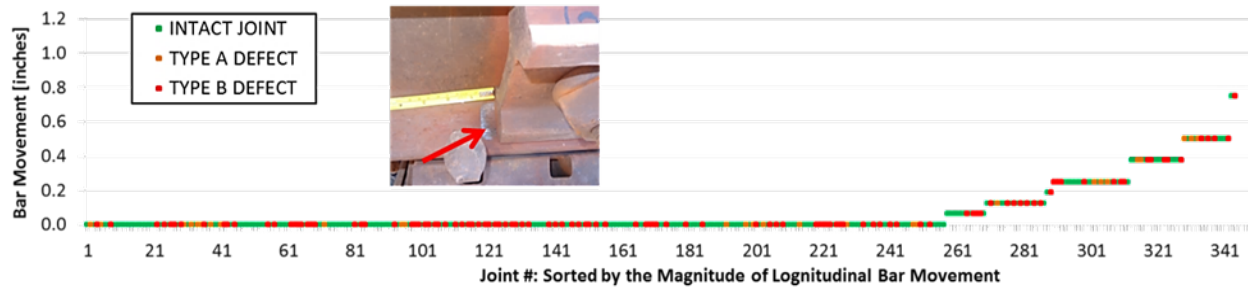
Figure 47. Combined JNT Sample—Overview of Longitudinal Bar Movement

Longitudinal bar movements and bolt conditions are also comparable at both intact and defect locations, see [Figure 47](#) and [Table 14](#).

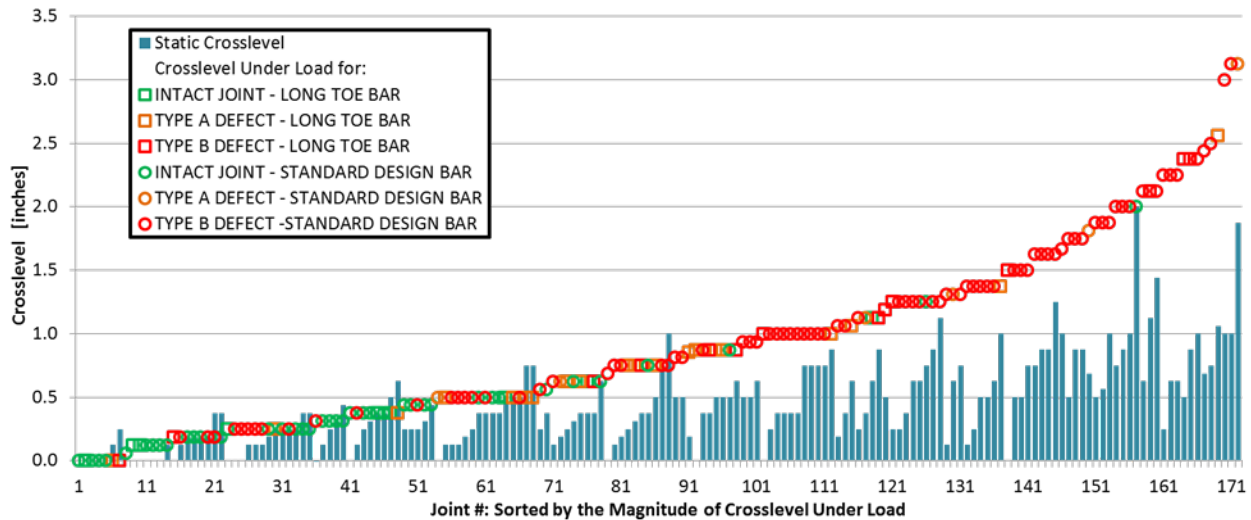
Figure 48. Combined JNT Sample—Overview of Static and Under Load Crosslevel

Figure 48 presents values of crosslevel under load overlaid with its static value. The value of static crosslevel does not appear to be such a distinct indicator of failed joint locations as crosslevel under load, even though a slight trend in the static values can be observed. It can be also observed that since static and under load values do not grow at the same rate, locations with increasing under load values also contain increasing proportion of vertical movements. An almost identical trend can be seen for static and under load profile measurements in Figure 49.

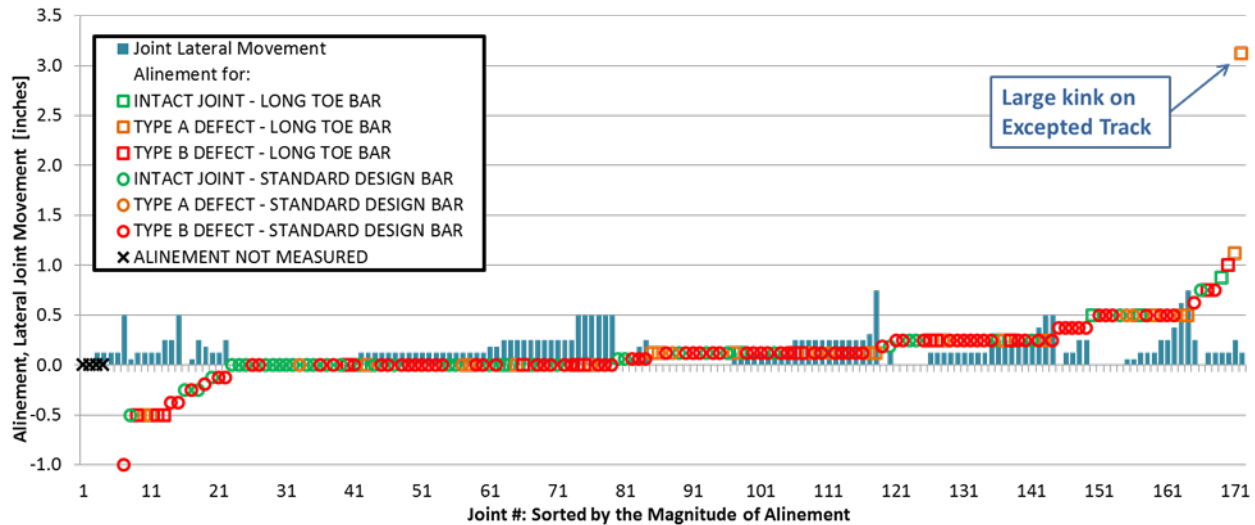
Figure 50. Combined JNT Sample—Overview of Static Alinement

Figure 50 shows static alinement for all locations overlaid with values of lateral movement. A negative value of alinement represents a deviation towards the center of track. The magnitudes of encountered alinement deviations in either direction (positive and negative values) are very small in general and many failed and intact locations do not exhibit any alinement deviation at all. Further statistical analysis was performed to determine if a significant difference between intact and failed joint locations exists separately for positive and negative values of alinement.

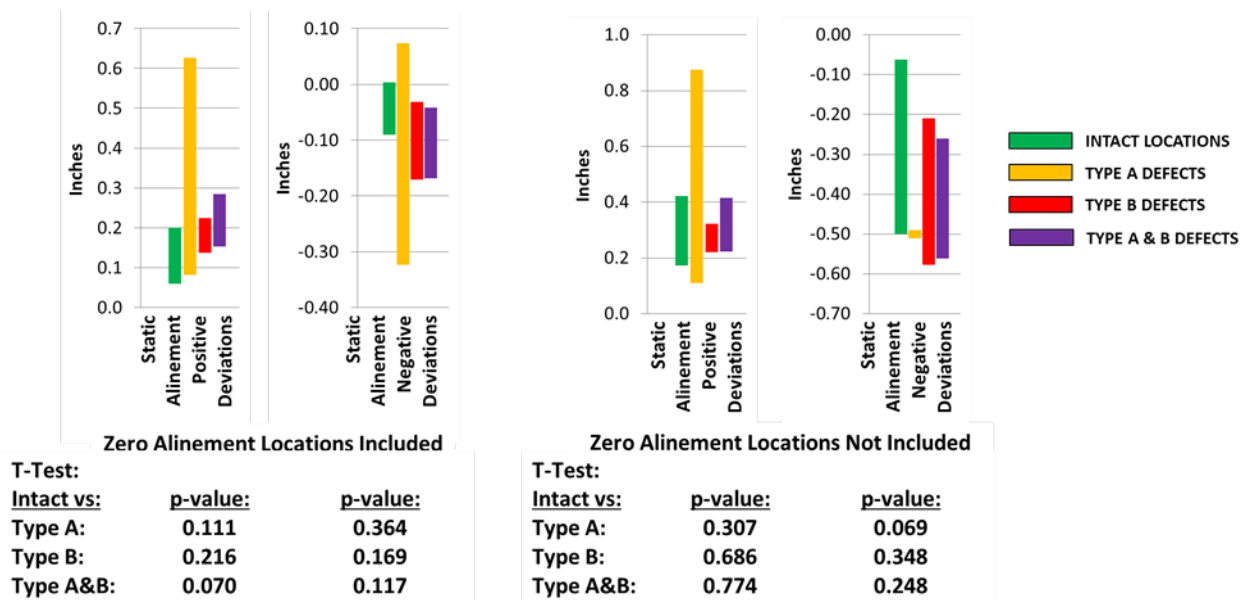
Figure 51. Combined JNT Sample Track—Detailed 95% Confidence and T-Test Results for Alinement

The T-test analysis was performed and confidence intervals constructed for cases—for positive and negative deviations of alinement with either locations of zero alinement included or not included in the samples. The results summarized in Figure 51 do not support positive or negative alinement as a significant factor contribution to joint failures.

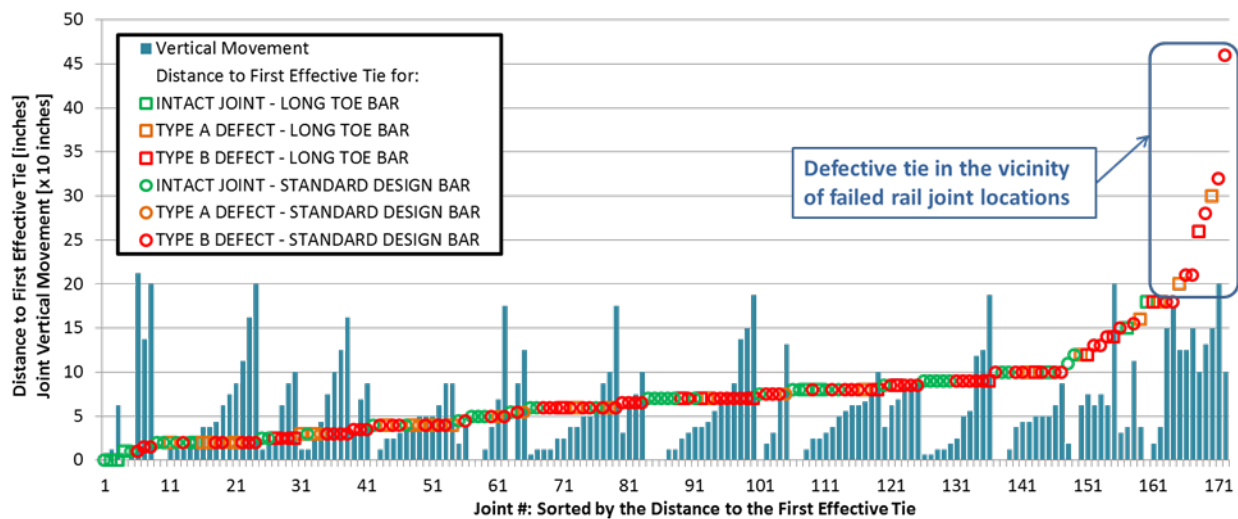
Figure 52. Combined JNT Sample—Overview of Distance to First Effective Tie and Vertical Movement

Figure 52 displays the distance to first effective tie measured on combined JNT samples overlaid with values of vertical movement. The locations are sorted by the magnitude of the distance to first effective tie and the vertical movement is scaled up 10 times. There is no trend in growing vertical movement with increasing distance to the first effective tie. In general, failed locations are accompanied with comparable values of vertical movement regardless of this distance. Locations with a distance to the first effective tie larger than 12 inches, indicating the presence of defective ties under the joint, all contain significant vertical movement. This is comparable to the magnitudes at other failed locations and it is in agreement with the conclusions made separately in lower and higher track class samples and with field observations. Rail joint failure appears to be independent of the original suspended and supported rail joint configurations but it is dependent on deterioration of vertical joint support regardless of the original tie configuration. The presence of defective ties under the rail joints results in and may exacerbate deteriorated vertical support and subsequent vertical movements.

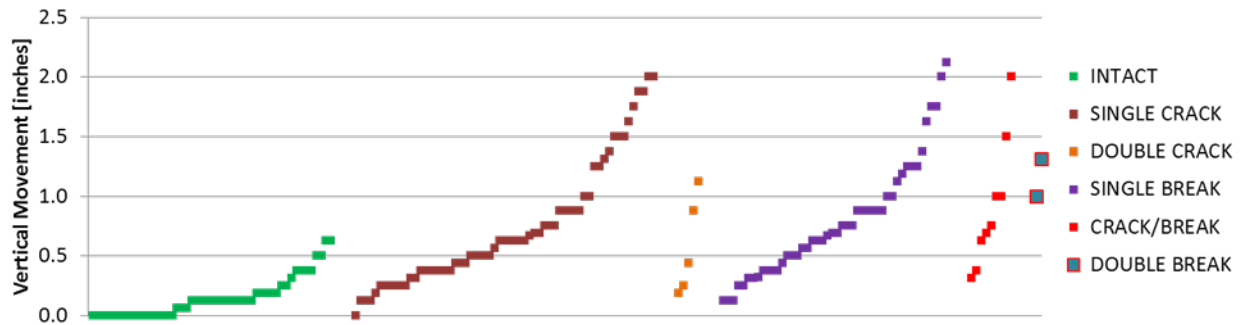
Figure 53. Combined JNT Sample—Overview of Vertical Movement Based on Defect Type

Figure 53 presents the vertical movement for intact locations and locations in the following categories: single crack bar, double crack, single break, crack/break and double break defect. The categories are ordered according to the theoretical decrease in bending stiffness, i.e., the capability to rigidly connect two rail ends at the rail joint for the particular defect configurations. The vertical movements in each group are sorted by their magnitude. Cracked bars (top cracks especially), which offer similar capability to rigidly connect two rail ends as intact bars appear to contain much larger vertical movements than intact bars. Locations with joint bar breaks show comparable vertical joint movements as locations with cracked bars, even though locations with at least one broken bar have reduced cross sectional characteristics at the rail end connection. This is confirmed by 95% confidence intervals shown in Figure 54.

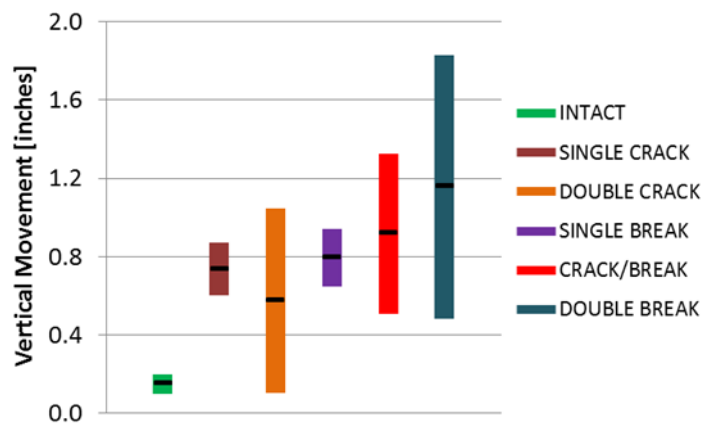
Figure 54. Combined JNT Sample—95% Confidence Intervals of Vertical Movement Based on Defect Type

The difference in the magnitude of vertical movement between the defect locations at intact locations is statistically significant for all defect types except for the double crack category and breaks where the number of sample is very small (five and two locations respectively). The differences are not significant among the defect type combinations, which suggests that joint movements precede the joint bar defects and vertical movements are a factor that contributes to joint failures. The results—due to limited size of crack/break and double break sample groups—do not provide statistically significant evidence to the assumption that vertical movement would grow further once defects develop into full breaks.

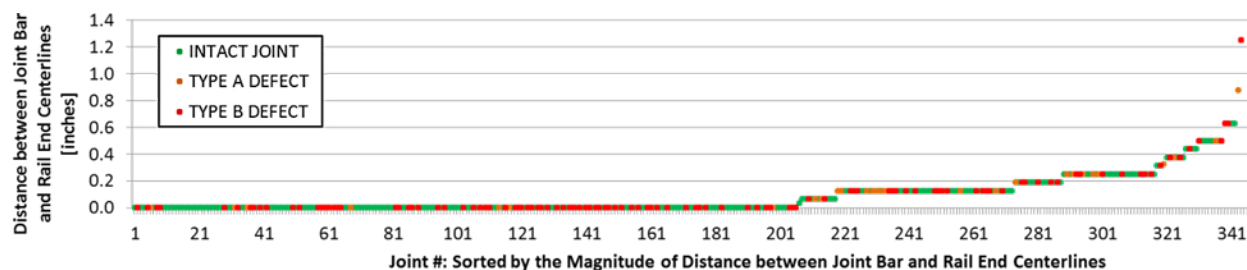
Figure 55. Combined JNT Sample—Overview of Distance between Joint Bar and Rail End Centerline

The field surveys also documented the distance between the joint bar and rail end centerline. This measurement quantifies asymmetry in the joint bar placement at the rail ends. [Figure 55](#) illustrates comparable values at intact and defect locations.
