**Federal Railroad
Administration**

Joint Bar Failure Study—Field Investigation

1. AGENCY USE ONLY (Leave blank)		2. REPORT DATE June 2019		3. REPORT TYPE AND DATES COVERED Technical Report April 2016
4. TITLE AND SUBTITLE Joint Bar Failure Study—Field Investigation			5. FUNDING NUMBERS DTFR53-10-D-00002 Task Order 18

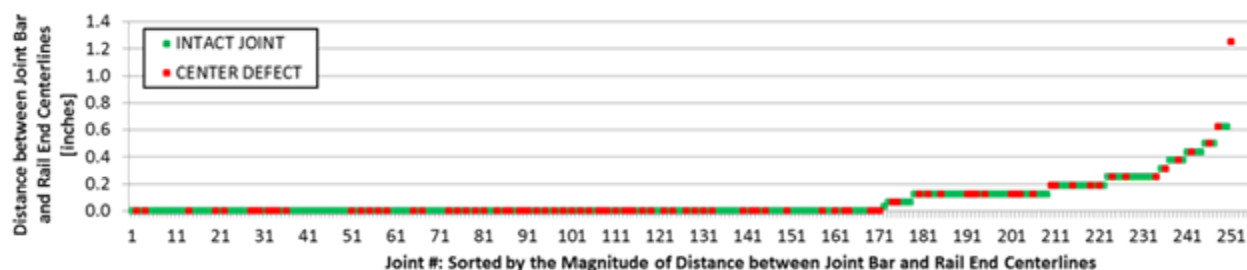
Figure 56. Combined JNT Sample—Overview of Distance between Joint Bar and Rail End Centerline for Head-Free Joint Bars with Center Defects or Intact

Easement, a term that describes an area in the middle of the joint bar where the material is recessed to prevent rail ends from coming in contact with the joint bar middle top section, may be present on modern design bars. The easement is supposed to be positioned in the center of the joint bar, which means that the distance between joint bar and rail end centerline distance parameter can evaluate the effect of the easement on joint failure indirectly. Since an easement may be present only in modern-design bars and should affect only failures originating close to the rail ends, a subset of data containing only head-free joint bars either intact or contain center defects was separated from the combined samples. The values at intact and defect locations are again compared ([Figure 56](#)). The T-test confirmed that there was no statistically significant difference between the intact and center-failed joint bars with p-value at 0.94. The difference was also found not statistically significant when only failed bars with top center cracks were considered, p-value at 0.20.

These results cannot confirm or rule out definitively any effect of easement on rail joint failure as it is not known to ENSCO whether investigated joint bars truly contained any centrally or otherwise located easement at all. Only selected failed bars were shipped to the TTC for further analysis, where easement presence would be documented.

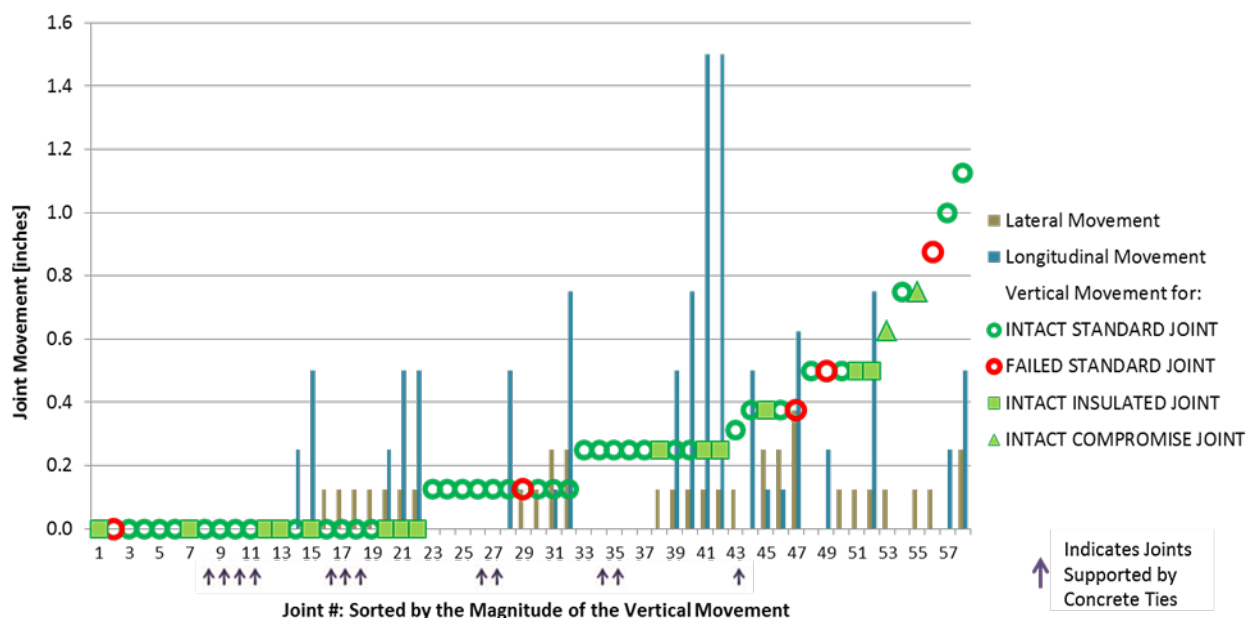
Figure 57. CWR Sample—Overview of Joint Movements

Figure 57 provides an overview of joint movements. The locations are sorted by the magnitude of the vertical movement. Three of the failed locations showed signs of significant vertical movement. One failed location without any measured joint movement may be an outlier, located in a switch with very recent maintenance work. The sample also contains several intact joints with adverse support conditions which were encountered during the first survey at test zone A. These locations were mostly temporary joints, which were very recently installed in track prior to the survey date and did not accumulate significant tonnage (see Figure 63). Permanent rail joint installations have insulated joints that tend to stay in the track for a very long time, and in general have better support conditions than standard temporary joints. Rail joints on concrete tie track including temporary ones had better vertical support than joints on wooden tie track.

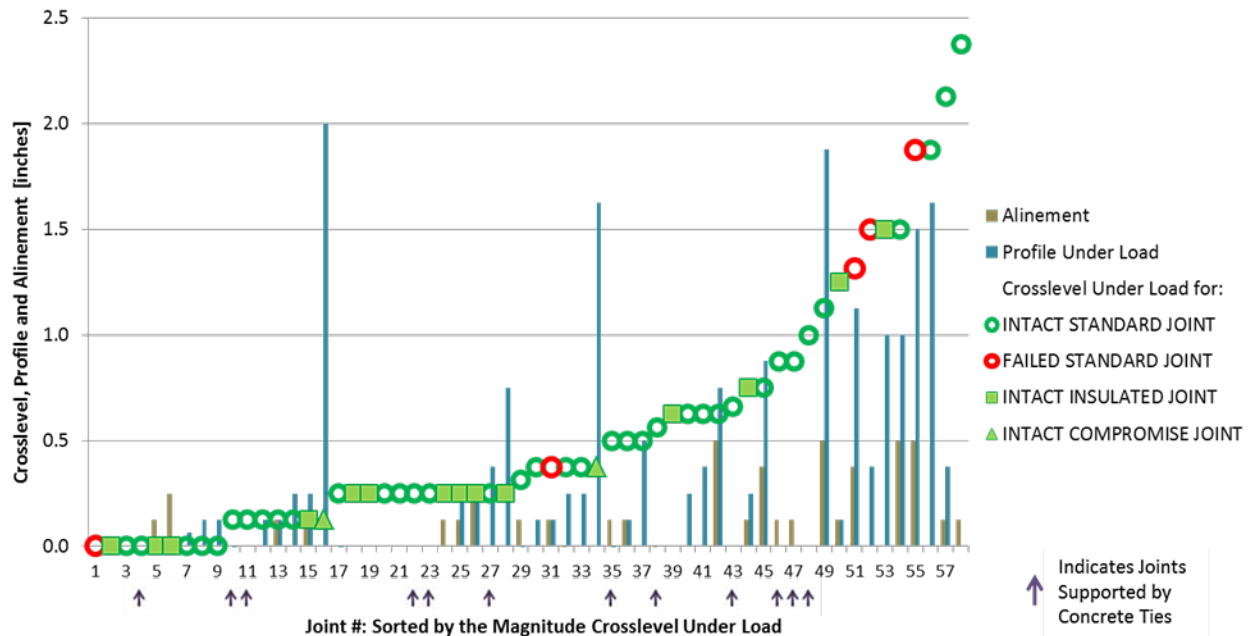
Figure 58. CWR Sample—Overview of Selected Track Geometry Parameters

Track geometry exhibit very similar trends as joint movement. Selected parameters, crosslevel and profile under load and alinement are presented in Figure 58. It is important to remember that under load crosslevel and profile measurements contain a significant proportion of vertical movement.

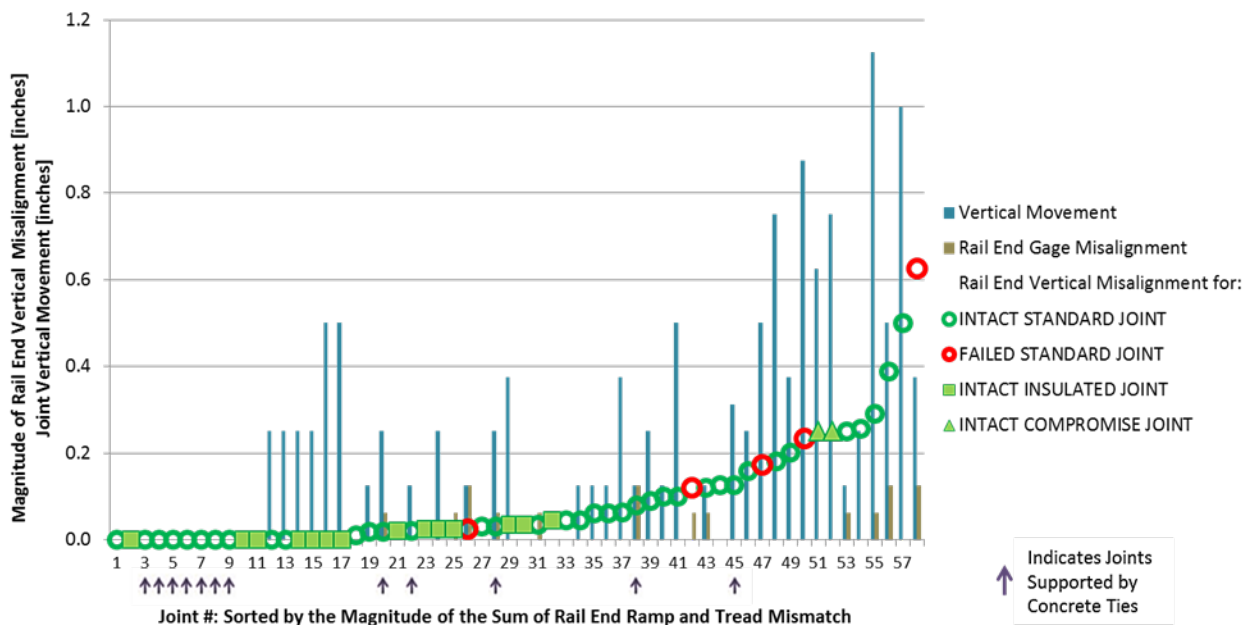
Figure 59. CWR Sample—Overview of Rail End Conditions

Figure 59 gives an overview of rail end conditions. The locations are sorted by the value of rail end vertical misalignment, which is defined as a sum of tread mismatch and rail end ramp. This is a calculated parameter used to evaluate the overall conditions of the rail ends in vertical direction. Vertical rail end misalignments are overlaid with vertical movements and gage rail end misalignments, which are defined as the sum of gage ramp and gage mismatch.

Permanent insulated joints in general contained better rail-end conditions than standard temporary joints. Rail joints on concrete tie track, including temporary ones, had better rail end

conditions than joints on wooden tie track. Both of those trends are more pronounced than similar trends in vertical joint support observed in Figure 57. Vertical movement seems to increase as the value of vertical rail end misalignment rises. Several intact joint locations contain adverse rail end conditions. Again, these locations were temporary joints that had been recently installed and did not have significant accumulated tonnage; they were encountered during the first field survey on test zone A (see Figure 63). Four failed locations contained significantly adverse rail end conditions. The last failed rail joint location with limited rail end ramp was located in a switch with very recent maintenance work.

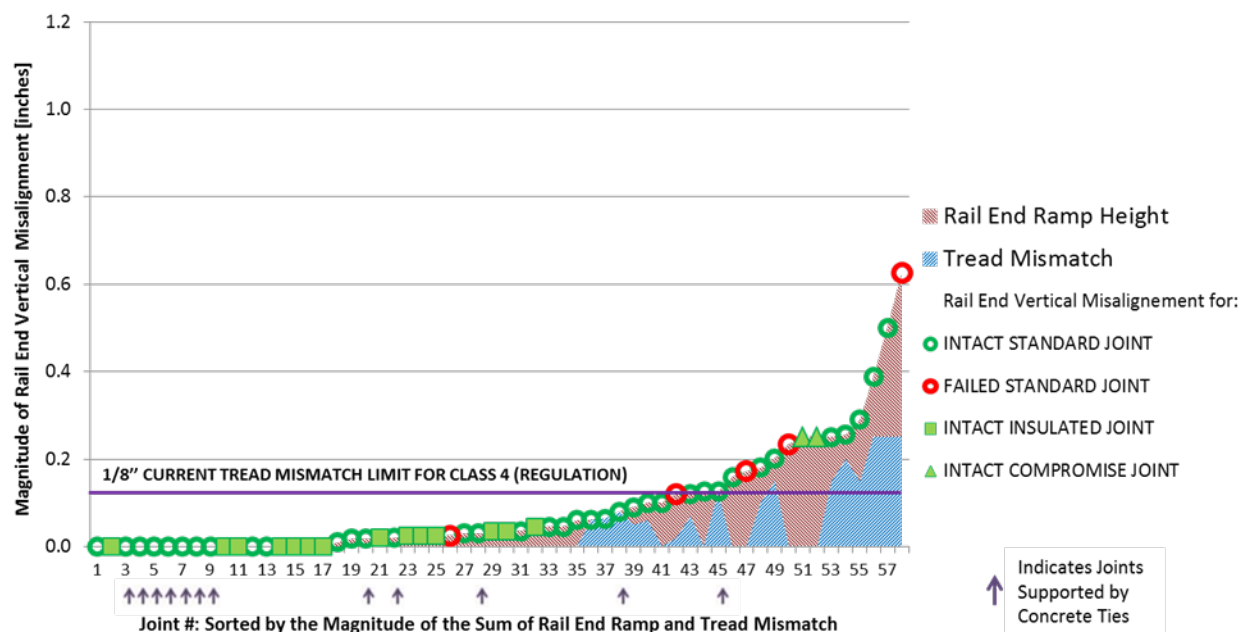
Figure 60. CWR Sample—Composition of Vertical Rail End Misalignments

During the field surveys, it was observed that CWR deteriorated rail end conditions were overwhelmingly represented by tread mismatches or abrupt rail end ramps, which were caused by the original mismatches being battered down by repeated wheel impact loads. This was especially the case when temporary joints were introduced in places of rail repair that used new or full ball repair rail sections in track with worn rail. Figure 60 displays the proportion of tread mismatch and rail end ramp height contributions to the overall rail end misalignment at the individual joint locations.

The proportion of abrupt rail end ramps is often very large, especially at the failed locations. Three out of the four failed rail joint locations with significant rail end misalignments contain mostly rail end ramps as a result of battered down original tread mismatches. This can be also observed in Figure 61 and Figure 62 which present the tread mismatches and rail end ramps at the locations separately.

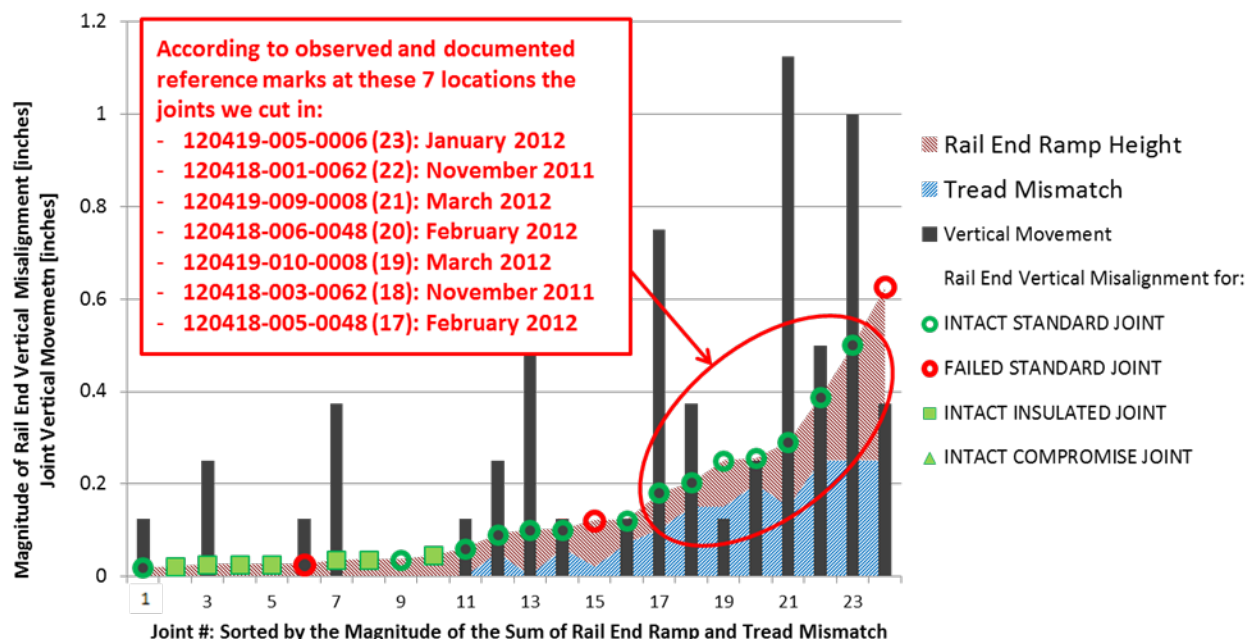
Figure 63. CWR Sample—Composition of Vertical Rail End Misalignments at Test Zone A Locations

During the first survey, most intact temporary rail joints with adverse rail end conditions in test zone A were installed in track very recently prior to the survey date and did not accumulate significant tonnage. They predominantly contained tread mismatch, suggesting they did not endure enough traffic for these mismatched rail ends to be battered down yet (See Figure 63).

Figure 63 shows overall vertical rail end conditions and the proportions of tread mismatches and rail end ramps contributing to the misalignments overlaid with vertical movement on locations investigated during the first field survey on test zone A. As mentioned previously, several intact temporary joints with high value of rail end vertical misalignments were found during the first field survey. These locations are highlighted along with the installation date based on

investigation of the welders' reference marks. The first field survey was conducted in April of 2012. All these temporary joints were cut in the track very recently and had not accumulated more than 7 MGT since they were installed in this territory. They also contain a large proportion of tread mismatch contribution to the overall misalignment.

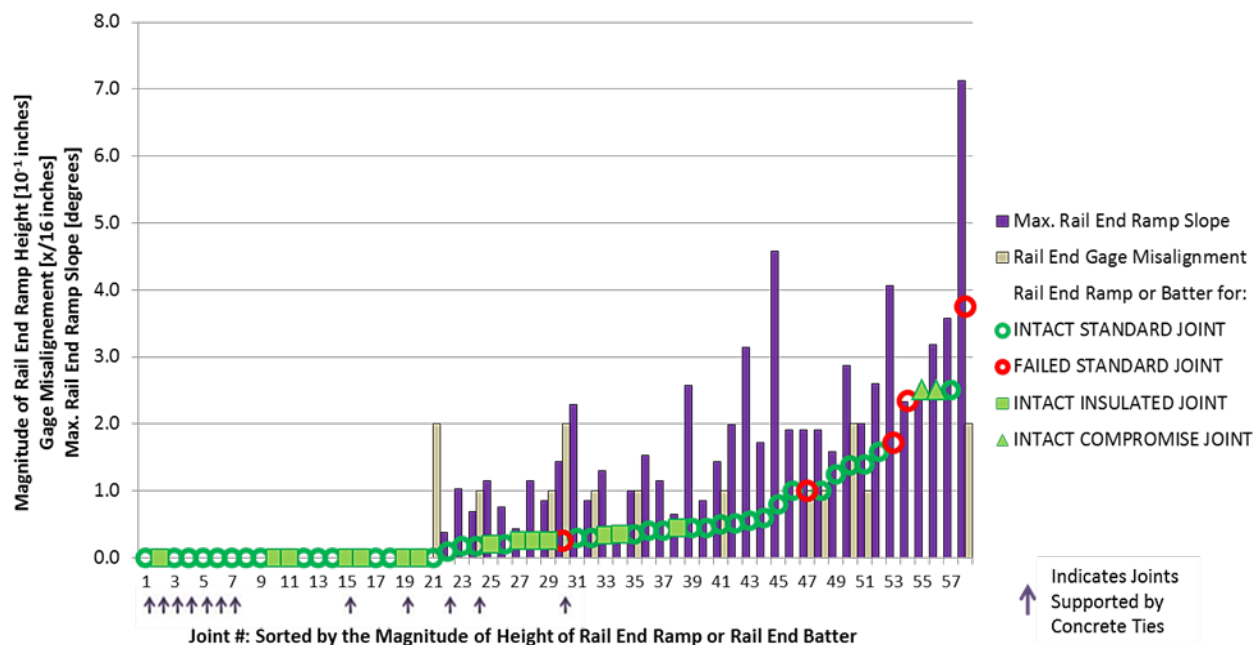
Figure 64. CWR Sample—Overview of Rail End Slopes

The field surveys indicated that most of the rail end ramps at temporary joints were very abrupt and appeared to be originally tread mismatches, which were battered down by wheel impact forces. The plot in Figure 64 provides an overview of the slopes of the measured rail end ramps. Rail end slopes were calculated for both rail ends at each location and the maximum slope for each location was plotted in the order of the growing height of the rail end ramp. The figure also includes the values of gage misalignments at each location.

There appears to be a correlation between the growing magnitude of the rail end ramps and the abruptness of the ramps. At locations where rail end ramps are around 0.1 in. or higher, the ramp slopes are also very steep, between 2 degrees and 7 degrees.

The correlation between the magnitude of the rail end ramps and the abruptness of the ramps supports the observation that many measured ramps at temporary joint were caused by impact loads battering down the rail heads with an originally installed mismatch. Battering down the head in this manner could also cause gage misalignments by widening the rail head. The plot in Figure 64 does not offer a strong correlation between magnitude of the rail end ramps and gage misalignments, as many locations with large rail end slopes do not contain a gage misalignment at all. However, the battering caused the rail head at many such locations to widen towards the field side rather than the gage side of the rail. Refer to Figure 17 for a good example of battered rail head widening towards the field side.

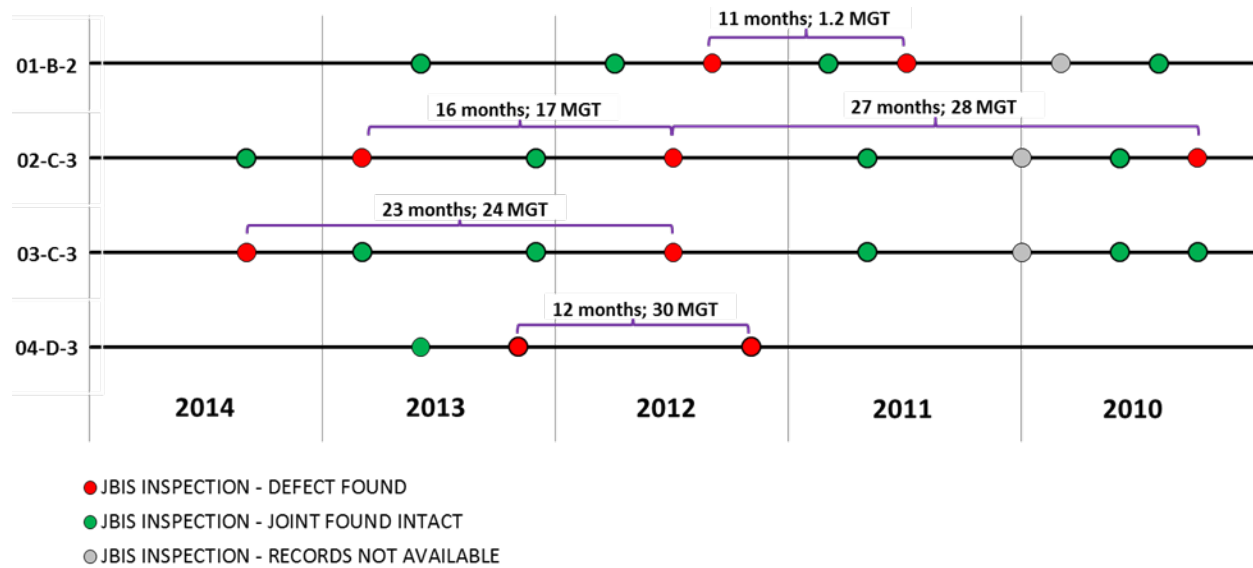
Figure 66. Timeline of Repeat Failures

Figure 66 shows the time line of JBIS inspections and identified defects at the four repeat failure locations. In repeat failure ID 02-C-3, the rail joint failed three times in a span of only 3 1/2 years. All four repeat failures occurred in jointed track territory.

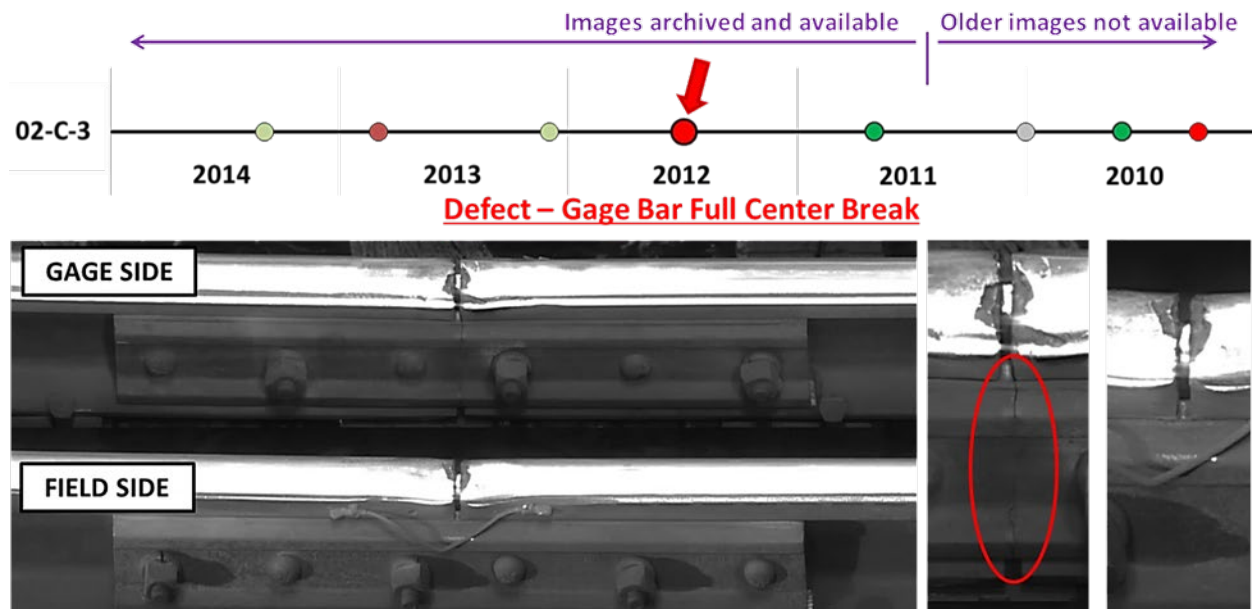
A repeat failure (ID 02-C-3) is confirmed by a review of system camera images in Figure 67 through Figure 71.

Figure 68. Repeat Failure Location 02-C-3—July 2012 JBIS Camera Image, Joint Failed

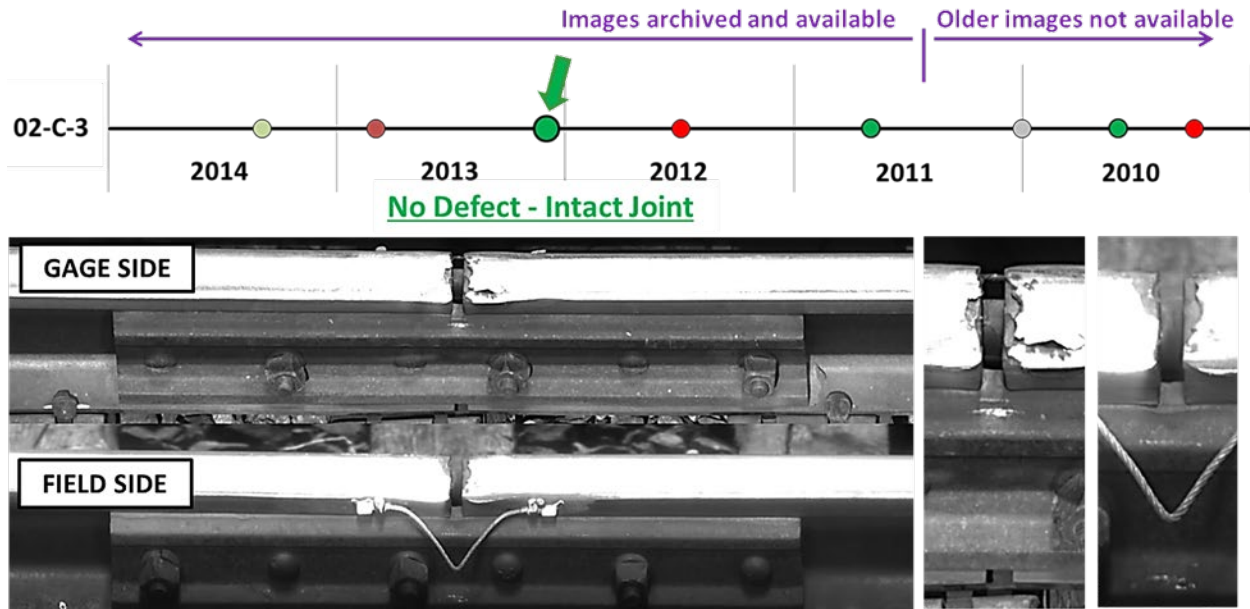
Figure 69. Repeat Failure Location 02-C-3—February 2013 JBIS Camera Image, Joint Intact

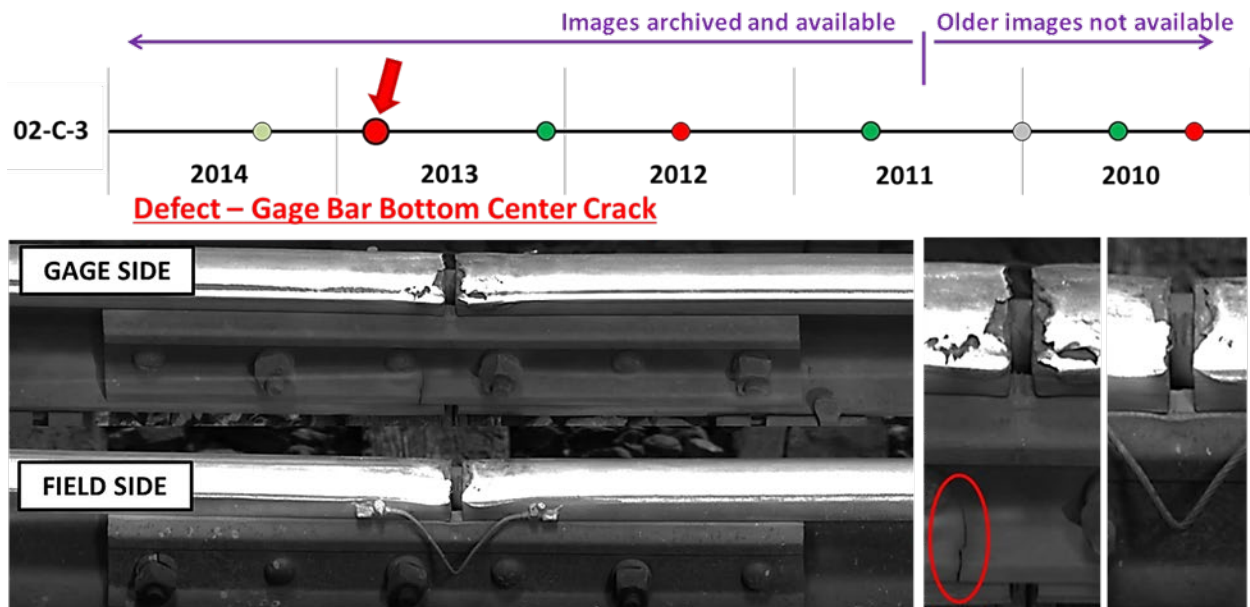
Figure 70. Repeat Failure Location 02-C-3—November 2013 JBIS Camera Image, Joint Failed

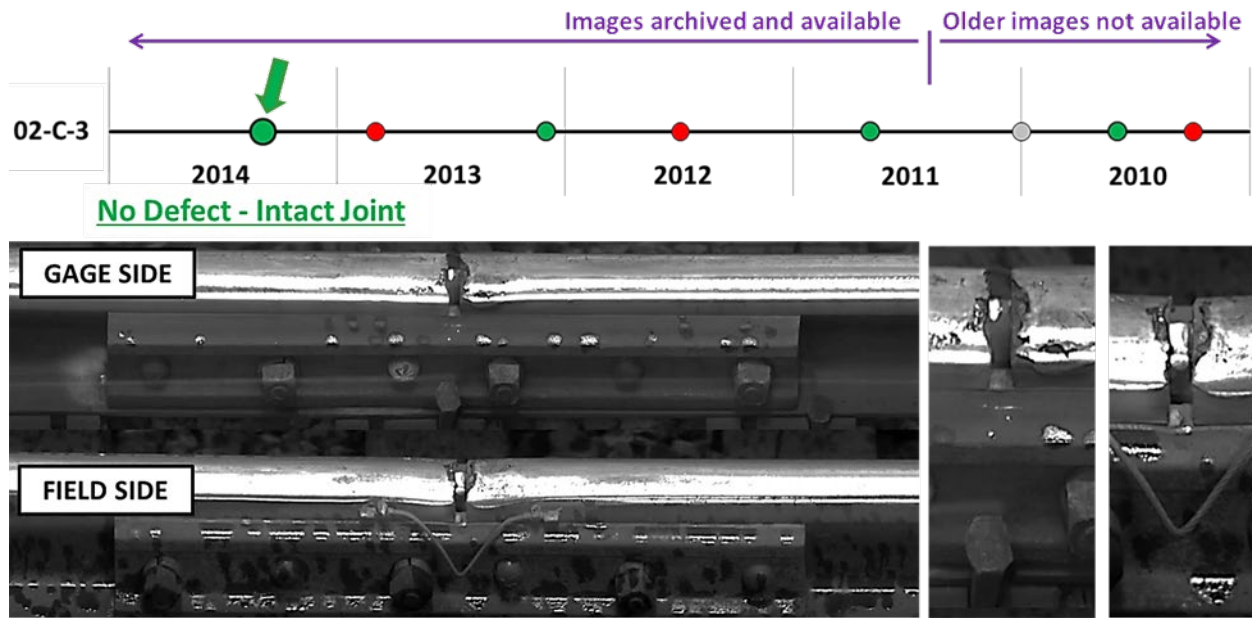
Figure 71. Repeat Failure Location 02-C-3—May 2014 JBIS Camera Image, Joint Intact

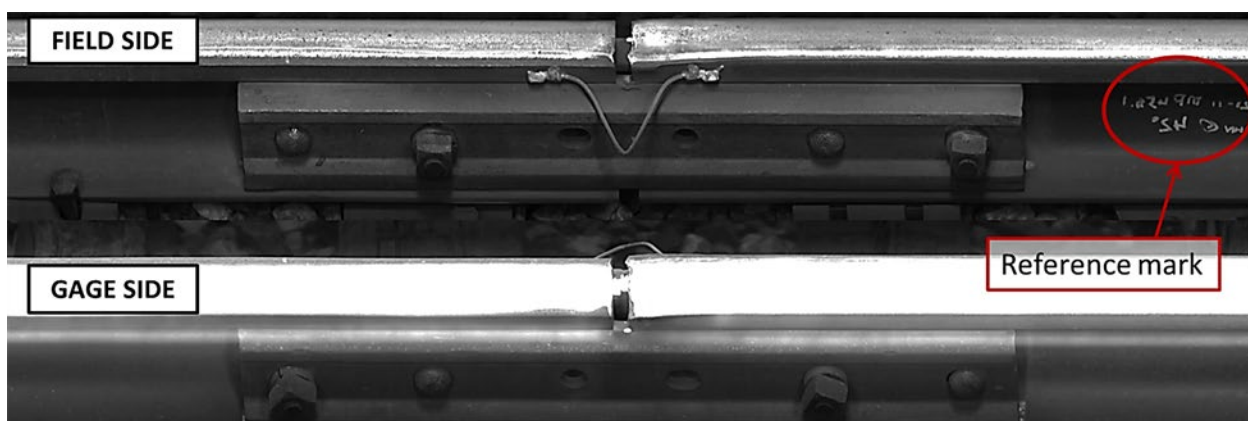
Figure 75. Repeat Failure Candidate 120727-004-0458—November 2013 JBIS Camera Image of Adjacent Intact Rail Joint

It is obvious that the November 2013 defect occurred at a different rail joint than the July 2012 defect. Most importantly, the reference mark does not match the one documented in [Figure 73](#). A JBIS camera image of an adjacent intact rail joint to the November 2013 failure is presented in [Figure 75](#). This intact location is the actual rail joint that failed in July 2012 as indicated by the matching reference marks.

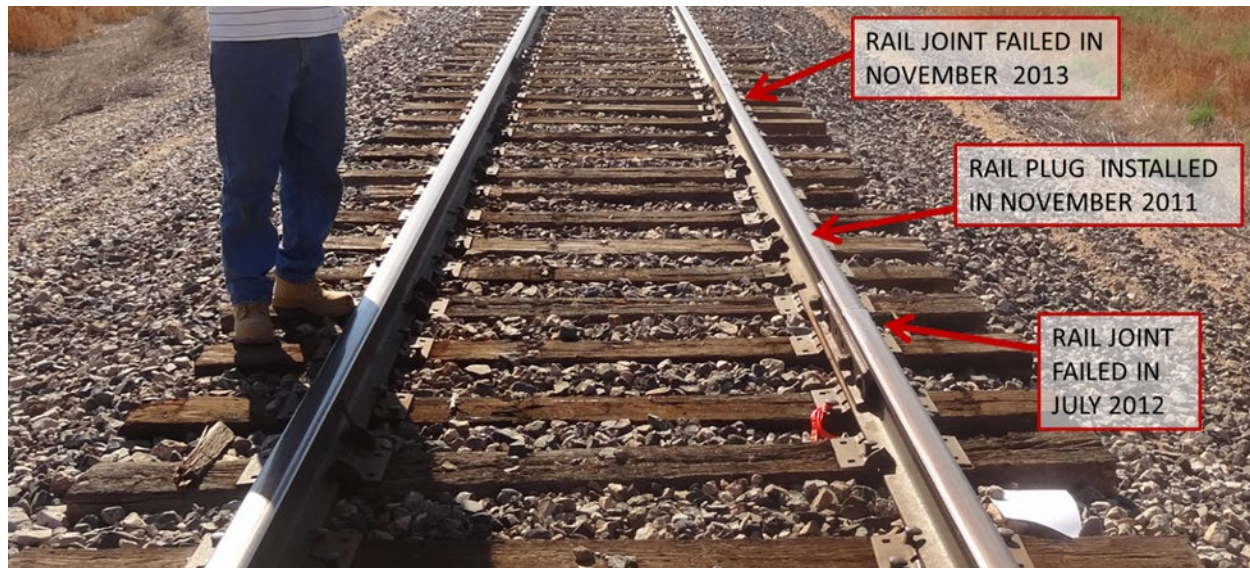
Figure 76. General Field Conditions in the Vicinity of a Recently Installed Rail Plug

Figure 76 illustrates the general field conditions at the rail plug and both the temporary rail joints as encountered during the July 2012 field survey. The first failed rail joint contained 0.5-inch vertical movement in combination with 0.13 inches of an abrupt rail end ramp. The second rail joint, which subsequently failed in November 2013, also appears to contain significant rail end ramp and insufficient ballast, which suggests at least some vertical movement based on the pictures in Figure 74 and Figure 76. Insufficient vertical support in combination with deteriorated rail end conditions, specifically abrupt rail end ramps resulting from an original tread mismatch battered down by repeated wheel loads appear to be the main contribution factor to failure in this case.

The same contributing factors were identified on the CWR sample, based on the analysis of the temporary and permanent joints (both failed and intact). In addition, it is interesting to note in Figure 76 that the rail ends were fully closed. The air temperature on the day of the survey was 95 °F. The rail plug was installed in November 2012 at a temperature of only 42 °F based on the rail reference markings. When we consider that that the location was at JNT territory and the joints allowed rail ends to move throughout the annual temperature cycle as visible in Figure 72 through Figure 75 it is safe to assume that the two failed temporary joints were not subject to significant tensile stresses while installed in this particular location.

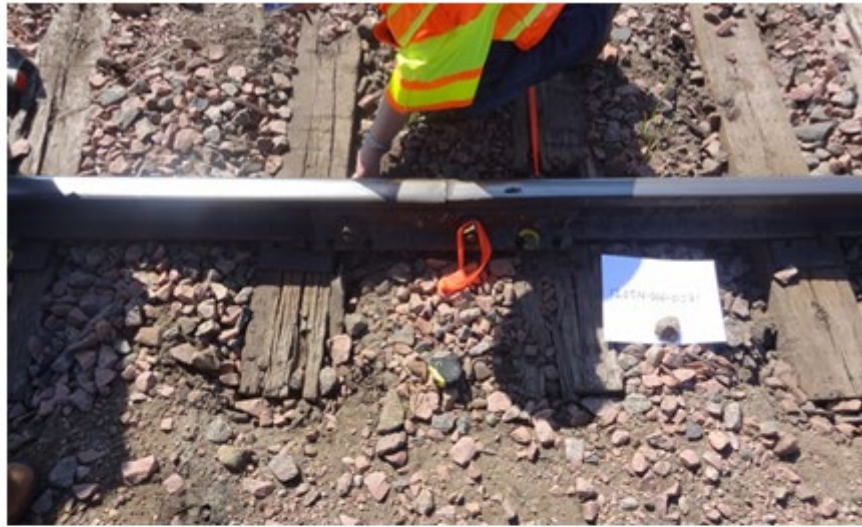
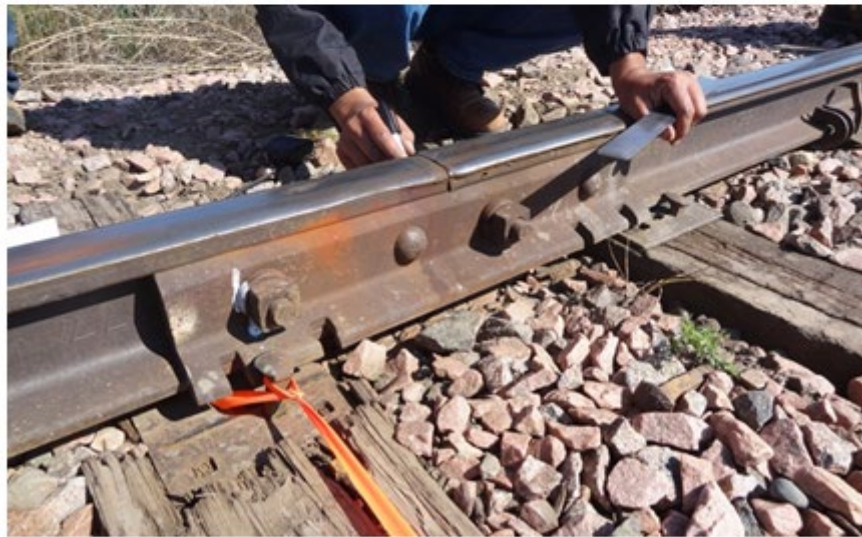
Figure 77. Repeat Failure 01-B-02—Field Conditions

[Figure 77](#) shows field conditions at repeat failure 01-B-02. The same defect, a full center break, occurred at a field side bar in July 2011 and May 2012. Survey in November 2011 did not find a defect at this rail joint. The joint accumulated ~1.2 MGT between the two failures in 11 months. It is most likely that an older previously long toe bar recovered from a different joint location was used when the original failed bar was replaced. This defect was found at a location with much deteriorated support conditions. The ballast was extremely contaminated, ties were split with large plate cutting and pumping, and tie plates were loose. Vertical movement was 2.0 inches at this location. This location contained the most severe support and track surface

geometry conditions encountered during the second field survey in test zone B1. Moderate rail end batter 0.07 inches high and gage mismatch of 0.01 inches was recorded. Bolts conditions were good with all bolts intact.

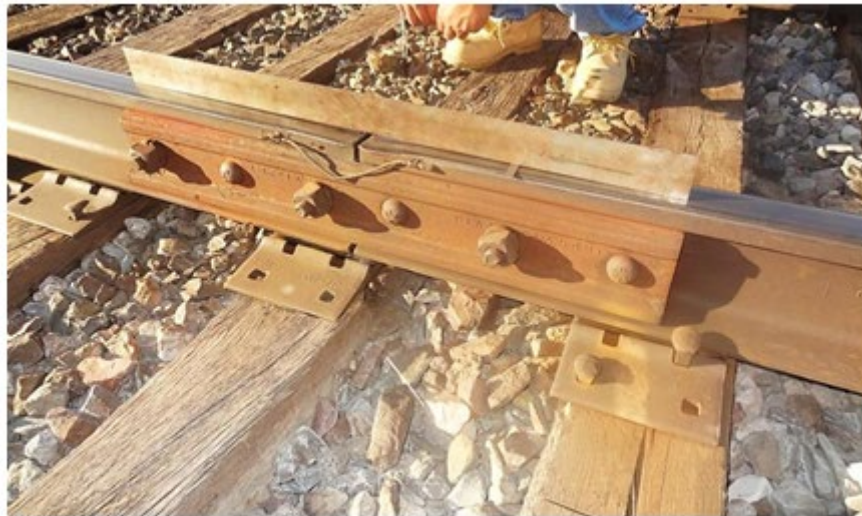
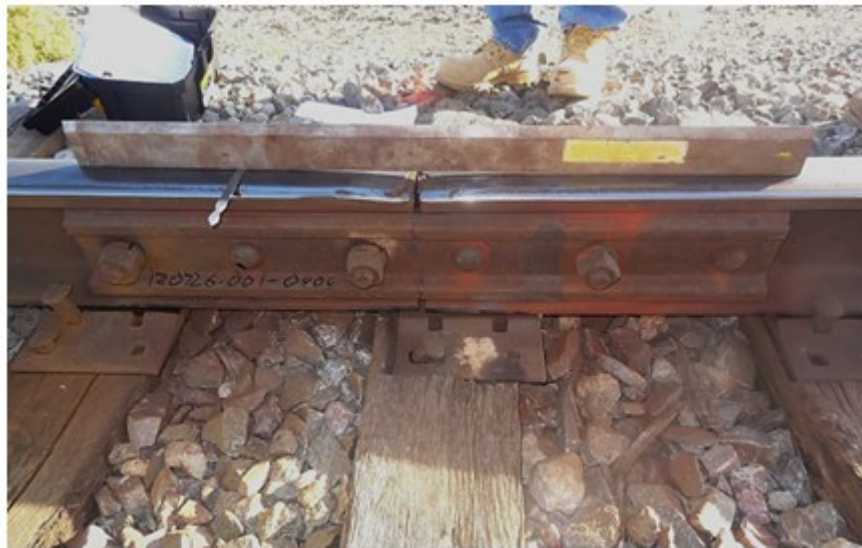
Figure 78. Repeat Failure 02-C-03—Field Conditions

Figure 78 shows field conditions at failure location 02-C-03, where the joint failed three times within 3 1/2 years. One defect, a full center break, occurred on gage side bar in April 2010 and July 2012, while in November 2013, a 50 percent bottom center crack occurred on gage side bar. The joint accumulated ~28 MGT between the first two failures in 27 months and ~17 MGT in the 16 months between the second and third failure. This defect was also found at a location with deteriorated support conditions. The ballast was moderately contaminated, ties were affected by plate cutting and pumping, and tie plates were loose. Vertical movement was 1.75 inches at this location and significant rail end batter 0.18 inches high was recorded, but bolt conditions were

good with all bolts intact. This location contained one of the most severe geometry, track support and rail end conditions encountered during the third field survey in test zone C.

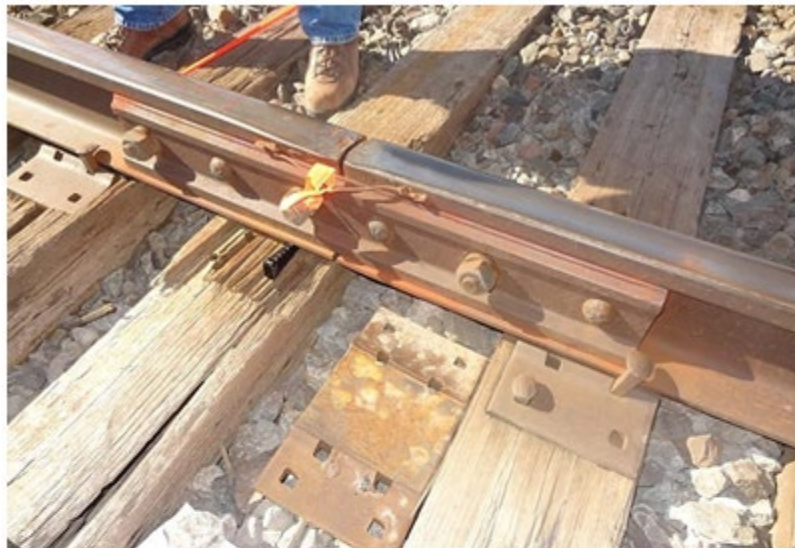
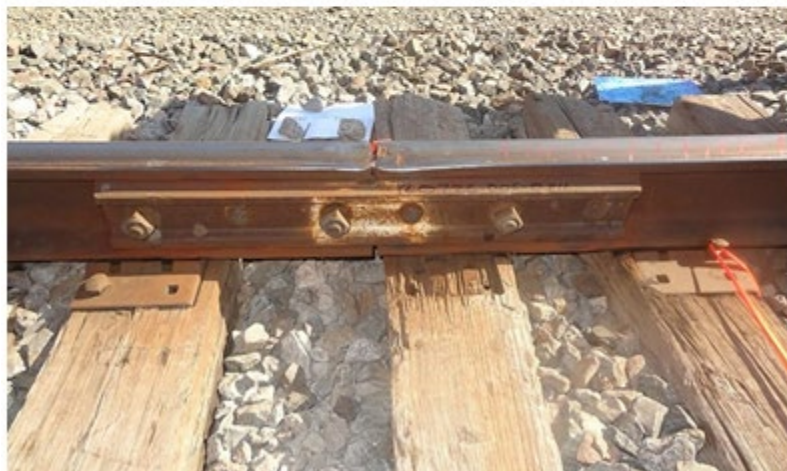
Figure 79. Repeat Failure 03-C-03—Field Conditions

Figure 79 shows field conditions at repeat failure 03-C-03. Two different defects occurred, a full quarter break on gage side bar in July 2012 and a 20 percent top center crack on field side bar in May 2014. The joint accumulated ~24 MGT between the two failures in 23 months. Support conditions were again deteriorated in this location. The ballast was fouled, ties were split and pumping, one tie plate was missing, and other plates were loose. Vertical movement was 1.5 inches at this location. Significant rail end batter (0.12 inches high) was also measured. Bolt conditions were good with all bolts intact. This location again contained one of the most severe geometry, track support and rail end conditions encountered during the third field survey on test zone C.

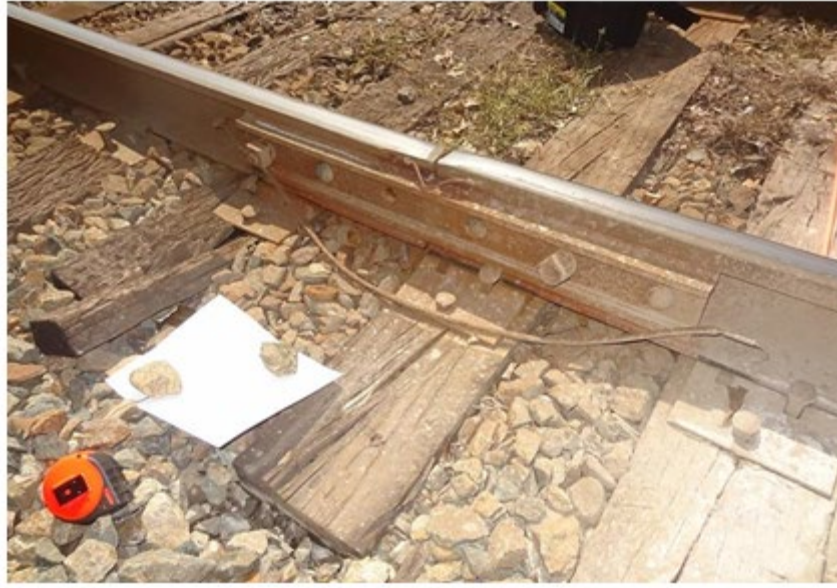
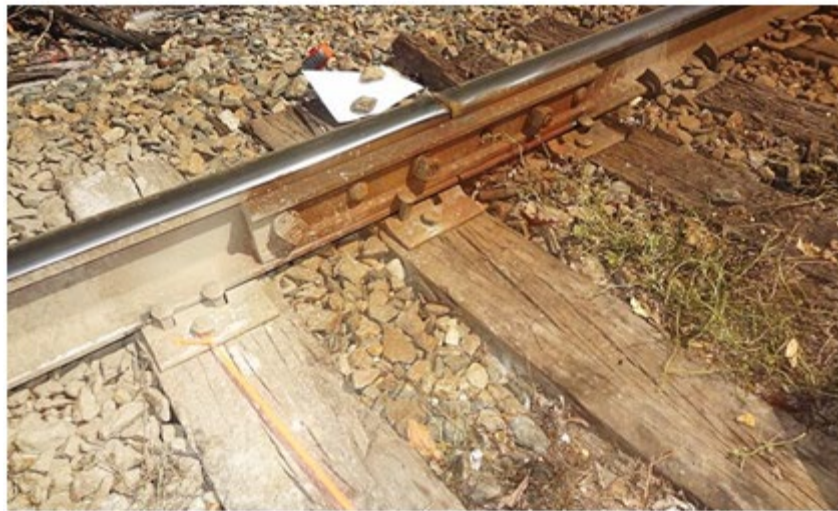
Figure 80. Repeat Failure 04-D-03 – Field Conditions

Figure 80 shows field conditions at repeat failure 04-D-03. Two different defects occurred: 1) A full center break on field side bar combined with a 20 percent top center crack on gage side bar in March 2012 and 2) a 10 percent top center crack on field side bar in March 2013. The joint accumulated ~30 MGT between the two failures in 12 months. Support conditions were also deteriorated in this location. The ballast was heavily fouled, ties were split and pumping, and tie plates were loose. Vertical movement was 1.75 inches and significant rail end batter (0.188 inches high) was also measured. One bolt was missing. This location contained one of the most severe geometry, track support and rail end conditions encountered during the fifth field survey on test zone D.

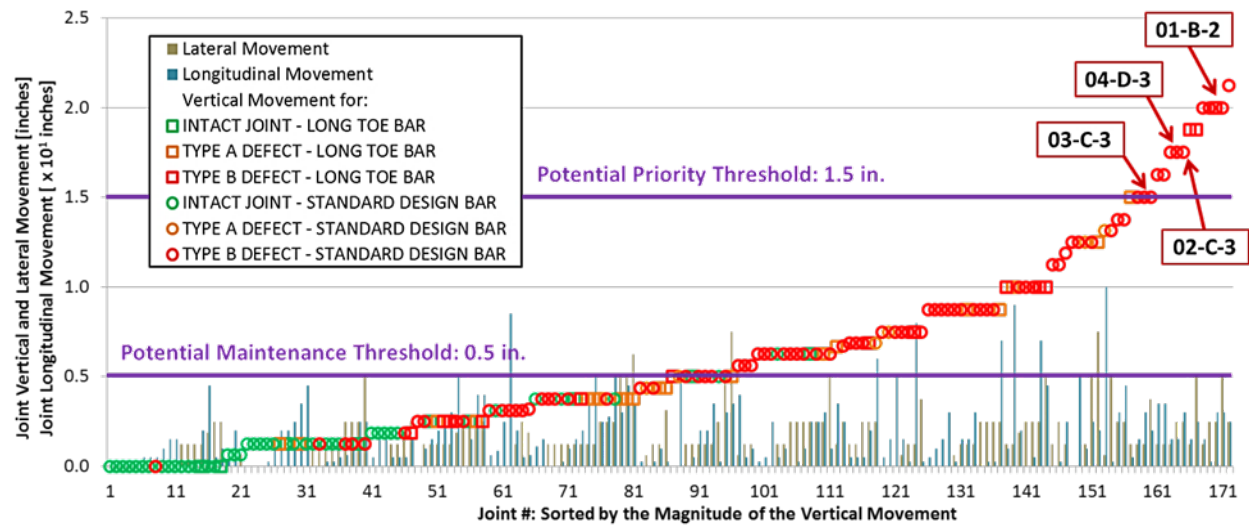
Figure 81. Joint Movements at Repeat Failure Locations in Respect to Combined JNT Sample

Rail joint movements are summarized in Figure 81. The four repeat failures occurred at locations with the highest vertical movements (magnitudes above 1.5 inches) encountered during the entire study. There appears to be a very distinct separation between intact and failed joint locations. Except for two intact rail joints with a vertical movement of 0.7 inches, all the locations with vertical movement larger than 0.5 inches contained a failed joint bar. Therefore, two purple lines in the plot represent two vertical movement levels of concern regarding rail joint failure. The first potential maintenance threshold of 0.5 inches indicates locations where a possibility of a joint failure exists and maintenance efforts would be beneficial. The second potential priority threshold (1.5 inches) identifies locations where the risk of imminent joint failure is much higher and more immediate remedial action or maintenance efforts should be performed.

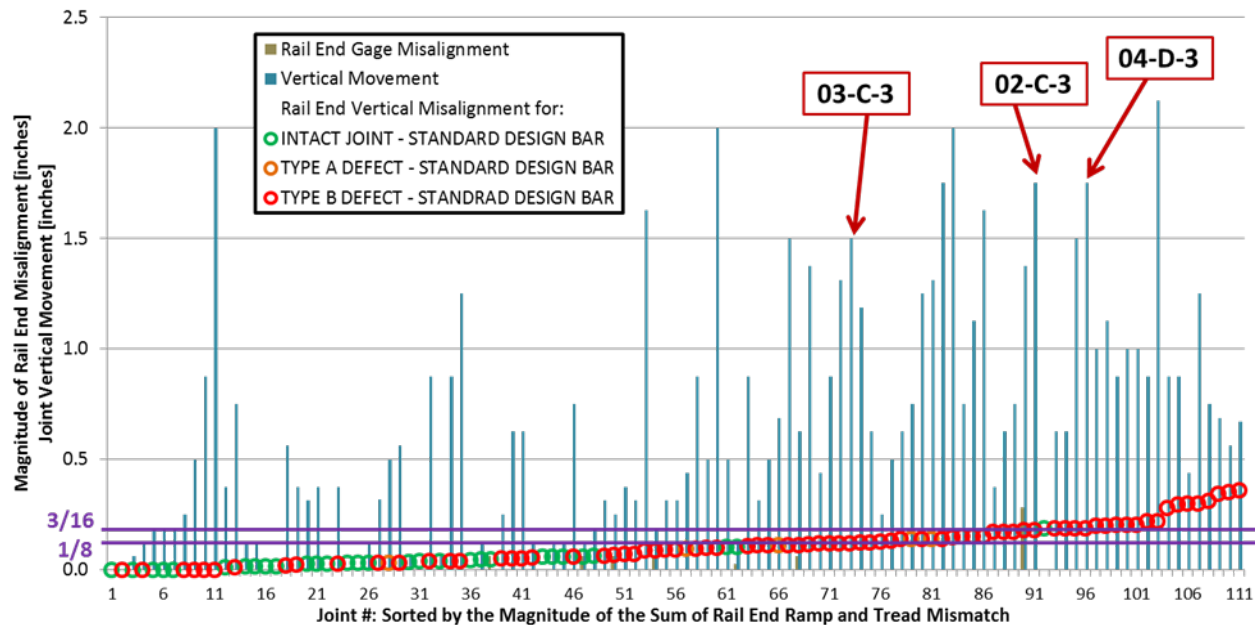
Figure 83. Rail End Conditions at Repeat Failure Locations in Respect to Combined JNT Sample

Figure 83 illustrates the state of rail end conditions at the four repeat failure locations in comparison to rail end conditions encountered throughout the surveys. Three repeat joint failures in Class 3 track contain significant rail end misalignments at the top 30 percent of locations with the combined JNT sample.

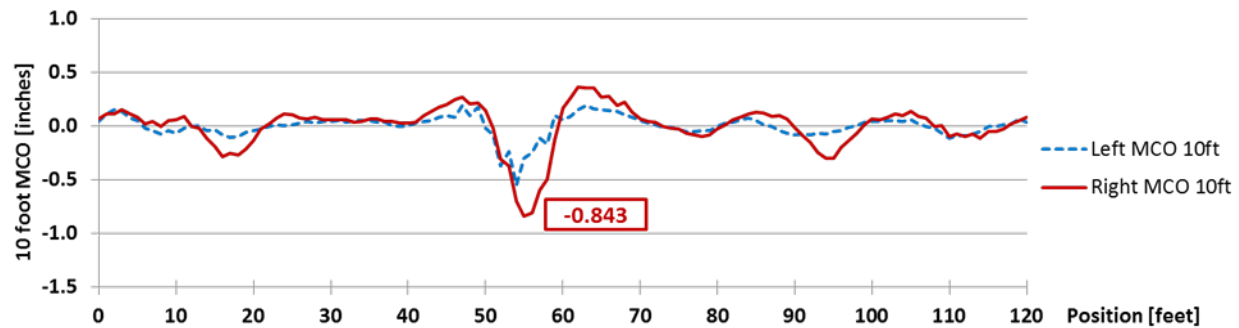
Figure 85. 10-Foot MCO at a Failed Joint Location—Example 1

Two examples of the 10-foot short chord MCO as it was calculated from the ATIP data for both rails are in [Figure 85](#) and [Figure 86](#). The first example shows the short chord MCO at a failed joint location with a vertical movement which was measured as 1.75 inches 3 months later. This is also the location of the identified triple repeated joint failure described in [Section 6](#). The second example shows short chord MCO at another failed joint location with measured movement at 1.5 inches 3 months after the collection of ATIP data.

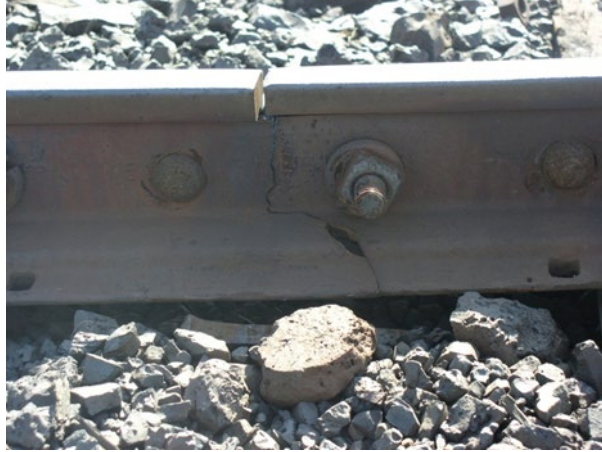
Figure F-6. Illustration of Long Toe Angle Joint Bar with Center Crack

Figure F-6 provides an example of a center cracked long toe angle joint bar. Some long toe joint bars are manufactured with slots to accommodate spikes. Cracks and breaks at or near the slot holes have been found. In addition, the spikes in the slots have been found to split timber crossties when the rail moves longitudinally. Common practice now is to install spikes at the edge of the slotted bar and avoid using the slots. If a failed slotted bar is found to be spiked in the manufactured slots, photographs should be taken to document the occurrence.

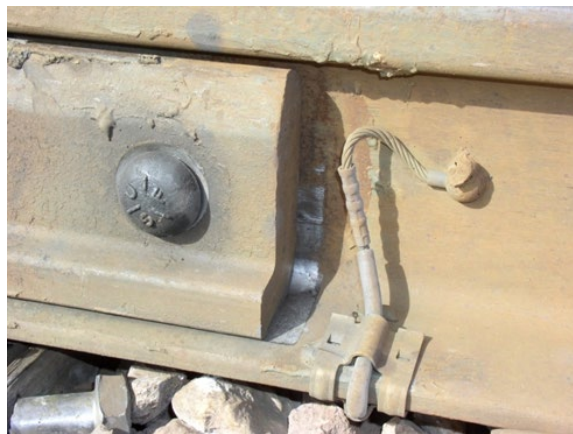
Figure F-9. Illustration of Evidence of Longitudinal Bar Movement

Worn joint components such as elongated bolt holes or worn out bolts may result in longitudinal movement of the rail in relation to the joint bars. If movement occurs, the rail end may rub the easement area of the joint bar. An indication of joint bar movement is a shiny area in the web of the rail.

A measurement of the length of the shiny area provides an indication of the amount of longitudinal bar movement. Figure F-9 illustrates this condition.

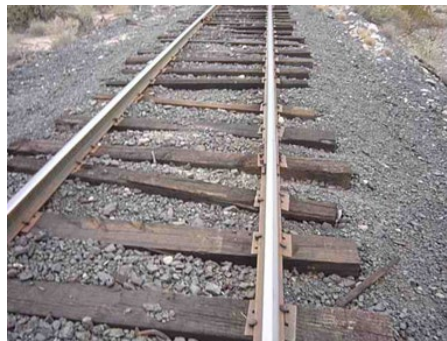
Figure F-10. Results of Lack of Rail Anchors

Figure F-10 shows a lack of anchors which caused crossties to become skewed with longitudinal movement. The amount of longitudinal movement can be estimated by determining how much the ties would have to be moved to restore their original perpendicular position.

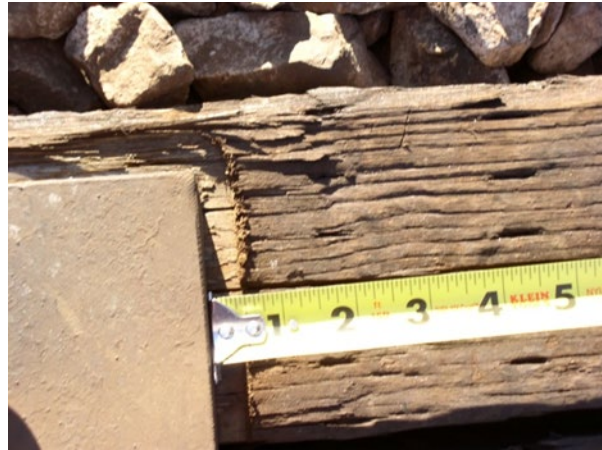
Figure F-11. Evidence of Tie Plate Movement

Figure F-11 shows evidence of lateral deflection as determined by the amount of the tie plate movement on the tie. In addition, any space between the base of the rail and the shoulder of the tie plate is also added to the static gage measurement. The gage under load value recorded is the sum of the static gage measurement and the amount of lateral deflection.

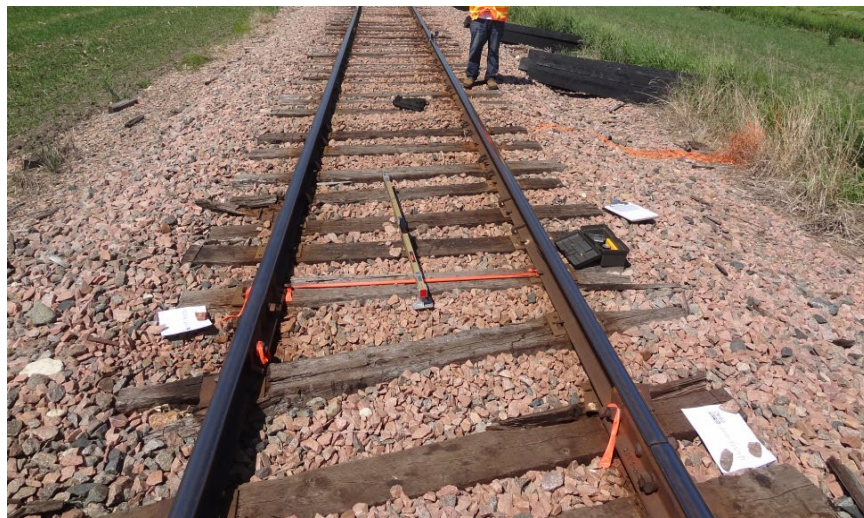
Figure G-1: Test Zone B1 – Example of Large Rail Longitudinal Movement and Skewed Ties

b) General View of Skewed Ties

Figure G-1 shows an example of a Class 2 location at test zone B1 with a large longitudinal rail movement (9 inches) resulting in skewed ties and narrow (tight) gage. There were two failed joints (#120516-010-0570 and #120516-010-0570) present in this area and the one shown on the photograph had a 56.25 inches static gage measurement with 0.25 inches of lateral movement and 1.0-inch vertical movement.
