**Federal Railroad
Administration**

Joint Bar Failure Study—Field Investigation

1. AGENCY USE ONLY (Leave blank)		2. REPORT DATE June 2019		3. REPORT TYPE AND DATES COVERED Technical Report April 2016
4. TITLE AND SUBTITLE Joint Bar Failure Study—Field Investigation			5. FUNDING NUMBERS DTFR53-10-D-00002 Task Order 18

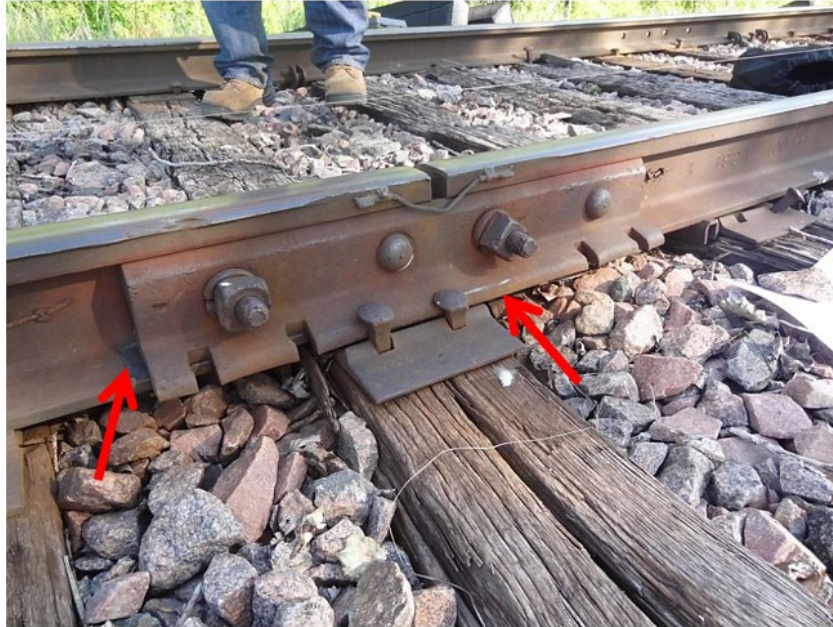
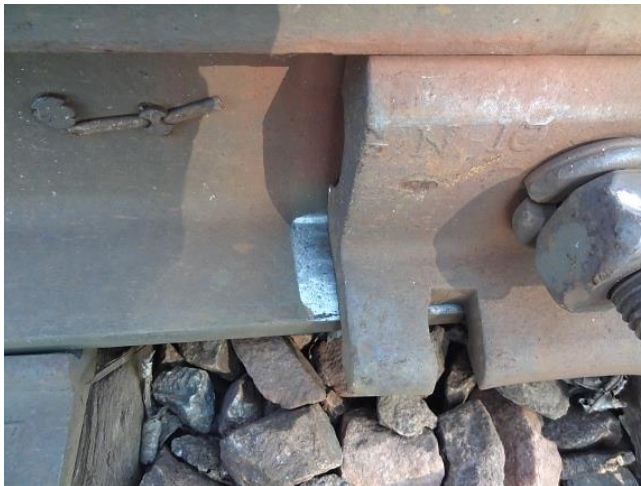
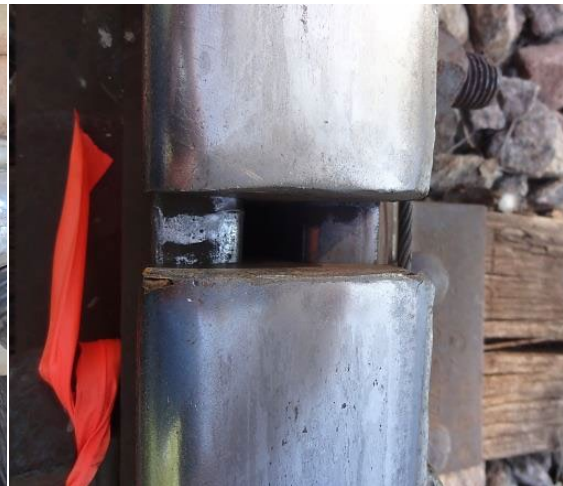
Figure G-2: Test Zone B1 – Example of Both Rail and Bar Longitudinal Movement

a) Field Side View of Signs of Longitudinal Bar and Rail Movement

b) Detail of Scratch Mark on Rail Base

c) Detail of Scratch Mark on Rail Head

Figure G-2 shows an example of a Class 2 location at test zone B1 with longitudinal rail movement (3.5 inches) as well as joint bar longitudinal movement. There was a failed joint (#120516-001-0573) present at this location. The ballast and drainage were in good condition. However, marginal (split) ties were found under the joint. The location had a 56.25 inches static gage measurement with 0.75 inches of lateral movement and 0.5-inch vertical movement. The location also showed signs of a large joint bar movement (measured 0.5 inches).

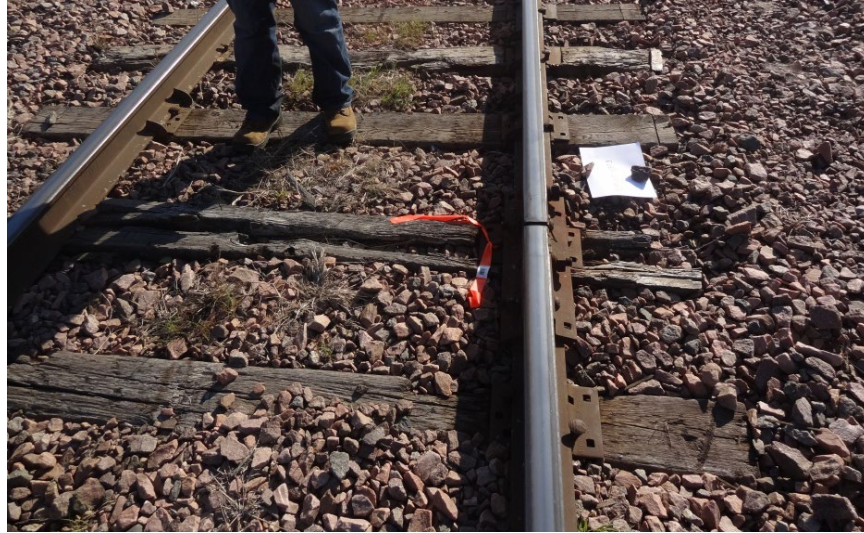
Figure G-4: Test Zone B1 – Example of Fouled Ballast and Broken Tie in a Location with Large Vertical Movement

a) Broken Tie under a Failed Joint

Figure G-4 shows the general condition of the location (#120516-001-0573) shown in Figure G-3 with a broken tie under the failed joint and fouled ballast in its vicinity.

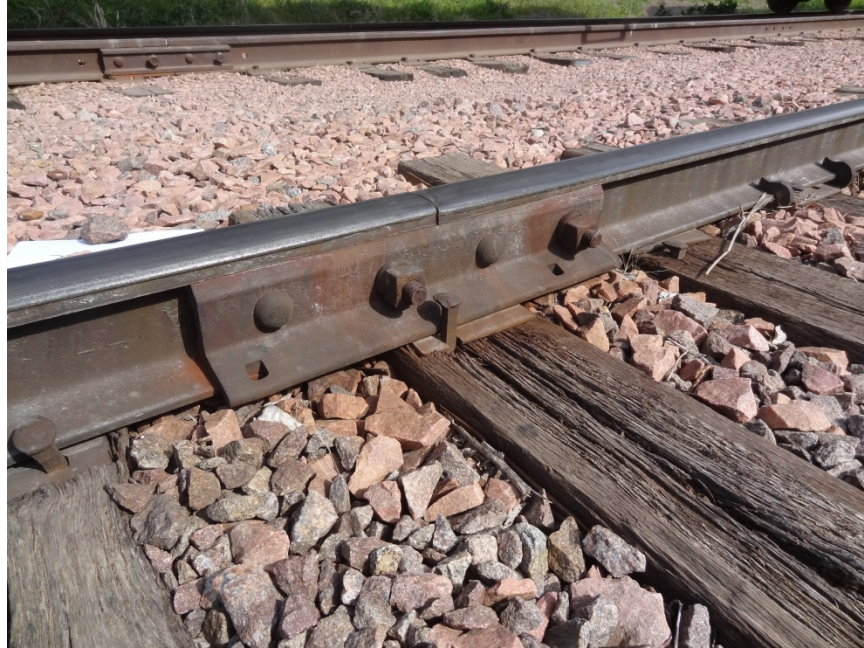
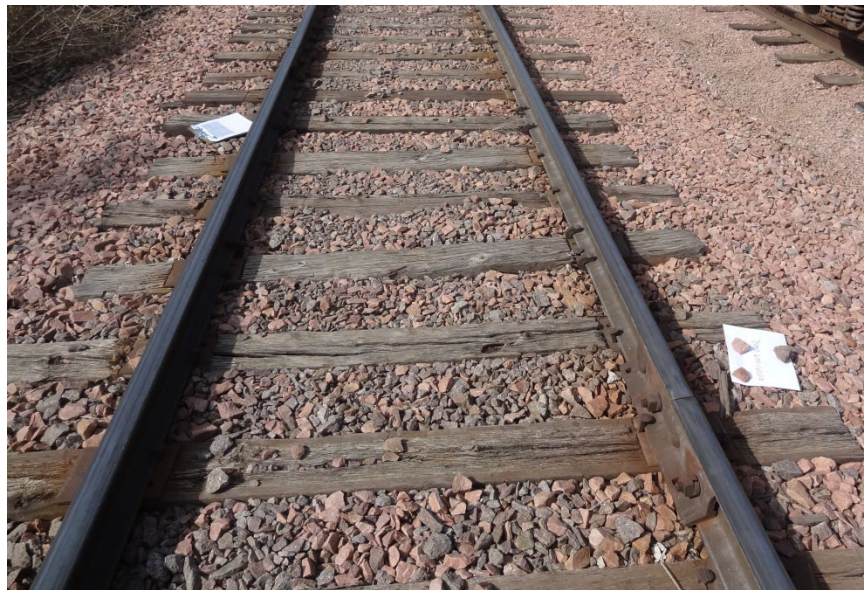
Figure G-5: Test Zone B1 – Example Intact Joint Location with Good Vertical Support and Longitudinal Movement Present

Figure G-5 gives an example of a typical Class 2 intact rail joint location at test zone B1 (#120515-005-0602) with very good vertical support conditions leading to no vertical movement. Even though the tie under the rail joint was marginally deteriorated it appeared to offer, in combination with ballast in good condition, a sufficient vertical support. Longitudinal rail movement of 2 inches was, however, present, and resulted in slightly skewed ties. The static gage was subsequently also slightly below nominal at 56.375 inches and lateral movement was measured to be 0.125 inches. Rail ends were in good condition.

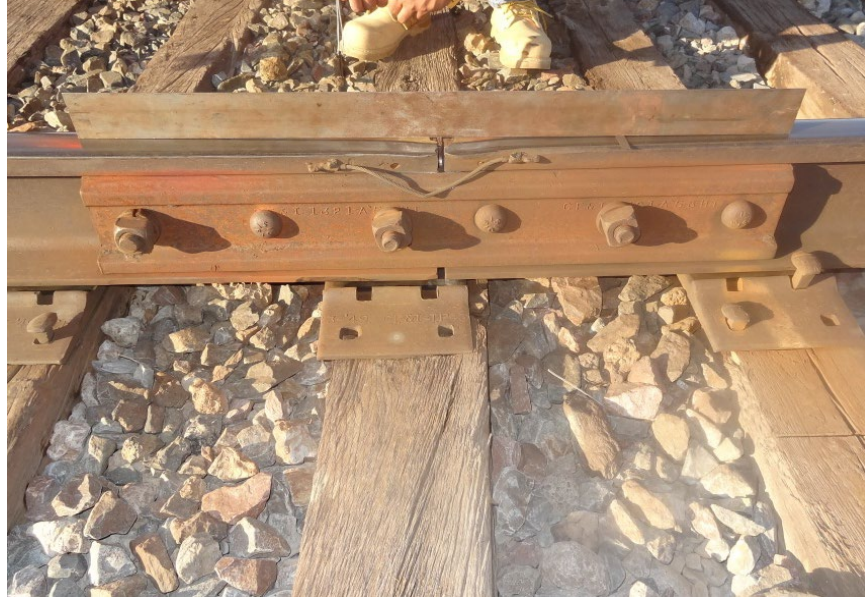
a) Rail End Batter at Location #120726-001-0404

Photograph a) in Figure G-6 shows an example of a 0.18-inch rail end batter in combination with “swinging ties” and the photograph b) in the same figure shows an example of skewed ties resulting in 40-inch spacing between ties under the rail joint. The photographs document two different Class 3 failed bar locations and #120726-001-0404 and #120723-010-0232 respectively, both located at test zone C.

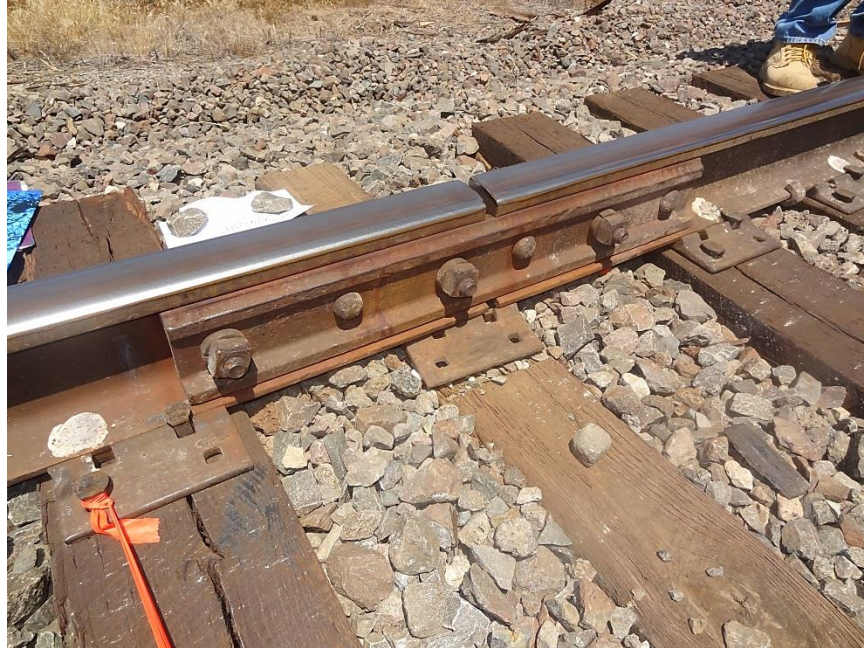
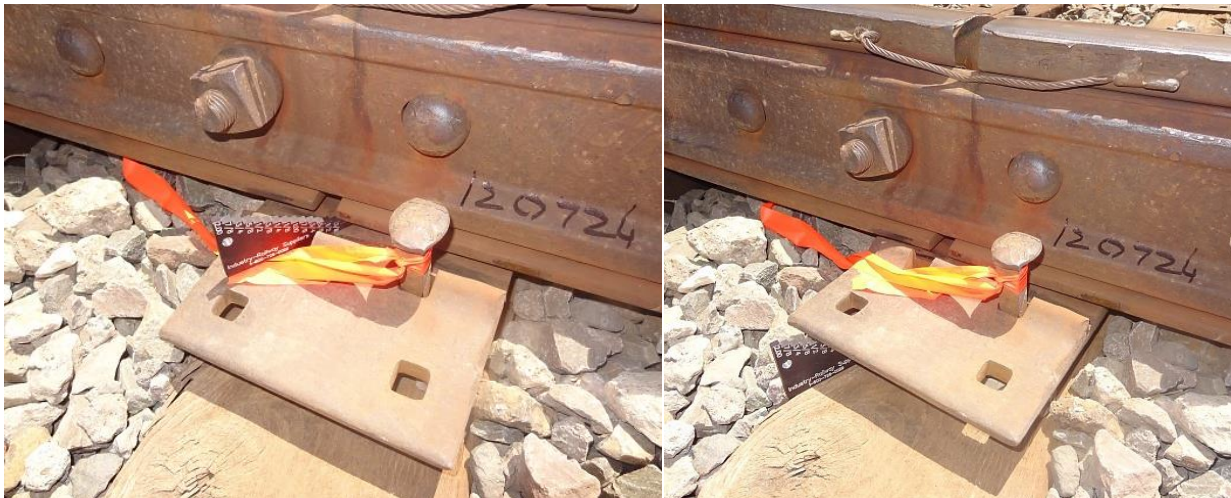
Figure G-7: Test Zone C – Example 1 of a Failed Bar Location with a Large Vertical Movement

b) Measurement of Gap between Rail Base and Tie Plate c) Measurement of Gap between Tie Plate and Tie

Figure G-7 shows an example of a Class 3 failed bar location (#120724-010-0344) at test zone C with a vertical movement of 2 inches. The factors contributing to the vertical movement were “swinging ties,” a loose tie plate, plate cutting and pumping ties. The static gage in this location was 56.5 inches, lateral movement was 0.125 inches and longitudinal movement was 1.5 inches. No rail end batter was measured but the gap between the rail ends was 0.75 inches.

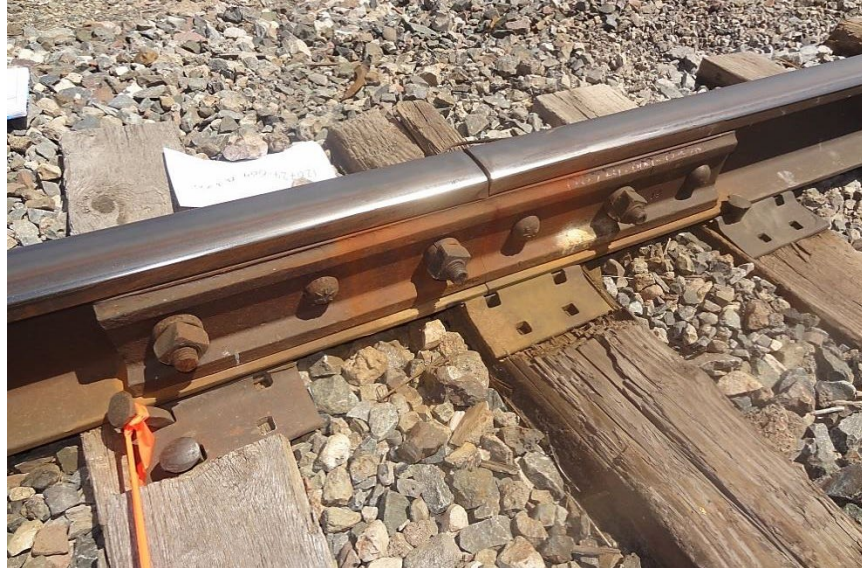
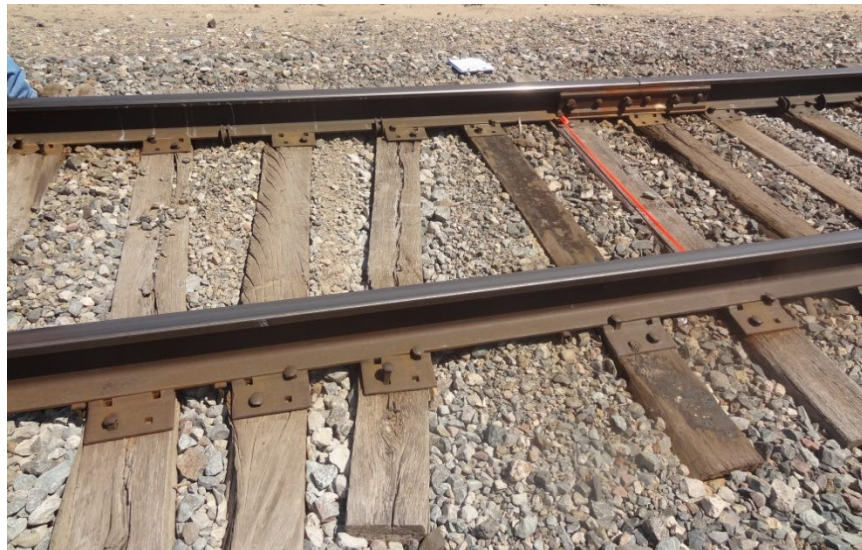
Figure G-8: Test Zone C – Example 2 of a Failed Bar Location with a Large Vertical Movement

b) Skewed Ties and Fouled Ballast

Figure G-8 shows an example of a Class 3 failed bar location (#120724-009-0370) at test zone C with a large vertical movement. Plate cutting and pumping ties contributed to the 1.25 inches of vertical movement. The static gage in this location was 56.25 inches. No lateral movement was present while the longitudinal rail movement was 5 inches. Skewed ties were also found in the vicinity of the failed joint. Minor rail end batter (0.04 inches high) was recorded.

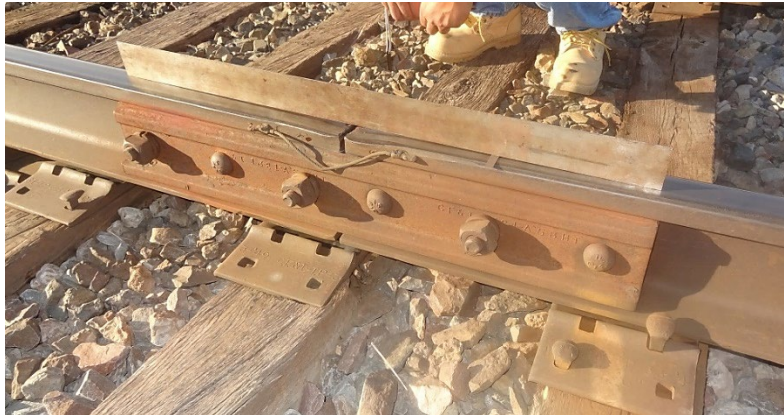
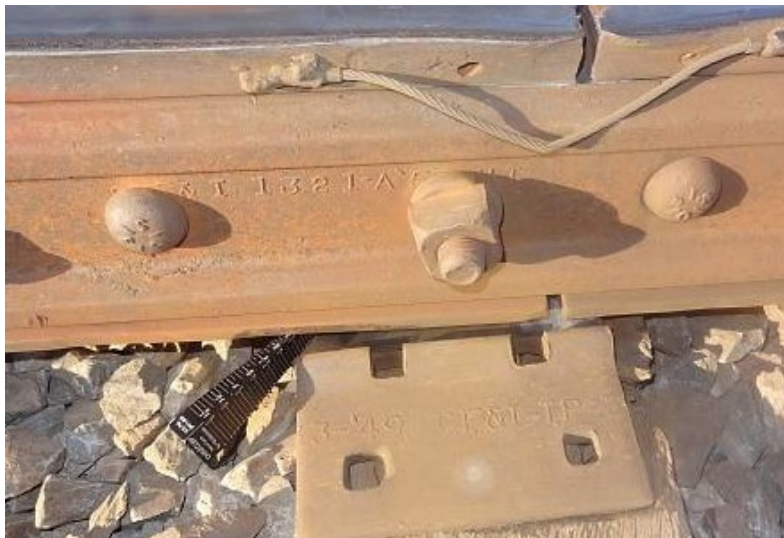
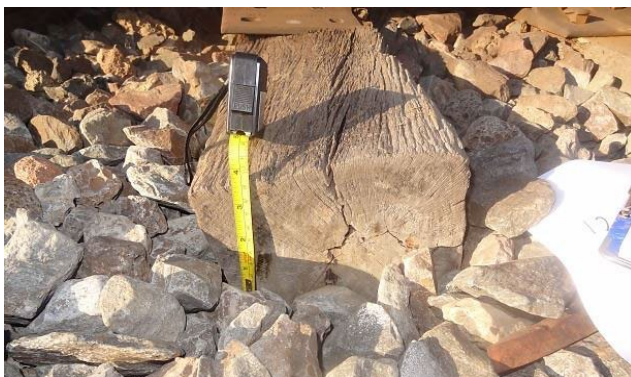
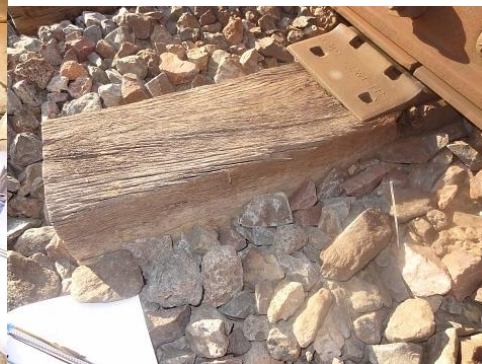
Figure G-9: Test Zone C – Example 3 of a Failed Bar Location with a Large Vertical Movement

Figure G-9 shows another example of a Class 3 failed bar location (#120726-001-0404) with a large vertical movement, measured to be 1.75 inches. Factors contributing to the vertical movement were “swinging ties,” loose tie plates, fouled ballast and pumping ties. The ties were in good condition. The static gage in this location was 56.625 inches, lateral movement was 0.25 inches and longitudinal rail movement was 3 inches. Moderate rail end batter was also present

(0.18 x 6.0 inches).

b) Measurement of Gap between Rail Base and Tie Plate

c) Signs of Tie Pumping on the Face of the Tie

d) Signs of Tie Pumping on the Side of the Tie

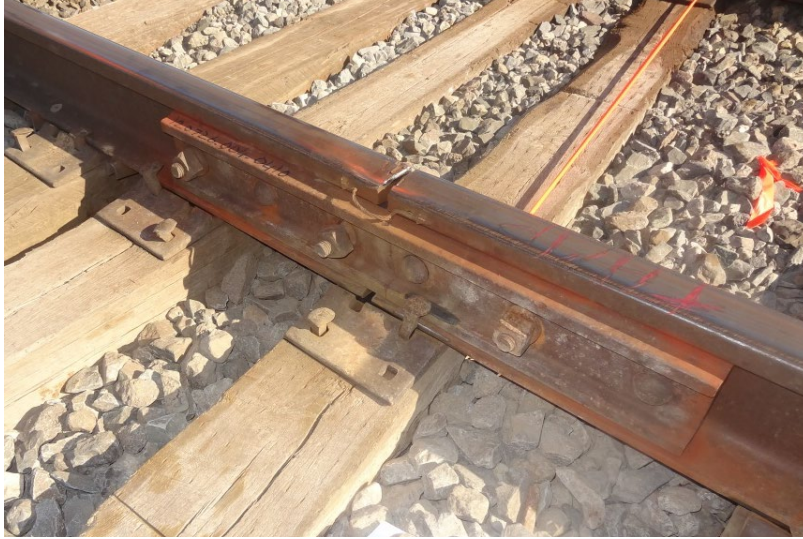
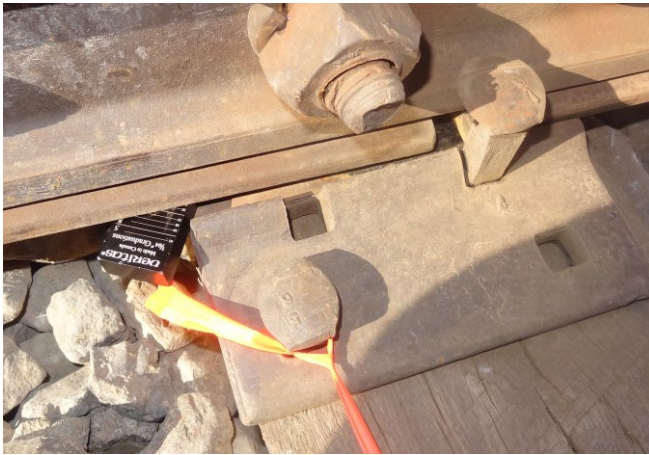
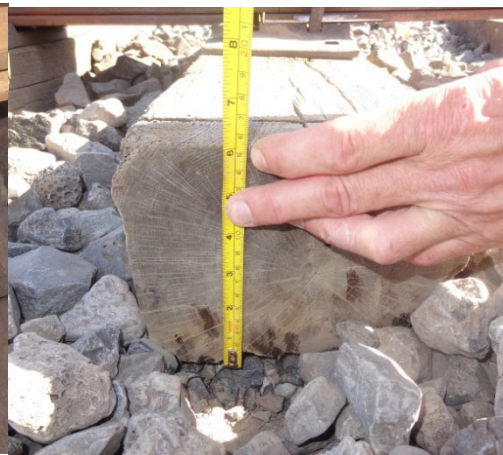
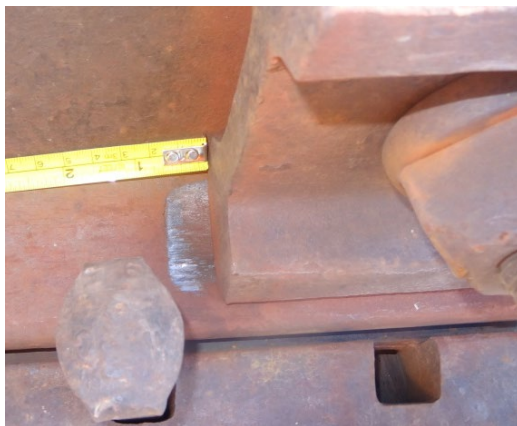
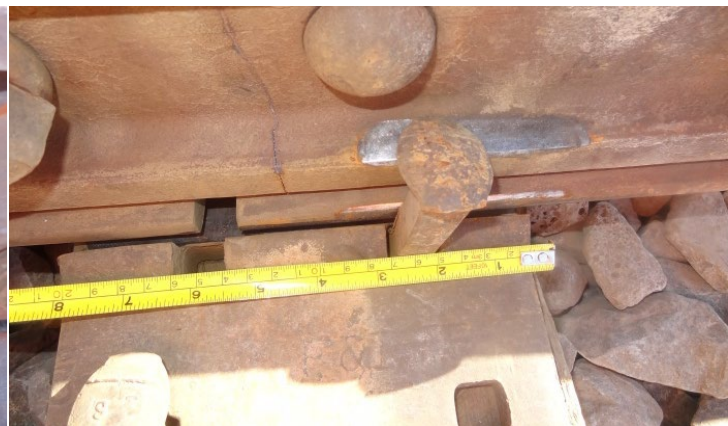
Figure G-10: Test Zone C – Example 4 of a Failed Bar Location with a Large Vertical Movement

b) Measurement of Gap between Rail Base and Tie Plate

c) Signs of Tie Pumping

d) Sign of Longitudinal Movement

e) Sign Longitudinal Movement near a Fastener

Next example of a Class 3 failed bar location (#120726-004-0410) at test zone C with a large vertical movement is shown in Figure G-10. The measurement was 1.625 inches and the factors contributing to the vertical movement were “a swinging tie,” fouled ballast and a pumping tie (the tie itself in a good condition). The static gage in this location was 56.625 inches, lateral movement was 0.125 inches and longitudinal rail movement was 3.5 inches. Moderate rail end batter was present at this location (0.15 x 3.0 inches) and 0.5 inches longitudinal bar movement was also measured.

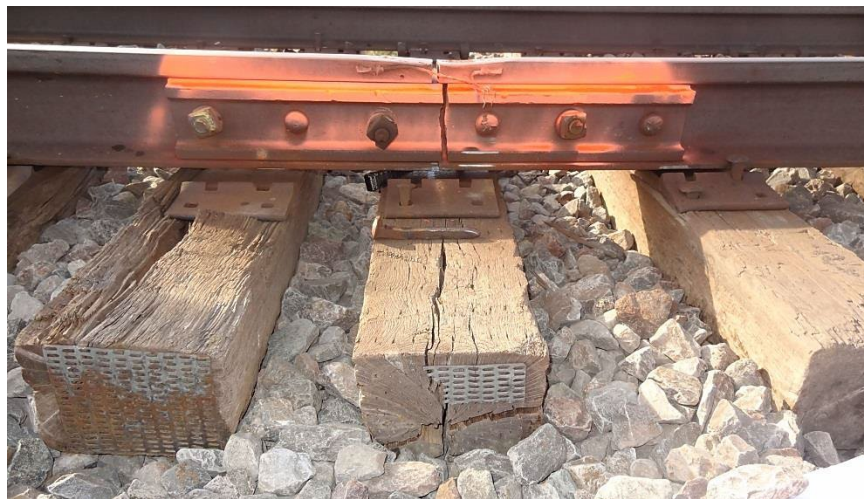
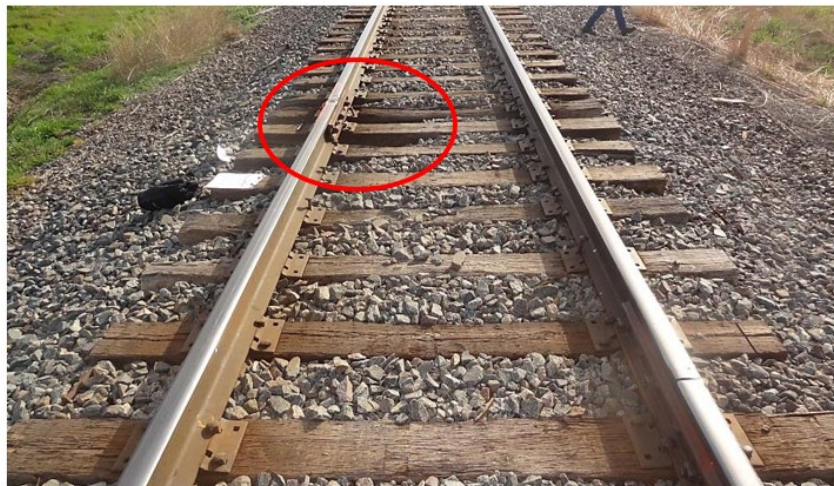
Figure G-11: Test Zone C – Example 5 of a Failed Bar Location with a Large Vertical Movement

Figure G-11 presents one of the Class 3 fail joint locations (#140505-002-0224) on test zone C during the second visit in May 2014. This rail joint is not adequately supported and contains very large vertical movement of 2.125 inches. Lateral and longitudinal movements were 0.25 and 2.5 inches respectively at this location. Marginally deteriorated ties, insufficient ballast at the rail joint and significant rail end batter (0.22 x 5.0 inches) was also present, contribution to the inadequate vertical support.

b) Insufficient Ballast at Rail Joint

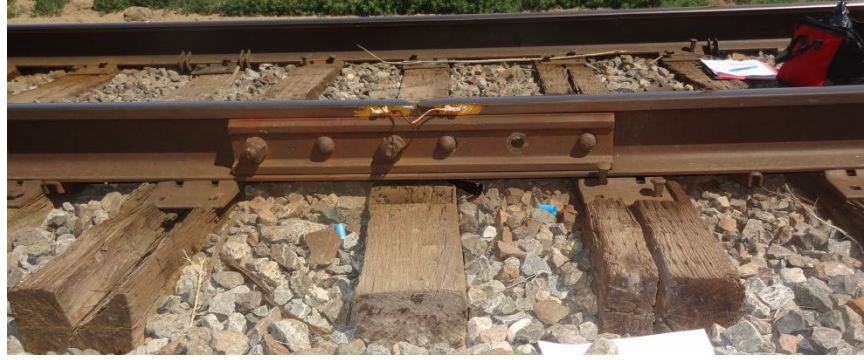
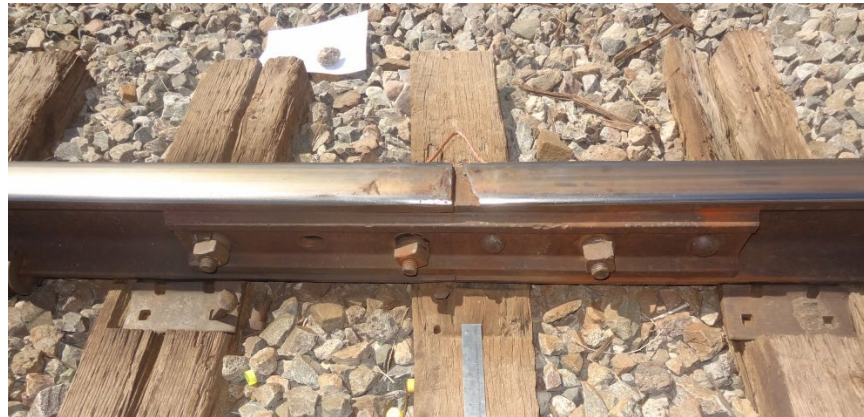
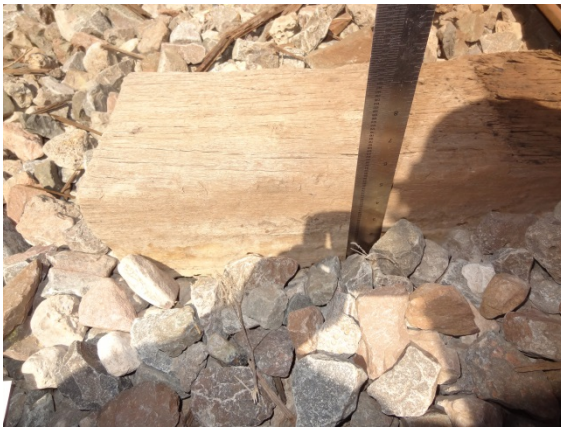
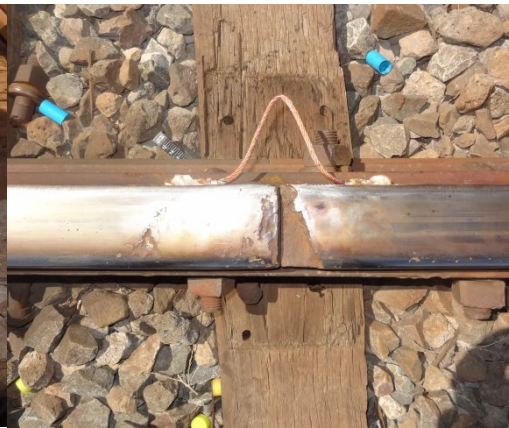
Figure G-12: Test Zone C – Crowned Failed Joint Location with a Large Vertical Movement

c) Signs of Tie Movements

d) Chipped Rail Ends

Several crowned¹ rail joints with a joint bar defect and large vertical movement were also encountered during the second visit to test zone C. Figure G-12 illustrates one those locations (#140528-004-0504) at Class 3. The vertical movement in this case was 1.375 inches and static

profile was -0.25 inches (high joint). Tie plate was missing on the tie directly under the joint centerline and adjacent ties exhibited signs of significant plate cutting. Deteriorated rail ends were also observed, containing rail end batter of 0.116x2.75 inches and large portions the rail material chipped away.

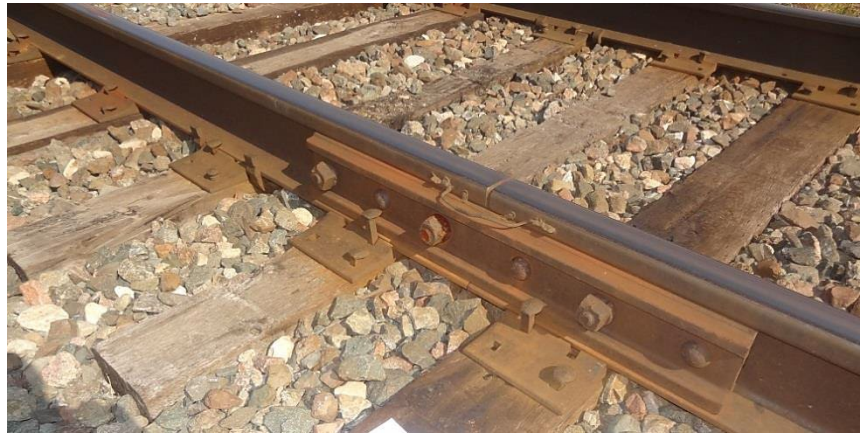
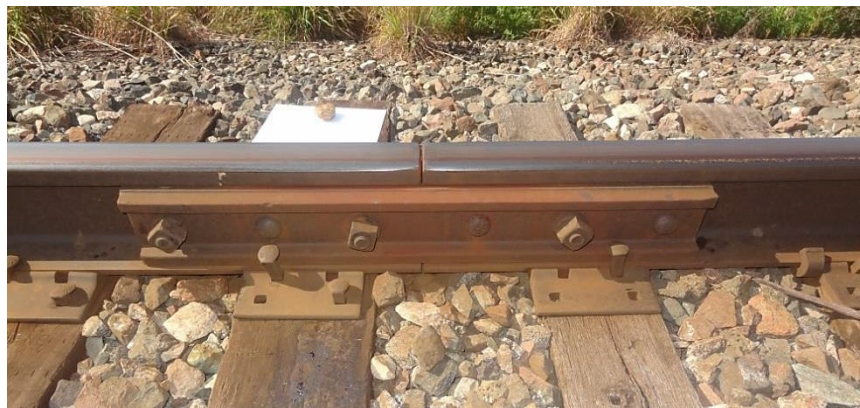
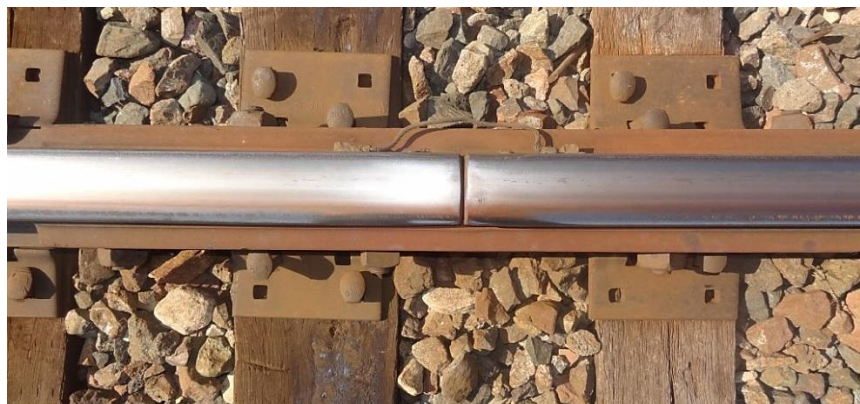
Figure G-13: Test Zone C – Example 1 of an Intact Bar Location

A typical example of a documented Class 3 intact joint location at test zone C (#120723-005-

0229) with very good track conditions and minimal or no rail end batter is represented in Figure G-13. Good support and tie conditions (no vertical and lateral movement, longitudinal movement 0.5 inches), minimal geometry deviations (0 alignment and profile under load, crosslevel under load 0.3125 inches) and minimal rail end batter (0.03 x 3.0 inches) were observed.

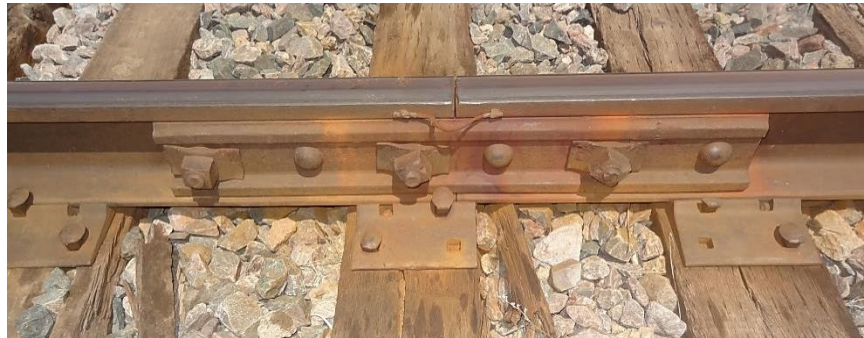
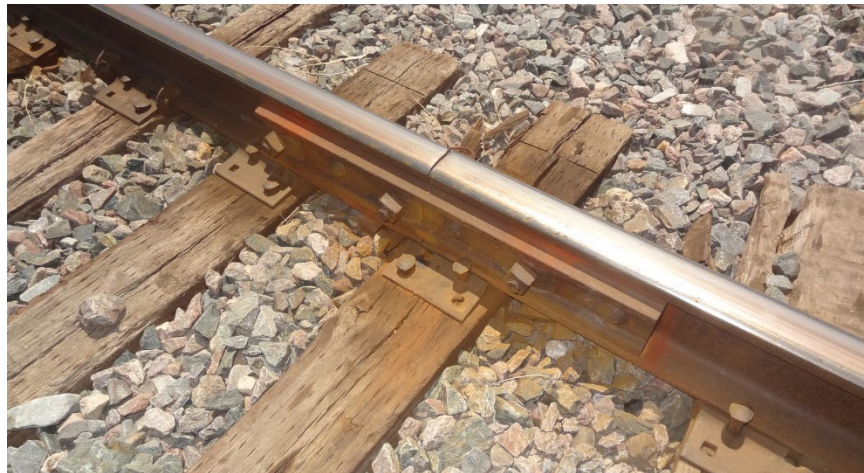
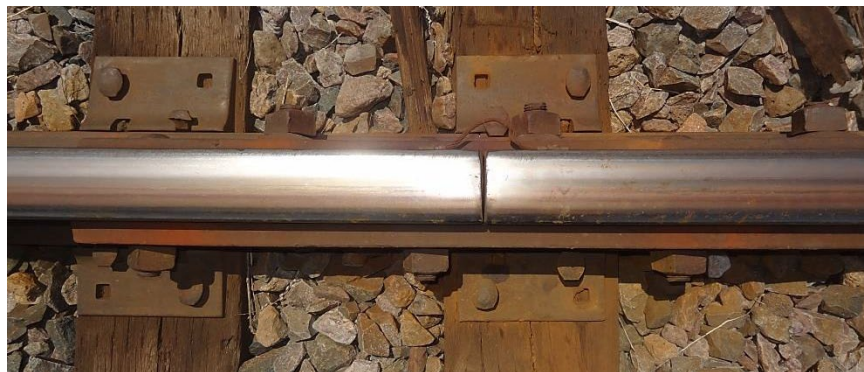
Figure G-14: Test Zone C – Example 2 of an Intact Bar Location

Another example of a Class 3 intact joint location at test zone C (#140530-007-0533) this encountered in 2014 with very good track conditions and minimal or no rail end batter is represented in Figure G-14. Good support and fair tie conditions (minimal tie splitting, vertical

and lateral movement both 0.125 inches, longitudinal movement 0.5 inches), and minimal rail end batter (0.015 x 0.75 inches) and no geometry deviations were observed.

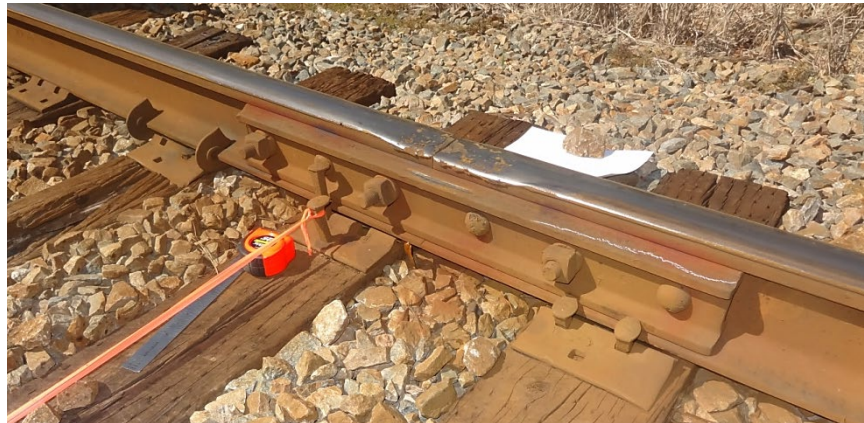
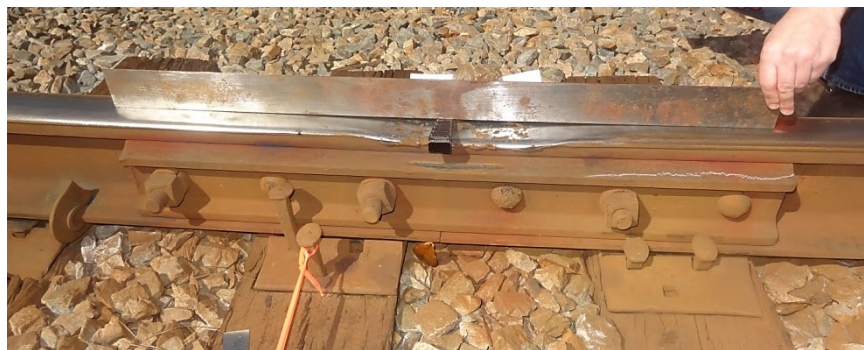
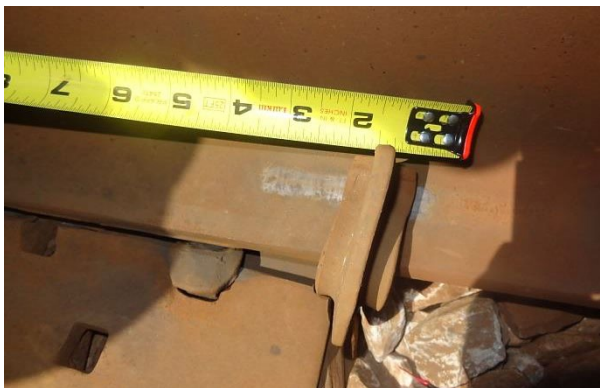
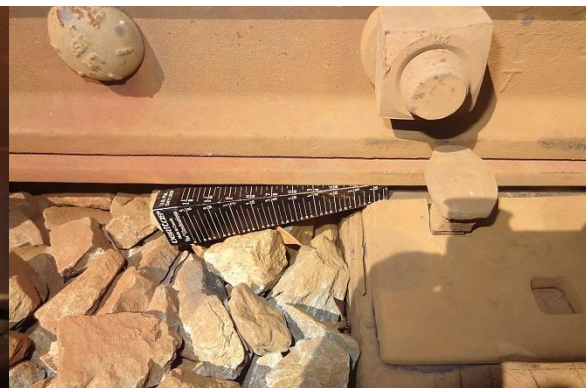
Figure G-15: Test Zone D – Example a Failed Bar Location with a Large Rail End Batter

b) Rail End Batter Magnitude Illustration

c) Signs of Longitudinal Movement

d) Gap between Rail and Tie Plate

Figure G-15 illustrates one of the Class 3 failed joint locations (#130325-017-0681) on test zone D with very large rail end batter (0.359 x 14.0 inches). This rail joint also contains 0.67 inches vertical, 0.25 lateral, and 2.5 inches longitudinal movements. Ties are in good conditions. Note that the straight edge in photograph b) of Figure G-15 is positioned in a way to demonstrate the severity of the rail end batter. When actual measurements of rail end batter were taken, a ramp on each rail end is assessed separately according to the procedure outlined in the Instruction

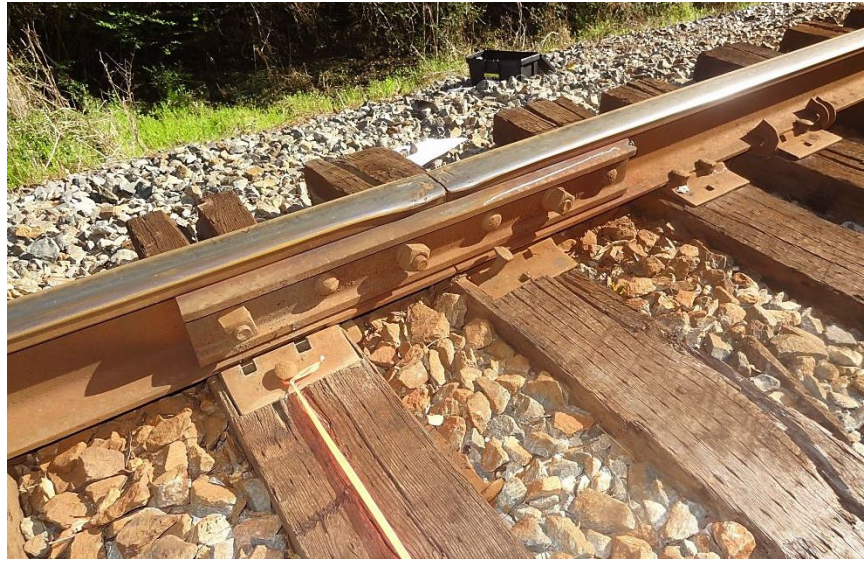
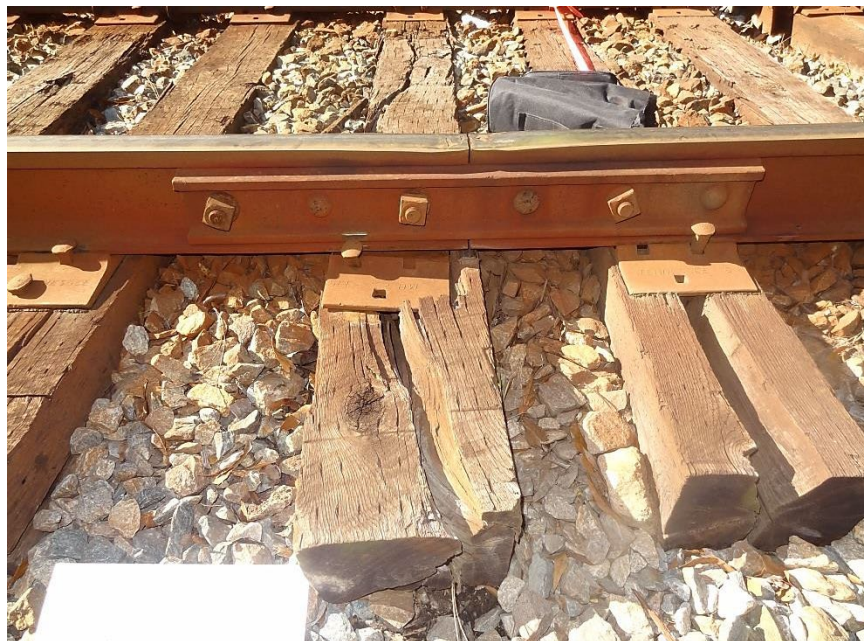
Figure G-16: Test Zone D – Example a Failed Bar Location with a Large Vertical Movement

Figure G-16 shows one of the Class 3 fail joint locations (#130325-002-0675) on test zone D with very large rail vertical movement of 2.0 inches. Deteriorated, split and pumping ties with significant plate cutting are present in this location. Mildly fouled ballast also contributes to the insufficient support conditions. Lateral movement of 0.25 inches and rail end batter of 0.146 x 7.5 inches were also measured.

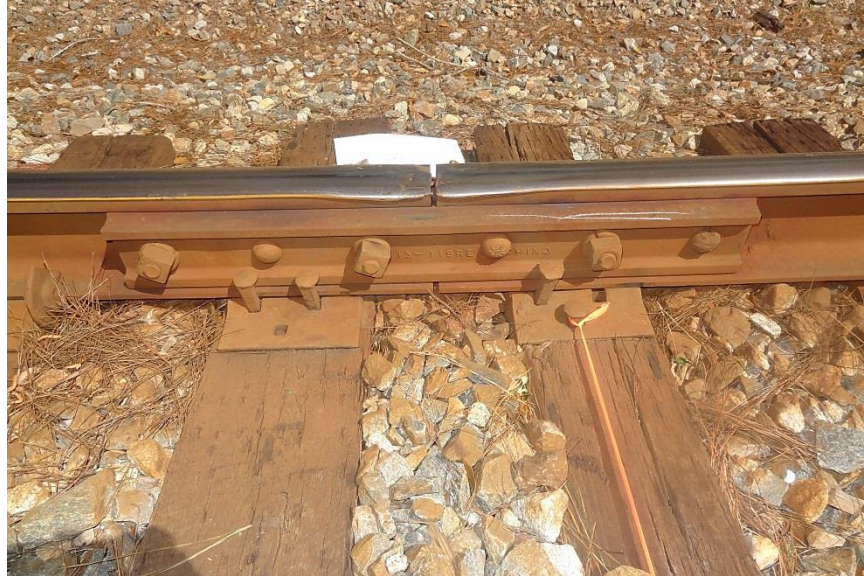
Figure G-17: Test Zone D – Example a Failed Bar Location with Good Tie Conditions

Several failed joint locations with good tie conditions were also encountered during the field surveys. Figure G-17 shows one of those Class 3 locations (#130325-010-0678) on test zone D. Vertical movement of 0.675 inches was still recorded, however, due to gaps between rails and tie plates and the movement of the ties themselves. Lateral movement of 0.25 inches and rail end batter of 0.125 x 7.0 inches were also measured. No longitudinal movement was recorded. This location also contained deteriorated rail ends with significant chipping.

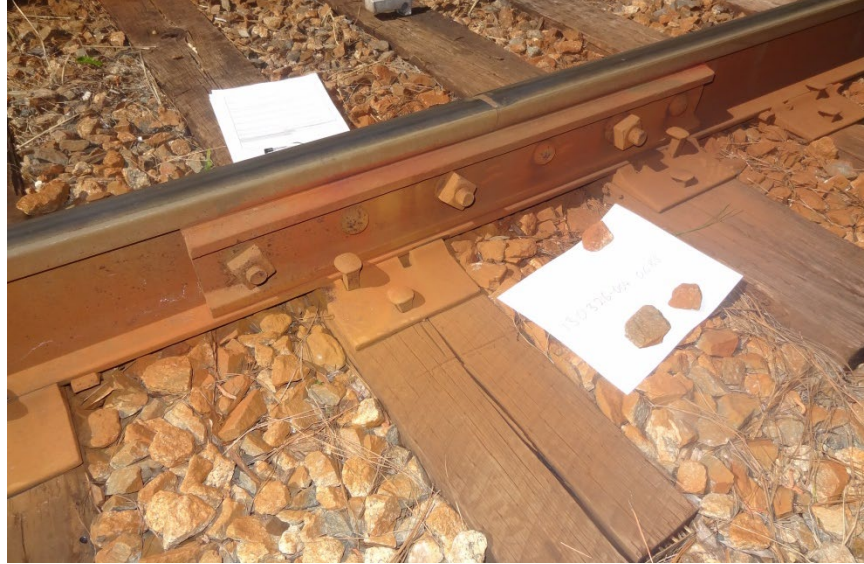
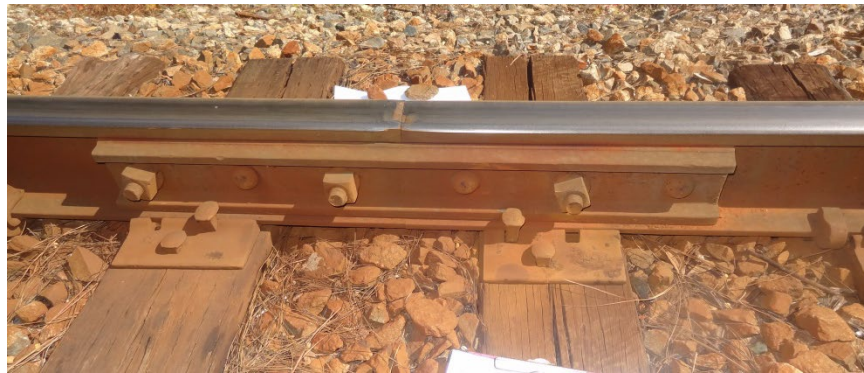
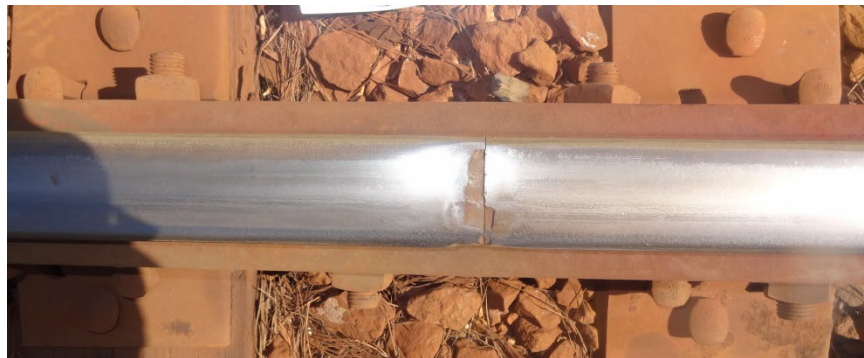
Figure H-18: Test Zone D – Example of an Intact Bar Location

An example of a documented Class 3 intact joint location at test zone D (#130326-004-0688) with very good track conditions and minimal rail end batter is represented in Figure G-18. Good support and tie conditions (minimal tie splitting, vertical and lateral movement 0.125 inches and 0.187 inches respectively, and longitudinal movement 0.5 inches), minimal geometry deviations

and minimal rail end batter (0.064×5.75 inches) were observed. One of the rail ends was, however, significantly chipped.

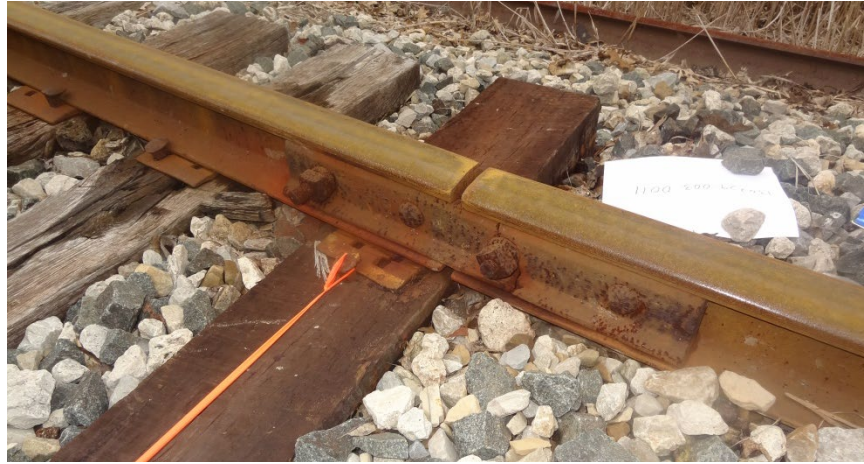
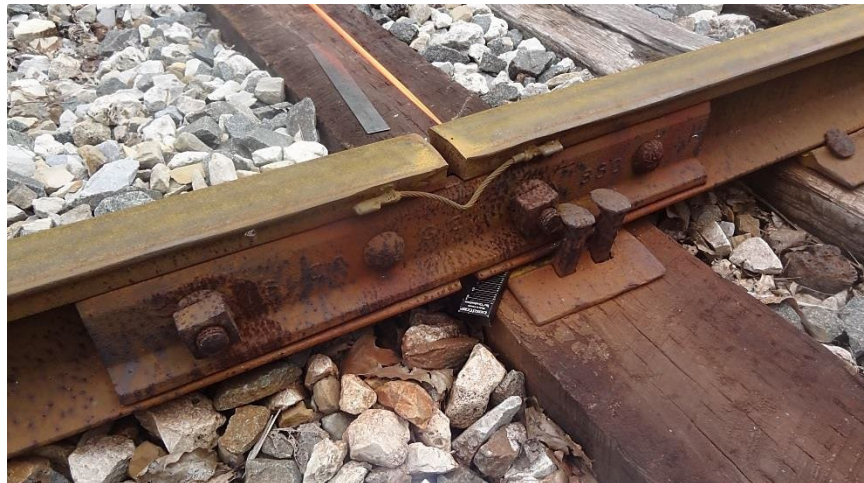
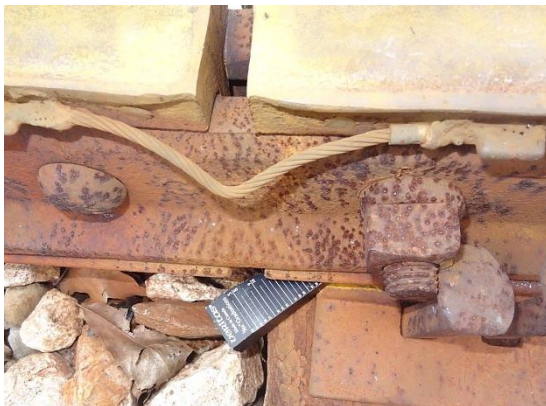
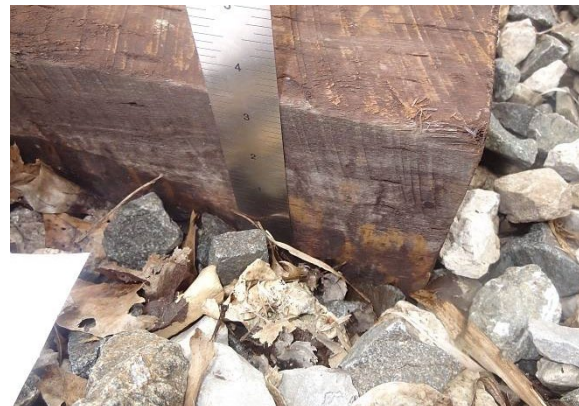
Figure G-19: Test Zone F1 – Example a Failed Bar Location with a Large Vertical Movement and Crosslevel under Load

c) Gap between Rail and Tie Plate

d) Signs of Tie Pumping

An example of a Class 1 failed joint on test zone F1 (#130729-003-0011) with large vertical movement and crosslevel under load is presented in Figure G-19. Void between rail and tie plate and extensive tie pumping contributed to vertical movement of 1.25 inches. This location was a low joint with crosslevel under load of 3.125 inches. Lateral and longitudinal movement of 0.123 inches and 1.0 inches respectively and rail end batter of 0.068 x 6.625 inches were measured. The tie directly under the rail joint was in a very good condition compared to the surrounding ties and appeared to be recently replaced.

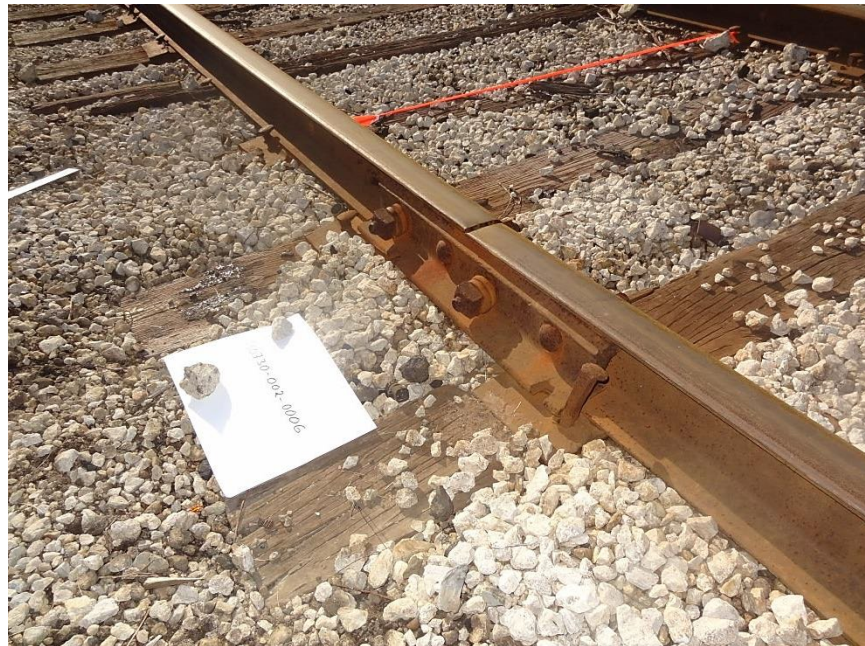
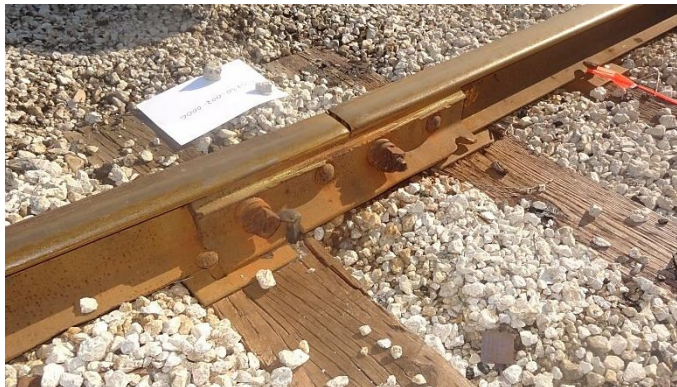
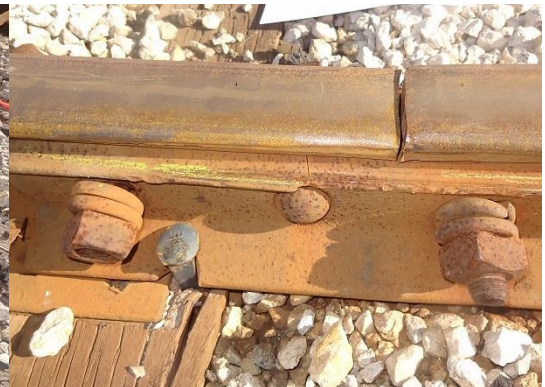
Figure G-20: Test Zone F2 – Example a Failed Bar Location with a Large Tread Mismatch

c) Spike in Bar Slot Causing Tie Split

Class X failed joint on test zone F2 (#130730-002-0006) with large tread mismatch of 0.235 inches is shown in Figure G-20. Additional rail batter of 0.75 x 4.625 inches was also measured. Vertical movement of 0.4375 inches was observed at this location. Spike in a bar slot caused a split at one of the ties.

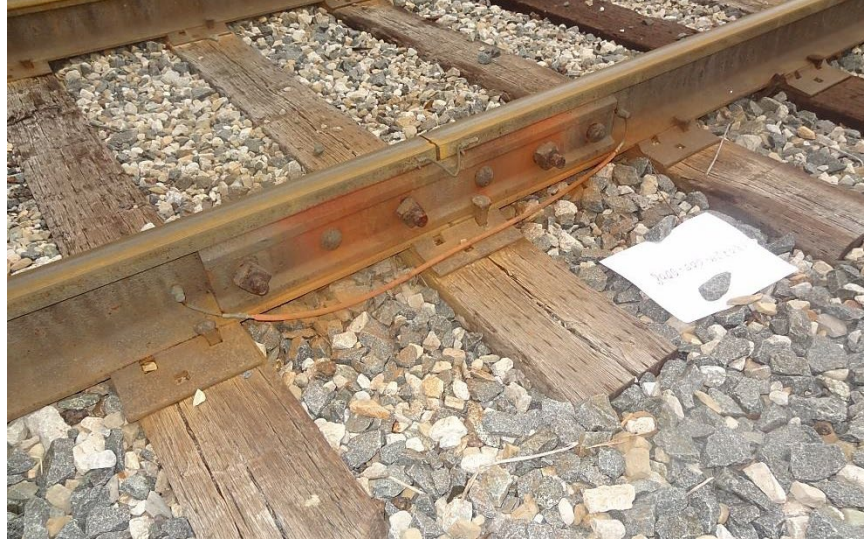
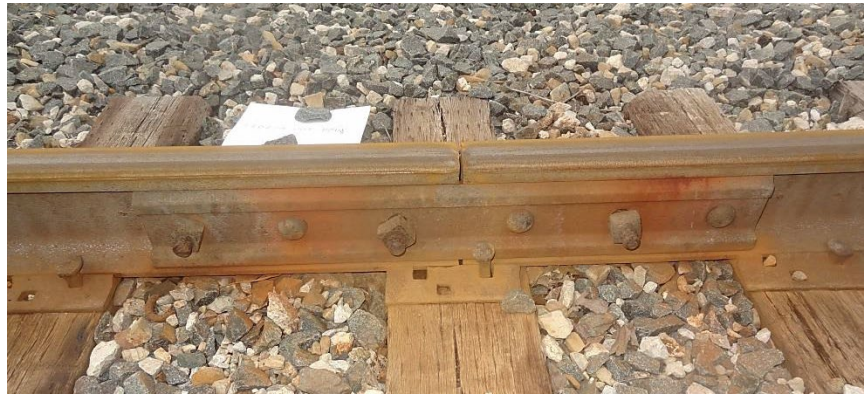
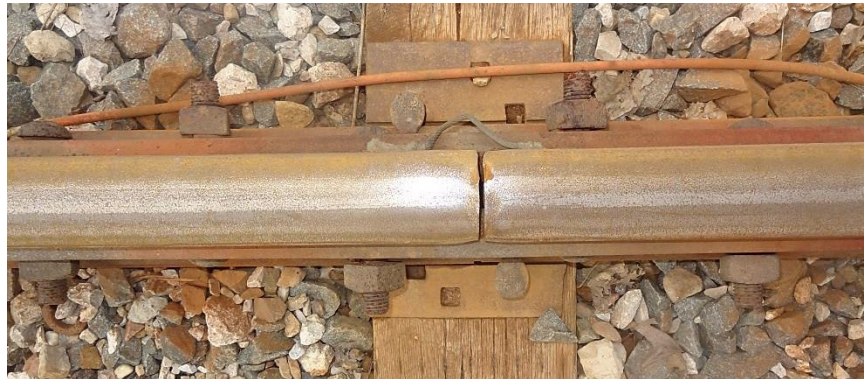
Figure G-21: Test Zone F1 – Example of an Intact Bar Location

The last example of encountered field conditions is a Class 1 intact joint location at test zone F1 (#120729-005-0008) with very good track conditions and minimal rail end batter represented in Figure G-21. Good support and tie conditions (no vertical and minimal lateral movement), minimal geometry deviations and minimal rail end batter (0.043 x 5.75 inches) were observed.
