**Federal Railroad
Administration**

Joint Bar Failure Study—Field Investigation

1. AGENCY USE ONLY (Leave blank)		2. REPORT DATE June 2019		3. REPORT TYPE AND DATES COVERED Technical Report April 2016
4. TITLE AND SUBTITLE Joint Bar Failure Study—Field Investigation			5. FUNDING NUMBERS DTFR53-10-D-00002 Task Order 18

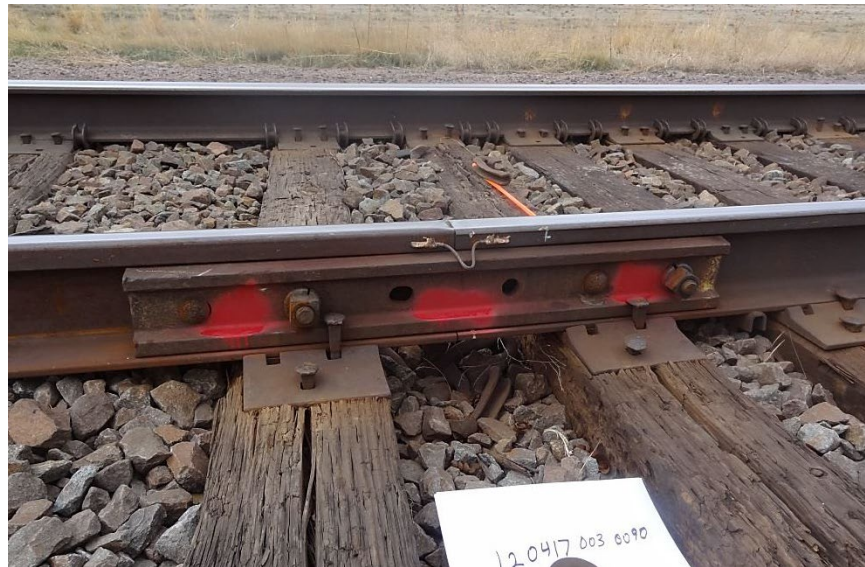
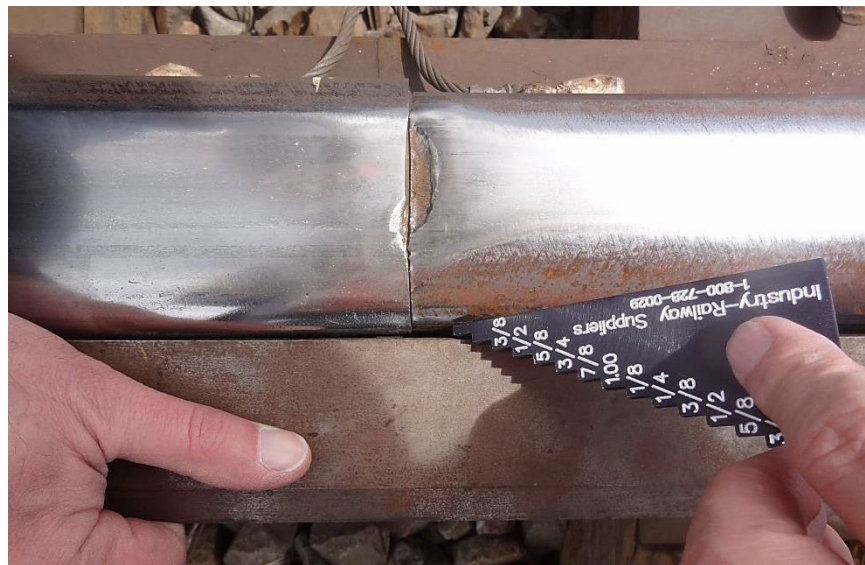
Figure H-1: Test Zone A – General Field Conditions at Frist Failed Rail Joint

Figure H-1 illustrates the general conditions in the vicinity of the first encountered defect on test zone A (location #120417-003-0090) and shows a measurement of a 1/8-inch gage mismatch. The two middle bolts were not installed, and the bolt holes were not drilled indicating that the joint was a temporary joint and intended to be welded in the future. The joint exhibited good ballast and drainage conditions with

marginal ties (see [Appendix E](#) for the definition of track conditions such as good or bad drainage, marginal or ineffective ties, etc.). Vertical and lateral movement, profile under load, and alignment were all measured to be 1/8 inch. Crosslevel under load was 0.375 inches low and gage under load was 56.625 inches (see [Appendix D](#) for the definition of profile and alinement measurements (using 62-foot cord length in all cases) and method for obtaining under load values). Signs of longitudinal movement were not observed. Vertical rail end ramp was measured to be 0.025 inches high and 1 inch long.

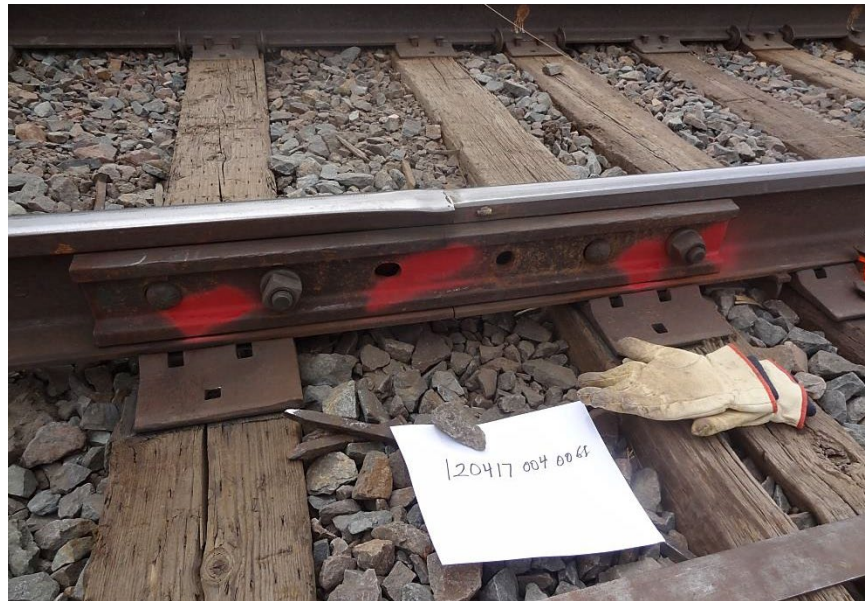
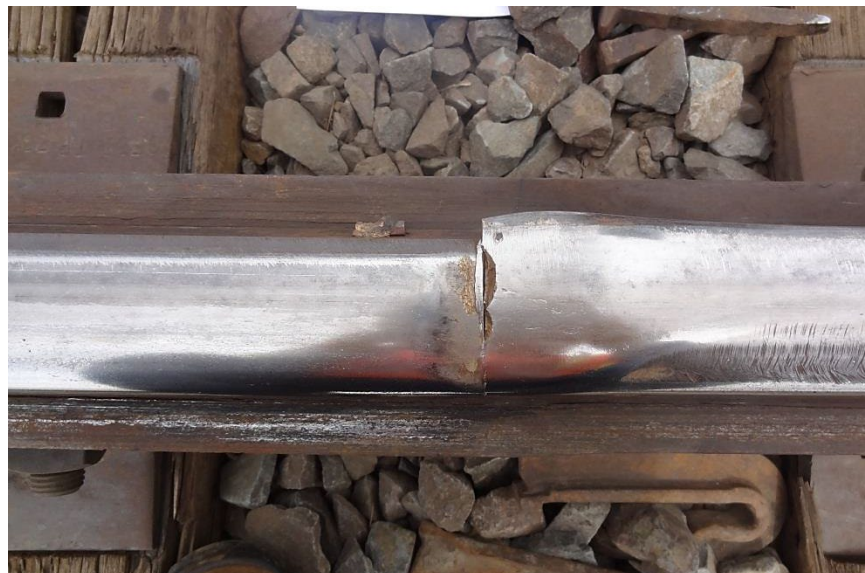
Figure H-2: Test Zone A – General Field Conditions at the Second Failed Rail Joint

b) Battered Down Rail Head

Figure H-2 illustrates the overall conditions in the vicinity of this defect. Also shown is an abrupt rail end ramp that apparently resulted from repeated wheel impact loads that caused the rail end to be battered

down when a repair rail with a significant tread mismatch was installed. The two middle bolts were missing, and bolt holes were not drilled indicating the temporary nature of the joint.

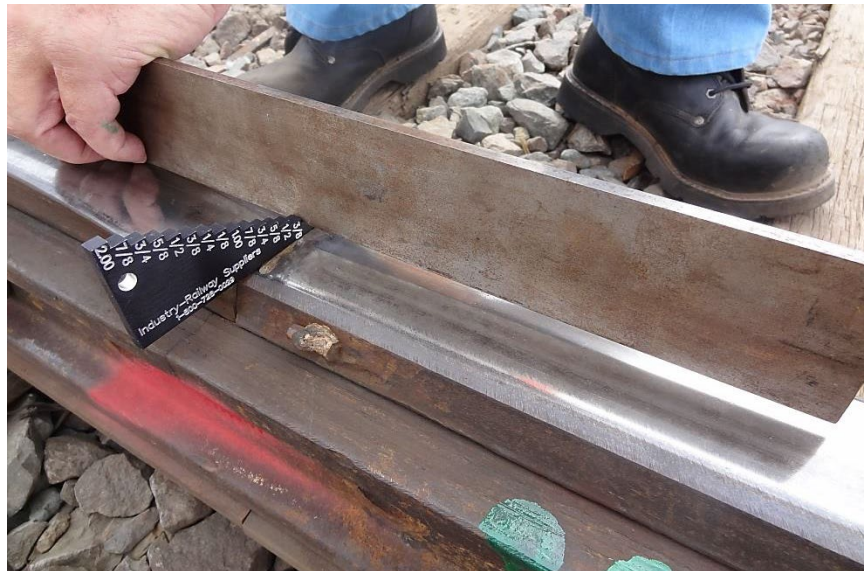
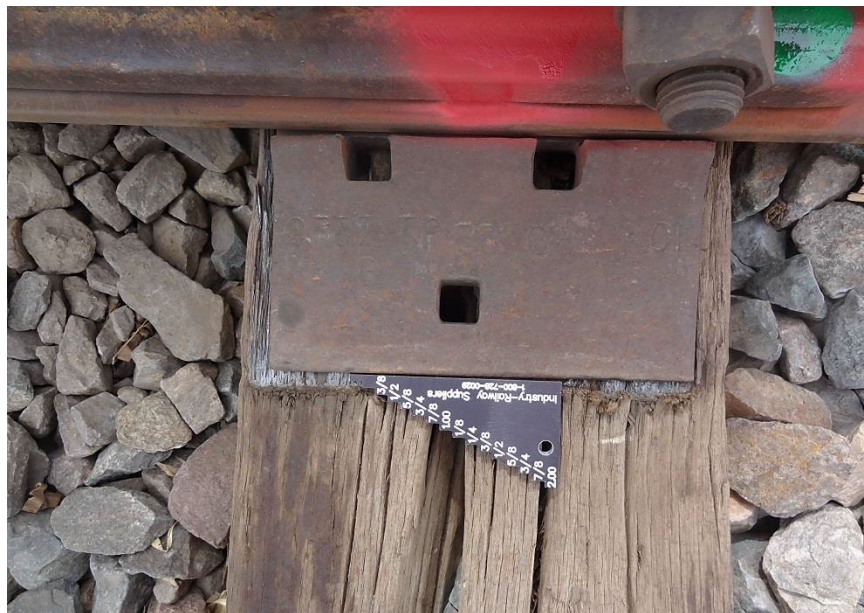
Figure H-3: Test Zone A – Selected Measurements at the Second Failed Rail Joint

Figure H-3 illustrates the measurement of rail end ramp and lateral movement. Good ballast and drainage conditions were present at the location. One ineffective tie was found under the joint. Vertical and lateral movements were measured to be 0.375 inches, and the longitudinal movement was 0.625 inches. Crosslevel under load was 1.5 inches low, profile under load 0.375 inches, and gage under load was 56.75 inches. As mentioned above, the head of the new rail was battered down, creating a 1/16-inch gage mismatch and a 1/16 gage ramp. A 0.375-inch-high and 3 inches long rail end ramp and a 0.25-inch tread mismatch were measured at this location. Overall, the joint exhibited a large rail end misalignment.

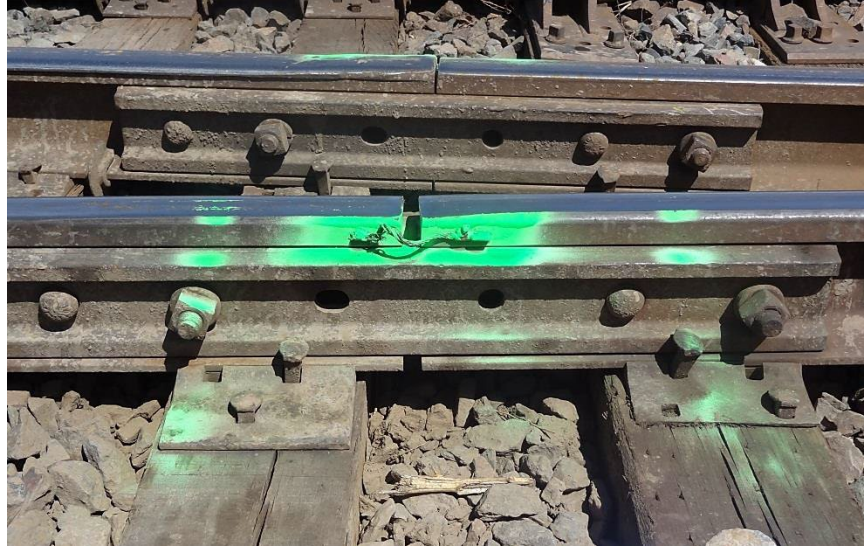
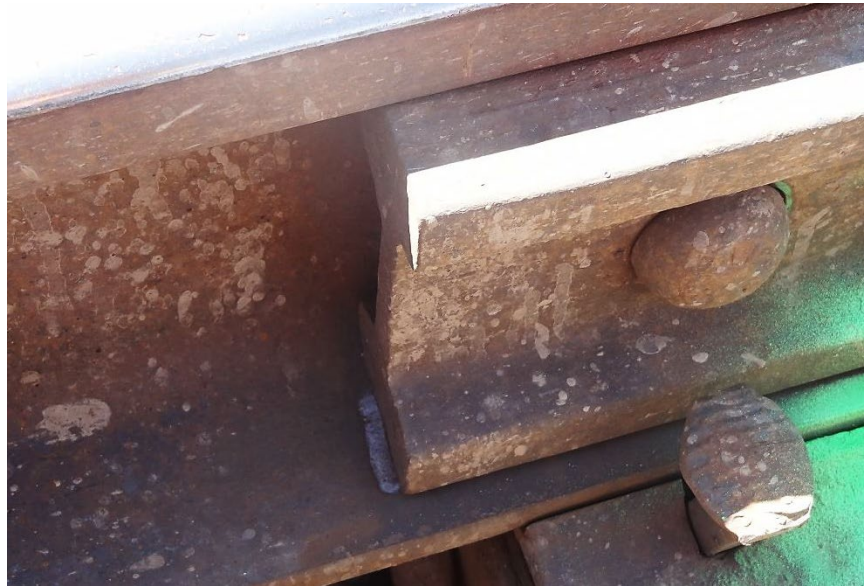
Figure H-4: Test Zone A – General Field Conditions at the Third Failed Rail Joint

b) Sign of Longitudinal Bar Movement

Figure H-4 shows the third and last failed bar location found at test zone A (#120418-004-0053). This joint was located in a turnout and didn't exhibit any significant deviations in geometry, lateral or vertical movement, although the joint exhibited signs of longitudinal bar movement. A moderate rail end ramp was present. The turnout appeared to have relatively new switch ties and ballast. Missing middle bolts and bolt holes not drilled again indicated a temporary joint. The ballast, drainage and ties were in very good condition. No vertical movement or lateral movement was found. The gage under load was a nominal 56.5 inches and crosslevel under load, profile under load and alignment were all zero. The bar longitudinal movement was measured to be 0.1875 inches. Rail end ramp was 0.1 inches high and 3 inches long and a 1/16-inch gage ramp was also present which may have increased the wheel impact loads at the joint. A gap between rail ends of 0.75 inches was also measured. It is possible that the initiation of the crack occurred before switch tie replacement and surfacing or was a consequence of the maintenance work.

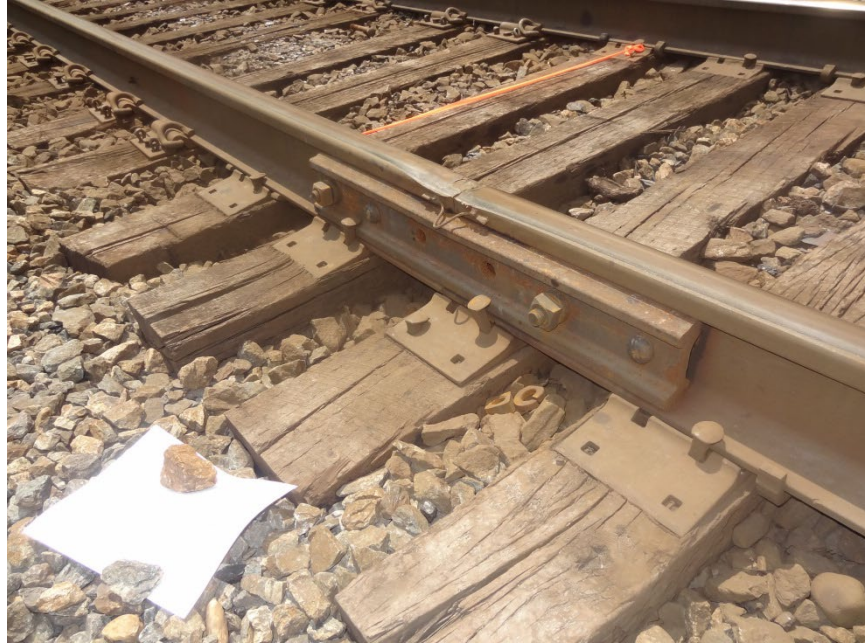
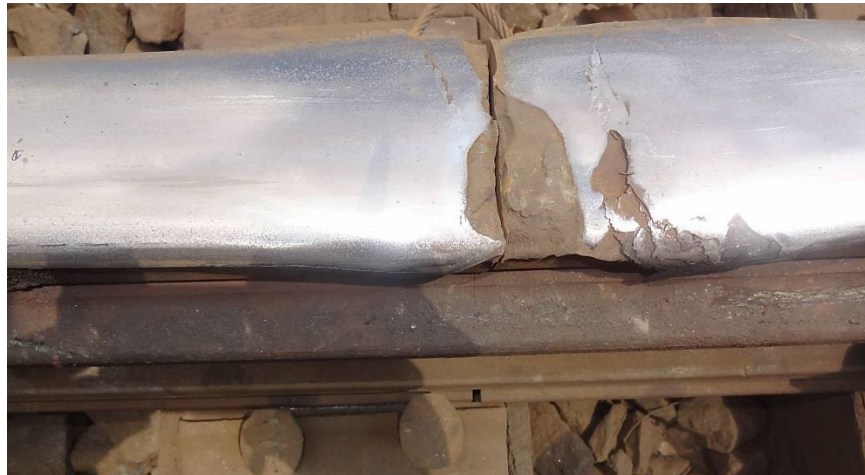
Figure H-5: Test Zone F5 – General Field Conditions at the Fourth Failed Rail Joint

b) Deteriorated and Battered Down Rail Ends

Figure H-5 shows the first failed joint found at test zone F5—fourth failed joint overall on CWR (#130801-003-0520). Missing middle bolts and bolt holes not drilled indicated a temporary joint. Insufficient and mildly fouled ballast, tie pumping and slight plate cutting contributed to vertical movement of 0.875 inches. Lateral movement of 0.125 inches was measured, no longitudinal movement was recorded. Profile under load and crosslevel under load and alignment were 1.5 inches, 1.875 inches and 0.5 inches respectively. Rail ends at this location were significantly chipped and battered down—rail end ramp of 0.234 x 5.75 inches was measured.

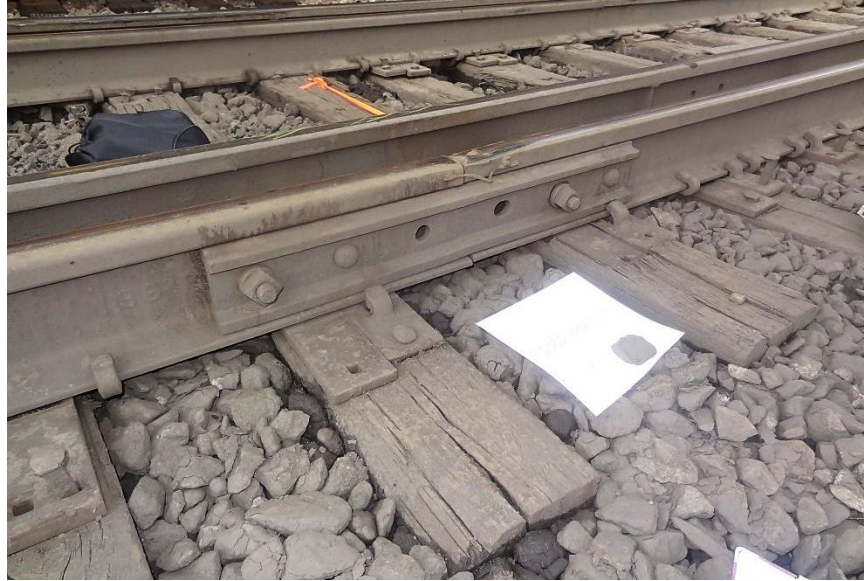
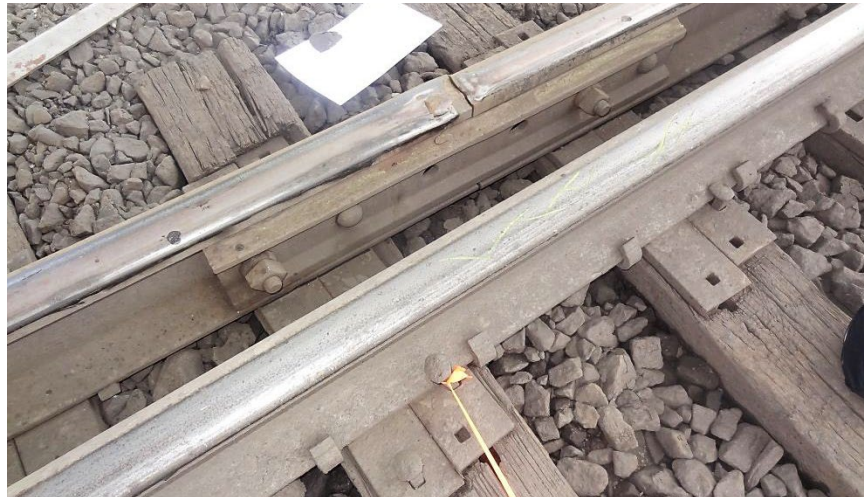
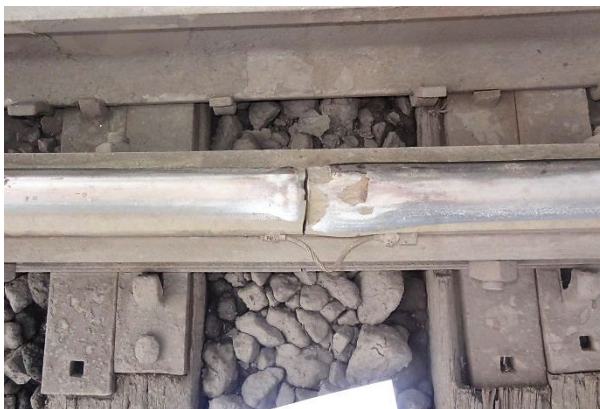
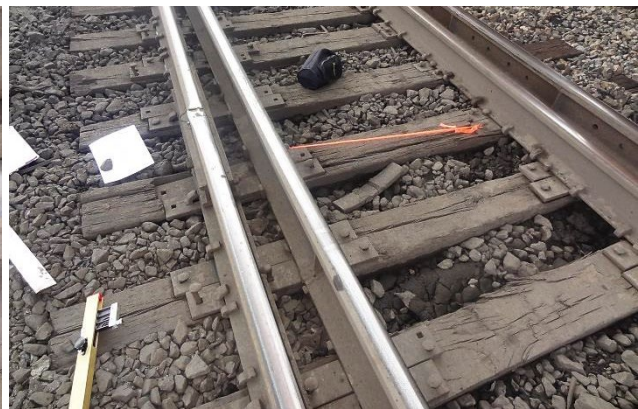
Figure H-6: Test Zone F5 – General Field Conditions at the Fifth Failed Rail Joint

c) Deteriorated and Battered Down Rail Ends

d) Fouled Ballast

Figure H-6 shows the second failed joint found at test zone F5—fifth and last failed joint overall on CWR (#130801-004-0516). Missing middle bolts and bolt holes not drilled indicated a temporary joint. Heavily fouled ballast, significant tie pumping, compromised drainage and plate cutting contributed to vertical movement of 0.5 inches despite no measurable gap between the rail and tie plate. No lateral movement was measured; 0.25 inches longitudinal movement was recorded. Profile under load and crosslevel under load and alinement were 1.125 inches, 1.312 inches and 0.375 inches respectively. Rail ends at this location were again significantly chipped and battered down – rail end ramp of 0.172 x 5.875 inches was measured.

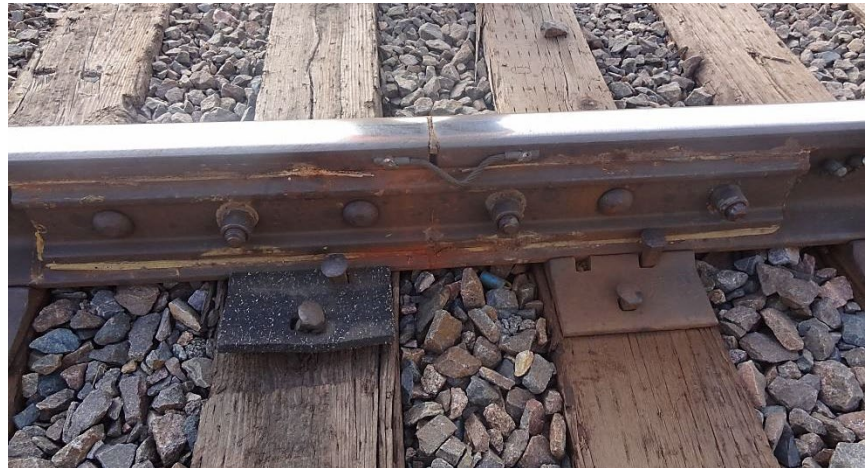
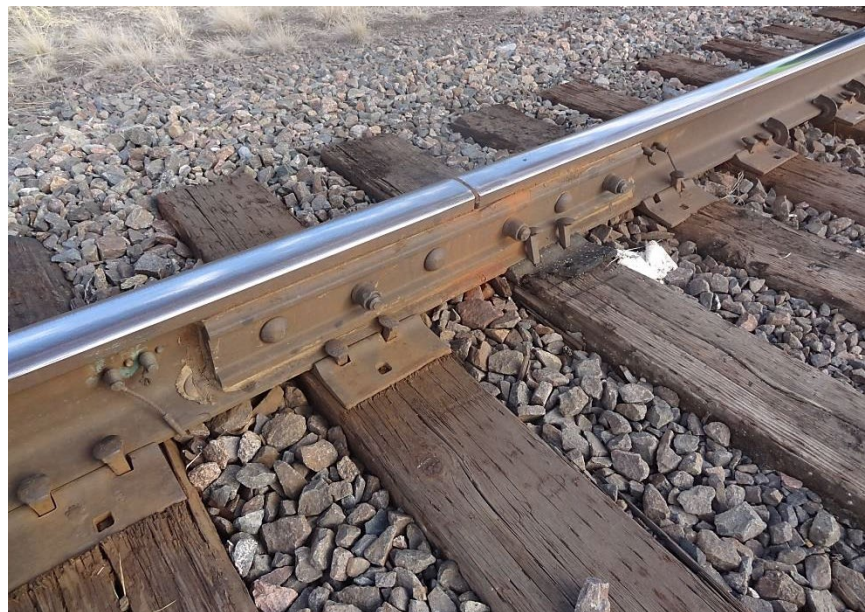
Figure H-7: Test Zone A – Example of Intact Insulated Joint – Good Track Conditions

Figure H-7 shows an intact permanent insulated joint location (#120419-002-0006) at test zone A with very good track conditions and minimal rail end misalignments. Negligible lateral and longitudinal movement were present. Zero vertical movement, profile under load and alinement were measured. Crosslevel under load was 0.25 inches low and gage under load was nominal

56.5 inches. Very small rail end batter was also measured at this location (0.025 x 3.0 & 0.015 x 1.0 inches).

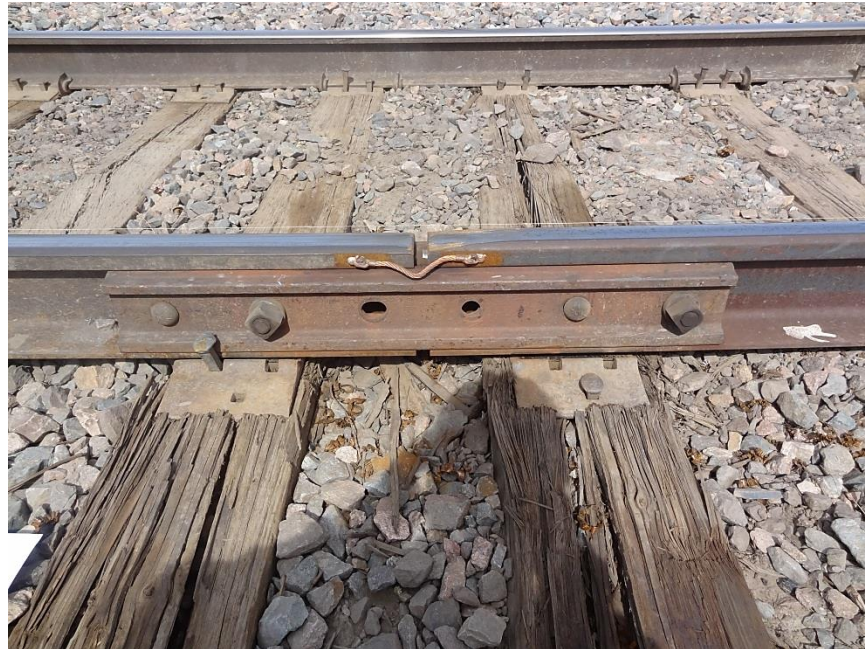
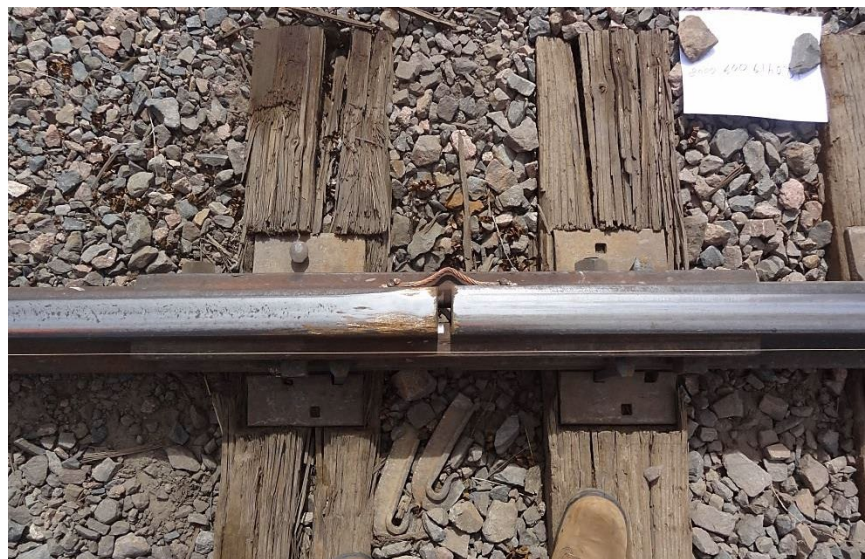
Figure H-8: Test Zone A – Example an Intact Joint Location – Deteriorated Track Conditions

Figure H-8 shows fouled ballast, split and plate cut ties, and loose or missing fasteners. The measured lateral movement was 0.25 inches, longitudinal movement was 0.5 inches and vertical movement was 1.125 inches. Gage was nominal at 56.5 inches, crosslevel under load was 1.125

inches low and profile under load was 1.875 inches. The gap between rail ends was 0.75 inches. An abrupt rail end ramp of 0.14 x 3.0 inches was measured in combination with a 0.15 tread mismatch and a 1/16 x 1.0-inch gage ramp. In addition, the joint exhibited signs of 0.375 inches of joint bar longitudinal movement on both the gage and field side bar.

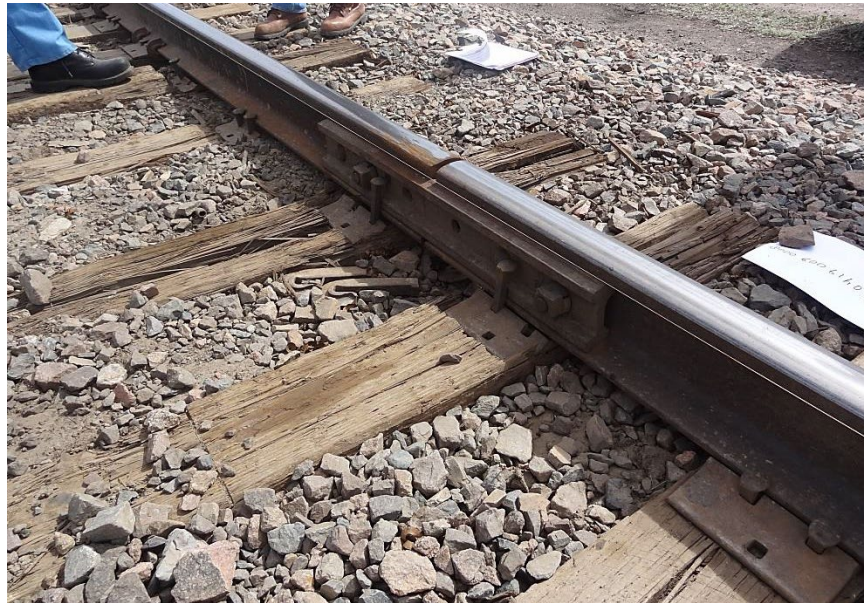
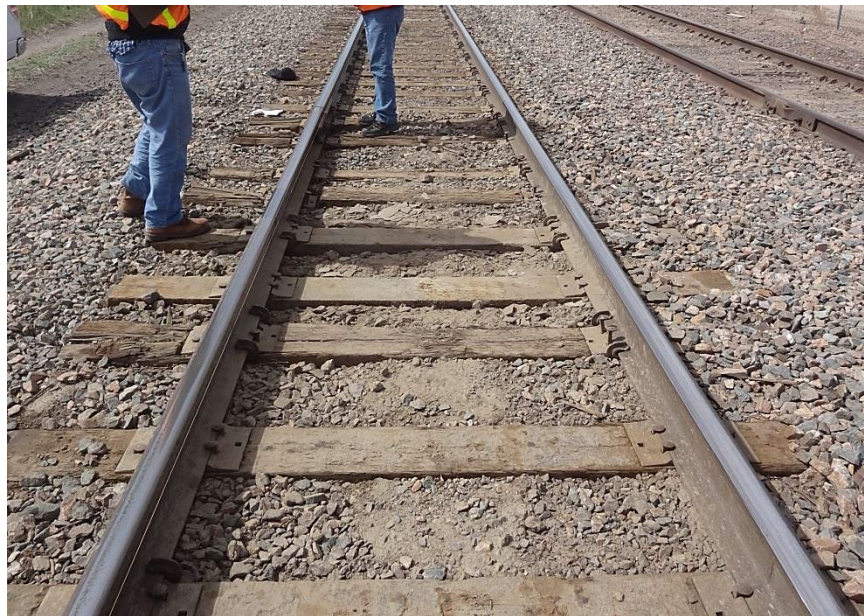
Figure H-9: Test Zone A – Example an Intact Joint Location – Fouled Ballast

b) Fouled Ballast

Figure H-9 shows missing or pulled up fasteners in the vicinity of the rail joint and fouled ballast in the general surrounding area.

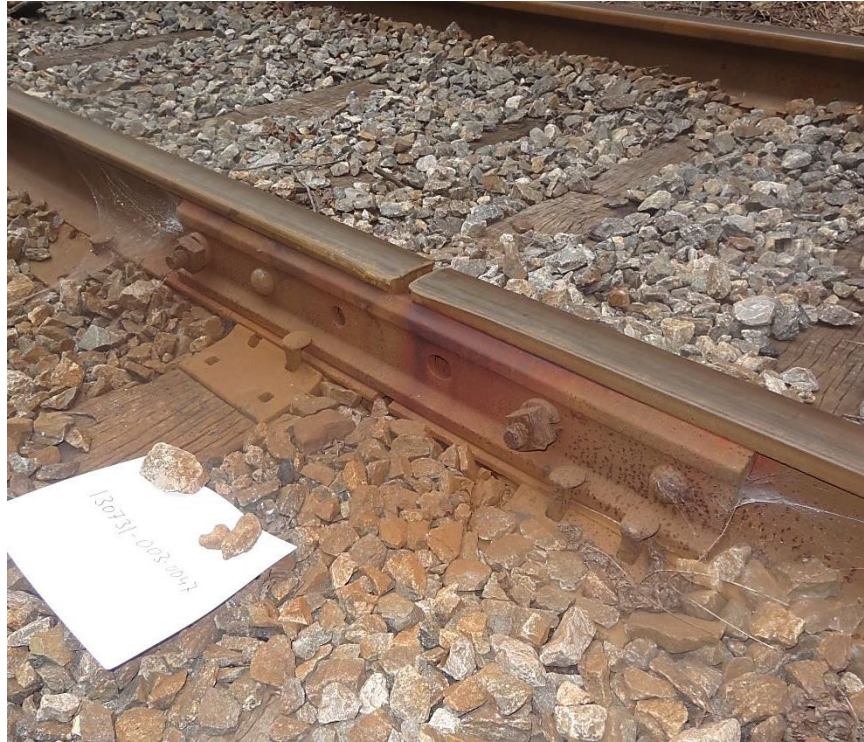
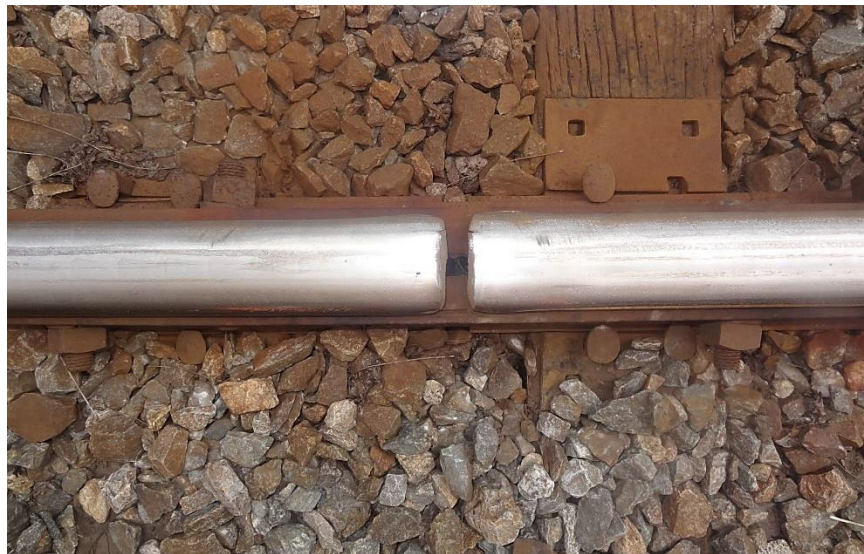
Figure H-10: Test Zone F3 – Example an Intact Joint Location – Good Track Conditions

Figure H-10 shows intact temporary rail joint location from test zone F3 (#130731-003-0047) with very good track support. Ballast and ties were both in good condition. No vertical movement and geometry conditions were recorded. Only moderate rail end batter of 0.125 x 6.75 inches was measured.

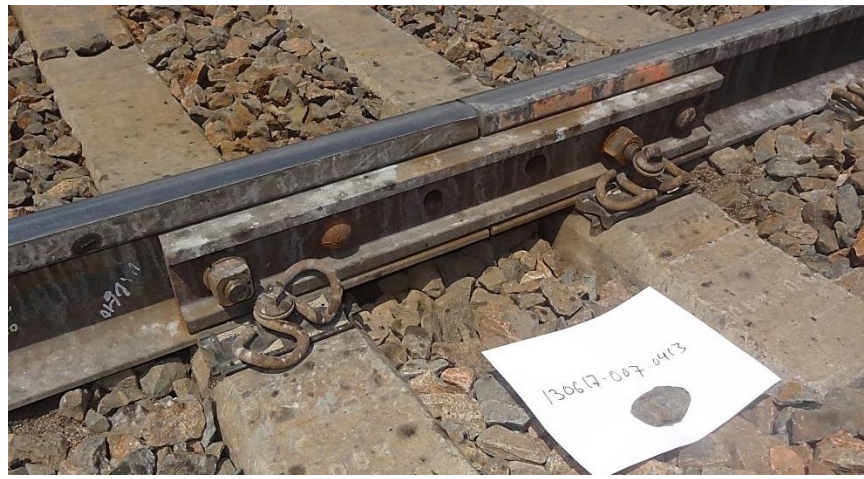
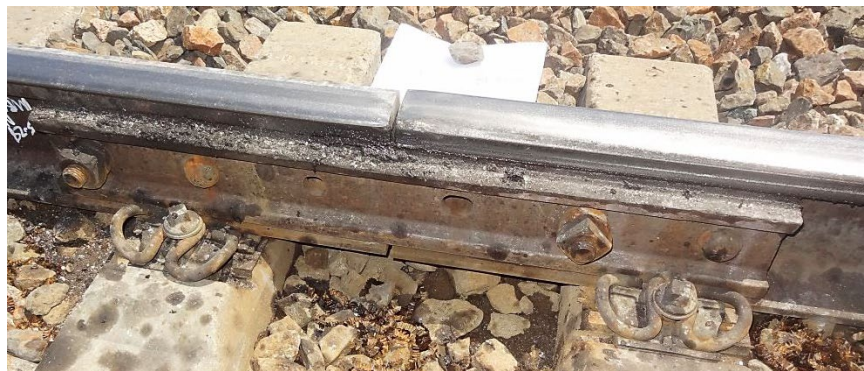
Investigated intact temporary rail joint locations on concrete tie track, test zone E, were characterized by very good support and rail end conditions. One example (#130617-007-0413) is shown in Figure H-11. No joint movements, rail end or geometry conditions were observed.

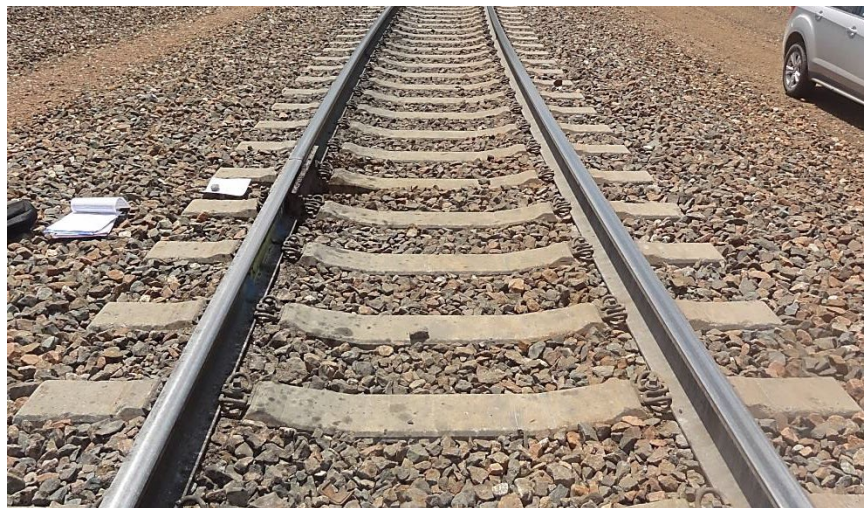
c) Overall View

Figure H-11: Test Zone E – Example 1 of an Intact Joint Location on Concrete Tie Track

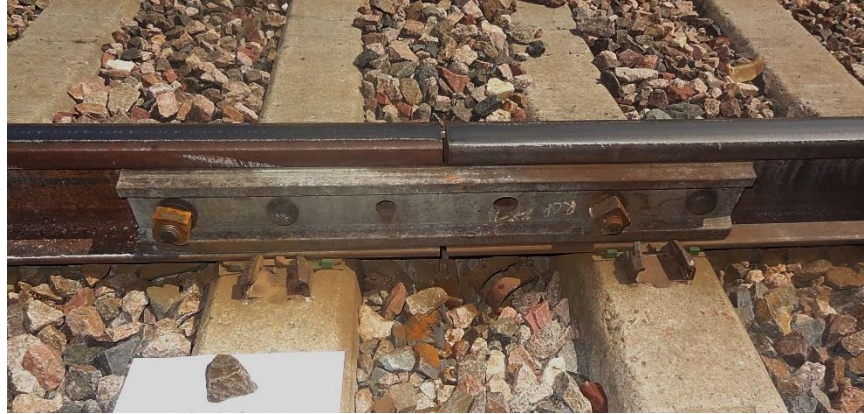
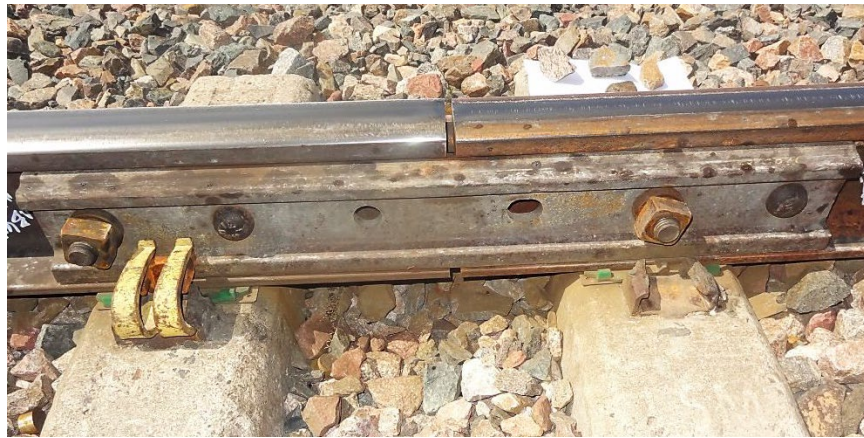
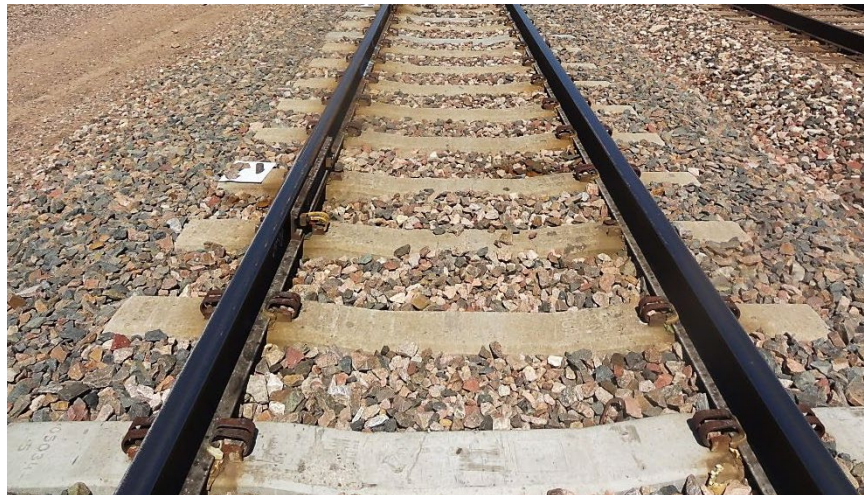
Figure H-12: Test Zone E – Example 2 of an Intact Joint Location on Concrete Tie Track

Another example (#130619-003-0407) of such location is shown in Figure H-12. No joint movements, rail end or geometry conditions were observed despite the joint being equipped with only one fastener.
