Federal Railroad Administration

DOT/FRA/ORD-19/38

Final Report October 2019

1. AGENCY USE ONLY (Leave blank)		2. REPORT DATE 3 October 2019		3. REPOR	3. REPORT TYPE AND DATES COVERED Technical Report April 2016 – August 2017	
4. TITLE AND SUBTITLE A Study of Environmental and Track Factors that Contribute to Abrasion Damage of Concrete Ties					5. FUNDING NUMBERS DTFR53-16-C-00009

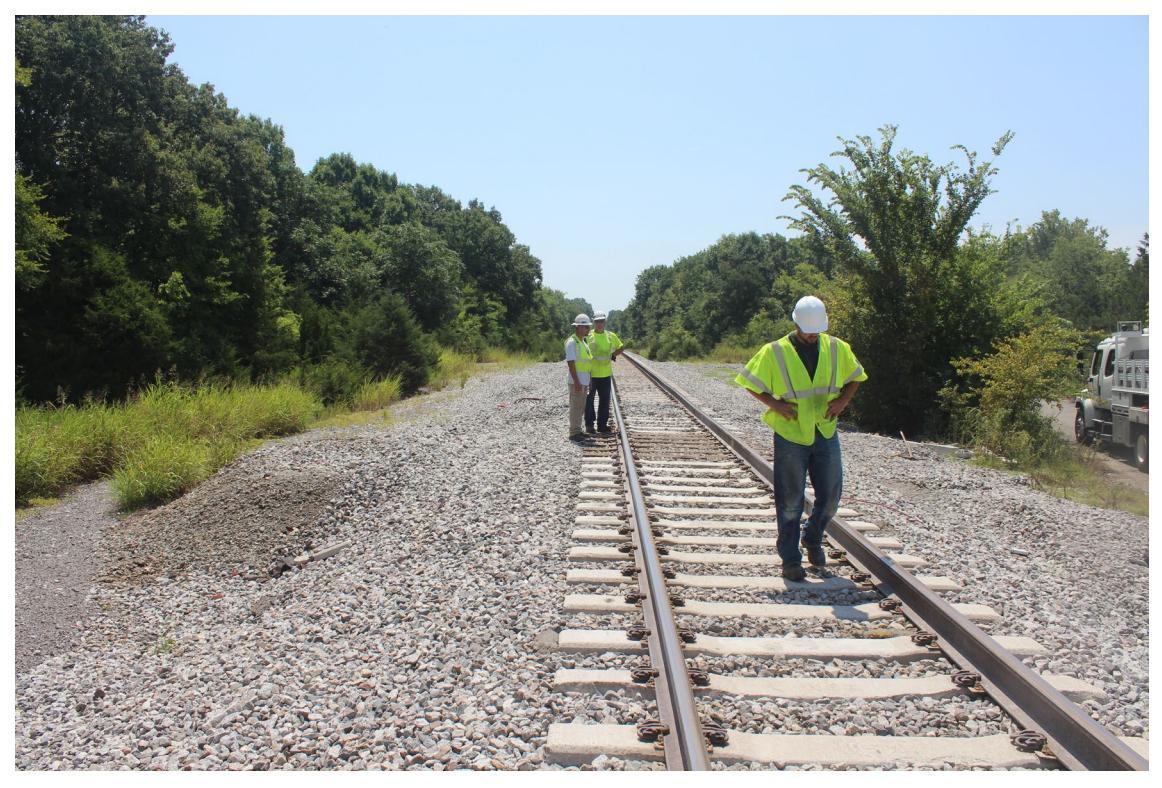
The presence of water or poor drainage was an issue at sites with significant abrasion damage. Poor drainage was seen in 95 percent of the sites that had tie abrasion damage greater than 0.5 inches. The cause of the poor drainage was in many cases inadequate grading. Figure 3-1 shows an example of a location with drainage issues at a signal (Signal #2, <u>Appendix B, Section B.3</u>). In other cases, poor drainage could have been caused by ballast breakdown. Sites with center-binding tie cracking but without significant abrasion were in locations with excellent drainage and often in arid climates. In a tunnel location, water was seen in the ditches on both sides of the road, as shown in Figure 3-2. After the water in the ditch traveled a few dozen yards from the tunnel entrance, it turned and went through the track structure to empty out into the ditch on the other side of the track. Concrete ties near the location where the water went under the track were recently replaced in part because of abrasion damage.

Figure 3-1: Location with concrete tie abrasion damage had grading issues at signal controls

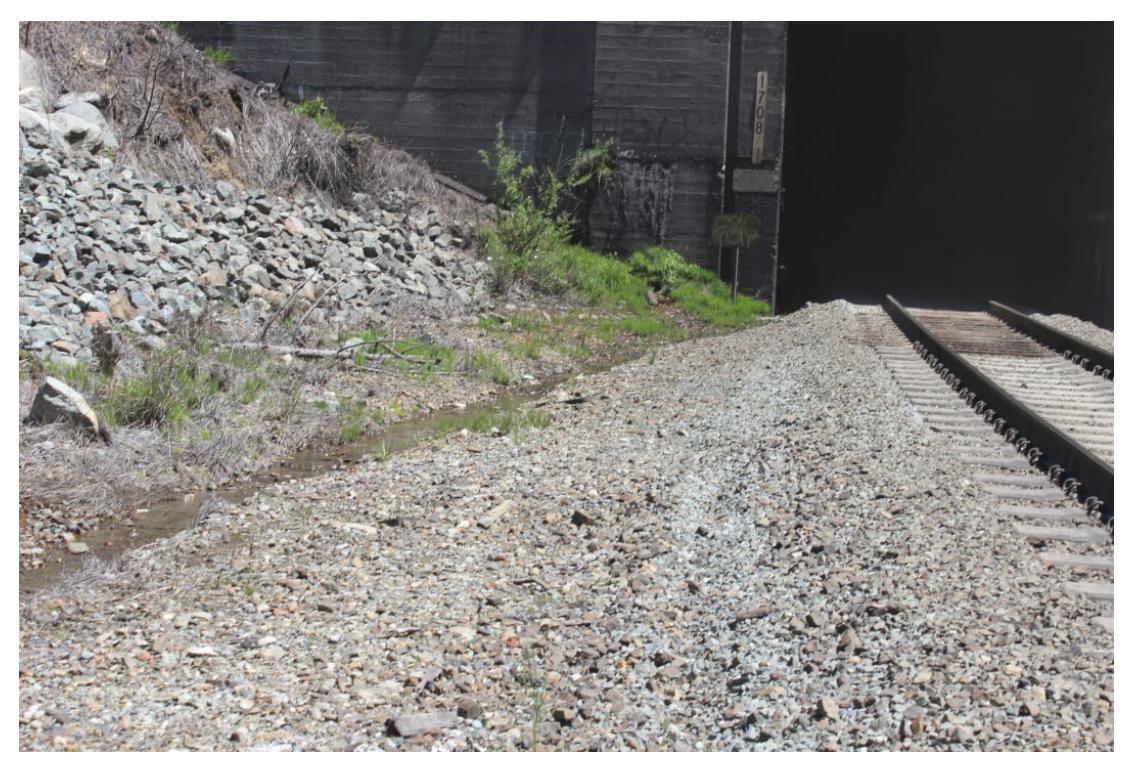
Figure 3-2: Water emanating from tunnel portal

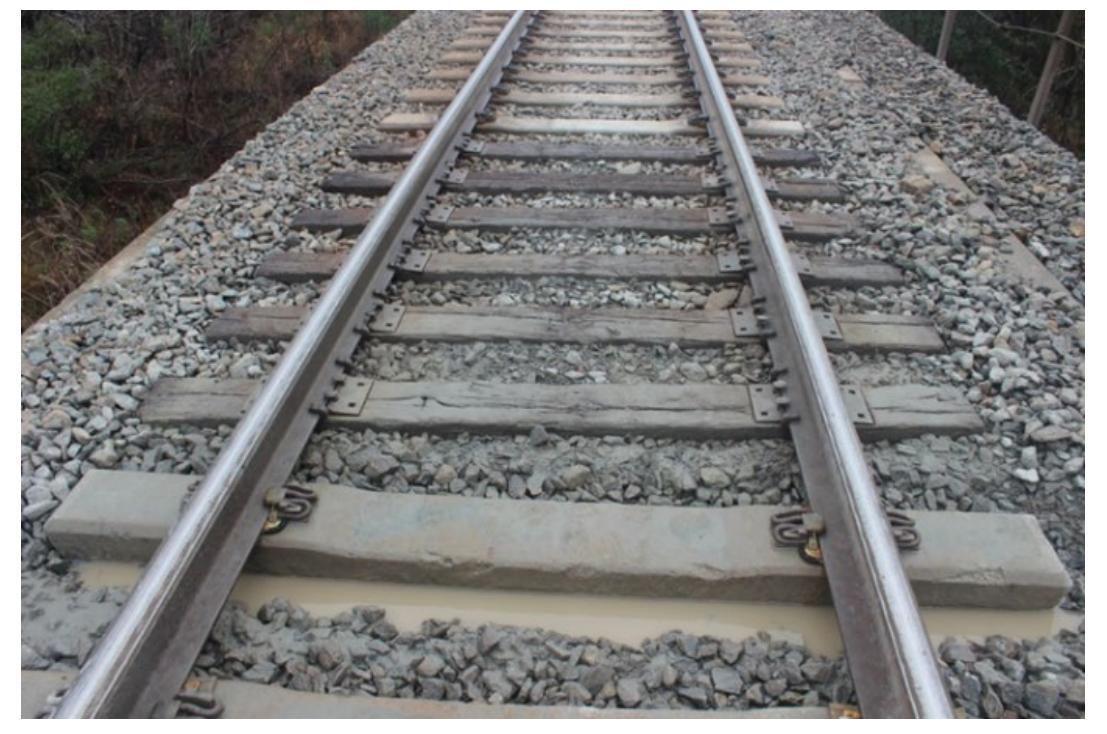
Bridge decks were especially vulnerable to drainage issues. Bridges have built-in weep holes, drainage pipes, and other drainage features, however these can quickly become clogged by ground-up ballast, coal, dust, or concrete fines. Figure 3-3 shows Bridge #3 with standing water in track (Bridge #3, <u>Appendix A, Section A.3</u>). In this case, concrete ties with significant abrasion were removed from track and replaced with wooden ties. Figure 3-4 shows one of those ties after removal from track. Since the ballast was not cleaned and replaced, the concrete fines remained in track to block drainage. All three bridges with abrasion damage had drainage issues.

Figure 3-3: Bridge #3 section repaired with wooden ties

The track visual inspection showed that six ties were removed from track and replaced with wooden ties, (Figure 3-3). The concrete ties that were removed from track were found on the side of the track, as shown in Figure 3-4 and Figure A-14. These were rounded on the bottom and had significant abrasion loss, exposing prestressing steel. The section of track where the concrete ties were removed had drainage problems. Figure A-15 shows a picture of the clogging seen on the bridge ends. Figure A-16 shows a diagram of the bridge drainage system in the bridge. Ties in this track section showed significant pumping, a likely contributing factor to the abrasion damage. Moderate center binding cracking was seen on some the ties as shown in Figure A-18 shows ties at the approach with center-binding cracking.

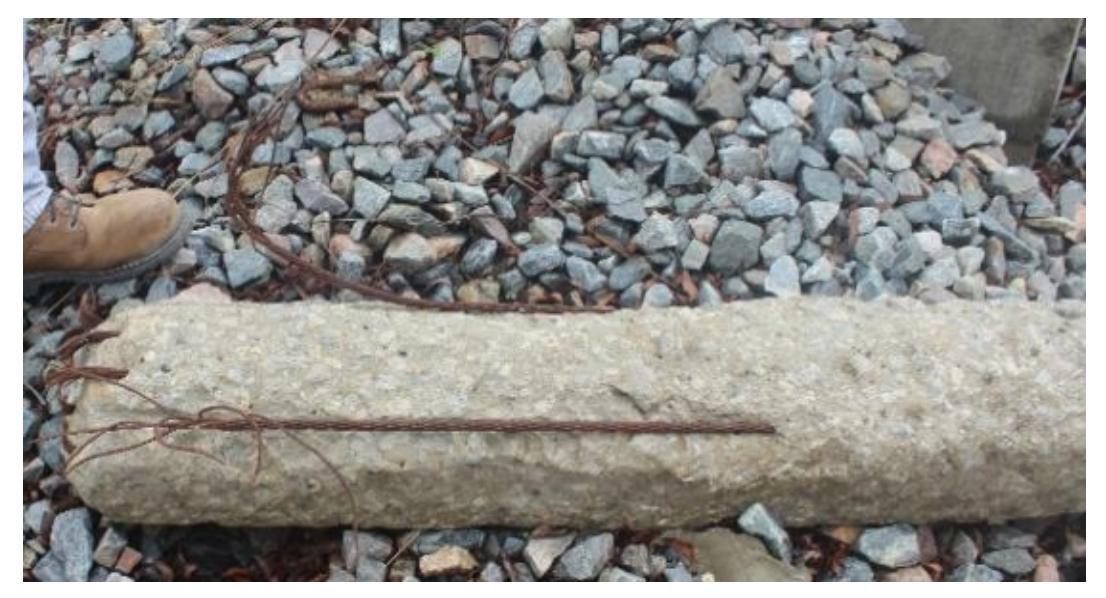
Figure 3-4: Tie from Bridge #3 after removal from track

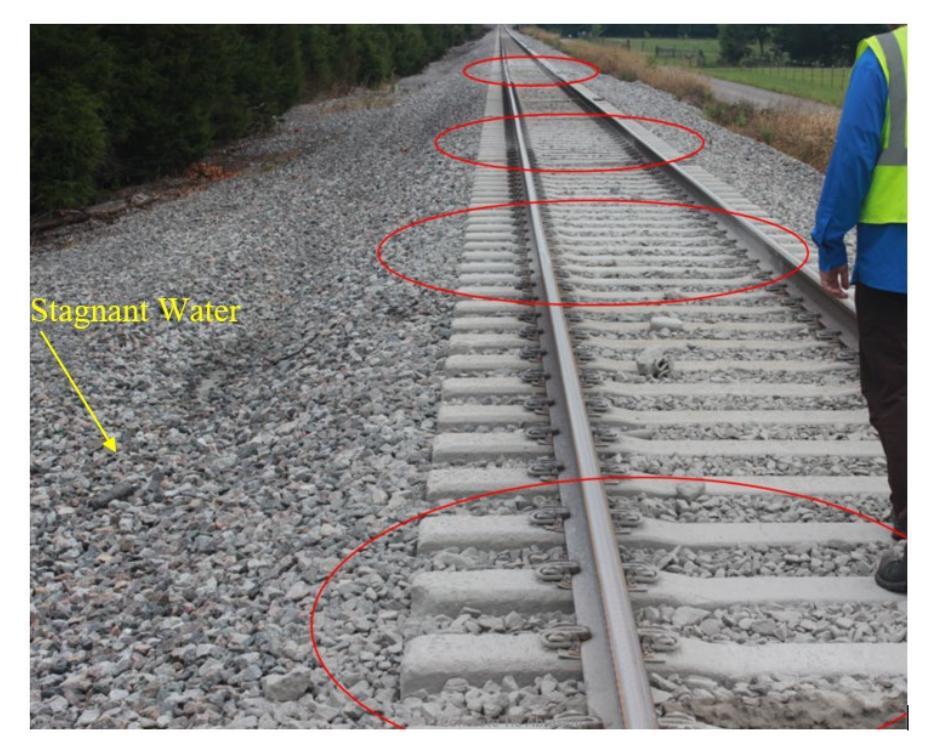
Figure 3-7: Adjacent mud spots seen near Crossing #3 (<u>Appendix C, Section C.3</u>)

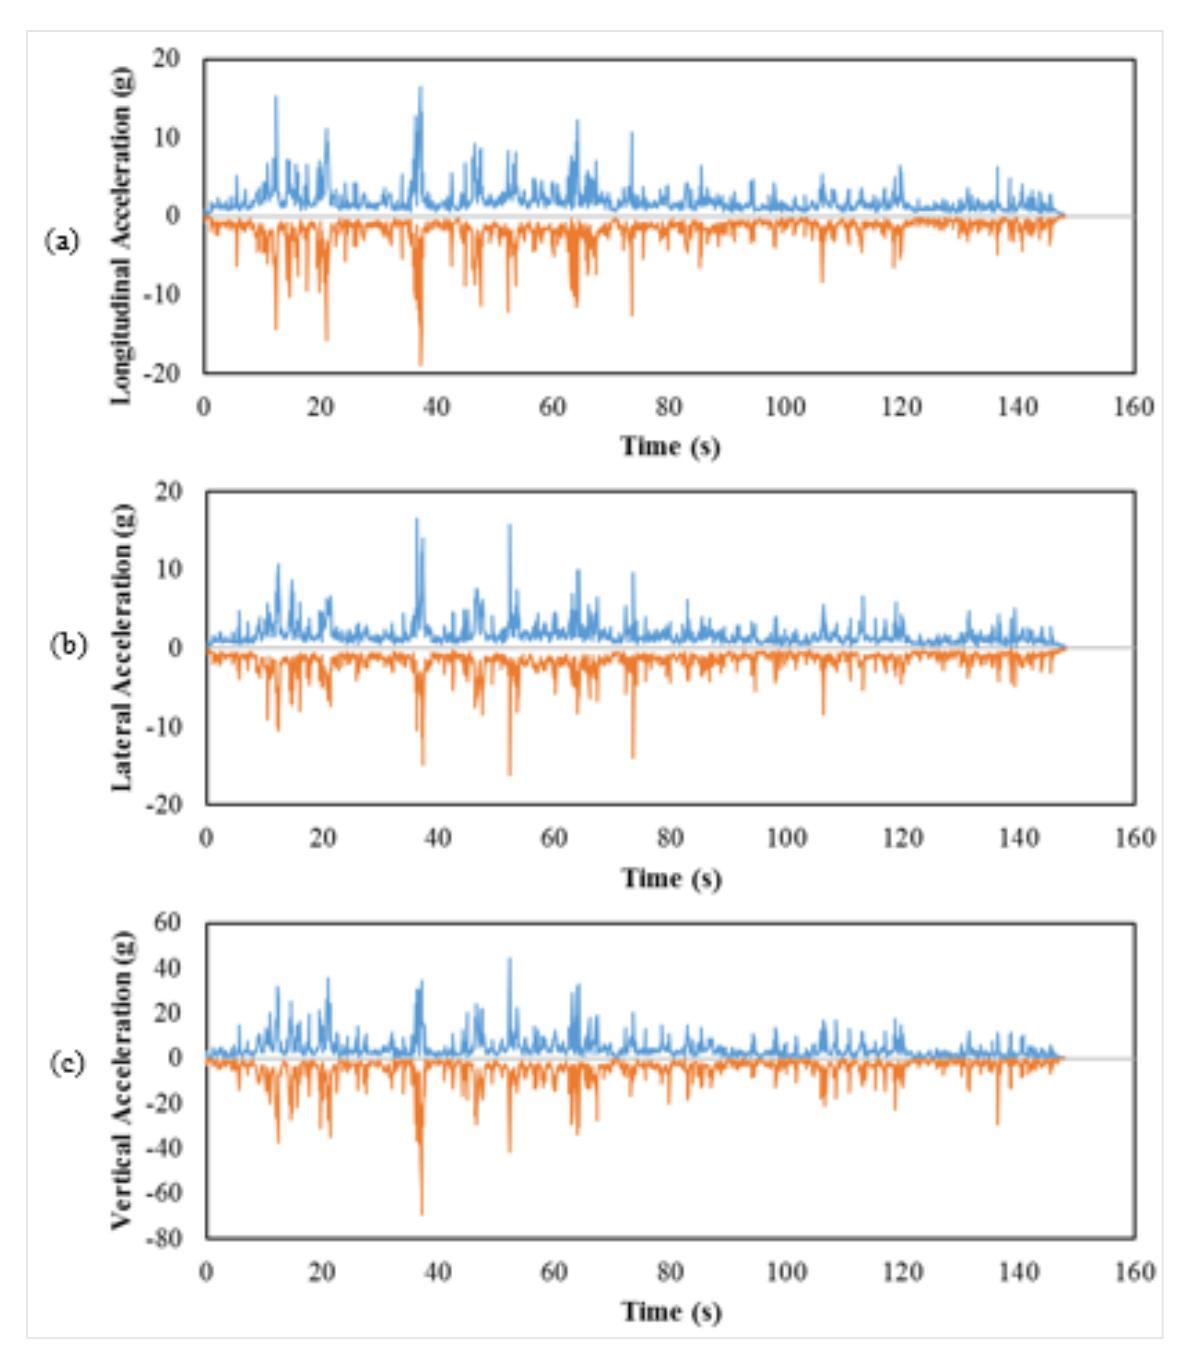
Figure 3-8: Acceleration measured with accelerometer in three dimensions: (a) vertical acceleration, (b) lateral acceleration (direction of tie), and (c) longitudinal acceleration (direction of rail).

The longitudinal and lateral forces that ties can experience, Figure 3-8, can create large contact stresses between the side of the tie and ballast. In the case of the ties shown in Figure 3-21 and Figure 3-22, these high stresses cause significant mass loss. Other locations with fines and insufficient ballast underneath ties showed mud pumping, but only minor amounts of abrasion damage. Track with fouled ballast is known to have varying stiffness depending on the track moisture content. During dry conditions, the fines greatly increase the track stiffness, while during wet conditions they greatly decrease the track stiffness.

Researchers measured tie accelerations in three directions in fouled ballast area. Acceleration readings were taken at 20 kHz. Figure B-19 shows the attached sensor to the tie for acceleration measurement. Figure 3-8 shows the acceleration in three dimensions. The lateral acceleration was more than 18 g, resulting in lateral tie movement. Analysis of the recorded video showed that the tie moved vertically 1.2 in., as shown in Figure 3-11.

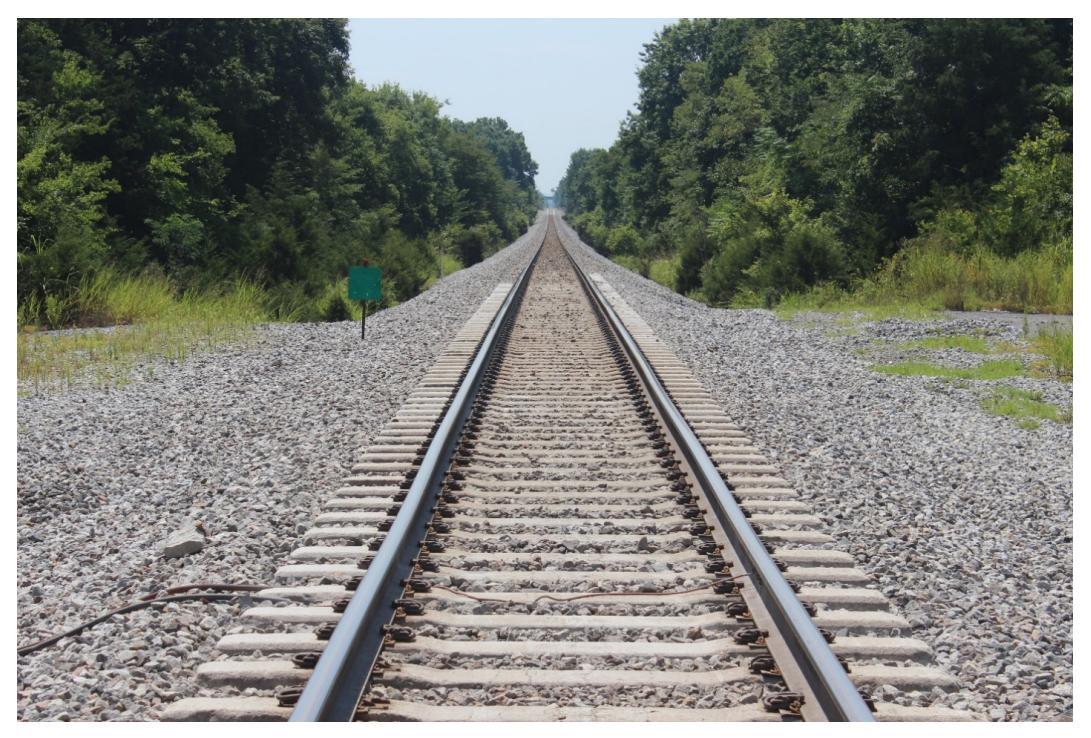
Figure 3-9: Picture of track before the train pass

Visually, the track displayed alignment and vertical profile deviations. A train passed over the site during the team's visit. Pictures taken before and after the train pass show the effect of this single train pass on the track, see Figure 3-9 and Figure 3-10. The track displaced laterally by approximately 1 inch.

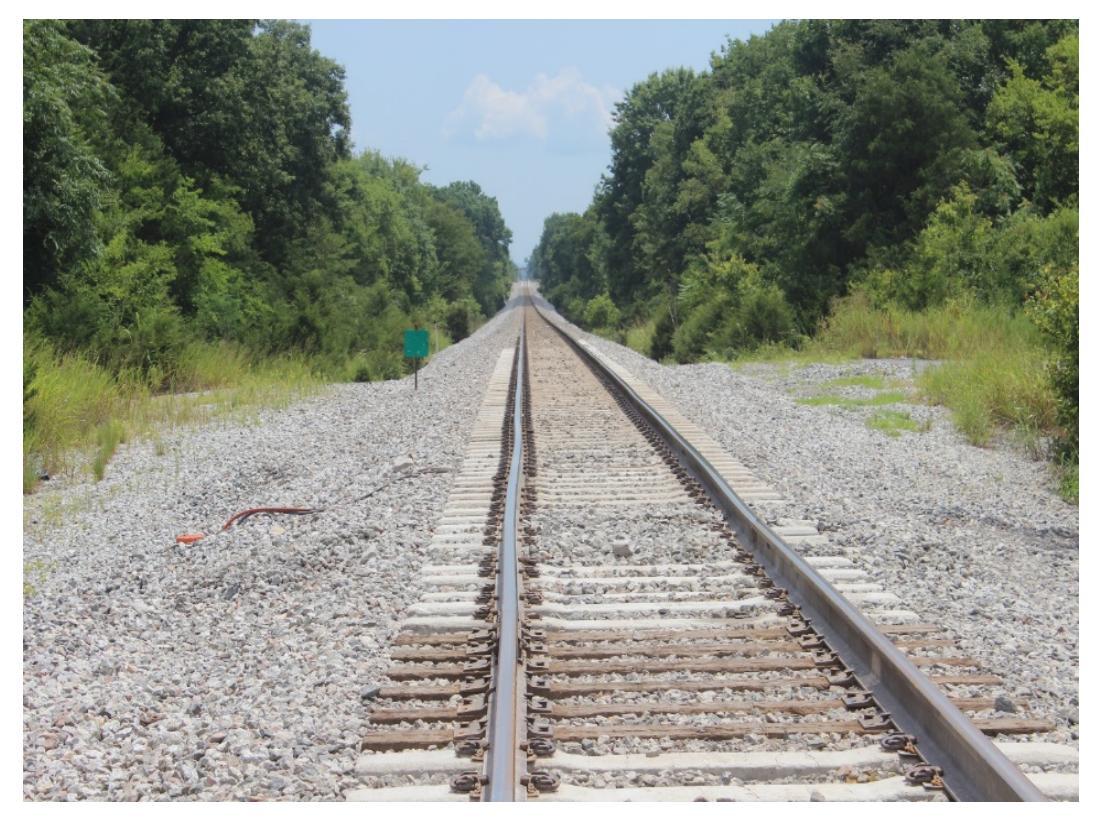
Figure 3-10: Picture of track after the train pass

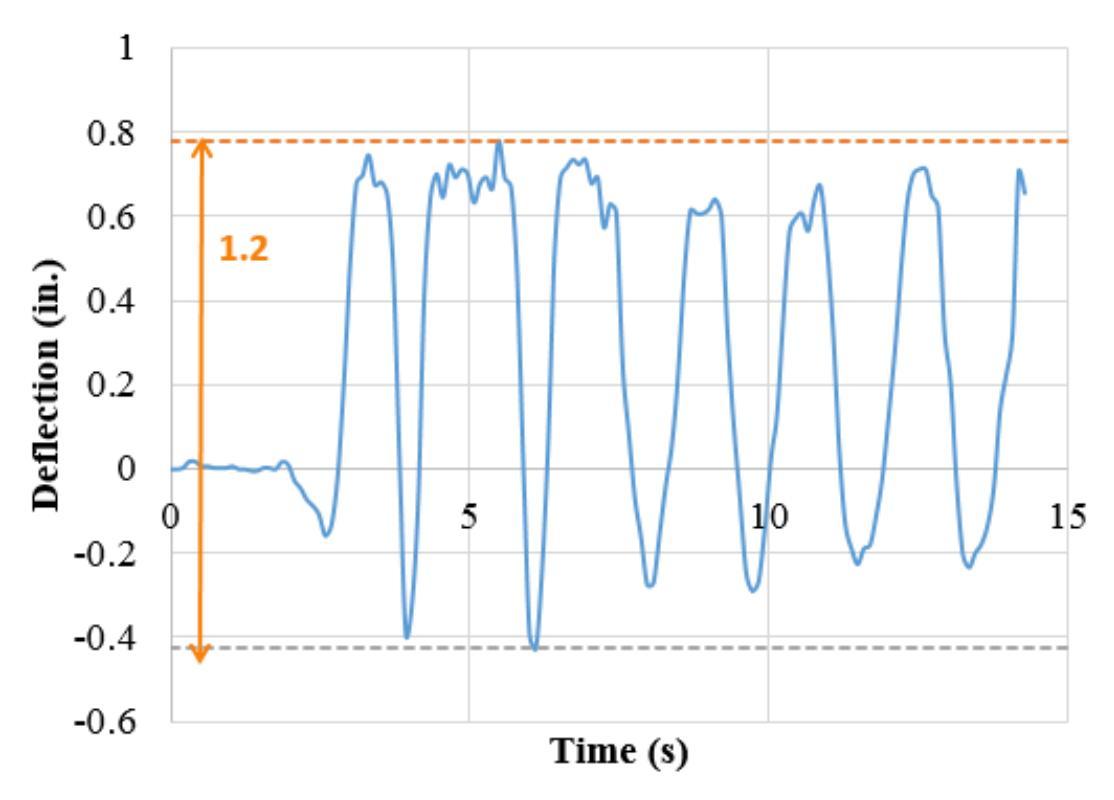
Figure 3-11: Tie deflection measured from video during train pass

Investigators measured large amounts of tie deflection at Signal #2 as shown in Figure 3-11, and for Crossing #5 and Tangent Track #6. A large rail surface profile variation was seen at a mud spot location with abraded ties, Figure 3-17. High levels of rail and tie deflections during loading can fatigue the rail and contribute to rail breaks. Rail welds were commonly found at locations with abrasion damage.

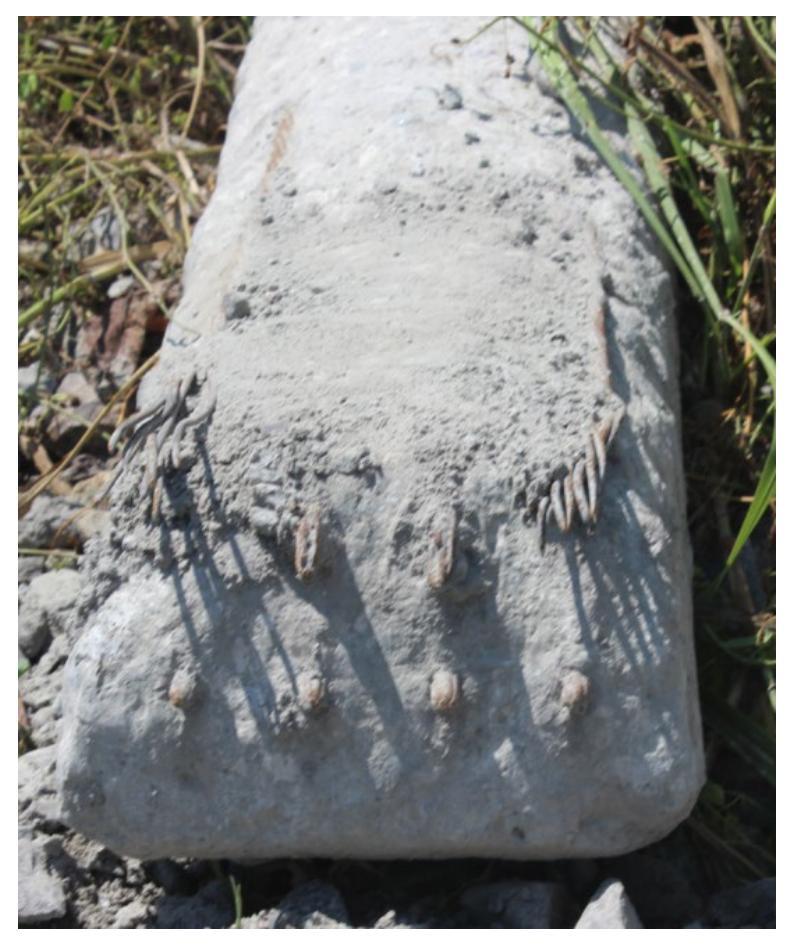
Siliceous gravel and limestone aggregates are known to be harder than limestone aggregates. Limestone and dolomitic limestones typically have a Mohs hardness under 4. Gravel and granite aggregates have a Mohs hardness above 6. Softer aggregates are known to abrade at faster rates than harder aggregates. Aggregate hardness was measured with Schmidt hammer readings. The average Schmidt hammer readings of ties made with limestone aggregates was 4.8 lower than that of the ties made with siliceous gravel or granite. Ties made with limestone aggregates showed more even wear across the tie bottom and sides, with tie bottom corner rounding more pronounced as shown in Figure 3-15 and Figure 3-16. Compared to siliceous gravel, the hardness of limestone aggregates is more similar to that of cement paste, giving a more even wear. Abrasion on concrete ties with siliceous aggregates showed to be much more varied, with the cement paste wearing at a much faster rate than the aggregates. These ties have a jagged wear pattern. The more even wear seen on ties with limestone aggregates is indicative of faster abrasion rate.

Figure 3-15: Bottom of a tie made with limestone coarse aggregates found with abrasion damage on the side of the road

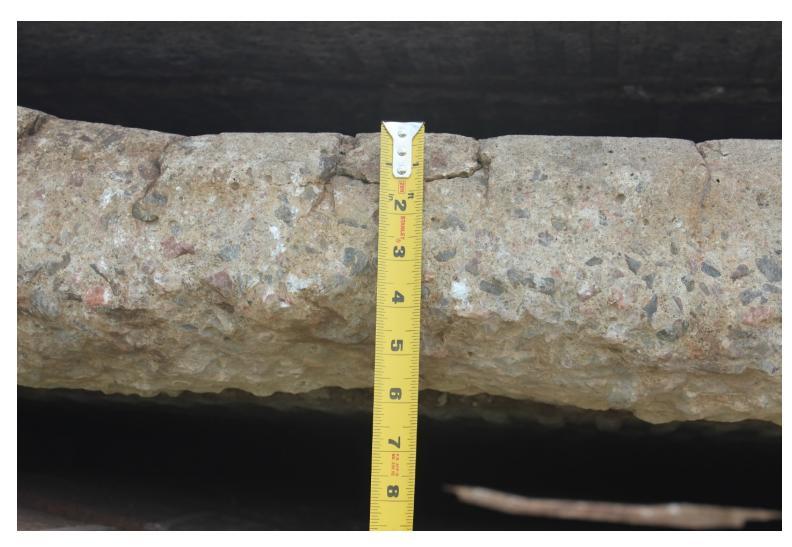
Figure 3-16: Tie made from hard siliceous aggregates in boneyard with significant abrasion damage

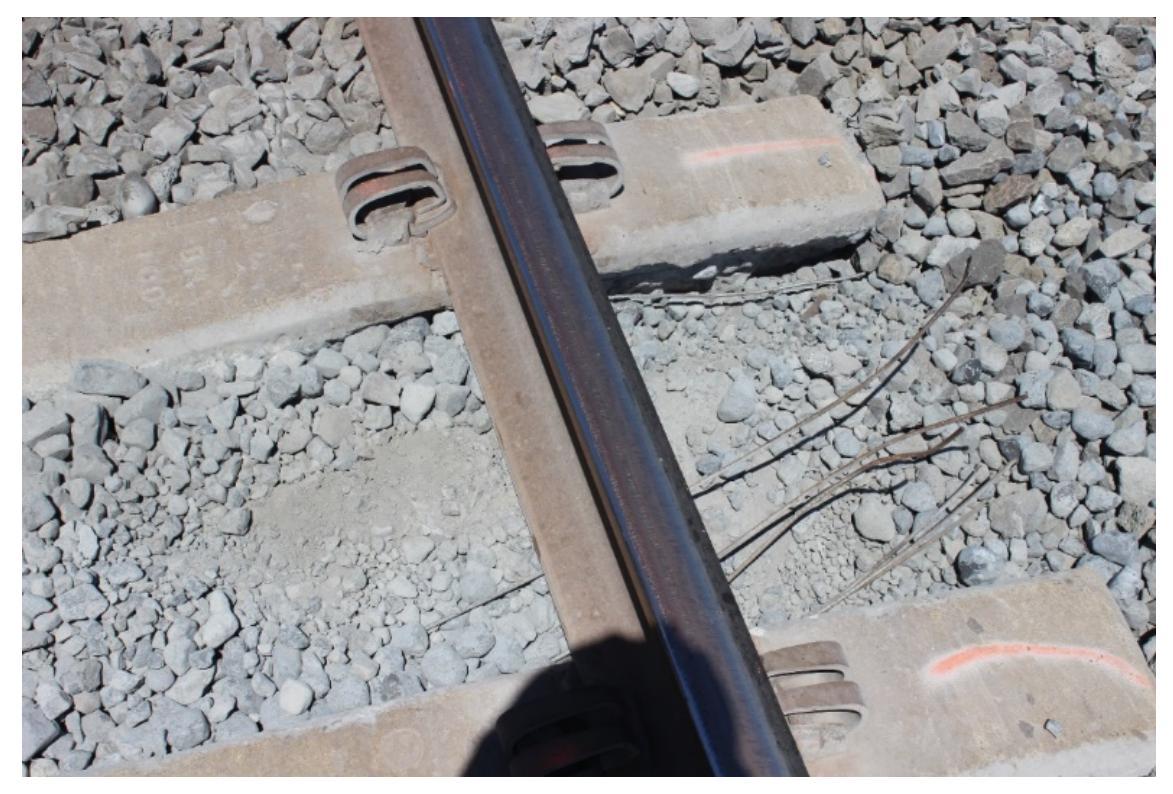
Another location that was especially illustrative of the effects of increased track stiffness was Curve #3 (<u>Appendix D, Section D.3</u>). Two ties were found with severe abrasion on the sides facing towards each other. Part of an old tie was left between the two ties with severe side abrasion damage, as shown in Figure 3-21. This situation creates a very stiff track condition between the ties, leading to fouled ballast and retained water.

Figure 3-21: Abrasion found on sides of ties with an old tie in between, Curve #3

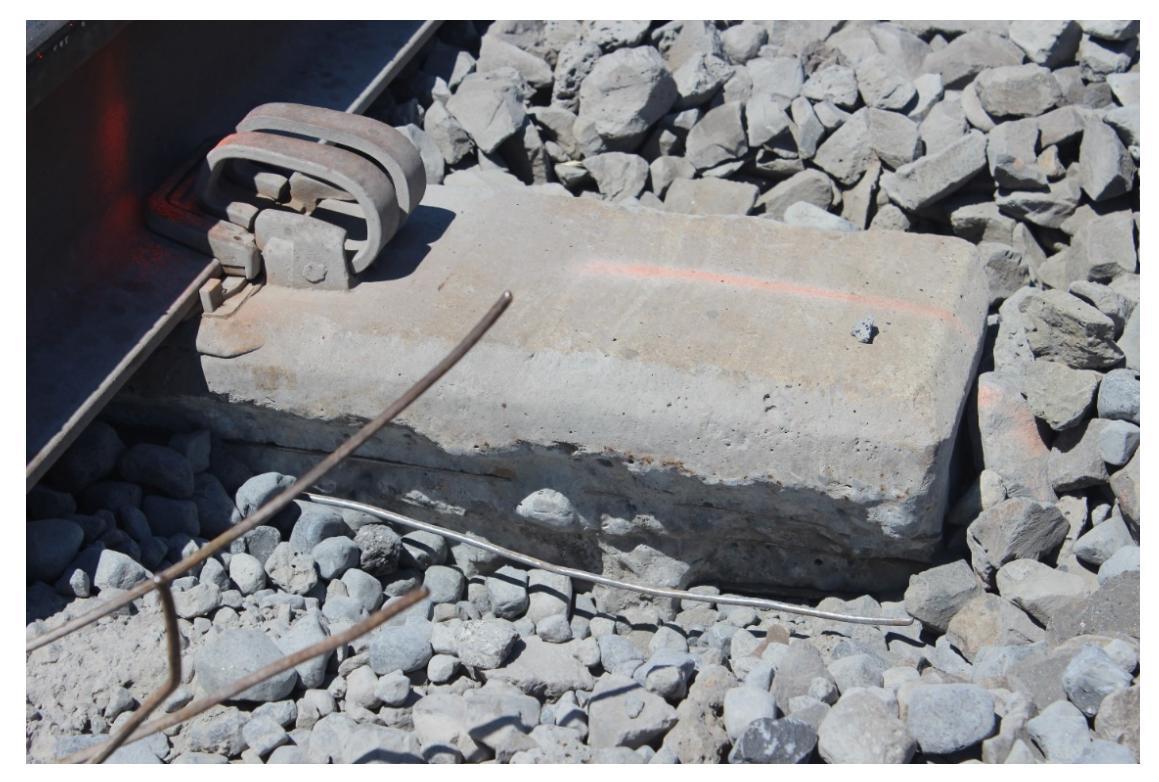
Figure 3-22: Close-up view of tie with side abrasion, Curve #3

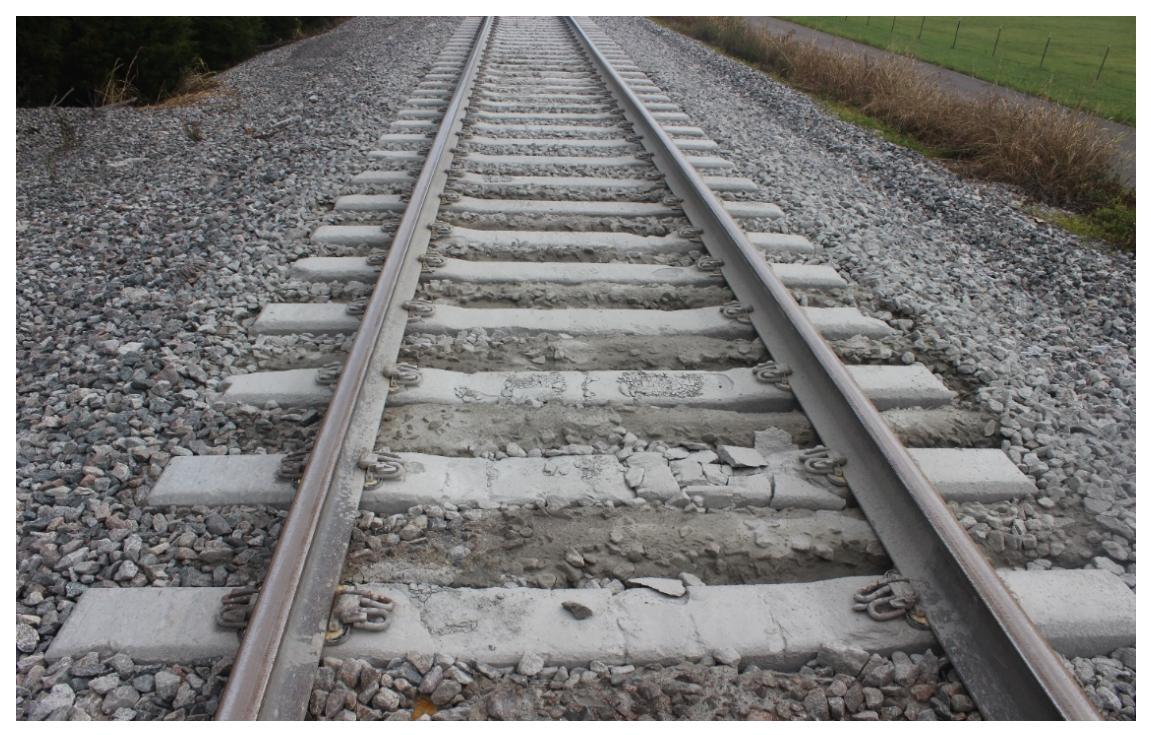
Center-binding cracks were regularly found at track locations with mud pumping and abrasion damage, as shown in Figure 3-23 for Crossing #3 (<u>Appendix C, Section C.3</u>). The presence of center-binding cracks did not directly correlate with abrasion damage. However, sections of track with center-binding cracking without fouling or drainage issues, but with low ballast support on the shoulders did show problems with abrasion damage. Figure 3-24 shows Tangent Track #1 (<u>Appendix E, Section E.1</u>) as an example of track with severe center-binding cracks, sometimes with shattered tie tops but without significant abrasion damage. In this case, the center-binding cracking was a recent phenomenon. Inadequate tamping after shoulder cleaning that had occurred the year prior to the research team visits appeared to reduce support at the rail-seat area. This led to center-bound ties and cracking within a month, without any evidence of abrasion damage.

Figure 3-23: Shattered ties at mud pumping location

2 inches. Figure C-12 shows a satellite view of the site investigated. Figure 3-23 shows a view of a portion of the track visited.

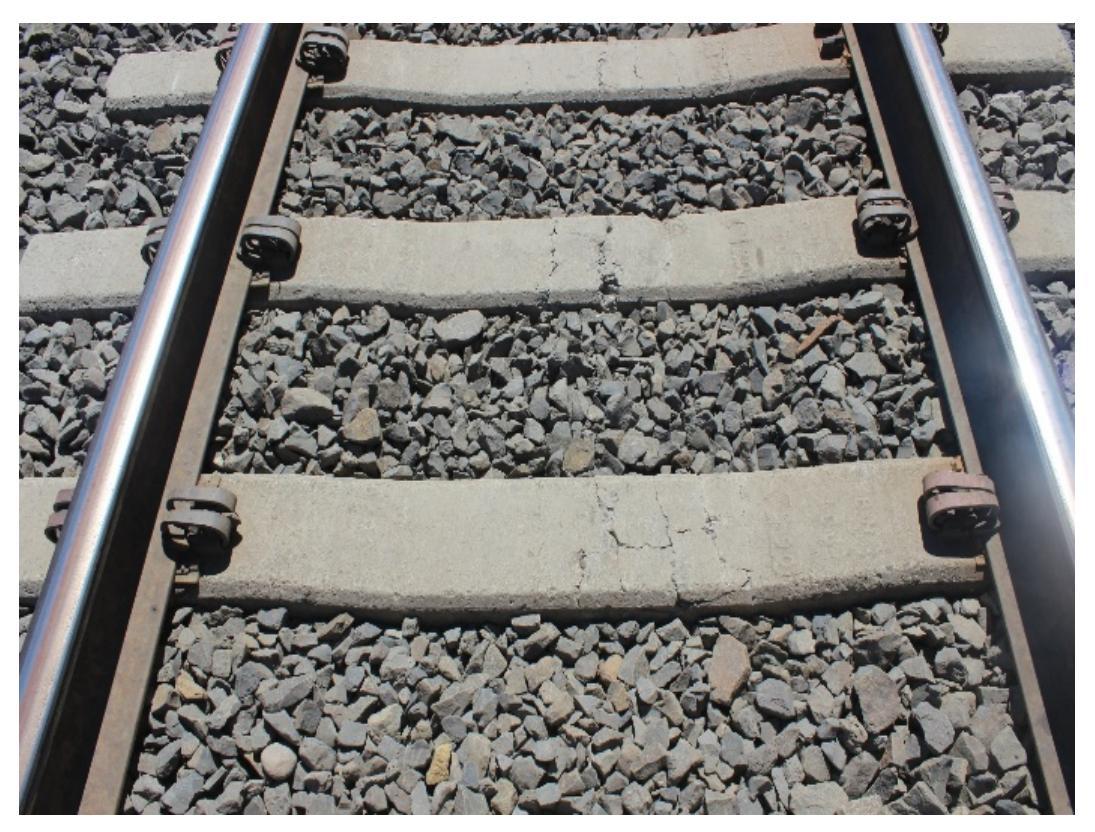
Figure 3-24: Ties with center-binding cracks in an area with good drainage, maintenance, and support conditions and very low measured bottom wear

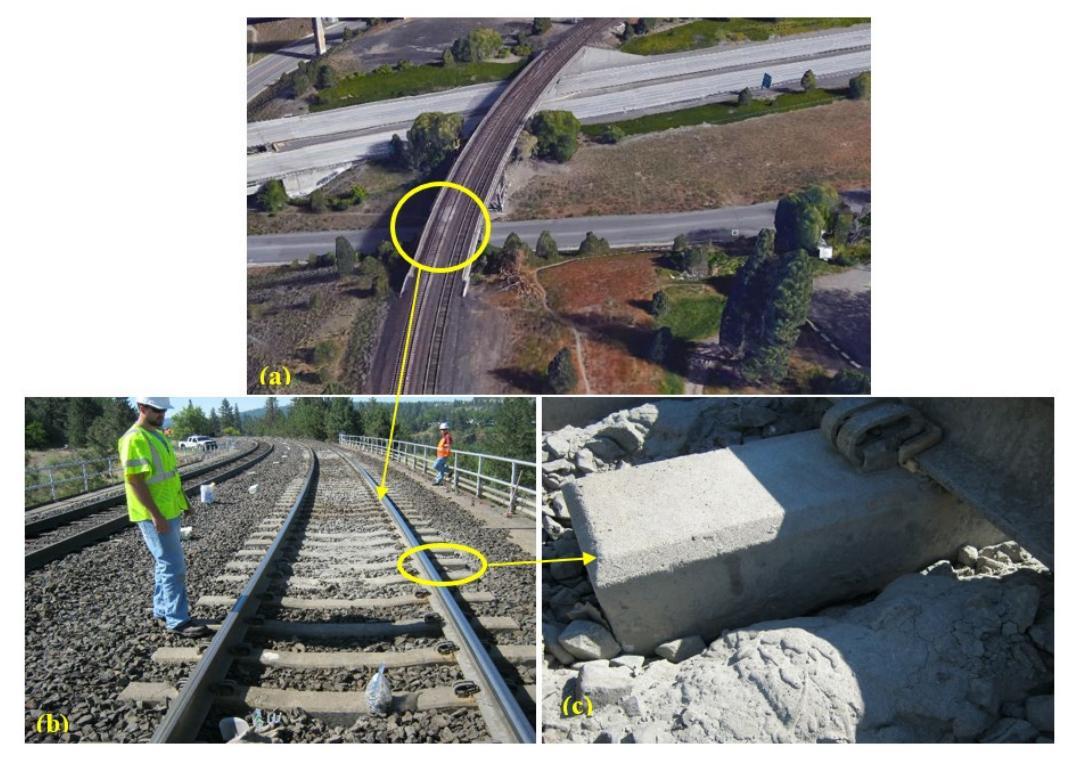
Figure A-1: Gray mud in track is visible in a) satellite image from Google Earth, b) track-level view, and c) up-close view of a concrete tie, Bridge #1

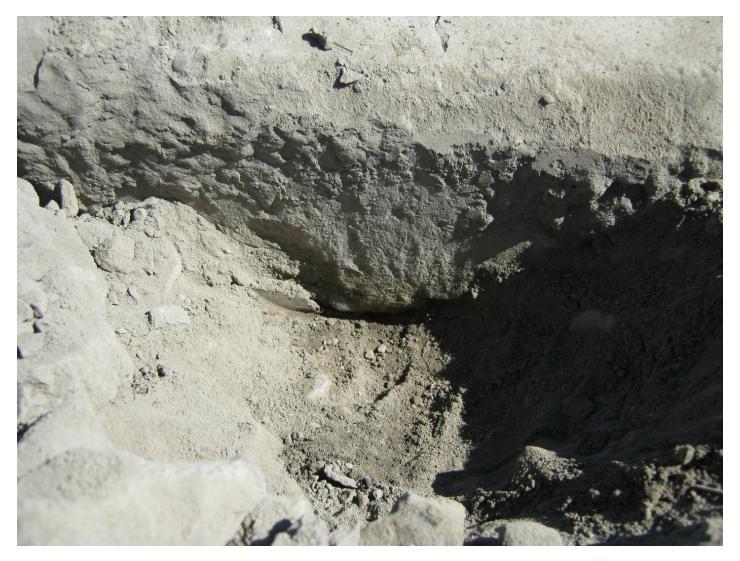
Figure A-3: Fine particles available due to tie abrasion, Bridge #1

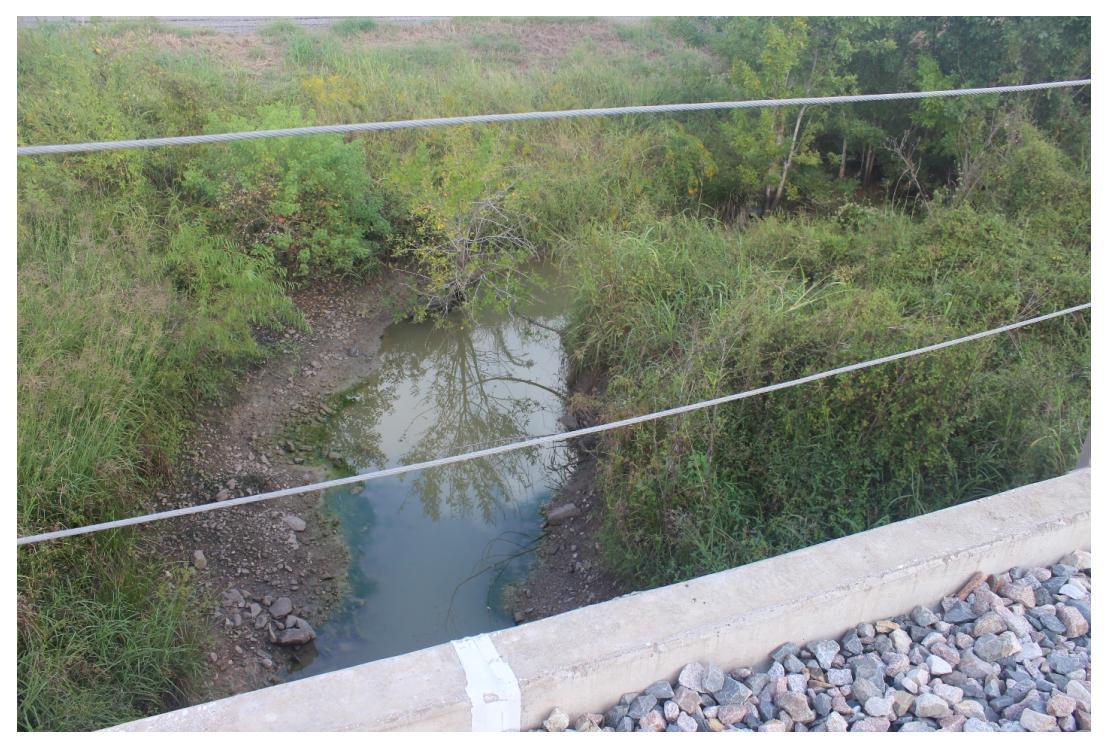
Figure A-5: Stagnant water under Bridge #2

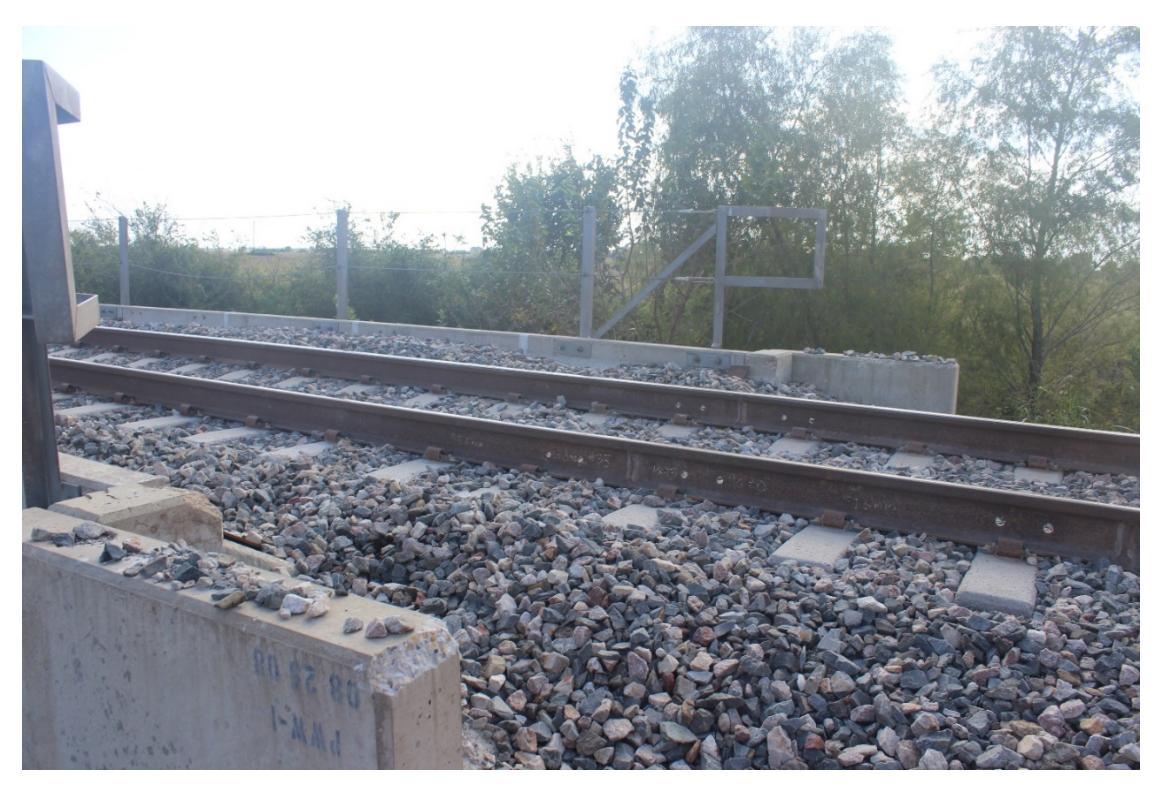
A section of the ballast near the bridge abutment was cribbed out to remove fouled ballast about 8 months before the research team visited the site (Figure A-8). A water ditch, Figure A-9, was created at the same time the ballast was replaced to improve drainage. Drainage holes at the location of the ballast fouling were plugged, whereas at the other locations on the bridge they were not clogged. Eight ties at the location where the ballast maintenance was performed showed moderate-to-severe center-binding cracking, as shown in Figure A-10.

Figure A-8: Bridge #2 abutment where ballast was replaced 8 months prior to the site visit by the research team

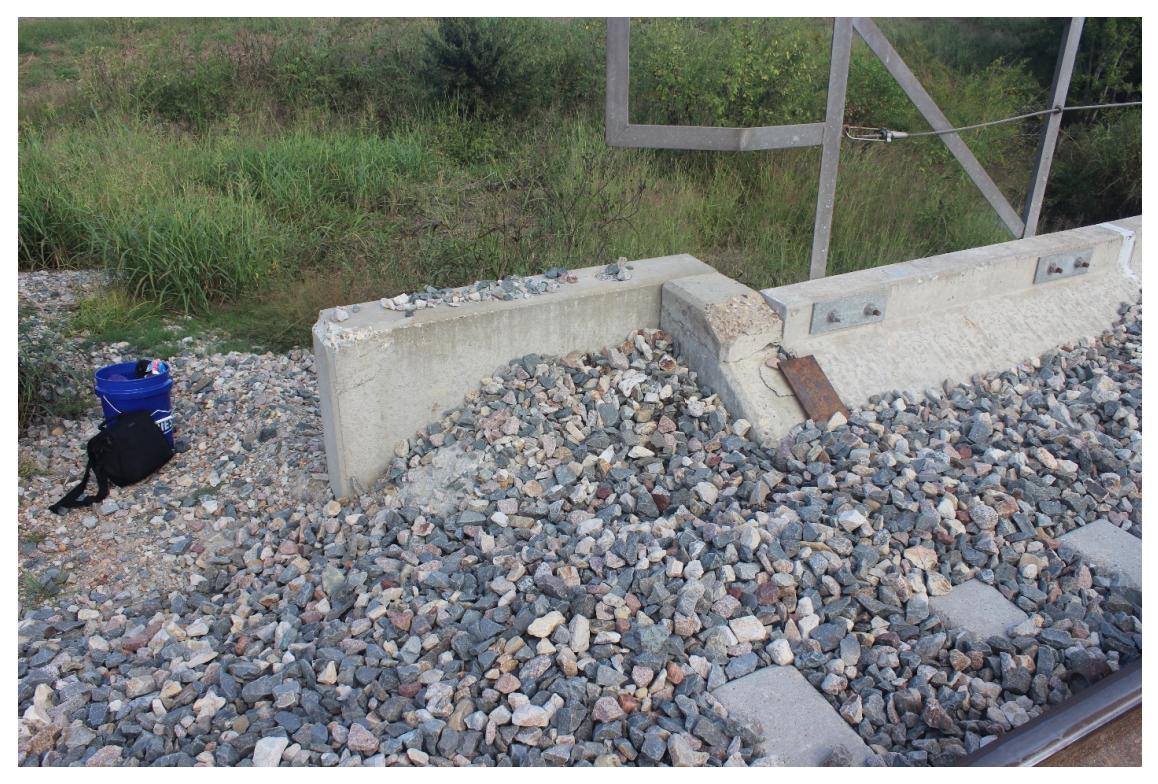
Figure A-9: Ditch in ballast to improve drainage on Bridge #2

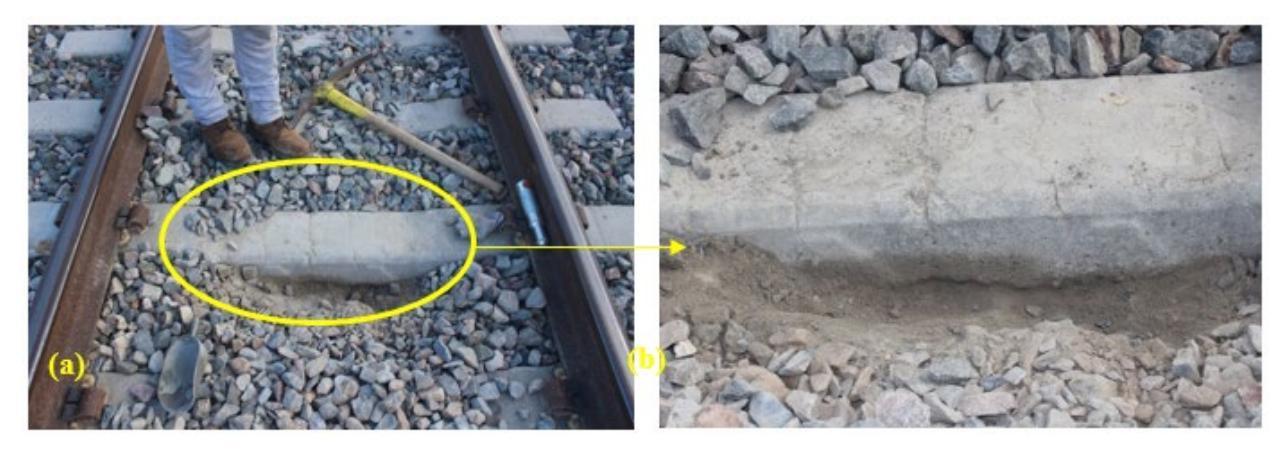
Figure A-10: Ties with moderate-to-severe center-binding cracking, Bridge #2

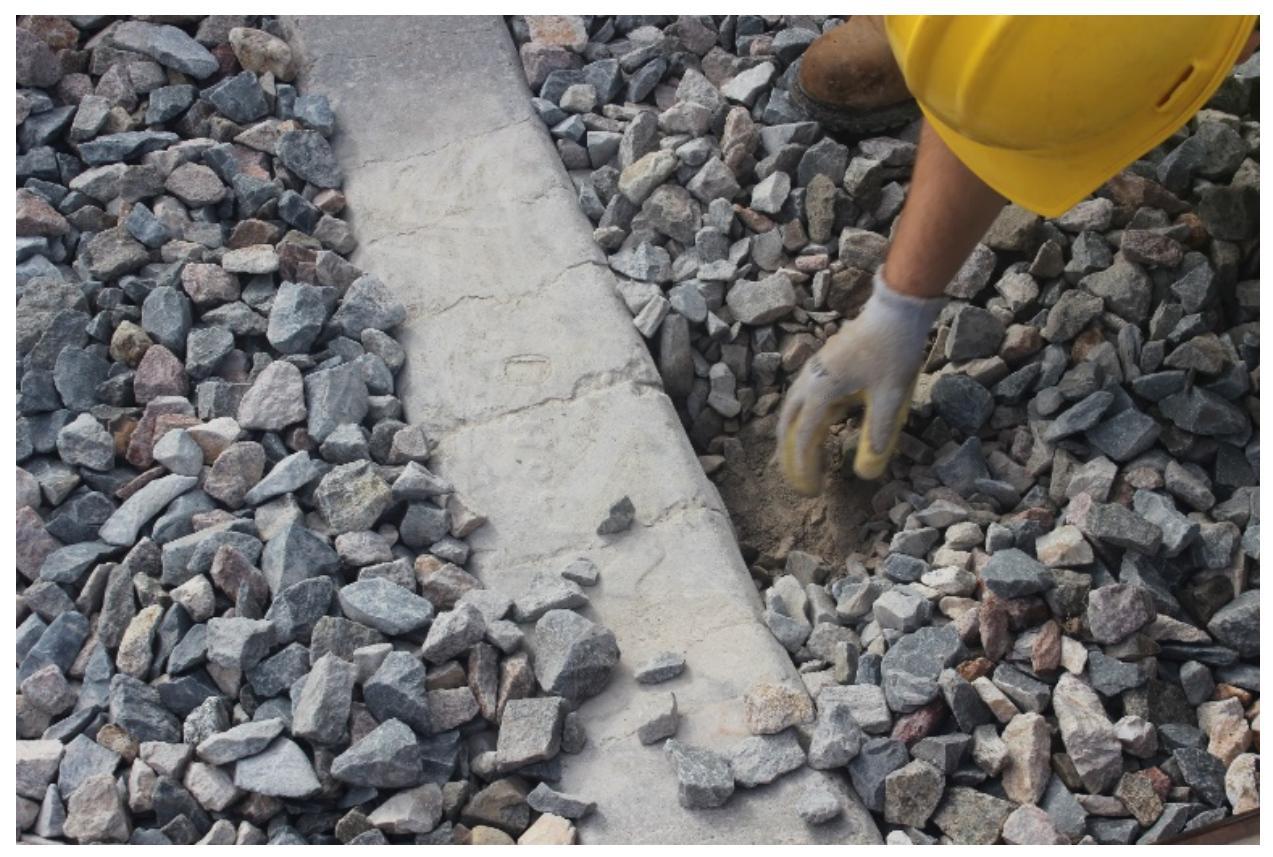
A ballast sample was taken at the depth of bottom of the concrete railroad tie from the location shown in Figure A-11. The ballast analysis is shown in Table A-4. Concrete fines were present in

significant amounts, confirming that the ties lost a significant amount of material thickness. The analysis also showed that the ballast was complrised of granite and gneiss aggregates that are known for being hard and durable.

Figure A-11: Ballast sample collection location, Bridge #2

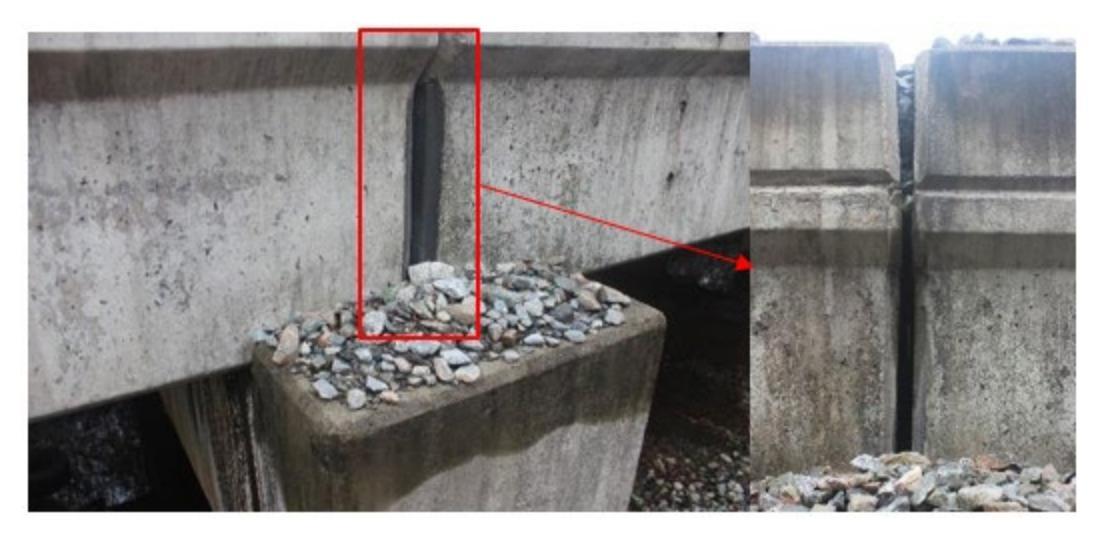
Figure A-15: Drainage issues on Bridge #3

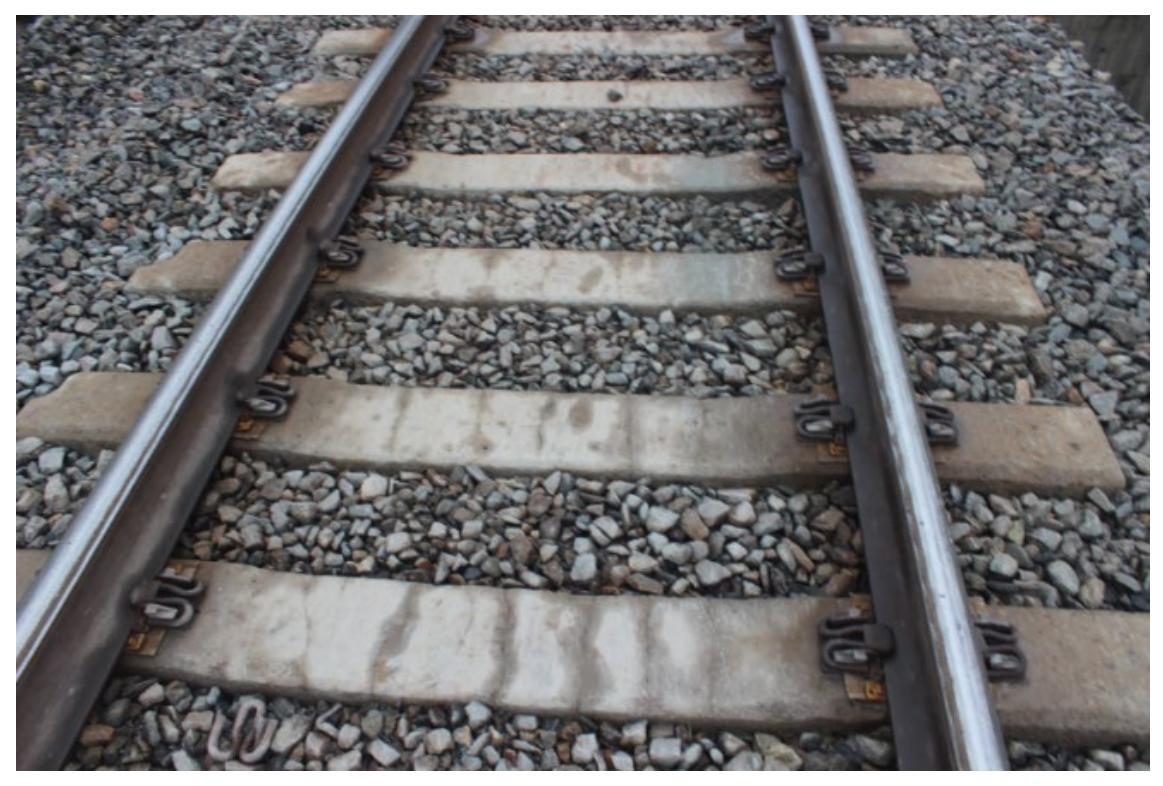
Figure A-17: Moderate center binding cracking, Bridge #3
