Federal Railroad Administration

DOT/FRA/ORD-19/38

Final Report October 2019

1. AGENCY USE ONLY (Leave blank)		2. REPORT DATE 3 October 2019		3. REPOR	3. REPORT TYPE AND DATES COVERED Technical Report April 2016 – August 2017	
4. TITLE AND SUBTITLE A Study of Environmental and Track Factors that Contribute to Abrasion Damage of Concrete Ties					5. FUNDING NUMBERS DTFR53-16-C-00009

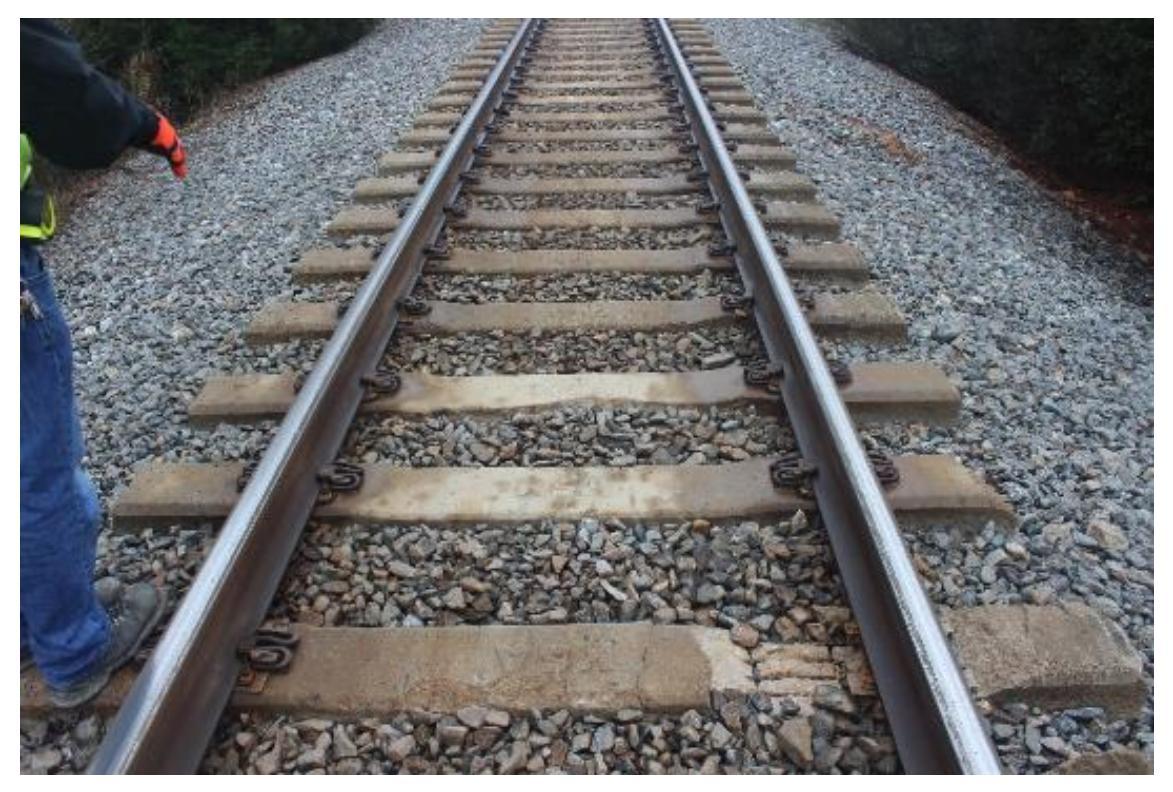
The track visual inspection showed that six ties were removed from track and replaced with wooden ties, (Figure 3-3). The concrete ties that were removed from track were found on the side of the track, as shown in Figure 3-4 and Figure A-14. These were rounded on the bottom and had significant abrasion loss, exposing prestressing steel. The section of track where the concrete ties were removed had drainage problems. Figure A-15 shows a picture of the clogging seen on the bridge ends. Figure A-16 shows a diagram of the bridge drainage system in the bridge. Ties in this track section showed significant pumping, a likely contributing factor to the abrasion damage. Moderate center binding cracking was seen on some the ties as shown in Figure A-18 shows ties at the approach with center-binding cracking.

Figure A-18: Damaged and cracked ties in Bridge#3 approach

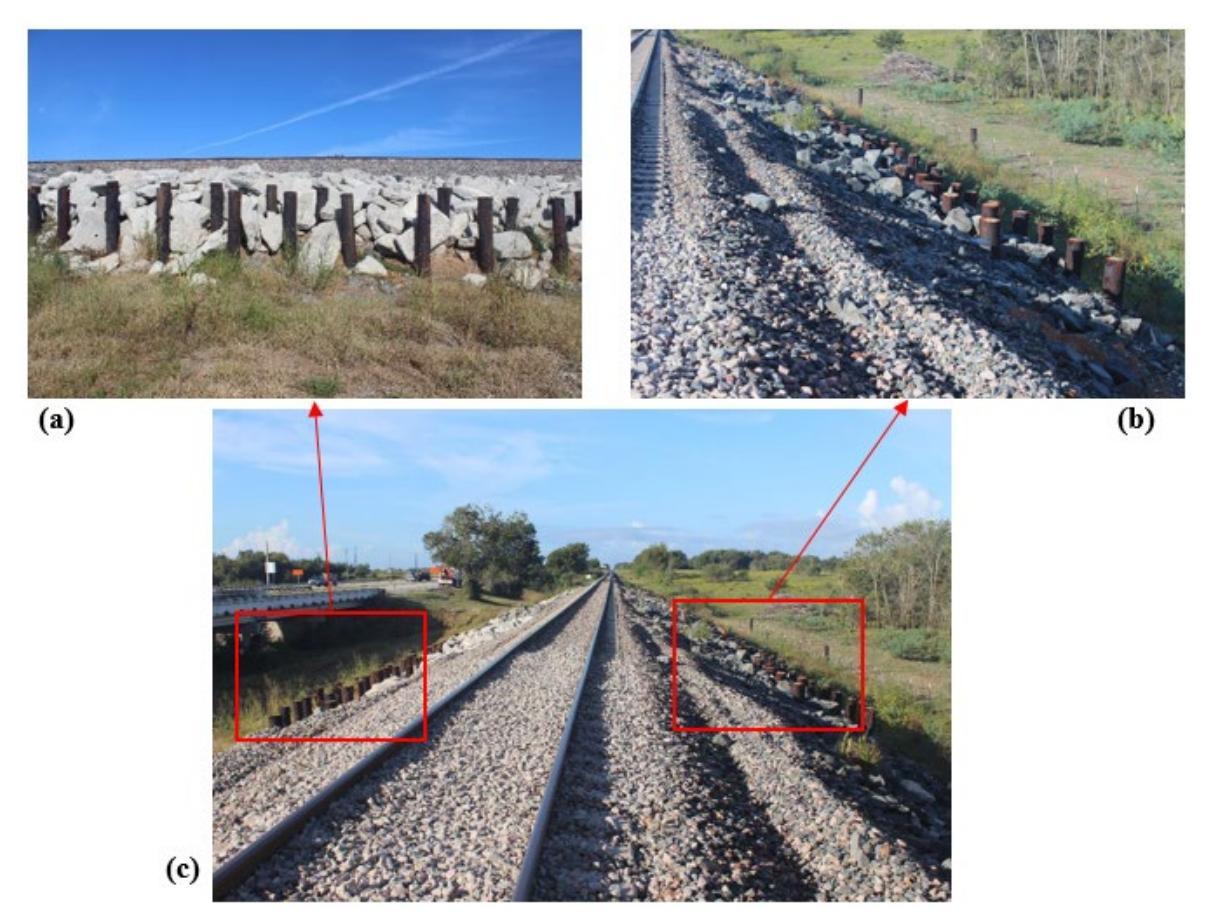
The bridge approach appeared to be in good condition. The track had surfacing issues in the past, probably because of the steep side slope. The railroad had installed rip-rap and wood posts to reinforce the track bed, as shown in Figure A-21. Track maintenance personal said that before this change, the track experienced water ponding because of fouling. Little wear was seen in the bottom of the ties in track. Ties taken from track and stored with the rip-rap still have side scallops and finishing roller marks, as shown in Figure A-22, indicating little abrasion damage. The recent track maintenance activities seem to be effective. Little abrasion damage was seen in track.

Figure A-21: Use of piles to stabilize the slope, Bridge Approach #1

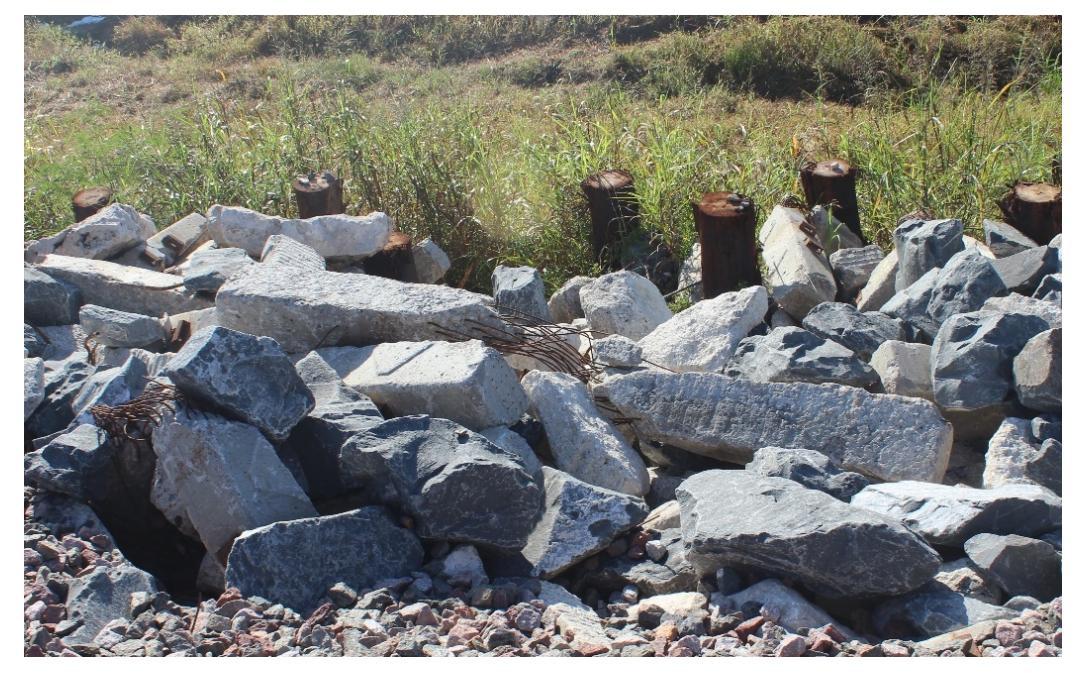
Figure A-22: Removed ties stored on the sides of the track, Bridge Approach #1

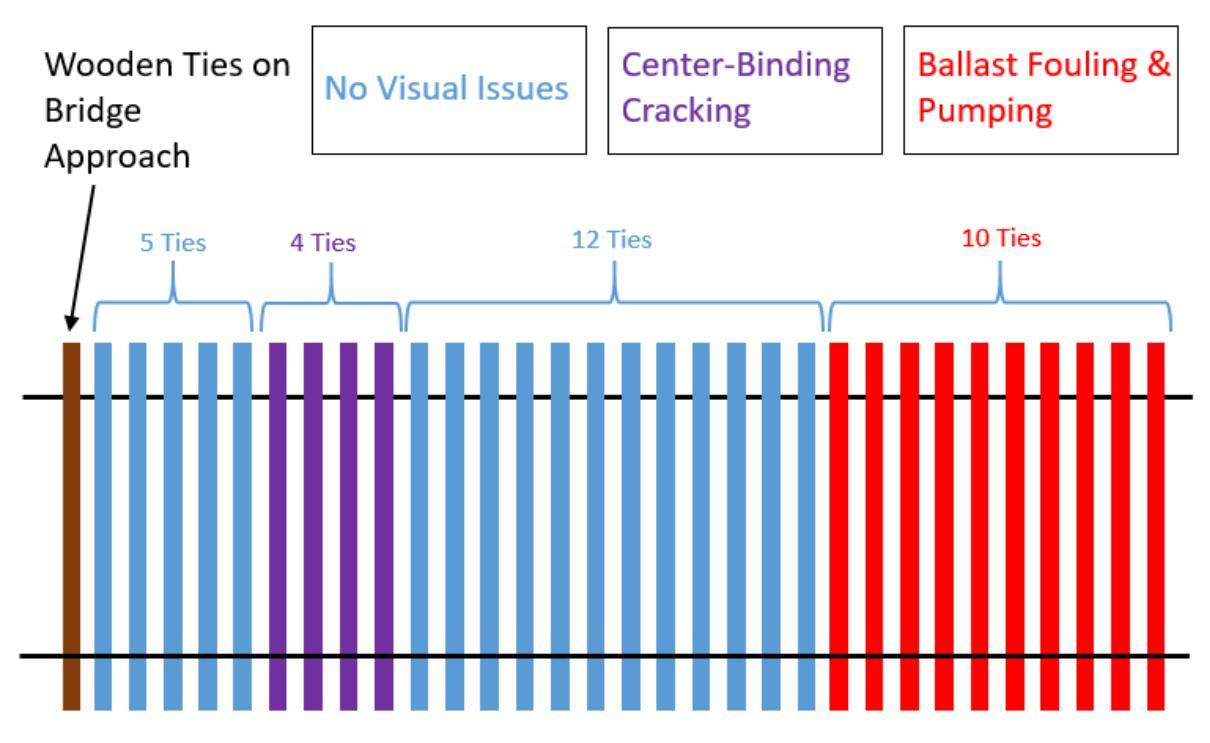
Figure A-26 shows a graphical representation of the general tie conditions along this track. The transition from wood ties to concrete ties is shown in Figure A-27. Longer wooden ties were used to give similar track stiffness as the concrete ties. The bridge appeared to be a few inches higher in elevation than the approach track. It is possible the change in elevation and a bump from the wood tie-to-concrete ties. The ties with center binding cracking had only minor cracks present, as shown in Figure A-28. Train vertical movement harmonics could result in higher loads where the fouling exists.

Figure A-26: Concrete tie condition, Bridge Approach #3

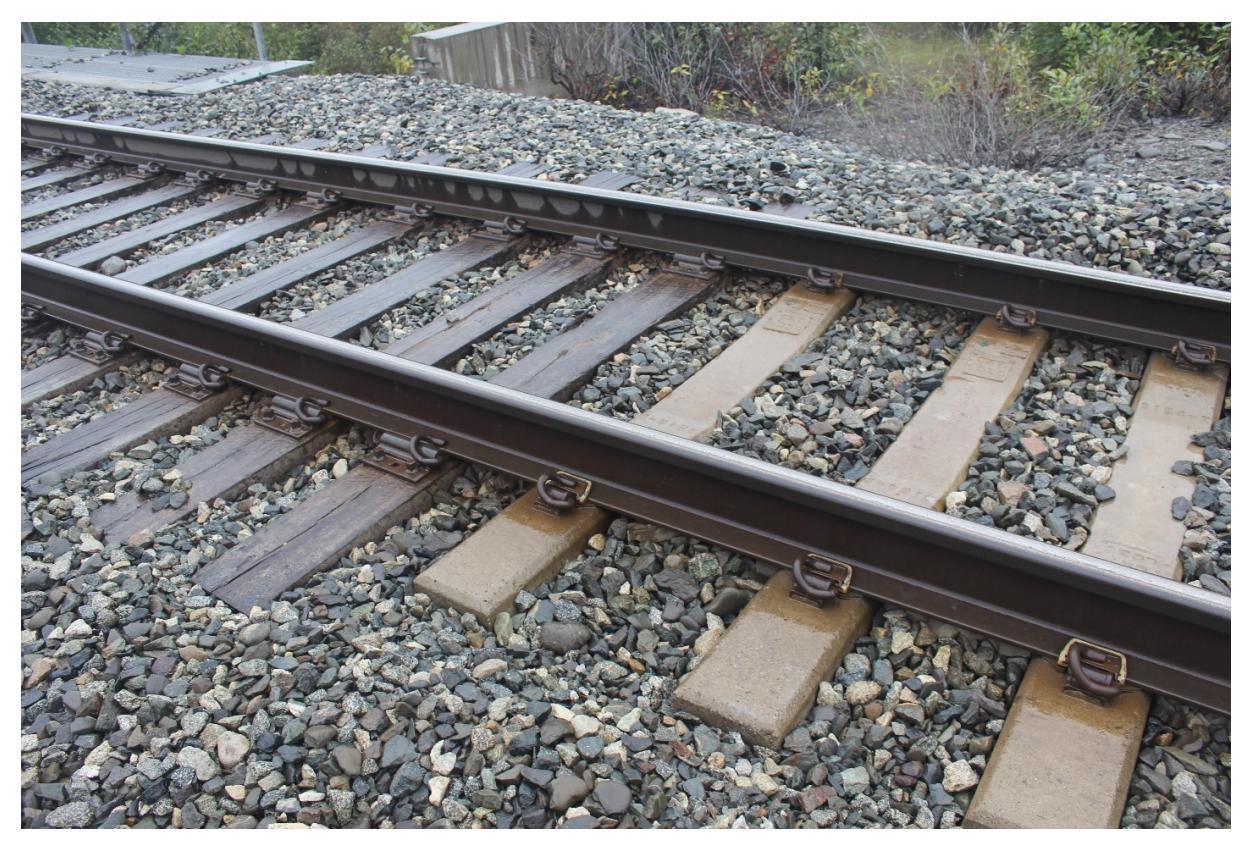
Figure A-27: Transition zone from concrete to wood ties, Bridge Approach #3

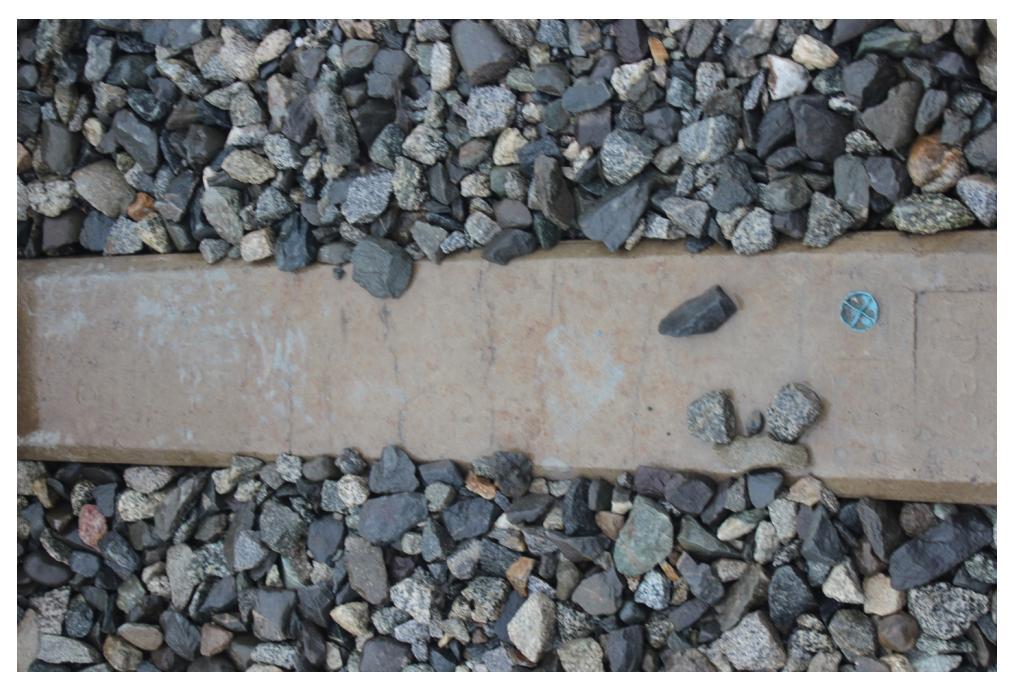
Figure A-28: Tie center cracking, Bridge Approach #3

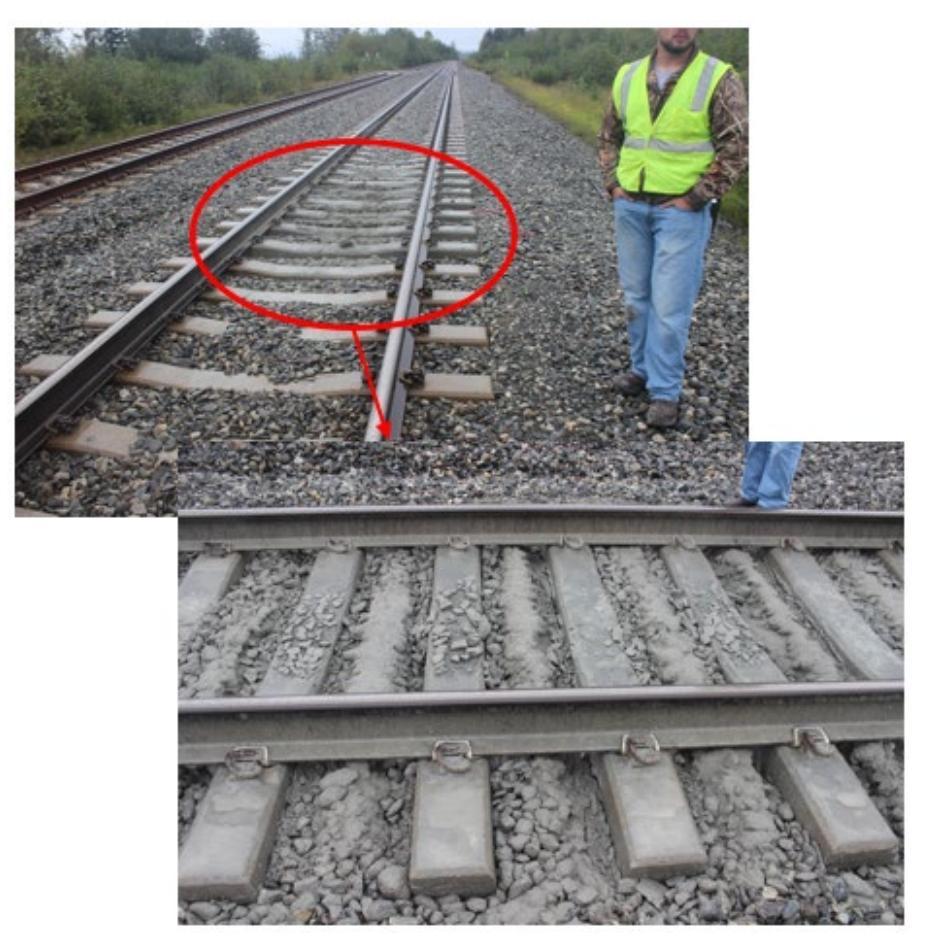
Figure A-29 shows the concrete ties with fouling and pumping present. Figure A-30 shows the gray colored fines on the site. Drainage appeared to be less than ideal in the location with ballast fouling. There was only limited drainage to the side of the track shared with another track. The area around the track showed evidence of water-loving vegetation, indicating that moisture is present much of the year. Utilities in track restrict maintenance to ballast tamping.

Figure A-29: Area with mud pumping, Bridge Approach #3

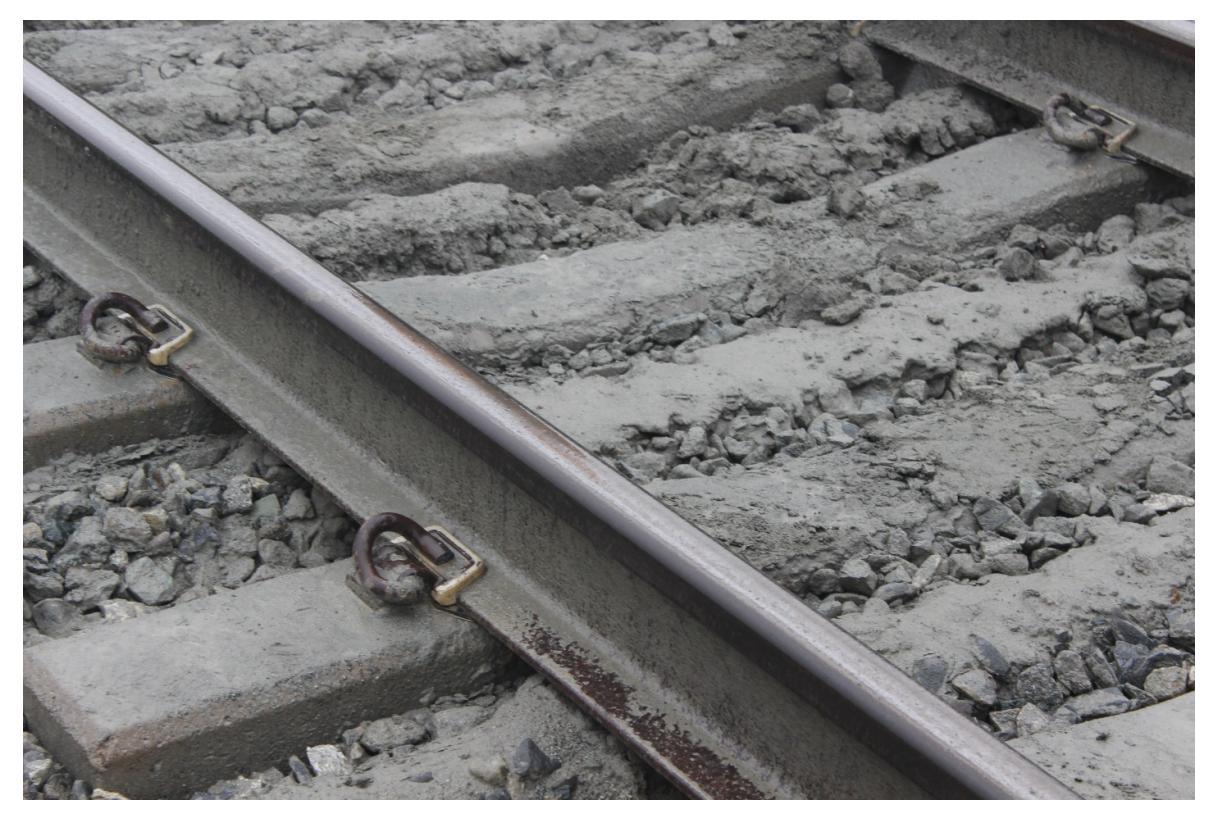
Figure A-30: Gray mud, Bridge Approach #3

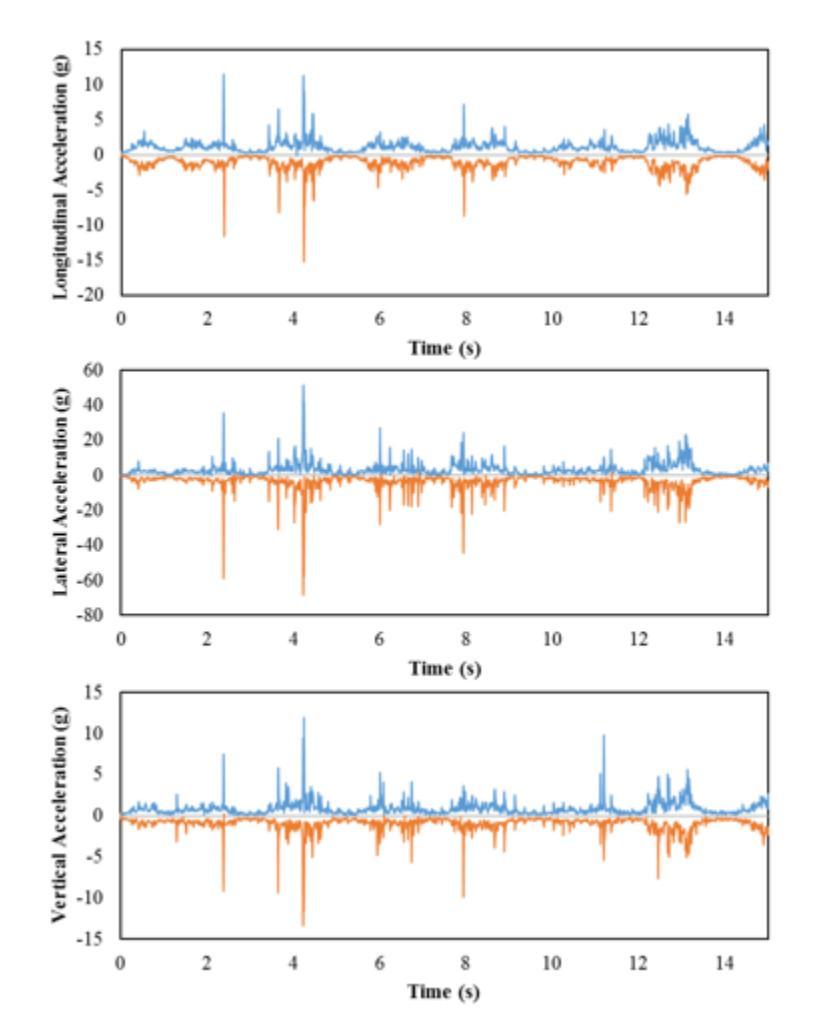
Researchers recorded tie acceleration during a train pass, Figure A-31. Video was taken of the train pass to document mud pumping and tie movement. The video shows a few ballast particles adjacent to the tie moving. Ballast movement during train passes could contribute to rubbing and wear. Figure A-32 shows the acceleration measured on the tie during train loading. The tie experienced significant vertical acceleration, indicating that there is a gap between the tie and ballast support. Tie lateral movement was higher than expected.

Figure A-32: Tie Acceleration data, Bridge Approach #3

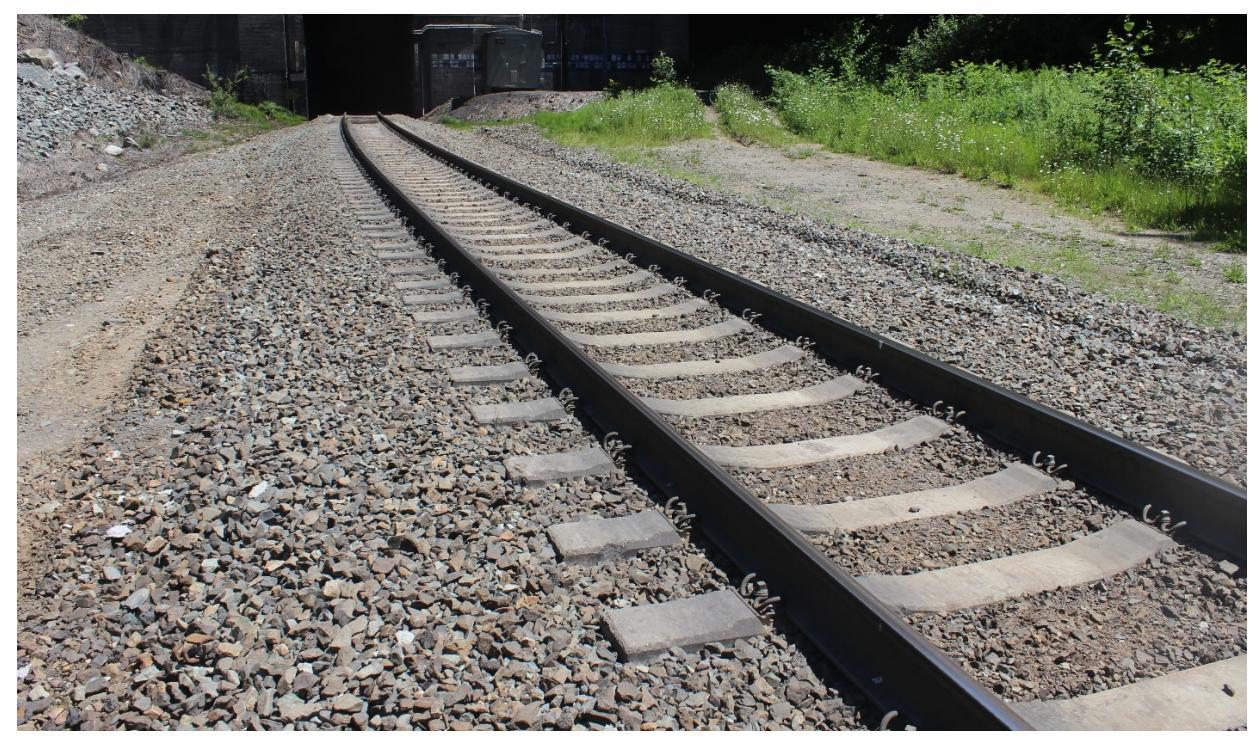
The railroad claims this site needs constant maintenance. The ties were replaced 2 years prior due to wear and deterioration. There were a few ties with center-binding cracking, and a few with longitudinal splitting cracks. The remainder of the ties near the tunnel entrance appeared to be in good shape, Figure A-34. Some ballast fouling was observed as shown in Figure A-35. The team was not allowed to access the track because of safety concerns from the short sight distance at the track tunnel. This precluded the team from taking ballast samples or measuring the tie thickness in track. Track drainage was not very good. Water was seen coming from the tunnel onto ditches on both sides of the track as shown in Figure A-36. The water on south side of tunnel was seen to go through the track to the ditch in the north side of the track. It is likely that the water movement through the track contributed to the track maintenance issues.

Figure A-34: Ties at tunnel approach

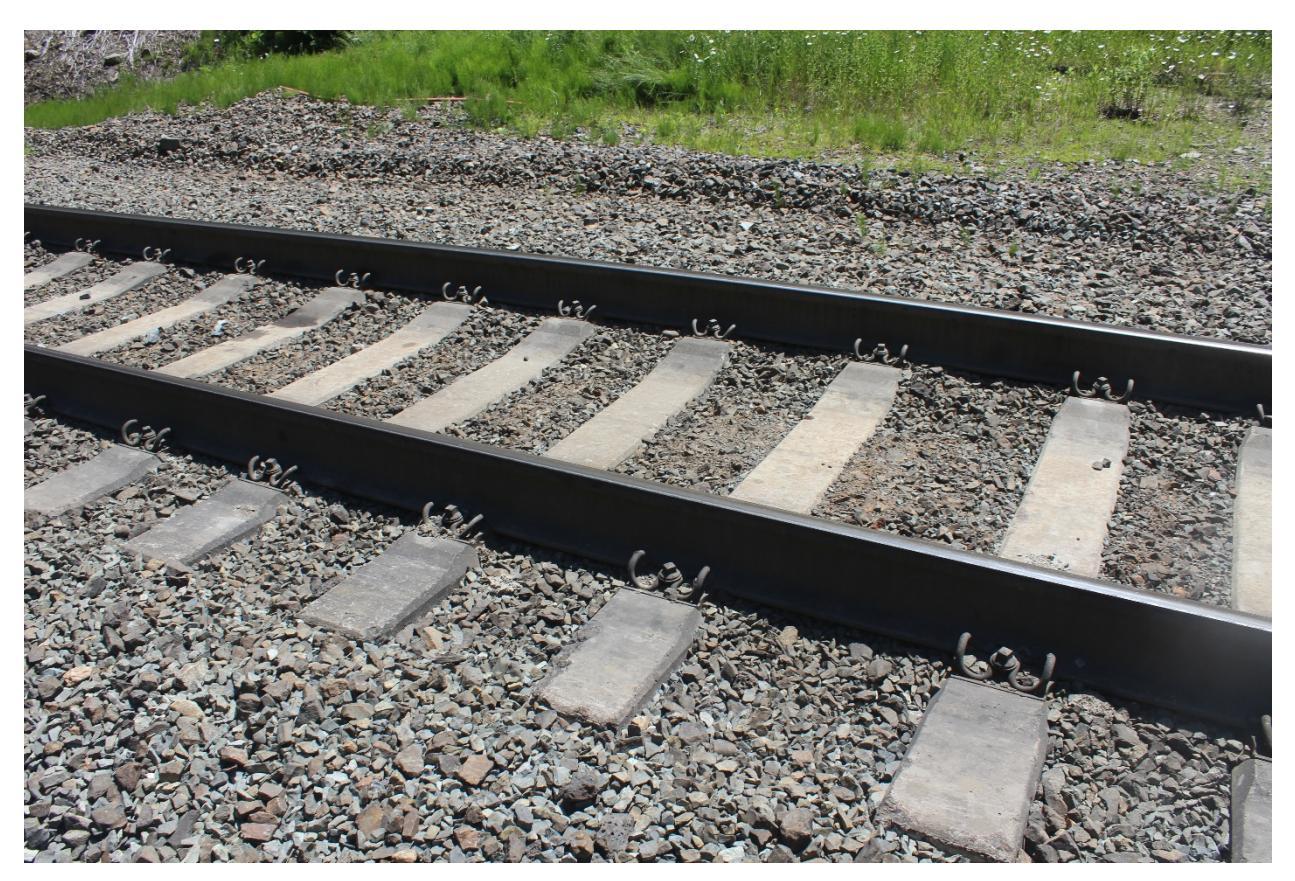
Figure A-35: Ballast fouling in track, tunnel approach

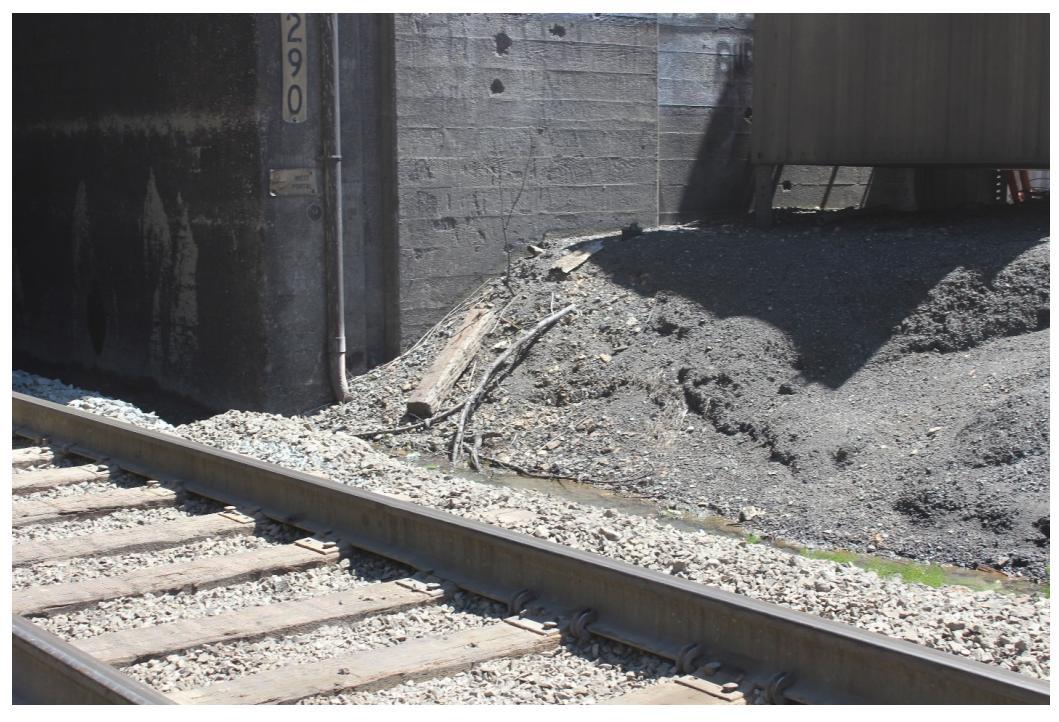
Figure A-36: Water from tunnel in ditch, tunnel approach

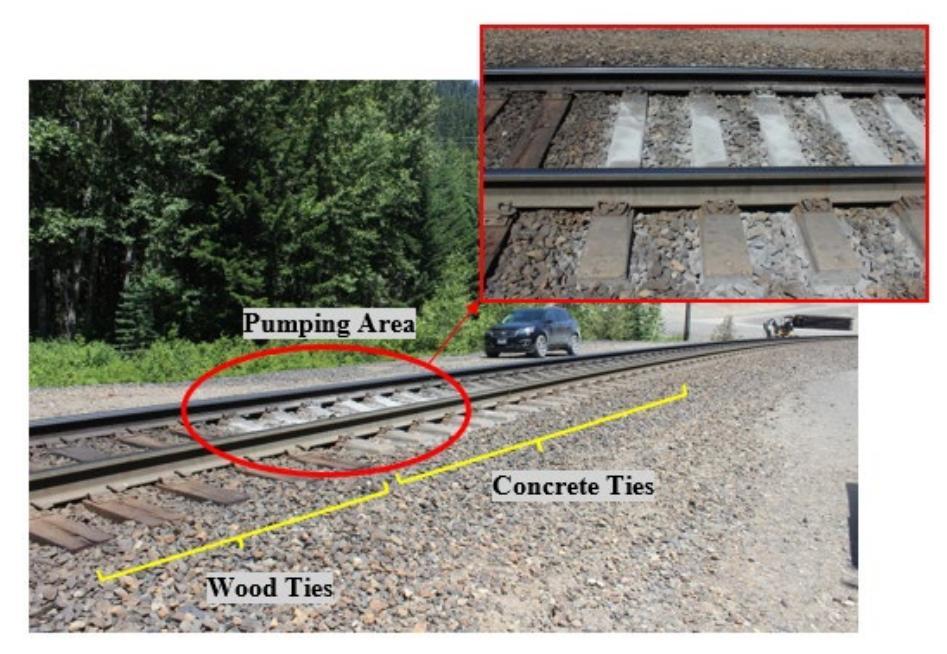
The tunnel east portal appeared to be in good shape except for the transition between wood and concrete ties. There was no standing water in ditches or signs of water in track, but the research team did not have access to the track to document moisture conditions with depth in the ballast. Given the high amounts of precipitation and lush vegetation in the area, it is very possible that moisture was present in the track structure. Ballast churn was evident from the gray fines present on the top of the ballast shown in Figure A-37.

Figure A-37: Ballast churn and center-binding cracking seen at wood-concrete tie transition area, tunnel approach
A.7.2 Track measurements

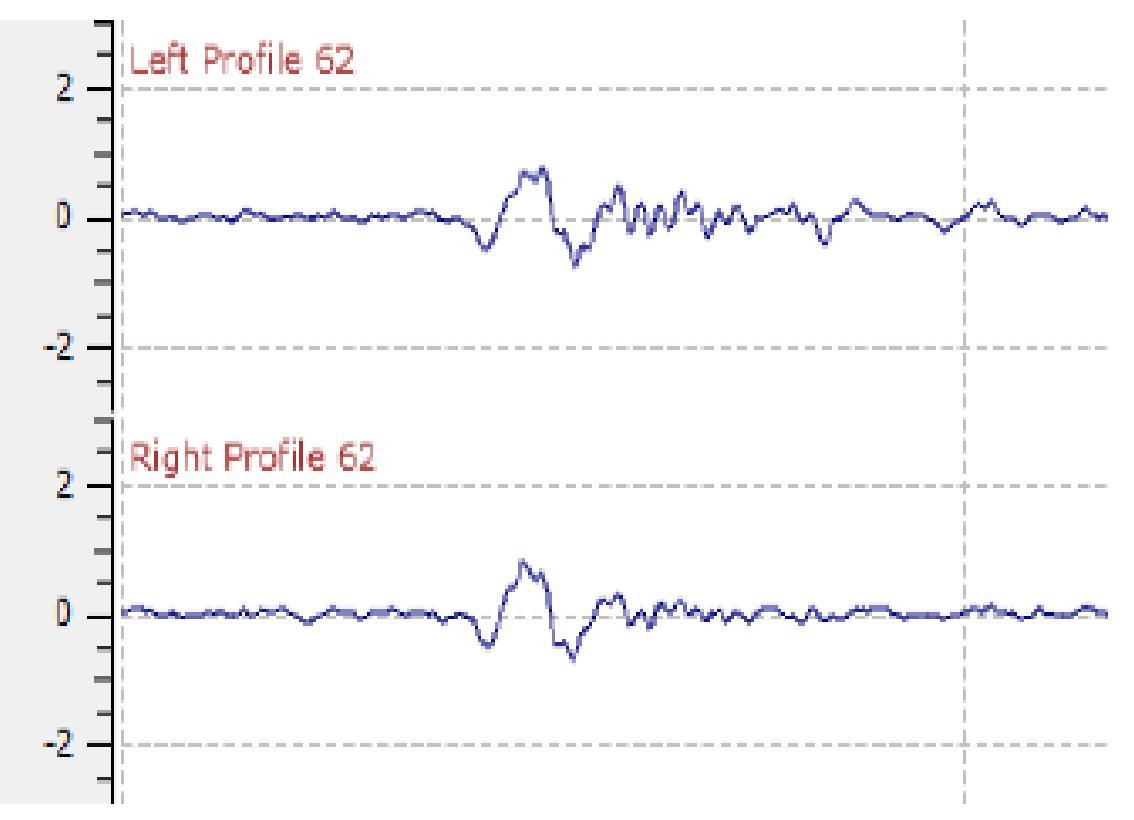
The ATIP geometry car visited the tunnel approach approximately 8 months before the research team. A small variation in profile was seen before the tunnel entrance, as shown in Figure A-38. The track profile variation was likely small because the ties were only 2 years old. Based on the track condition and the presence of a wood-to-concrete tie transition, the profile will likely grow with time.

Figure A-38: ATIP track profile measurements, tunnel approach

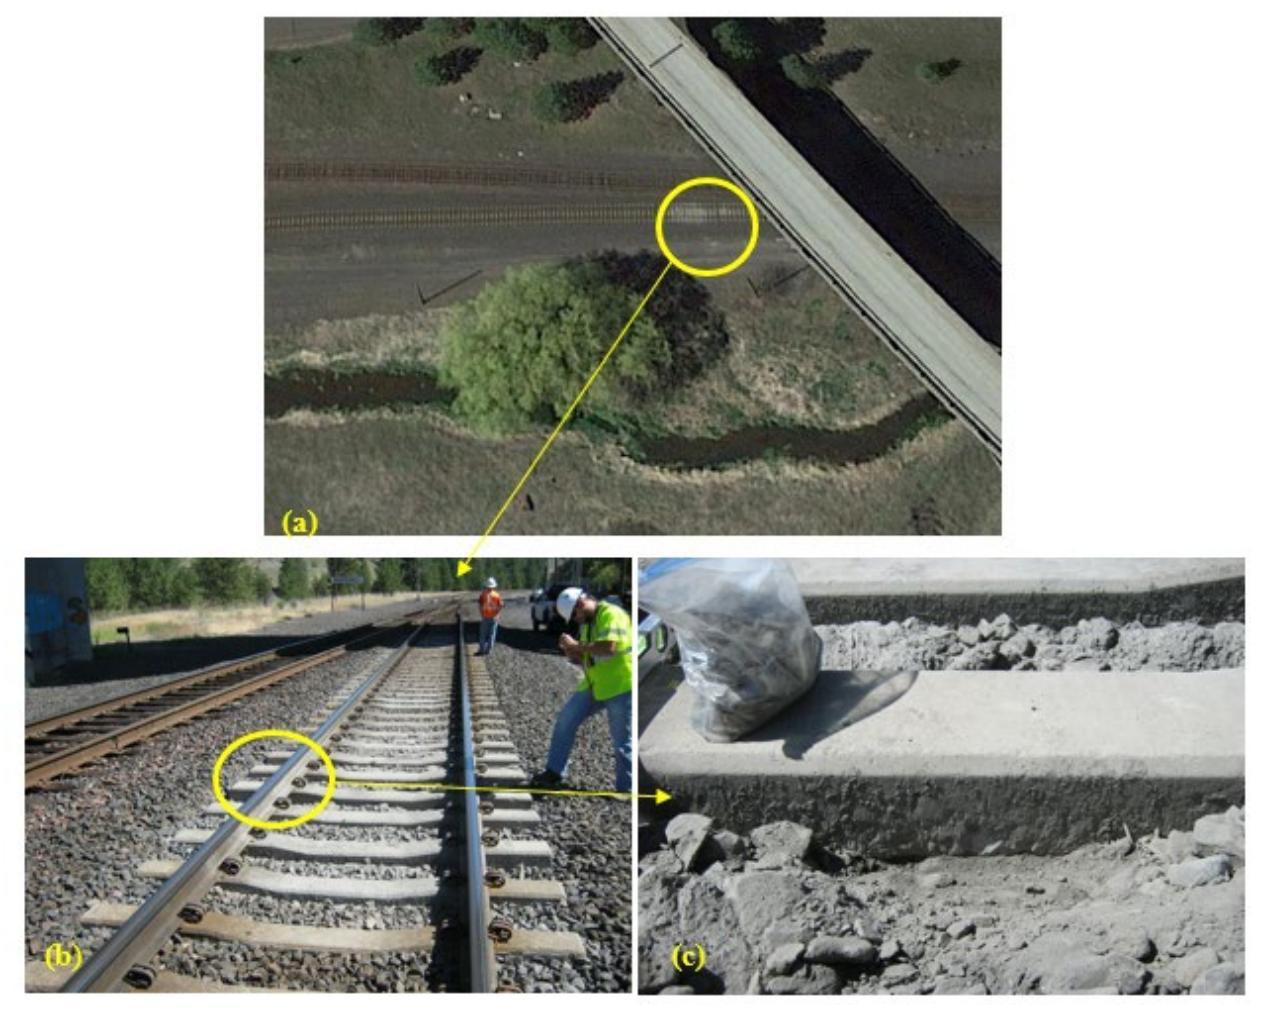
Figure B-1: Pumping area after a wood tie-to-concrete tie transition, Switch #1

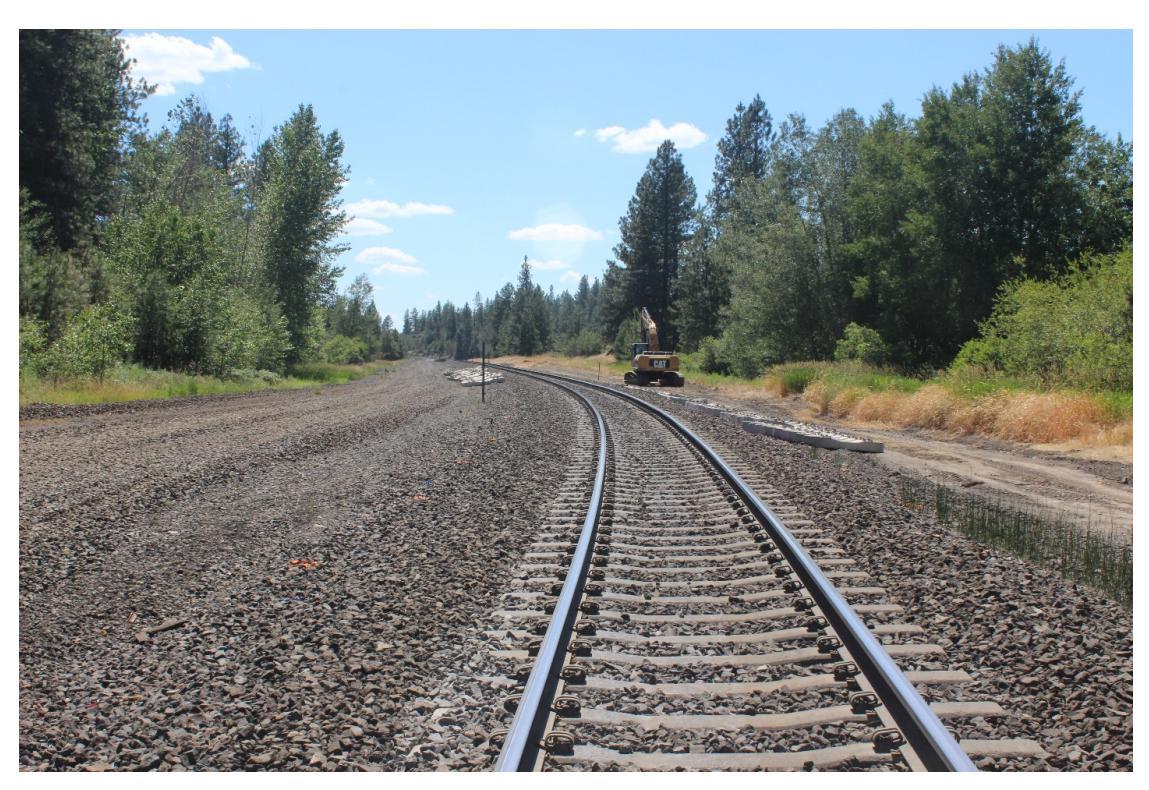
Figure B-8: Green grass growing on the edge the track, Signal #1

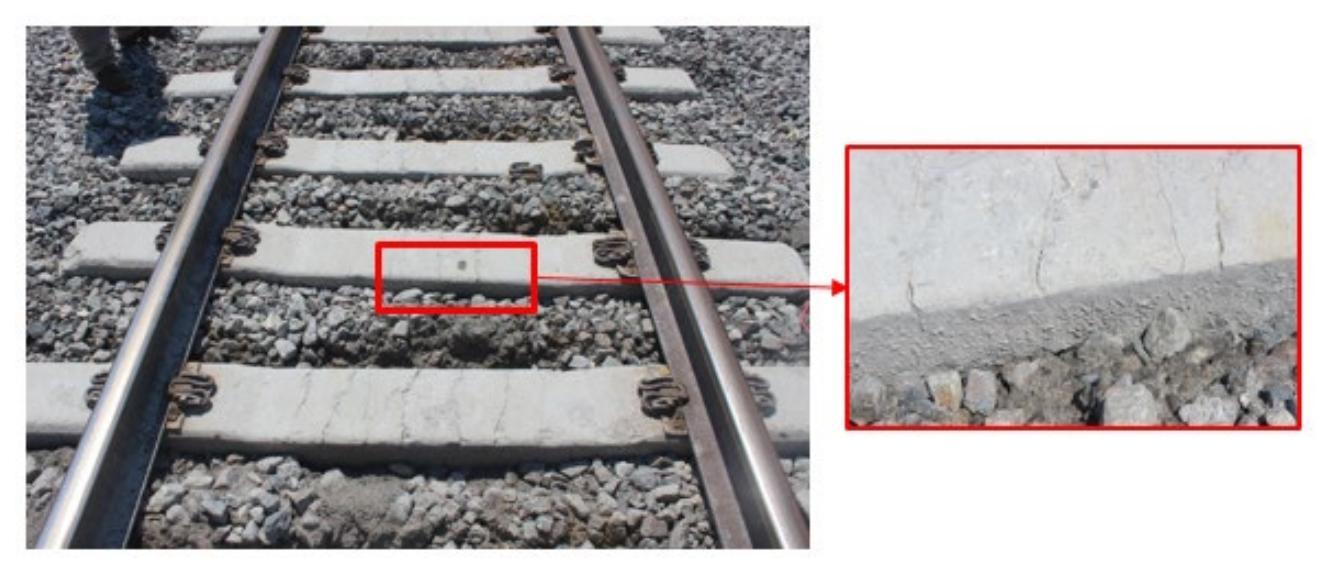
The railroad made repairs at this site. Six wooden ties replaced concrete ties due to fouling damage. Once mud is present in the site, the mud spot spreads quickly. The mud spot had already returned to the track when the research team visited the site. Most of the ties at the location had center binding cracking as shown in Figure B-12.

Figure B-12: Center binding cracking in the ties, Signal #2

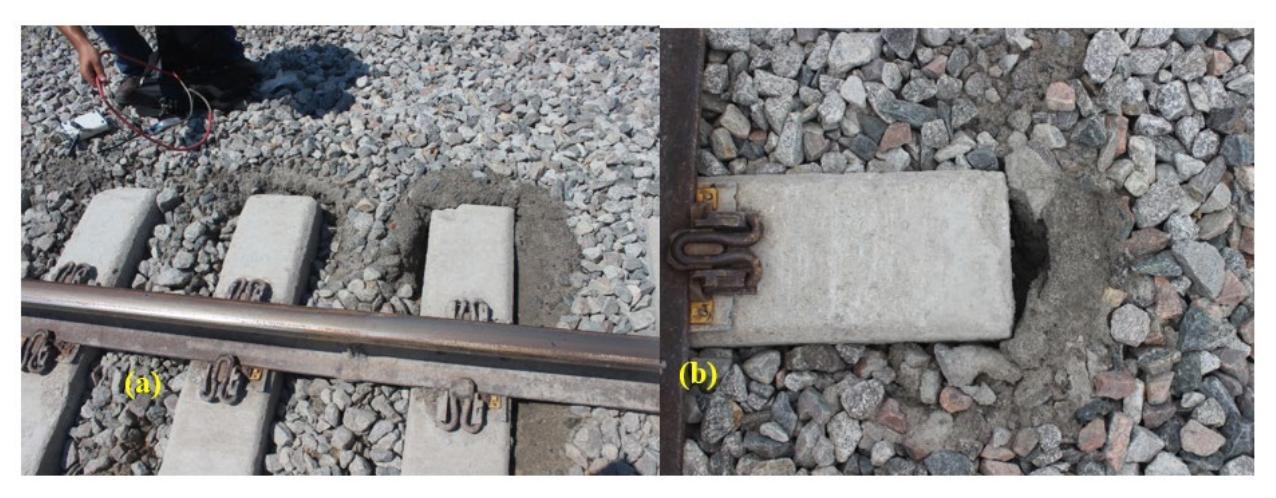
Figure B-14 show evidence of mud pumping and lateral tie movement. Fines migrating to the sides of the track provide evidence of ballast fouling and poor drainage, see Figure B-15.

Figure B-14: Pumping and lateral movement on the end of the ties, Signal #2

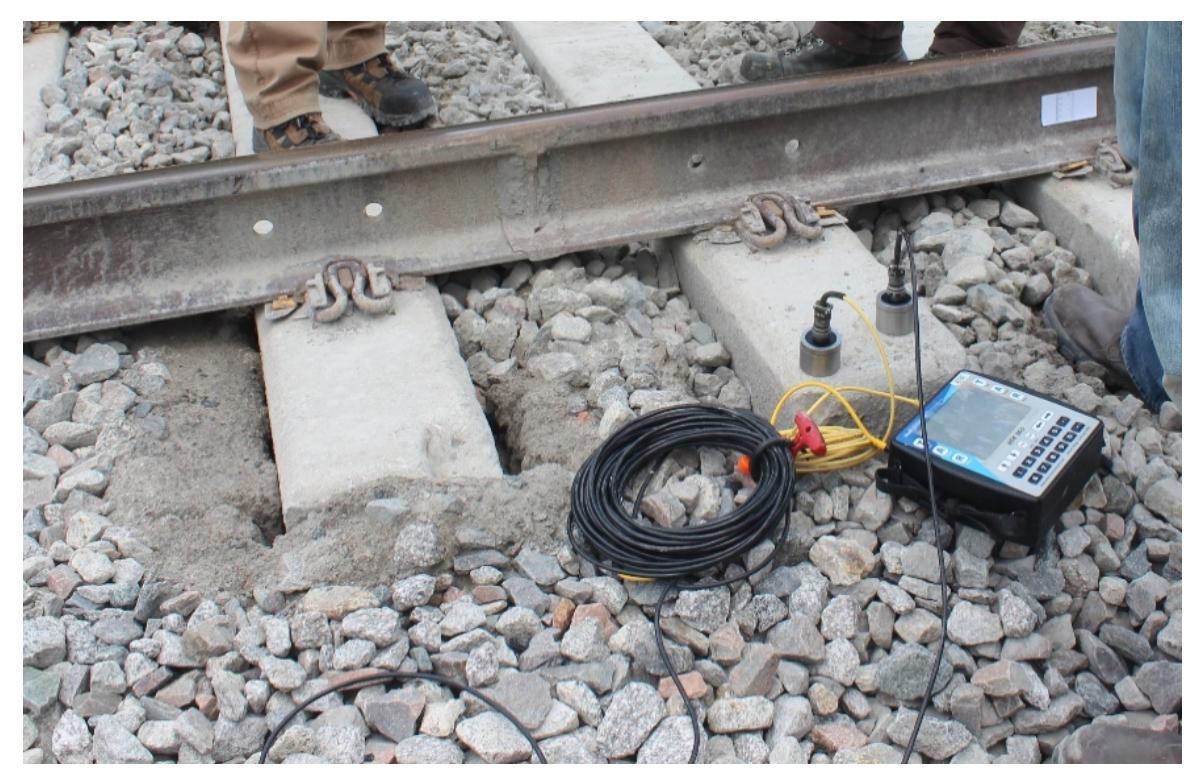
Distance (in)	UPV Reading (ft/s)
Same shoulder	5	5,125
Shoulder to center	53	4,282
Shoulder to shoulder	89	1,732

Figure B-17: UPV readings from the same shoulder

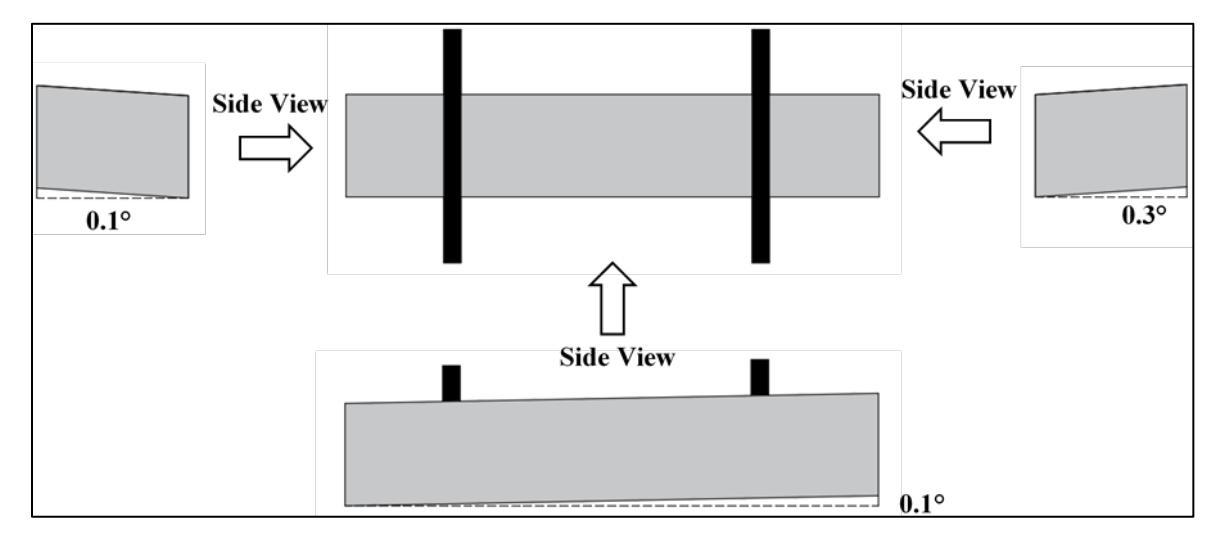
Figure B-18: Superelevation of the concrete tie and rail slope using digital level, Signal #2

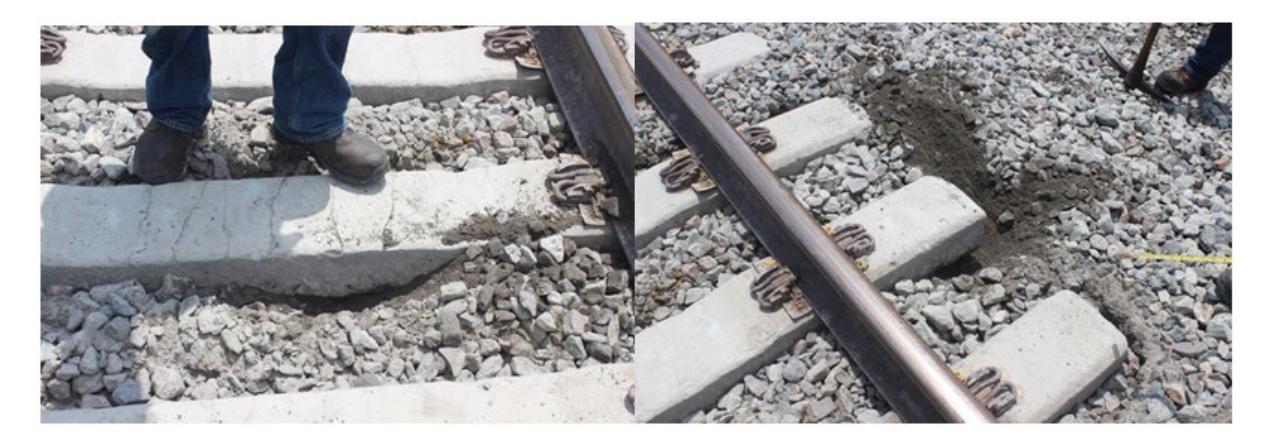
Researchers collected four ballast and subgrade samples from the site, as shown in Figure B-21. Ballast samples were taken in the ballast at the depth of the bottom of the tie. Table B-7 shows the ballast analysis. The results showed that concrete material in the ballast was smaller than 10 mm, indicating that the concrete material was abraded away instead of being taken off by impact.

Figure B-21: Samples collected from ballast, Signal #2

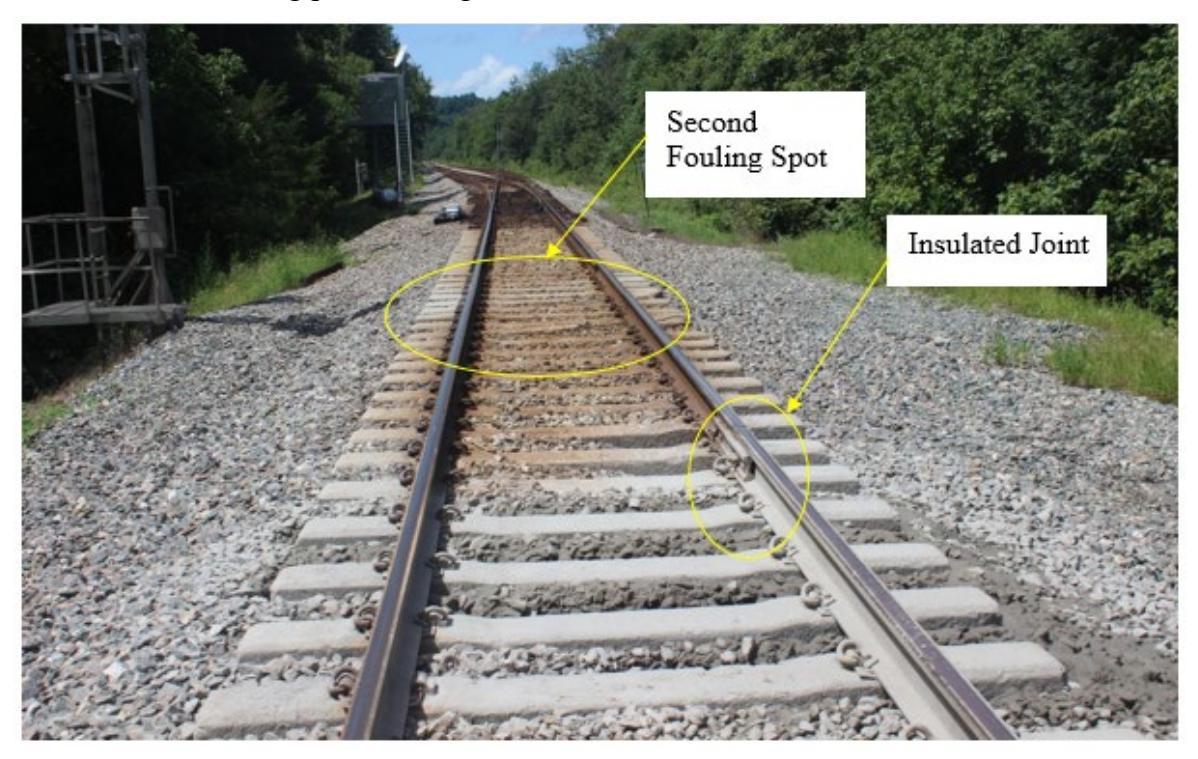
Train dynamics are influenced by the switch, the transition from wood-to-concrete ties, and an insulated joint at this location. Gray mud was fouling the ballast, Figure B-23. Significant mud pumping can be seen in Figure B-24. Fouling was present around nine ties in the primary mud pumping location. A second spot with minor amounts of fouling can also be seen in Figure B-24. A train that experiences vertical acceleration as it passes over an insulated joint would be expected to experience harmonics that increase wheel loads along the track. Vegetation was seen in the ballast-area of track as shown in Figure B-25. This is indicative of persistent water in the track structure, indicating poor drainage.

Figure B-23: Pumping next to the switch, Signal #3

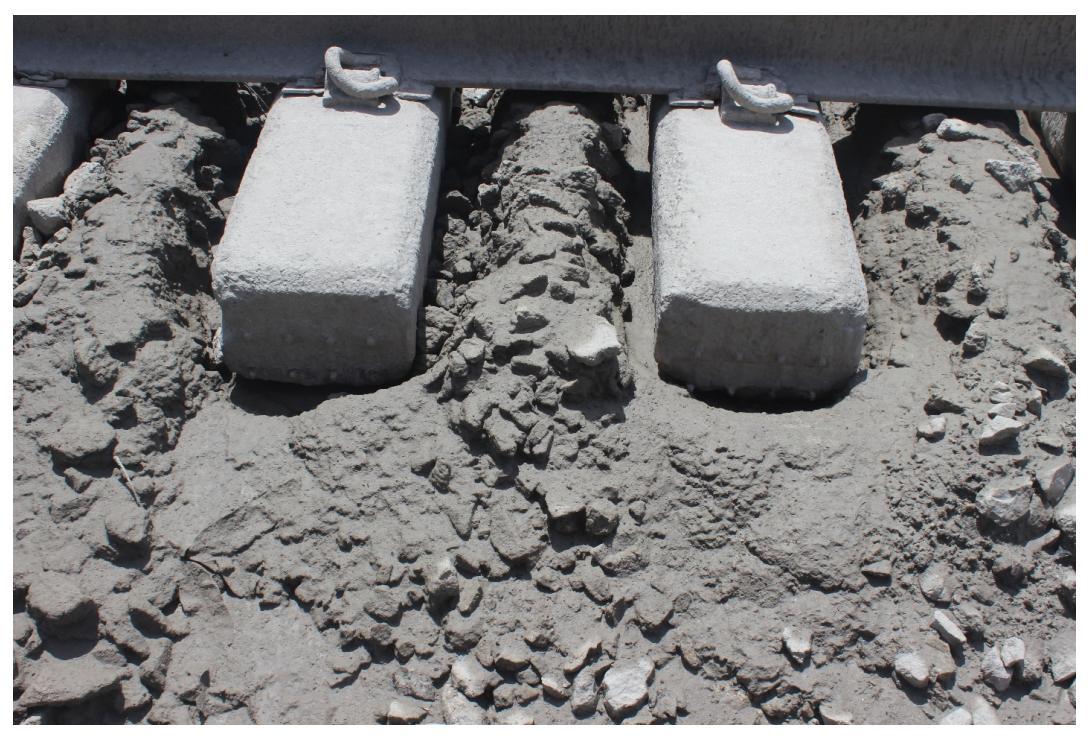
Figure B-24: Mud pumping, Signal #3
