Federal Railroad Administration

DOT/FRA/ORD-19/38

Final Report October 2019

1. AGENCY USE ONLY (Leave blank)		2. REPORT DATE 3 October 2019		3. REPOR	3. REPORT TYPE AND DATES COVERED Technical Report April 2016 – August 2017	
4. TITLE AND SUBTITLE A Study of Environmental and Track Factors that Contribute to Abrasion Damage of Concrete Ties					5. FUNDING NUMBERS DTFR53-16-C-00009

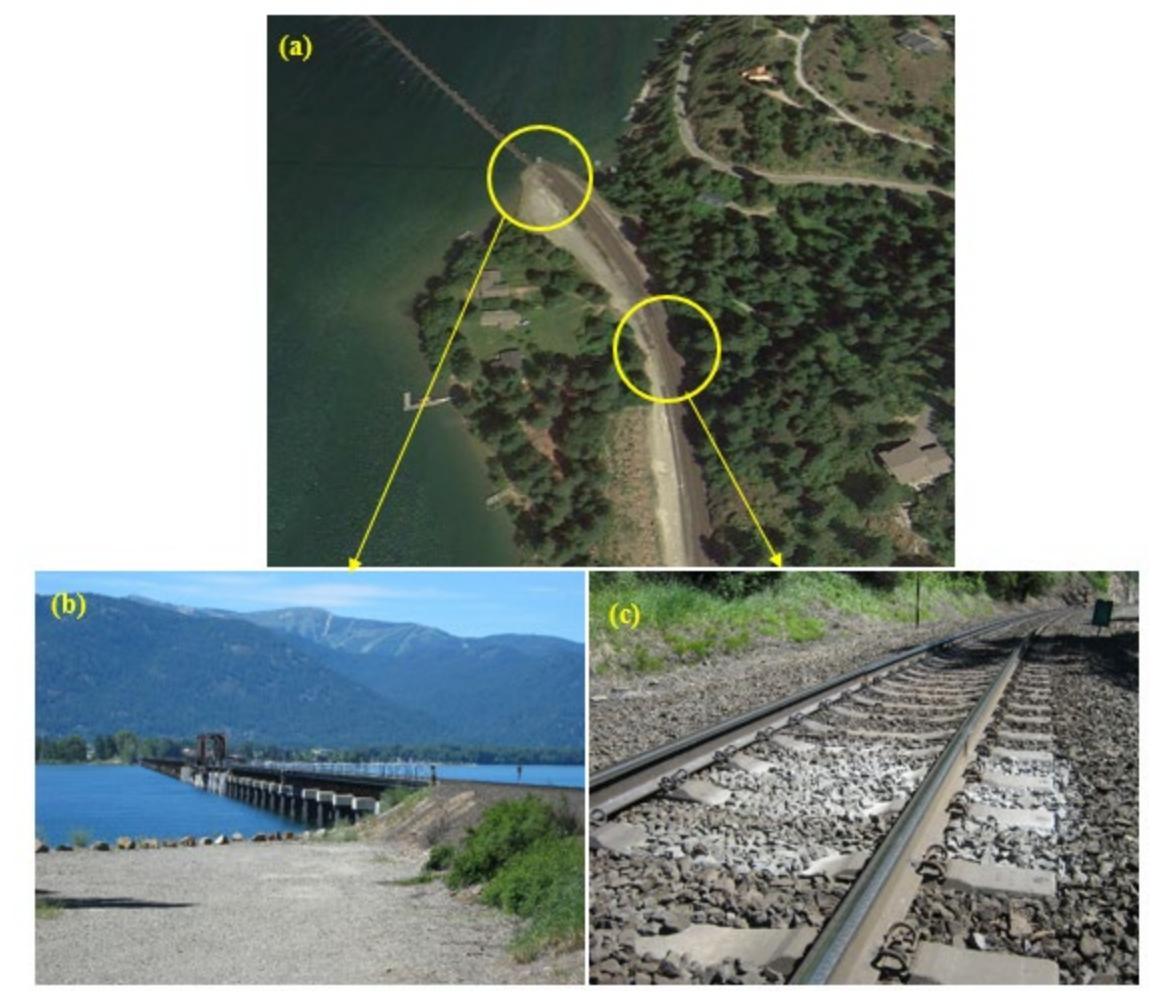
Figure C-1: Satellite view from Google Earth (a), photograph of inspected bridge (b) and (c) small area with ballast churn and fouling, Crossing #1

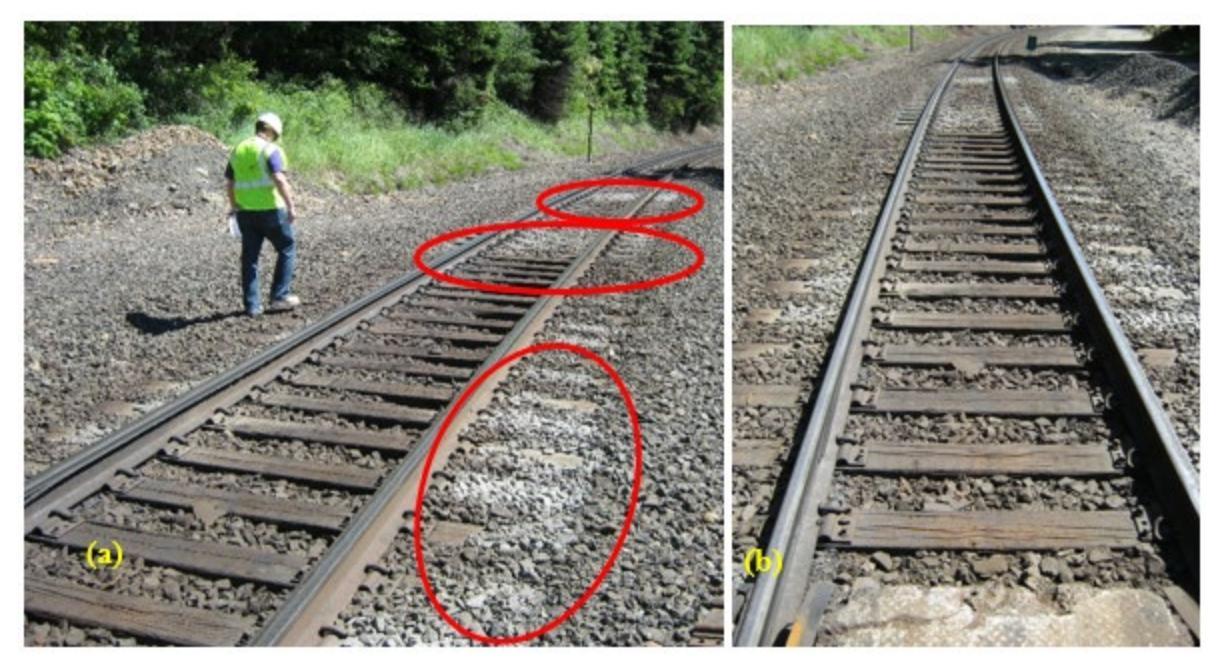
The concrete ties were relatively new and in good condition. There was a concrete road crossing in track, with 16 wood ties before and 19 wood ties located after the crossing, as shown in Figure C-2. The first tie after the wood transition had mild center-binding cracking.

There were periodic areas of ballast churn and breakdown. These spots are highlighted in Figure C-2 and shown from the reverse angle in Figure C-3. Rail welds were seen at the location of ballast churn, indicating possible previous surfacing issues that led to rail damage. A little more ballast churn was seen on the low rail side of the track. Ballast was removed in the churned area to inspect ballast condition with depth. Ballast fouling and organic matter were seen at the bottom of tie. There were signs of early abrasion wear on the sides of the tie at the ballast level as shown in Figure C-4, but no significant section loss. A discarded tie adjacent to the track showed the potential for tie abrasion damage in this track location, see Figure C-5. This curve had significant abrasion wear before new ties were installed. Railroad officials stated that tamping and ballast maintenance was performed, but no undercutting.

Figure C-2: Replaced concrete ties with wooden ties, Crossing #1

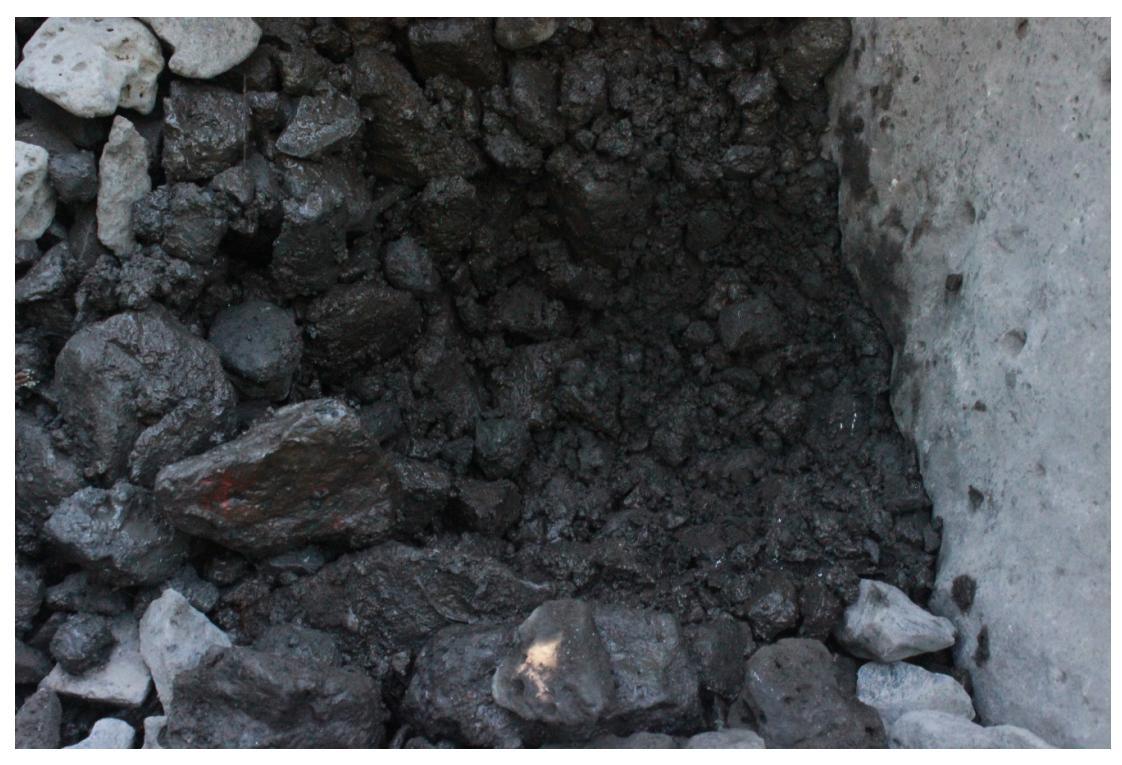
Figure C-4: Ballast fouling and beginning of concrete tie wear, Crossing #1

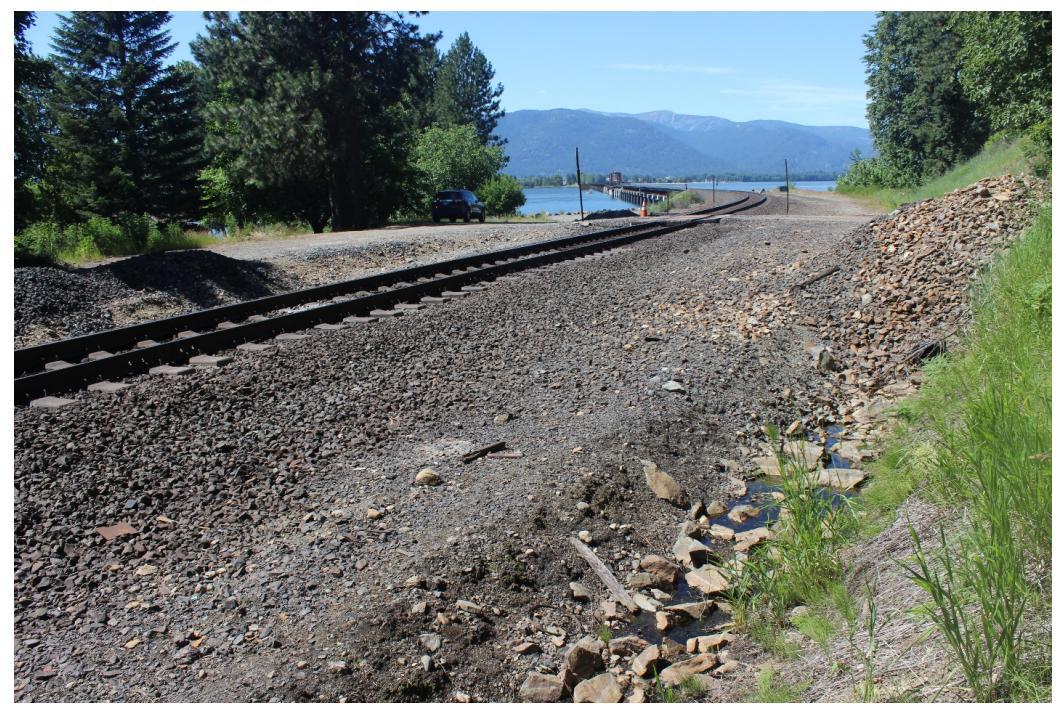
Water was present in this section of track, as evidenced by the moist ballast a few inches below the track surface and by standing water in the ditch, Figure C-6. The nearby vegetation indicates significant water availability. Some sections of track also had issues with grading because of hillside slope conditions, as shown in Figure C-7.

Figure C-6: Standing water and vegetation in ditch, Crossing #1

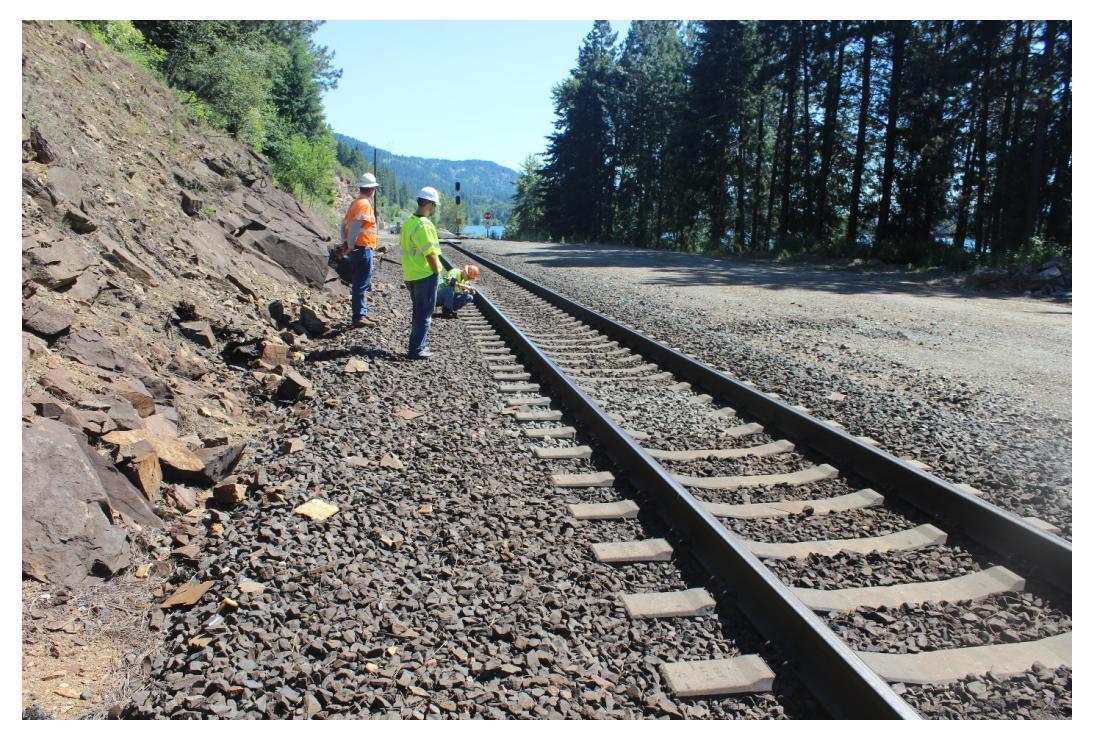
Figure C-7: Grading issues seen in some locations, Crossing #1

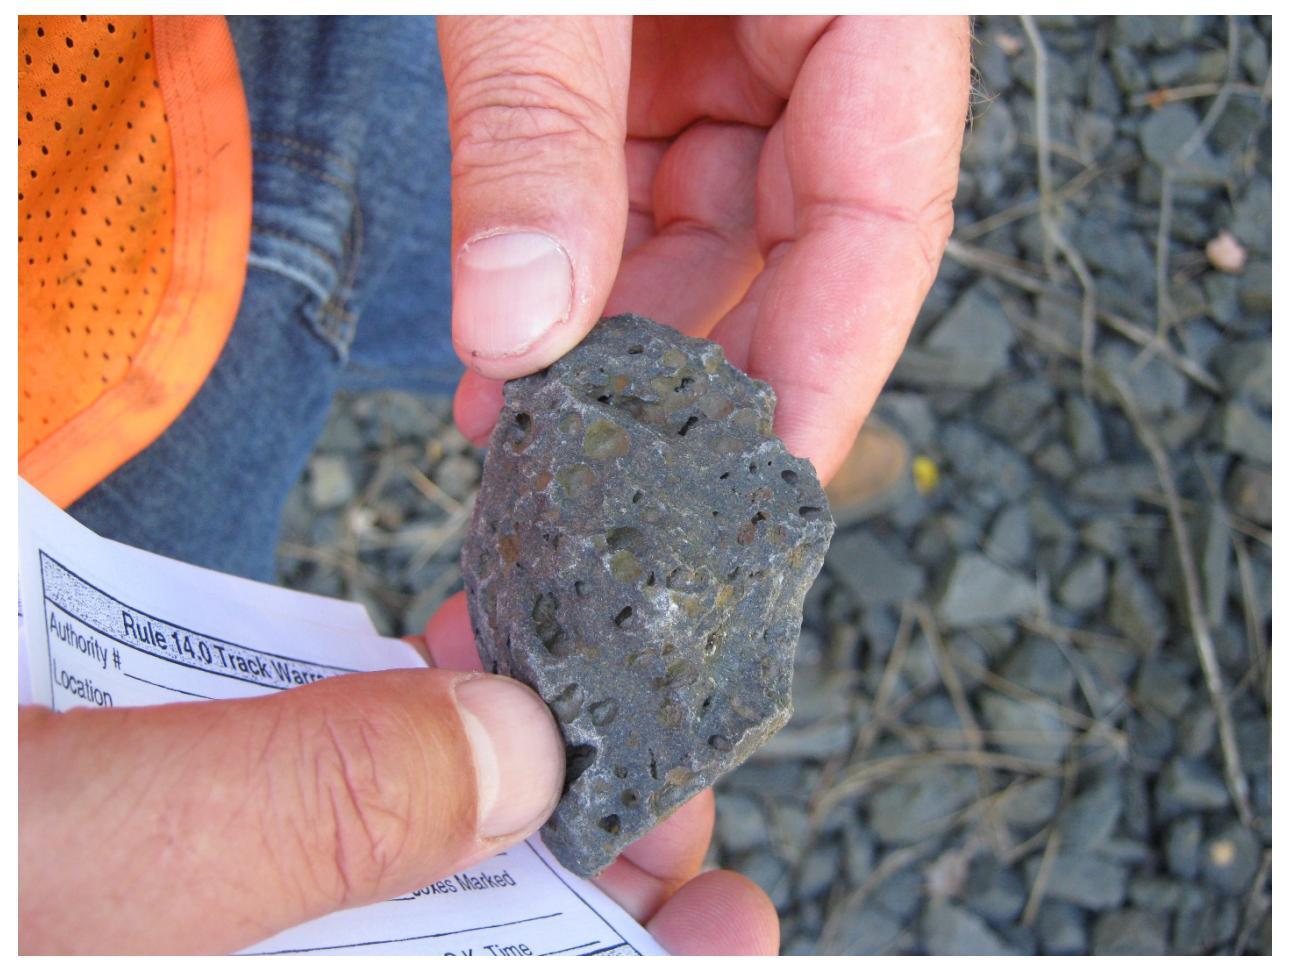
Two ballast and subgrade samples were collected. Although the aggregate is a good, hard basalt, it is also vesicular, as shown in Figure C-8. It is unknown what effect the vesicular nature of the ballast played in ballast fouling and concrete wear. Ballast samples were taken at the depth of the bottom of the tie. Table C-1 contains the ballast analysis results. The ballast sample did not show evidence of concrete fines, likely because of track maintenance activities and relatively new ties used. This could indicate that ballast breakdown occurs before concrete bottom tie abrasion at this location.

Figure C-8: Close-up picture of vesicular basalt ballast, Crossing #1

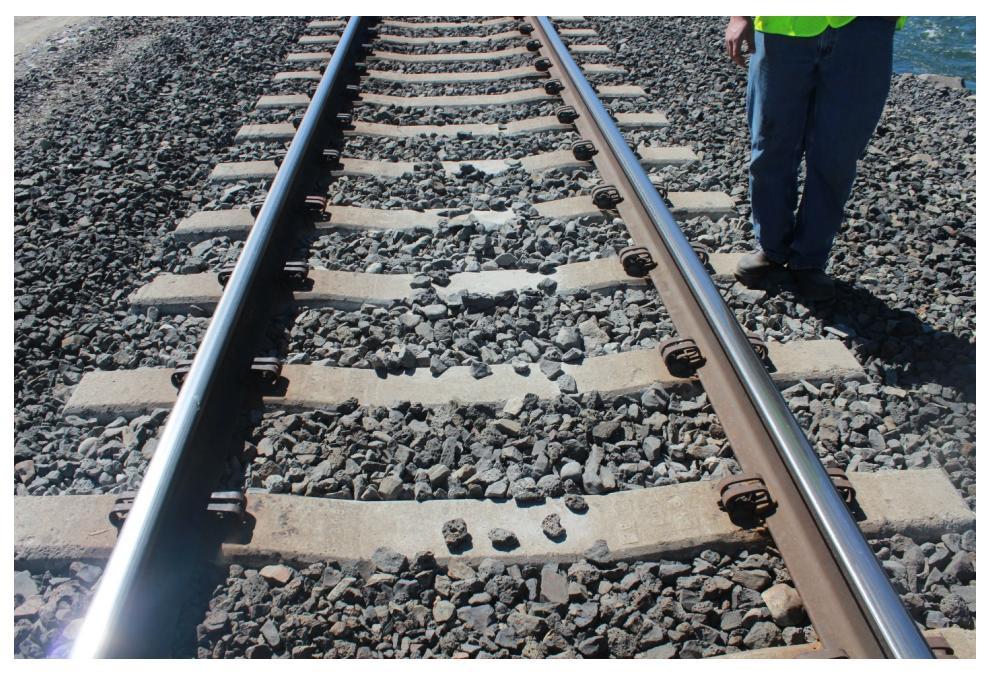
The ties were in good condition near the switch. Only three ties with minor center-binding cracking were seen in a few hundred yards of track and no abrasion damage was seen on the bottom or sides. The ballast appeared to be in good shape overall with only one spot with a little gray dust from ballast churn as shown in Figure C-10. A track-level view of the switch is seen in Figure C-11. The drainage was good with built up embankments. There were no water or damp spots in track at the bottom of ties.

Figure C-10: Minor gray dusting of ballast particles, Crossing #2

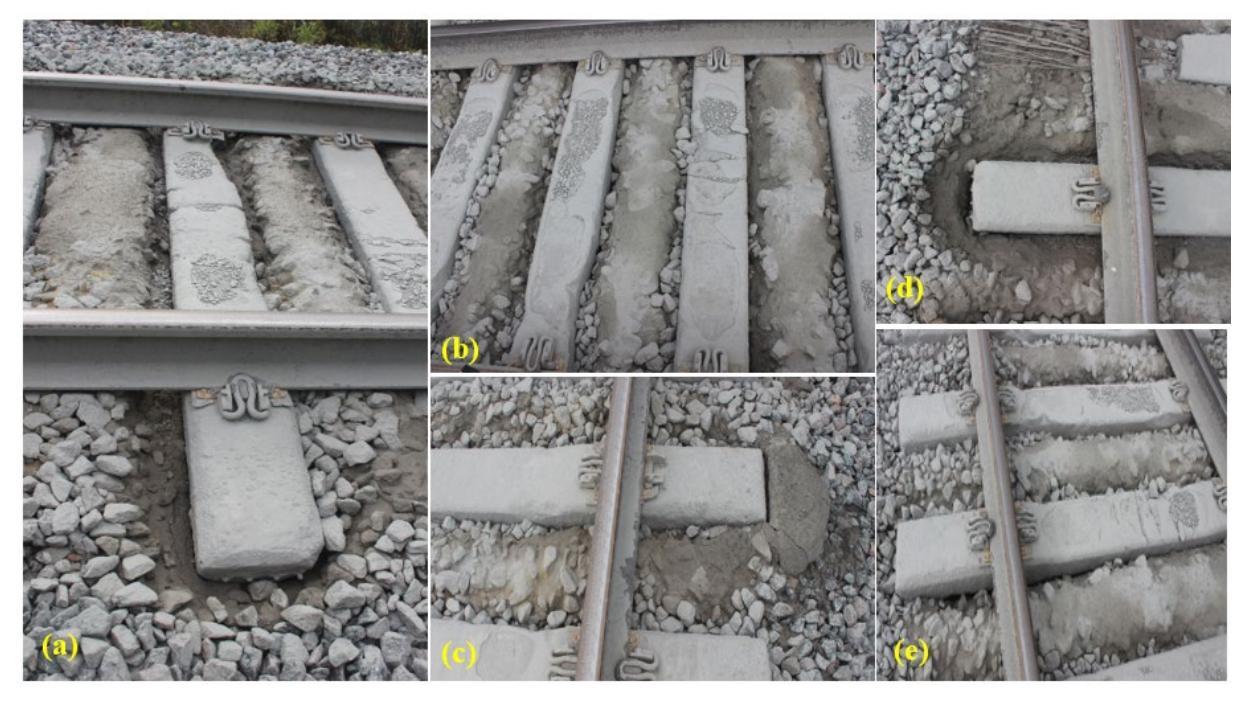
The railroad reported that some spot undercutting in problem areas was performed 5–6 years ago, with additional undercutting 3-4 years ago. Ballast fouling returned after each maintenance activity. Per the road master, the fouling occurs under the track surface and spreads farther than can be seen at the surface. Ballast fouling and pumping was seen at periodic intervals, as shown in Figure 3-7. The fouled ballast spots were near a crossing and appeared to follow vertical dynamic harmonics of the train on either side of the crossing. Many additional spots were noticed in both directions that were similar in nature to the ones investigated. The road master commented that the track contained many similar spots similar for several miles in each direction. Water was seen ponding in the side of the track near the fouled ballast as shown in Figure 3-7 indicating drainage problems in track. Standing water and plants were seen in and around the ditch, indicating a source of water present near the track. Figure C-13 shows several examples of ties in fouled ballast on site. Figure C-14 shows ties that were damaged at the track locations with pumping. Wear seen was non-uniform across the length of the tie however. Severe center-binding cracking was present in many ties. Damage was seen on the top surface of ties from a broken axle that was dragged by the train for several miles about 10 years prior, Figure C-15. This damage was separate from the center-binding cracking and did not appear to affect the tie abrasion performance. Figure C-16 shows shattered ties that may have resulted from centerbinding cracking.

Figure C-13: Severe pumping that led to section loss, Crossing #3

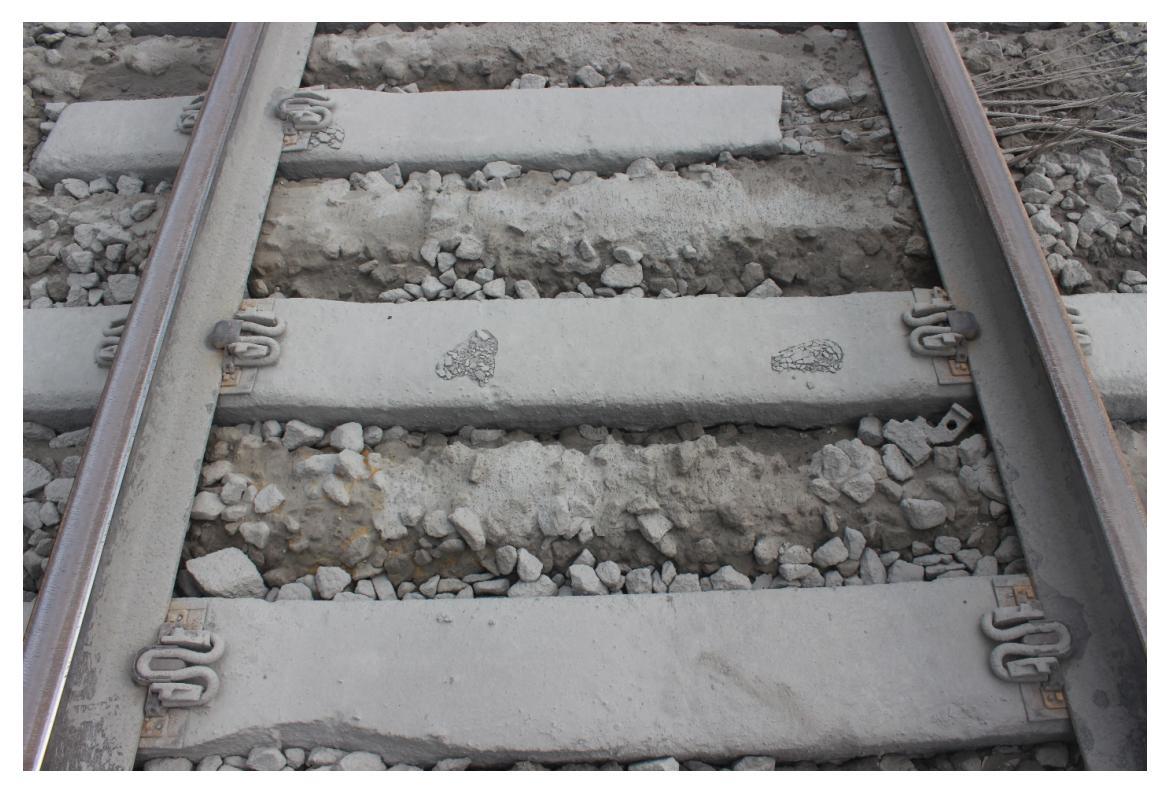
Figure C-14: Ties at locations with mud pumping with severe damage, Crossing #3

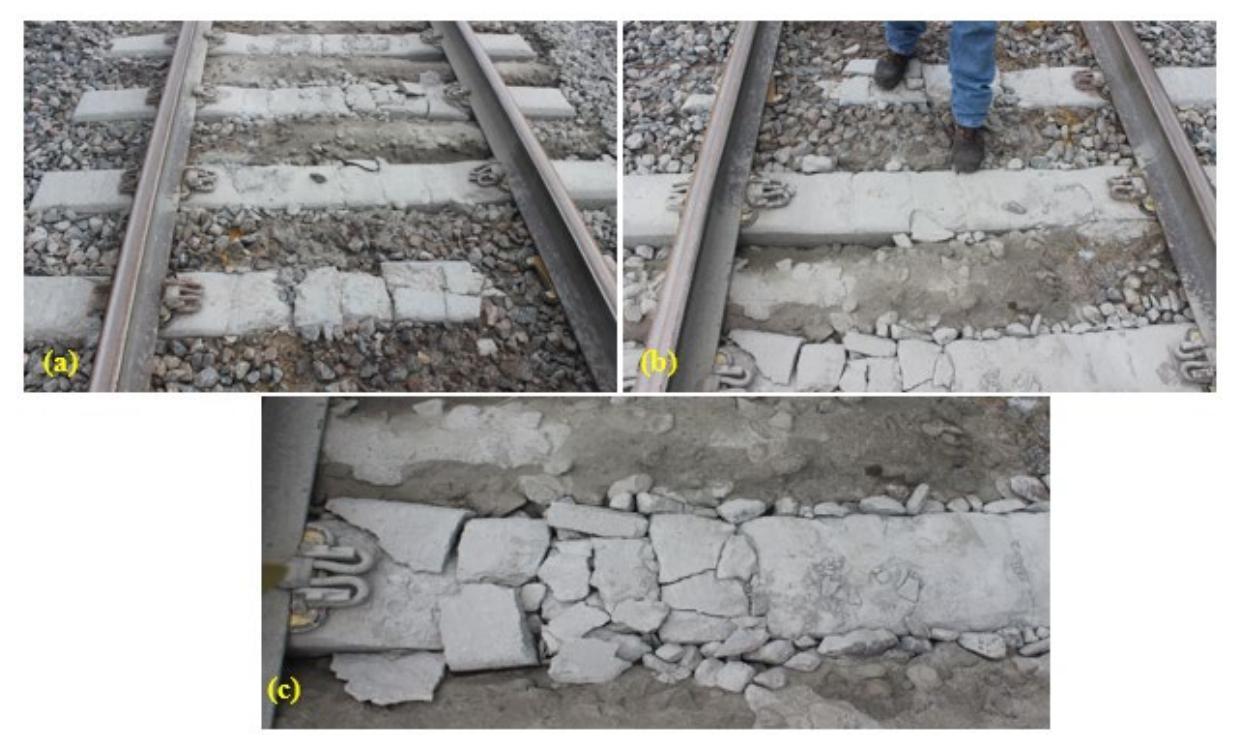
Figure C-16: Shattered ties that began as center-binding cracks, Crossing #3

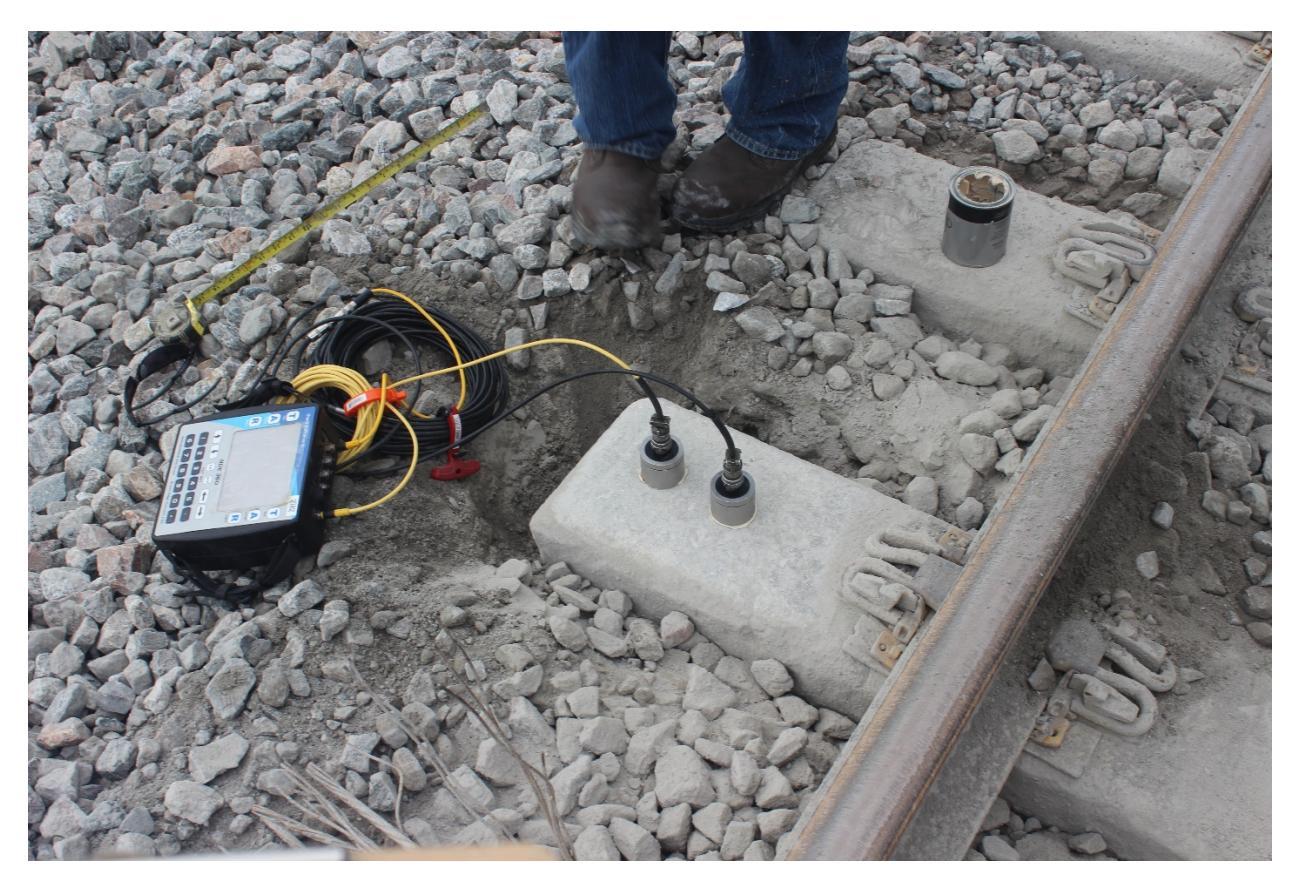
Figure C-18 shows the UPV setup. Table C-4 shows the UPV reading from the same shoulder on the site. UPV measurements show that the UPV readings for center-to-shoulder and shoulder-to-shoulder measurements were lower than the one for the same shoulder because the center-binding cracks reduced the wave propagation speed through the concrete tie.

Figure C-18: UPV measurement setup, Crossing #3

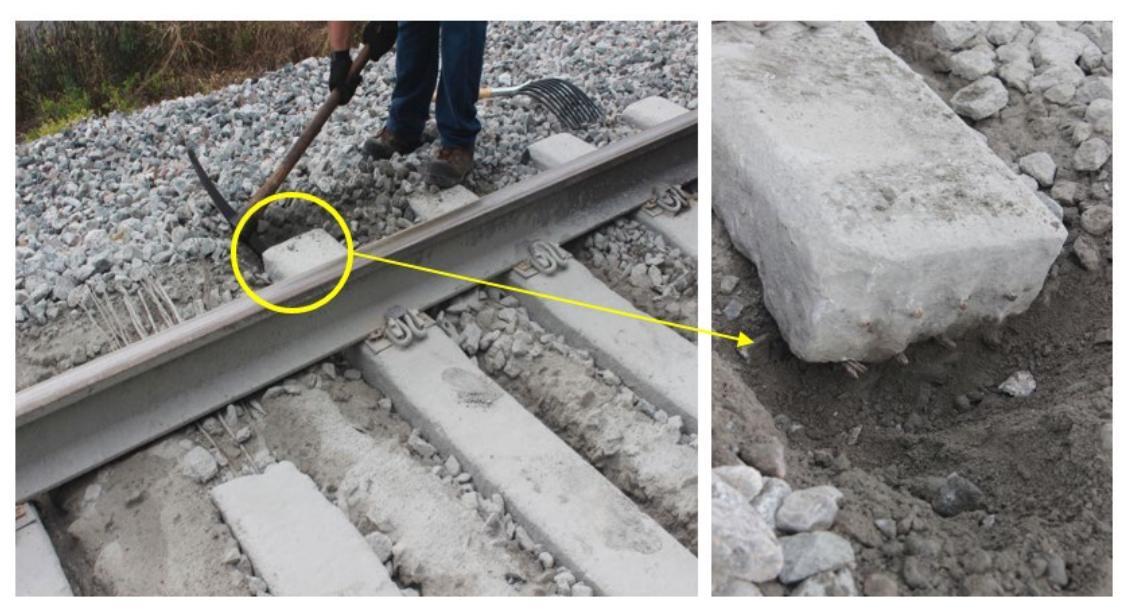
Ballast samples were taken from area around the bottom of the tie. These ballast samples were gray in color, see Figure C-19. The gray color indicates the presence of cement particles from abraded concrete ties. Hydration of the unhydrated cement particles made the ballast stiff and it was difficult to dig through the ballast layer. The ballast sample was composed of granitoid/gneiss rocks and large amounts of fines. The fines reacted strongly with HCl, suggesting that a large percentage of the fines were ground-up concrete particles that came from the tie abrasion.

Figure C-19: Samples taken from subgrade and ballast, Crossing #3

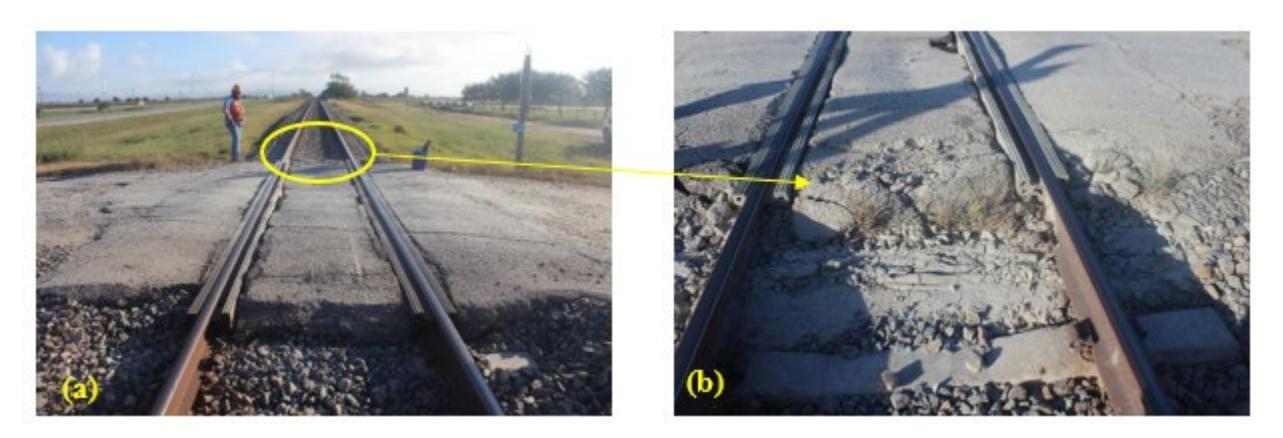
Figure C-21: Asphalt area with mud pumping, Crossing #4

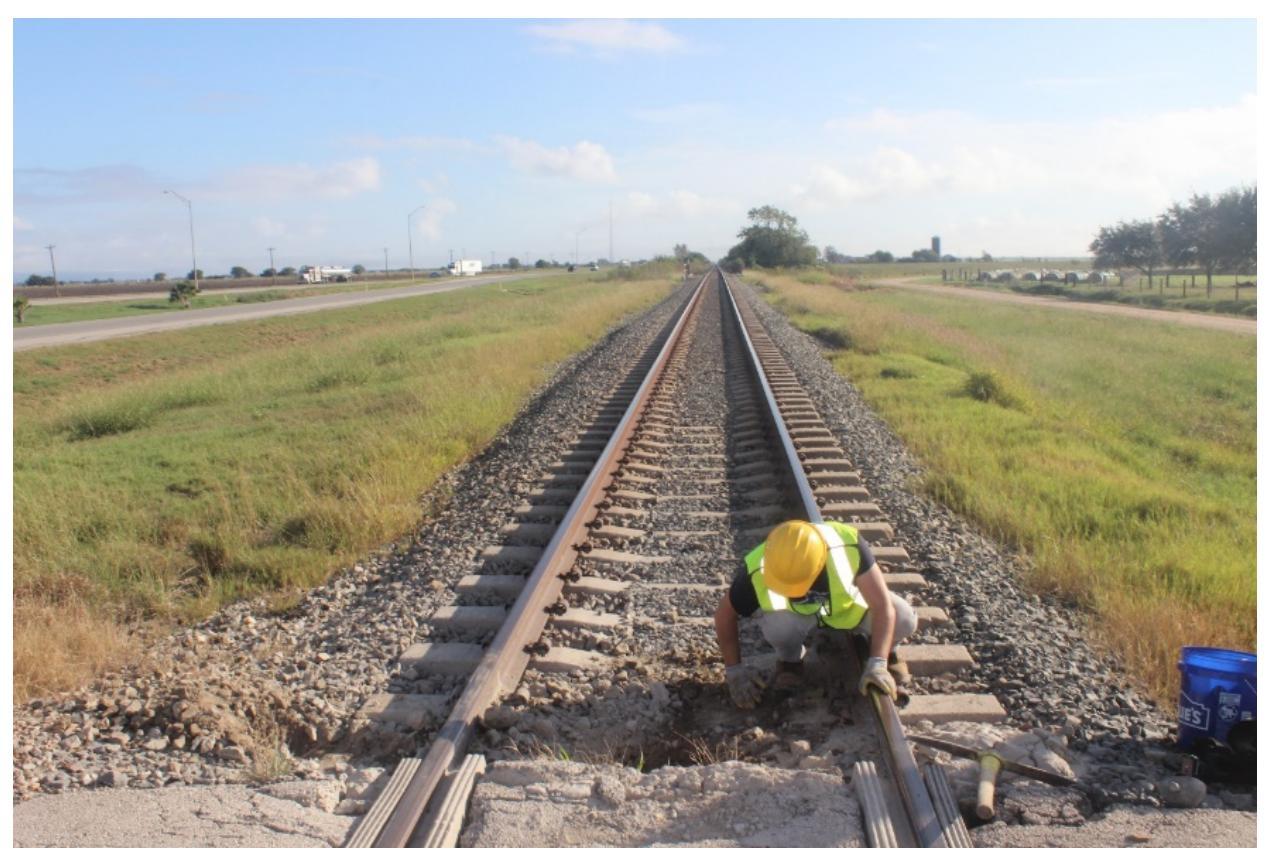
A ballast sample was taken from track at the depth of the bottom of the ties, as shown in Figure C-24. The sample contained some large concrete pieces (>10 mm). Some concrete fines were present. Silicate clasts were also present in the material, indicating some ballast breakdown.

Figure C-24: Subgrade and ballast sample collection, Crossing #4

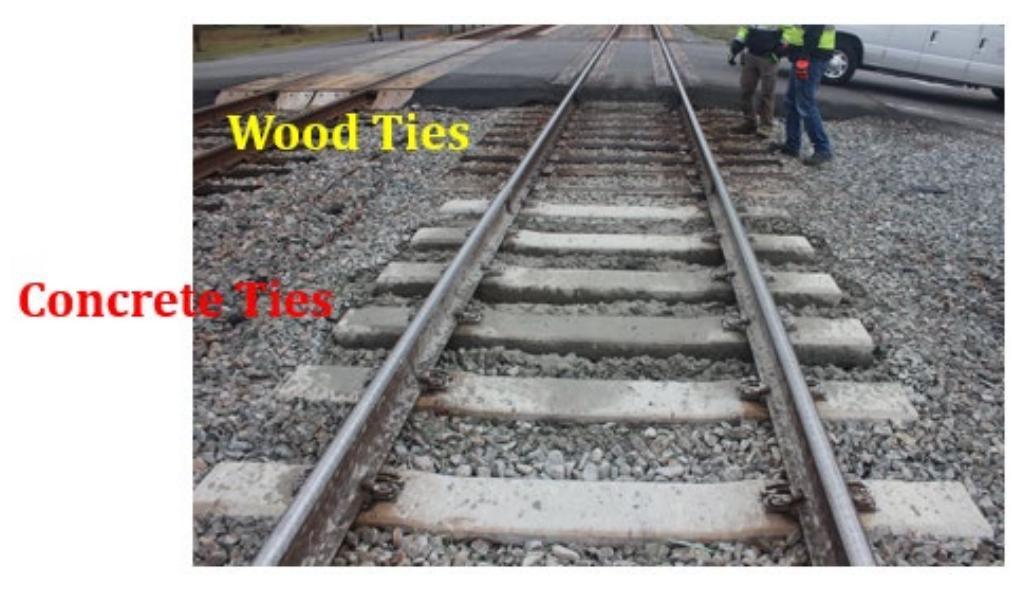
Mud pumping was evident at the site, Figure C-27. Figure C-28 shows a schematic view of the site and track condition determined from the visual observations. Figure C-29 shows a closer view of the concrete ties and water ponding in track. The pumping was most likely caused by dynamic forces from the trains passing over track with varying stiffness. Car and truck traffic over the intersection likely caused some ballast settlement and drainage is generally poor. There was a bungalow next to the track with a low grade as shown in Figure C-30, reducing track drainage. Some grass was seen present in track, confirming the regular presence of water and fines in track.

Figure C-27: Concrete-to-wood tie transition, Crossing #5

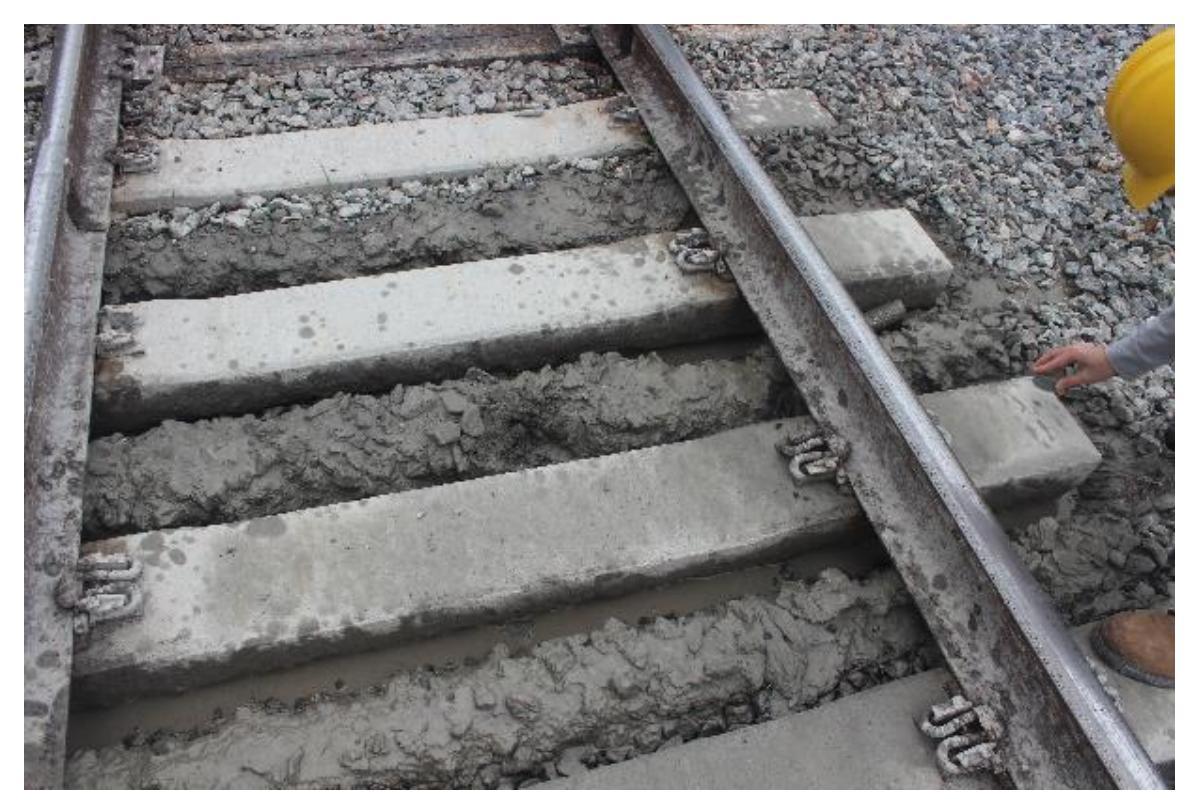
Figure C-29: Mud Pumping at Crossing#5

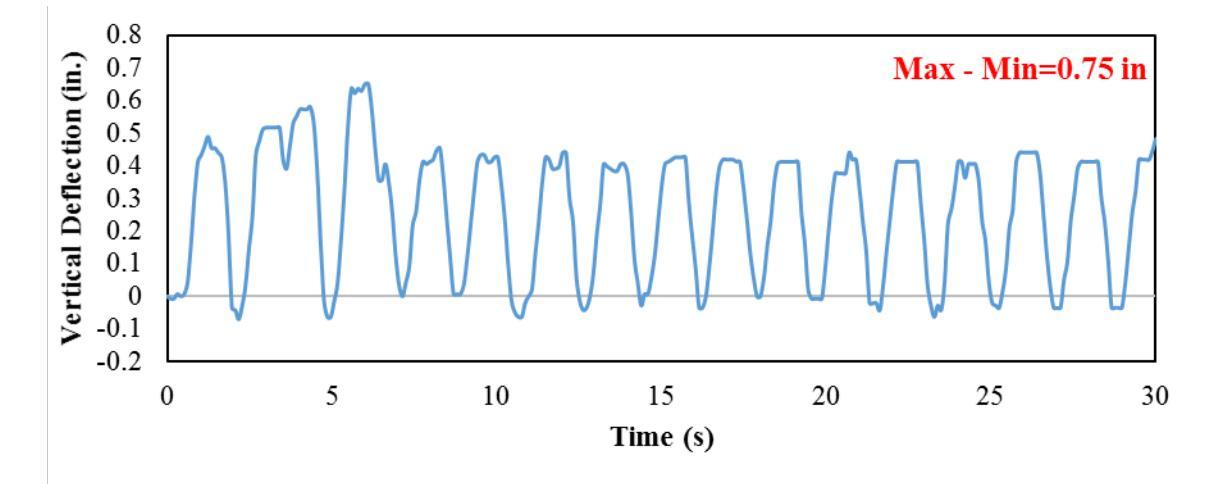
The vertical deflection of the tie with the most severe pumping was measured using high definition video. The camera was placed on a tripod and focused on a concrete tie, as shown in Figure C-31. The camera and tripod were held in place while the train passed to control vibration. The maximum deflection of the tie was 0.75 inches. Water in track rose with the applied loads and splashed over the tie. Figure C-32 and Figure C-33 are screenshots of the track video during a train pass with the ties in high and low positions in the track, respectively. Figure C-34 shows the tie vertical deflection measured from the high-speed video. An accelerometer was attached to the tie to measure the tie acceleration during loading, as shown in Figure C-31. Figure C-35 shows the measured acceleration of the tie three directions. The high level of vertical acceleration indicates poor ballast support. The lateral acceleration data indicates that the tie moves significantly to the sides of the track. This movement may contribute to abrasion losses on the tie.

Figure C-34: Vertical deflection of ties measured with high-resolution camera, Crossing #5

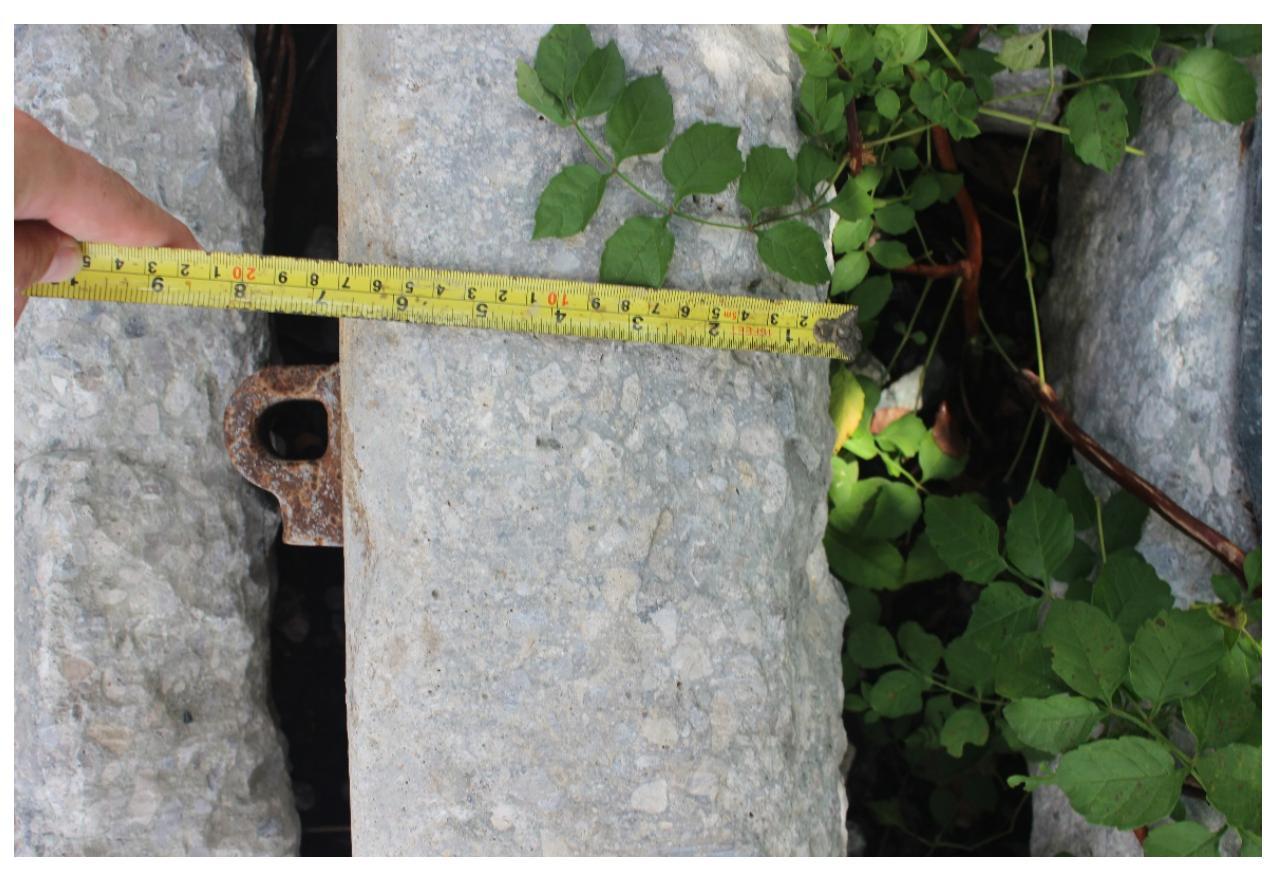
Figure C-40: Tie found beside the track, Crossing #6

Researchers measured thickness of two ties, one in track and the other found beside the track. Table C-9 shows the tie thickness measured on the tie in track. Figure C-40 shows a picture of a tie beside the track. These ties were made with a relatively soft aggregate. Damage seen with this tie showed less surface roughness than ties made with harder aggregates.

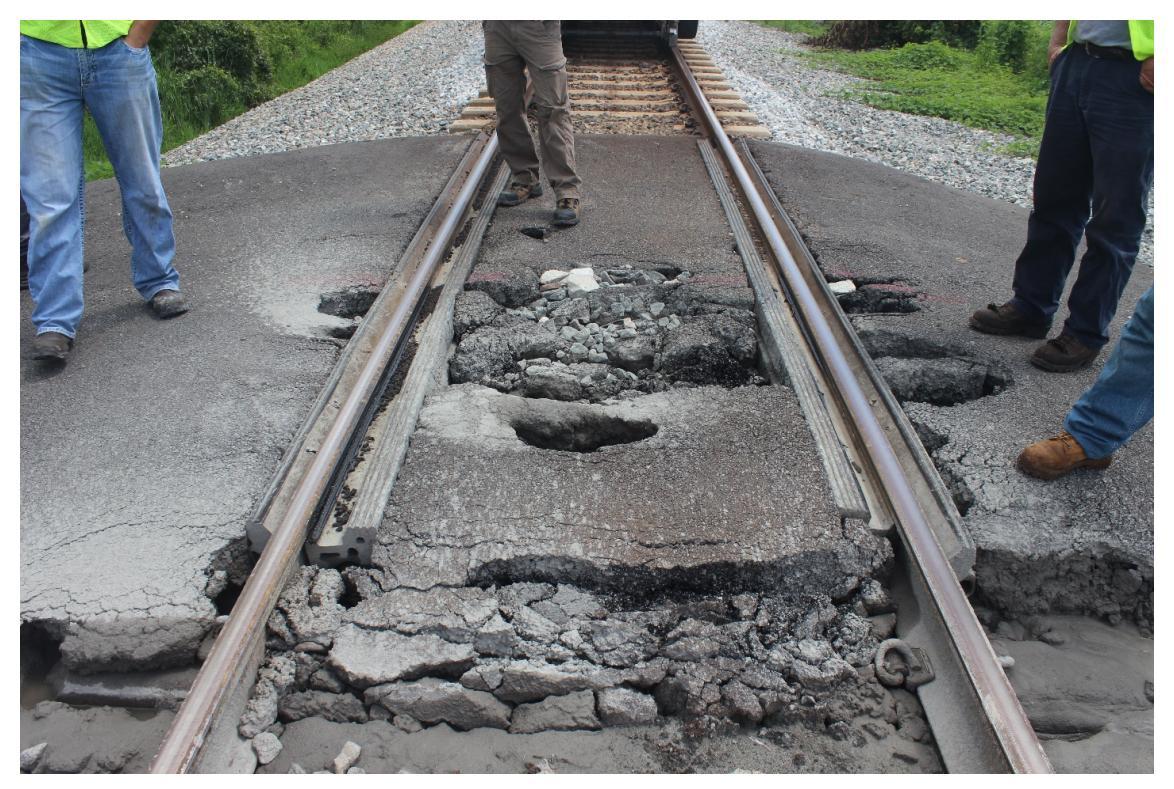
Figure C-42: Crossing #7

The asphalt crossing showed significant deterioration that appeared to originate underneath the asphalt causing erosion, Figure C-42. Water was seen present in the crossing and in the fouled ballast adjacent to the crossing. Fines from asphalt stripping were seen to have migrated from the asphalt topping in the crossing to the fouled ballast in track. Asphalt fines are cohesive and likely helped contribute to fines sticking together and clogging up ballast pores, enhancing water retention. The gray-colored fines and water are shown in Figure 3-6. Figure C-43 shows a close-up picture of the ballast fouling at the edge of the crossing. Asphalt fines and water are documented in this picture.

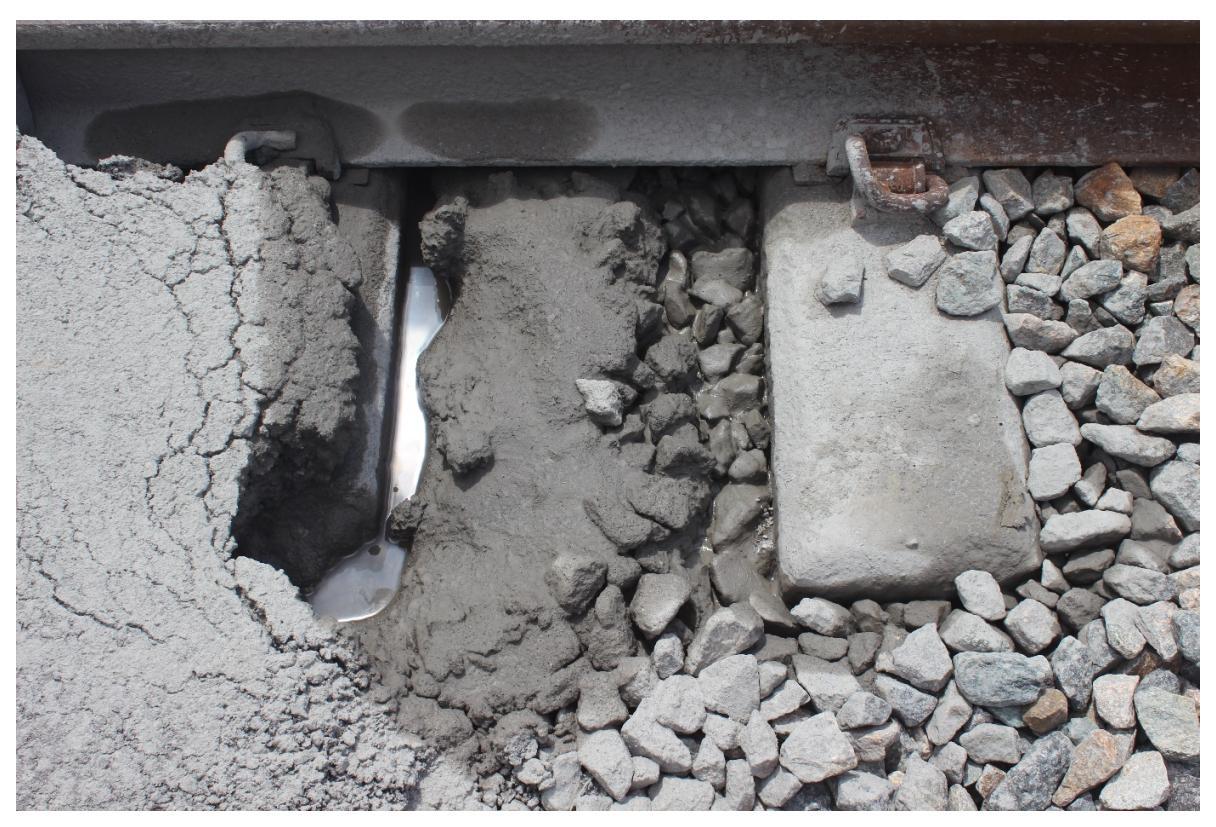
Figure C-43: Ballast fouling adjacent to Crossing #7

A ballast sample was collected from the fouled ballast in the area near the bottom of the ties. Table C-10 details the ballast analysis. The results indicate that a large percentage of the ballast fouling fines were from ground-up concrete. Silicate fine particles were from broken-down ballast.

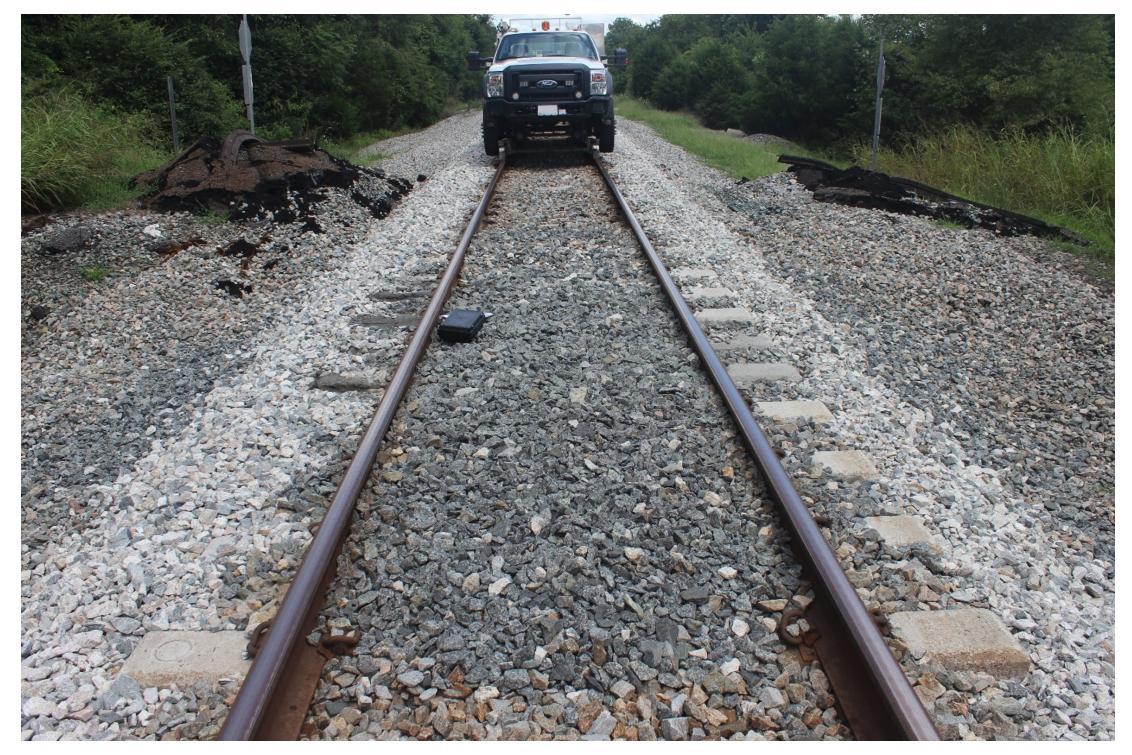
Figure C-45: Track section with removed crossing, Crossing #8

A mud spot was seen in track at the location where the road crossing once existed. The site had significant evidence of mud pumping. Figure C-45 shows the areas on the side of the track. Figure C-46 shows an up-close view of some of the ballast fouling. Pieces of asphalt are visible in the fouling. A culvert is located under the fouled track, as shown in Figure C-47. A culvert would likely increase track stiffness.

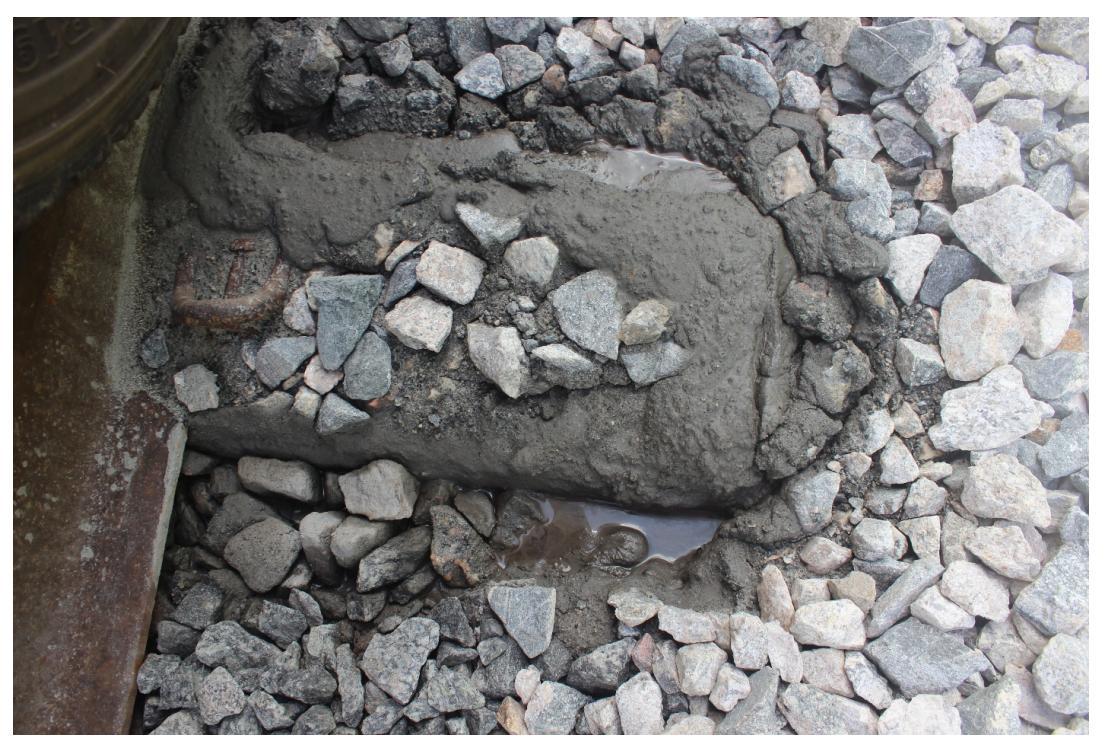
Figure C-46: Asphalt pieces are present in the fouled ballast, Crossing #8

A culvert, combined with a nearby asphalt crossing, could have created stiff track conditions with drainage issues and high ballast stresses. Fines may have migrated from the crossing into the ballast, increasing fouling.
