Federal Railroad Administration

DOT/FRA/ORD-19/38

Final Report October 2019

1. AGENCY USE ONLY (Leave blank)		2. REPORT DATE 3 October 2019		3. REPOR	3. REPORT TYPE AND DATES COVERED Technical Report April 2016 – August 2017	
4. TITLE AND SUBTITLE A Study of Environmental and Track Factors that Contribute to Abrasion Damage of Concrete Ties					5. FUNDING NUMBERS DTFR53-16-C-00009

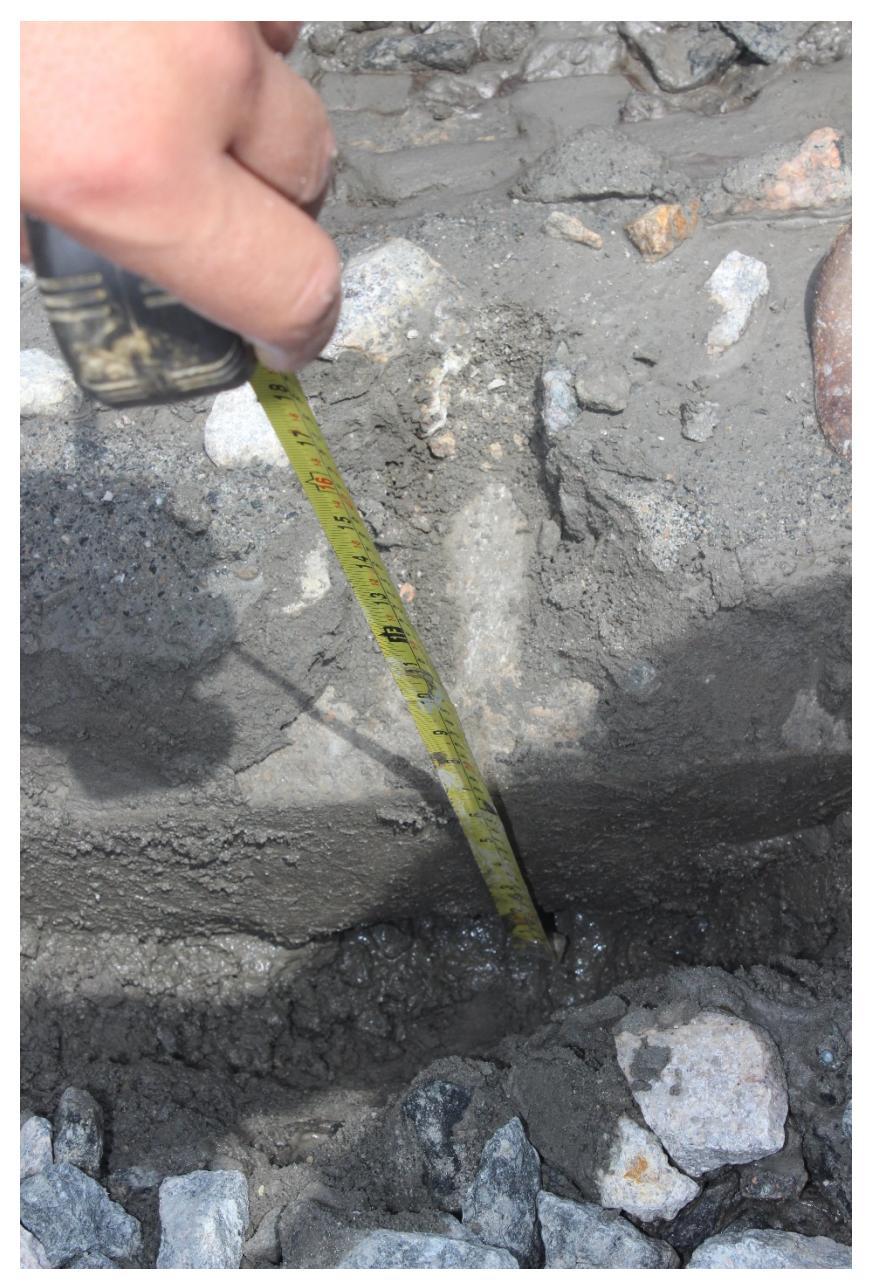
Location	Design thickness	Measured	Estimated
	at location (in.)	thickness (in.)	wear (in.)
Tie End	8.25	6.75	1.5

Figure C-48: Tie thickness measurement, Crossing #8

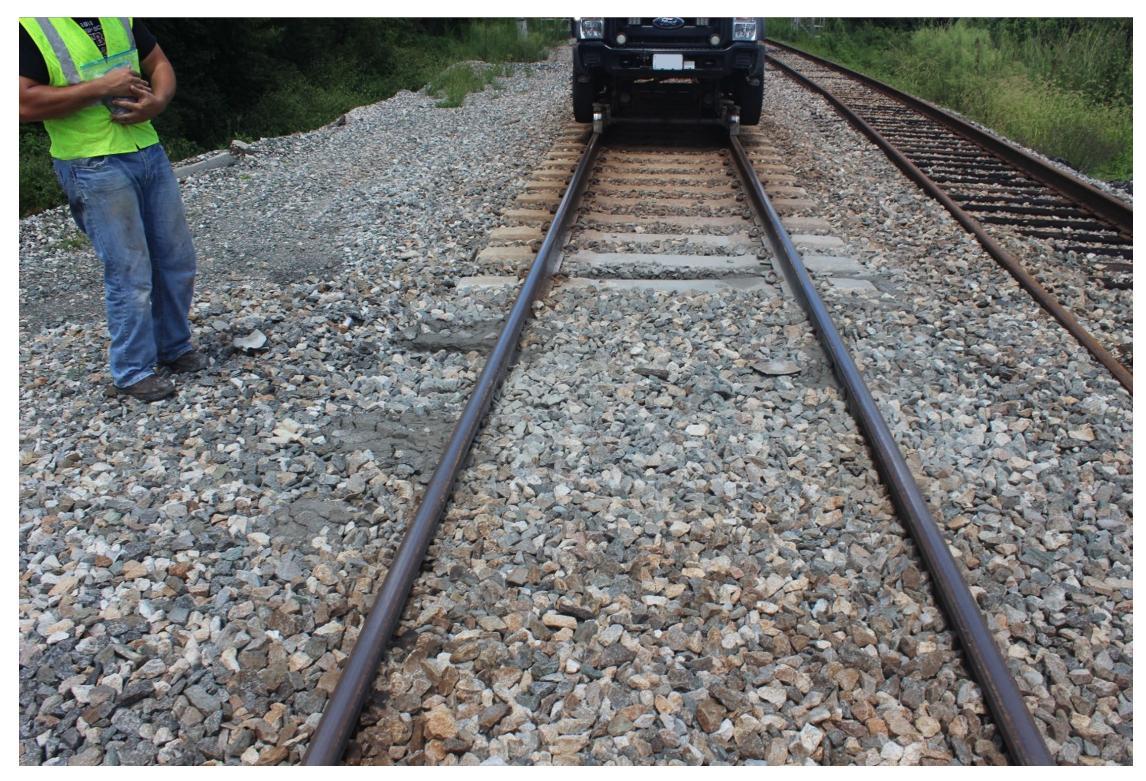
Figure C-54: Mud pumping coming up through crossing ballast and on the edge of Crossing #9

The crossing has a transition from wood-to-concrete ties. Center-binding cracking and shattered tie tops were seen in track right at the transition from wood-to-concrete ties, as shown in Figure C-53(a). Clean ballast appeared to be placed on top of the crossing to allow for better car movement over the tracks. Ballast fouling was seen to be present underneath the new ballast and on the outskirts of the crossing, as shown in Figure C-53(b). Asphalt fines appeared to be present in the ballast fouling in the concrete track. Figure C-54 shows the pumping around the tie immediately after the crossing on the opposite side of the crossing from the wood-to-concrete tie transition. Track grading and drainage appeared to be poor at the crossing as evidenced by the vegetation seen in Figure C-53 and the damp fines seen in Figure C-55, contributing to water retention in-track.

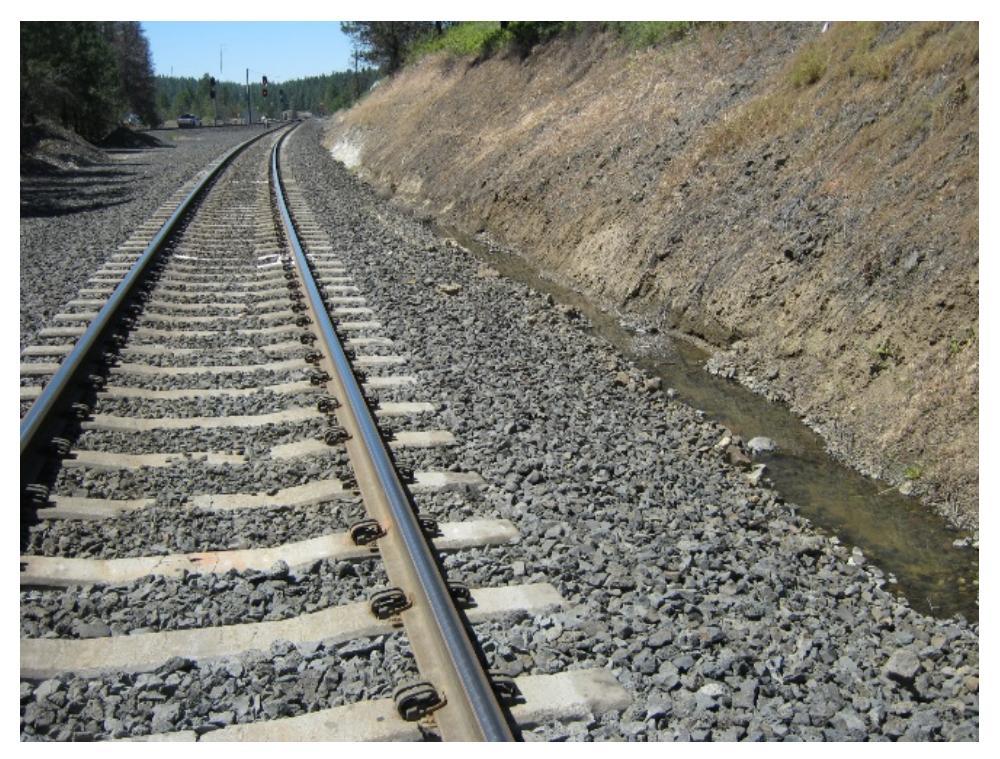
Figure D-4: Water available on the site, Curve #1

The track is in a section cut with higher elevation on both sides of the track. The ballast layer was undercut 3–4 months before the research team visited the site. The railroad claims there was a creek of water flowing through the track during undercutting. Standing water is adjacent to the track, Figure D-4. Figure D-5 illustrates how water could be flowing through the cut sections of hill, allowing for water damage in track. The steep slopes show recent erosion that is further evidence of local water.

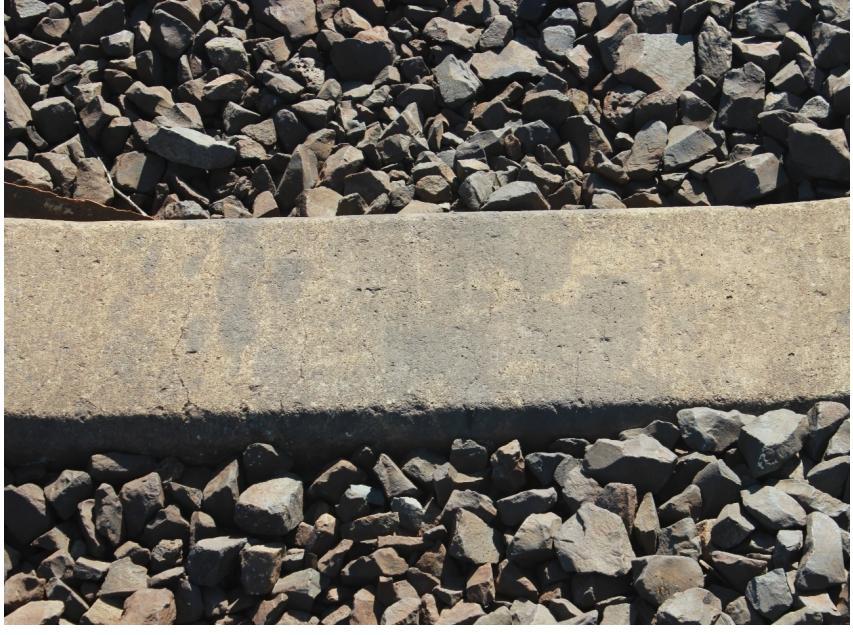
Figure D-6 shows gray mud present in some track segments. Three fouled-ballast patches were seen during the site visit. The ties had minor center-binding cracking and some had minor splitting cracks. Figure D-9 shows an example of the minor center-binding cracking present on the ties, while Figure D-10 shows vertical splitting cracks found on some ties. The site had been undercut 3 years before this inspection, and fouling had returned at three locations. There were rail welds near the fouled area, indicating potential surfacing issues and/or elevated rail

Figure D-9: Minor center-binding cracks, Curve #2

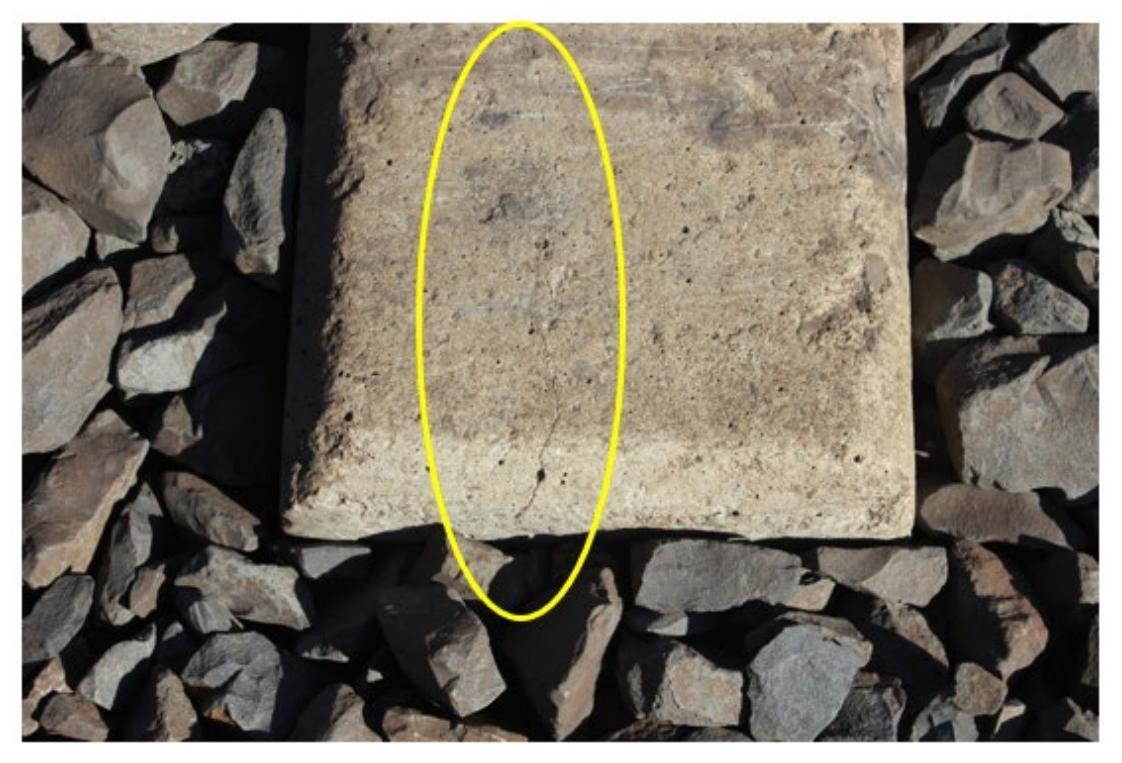
Figure D-10: Vertical splitting crack, Curve #2

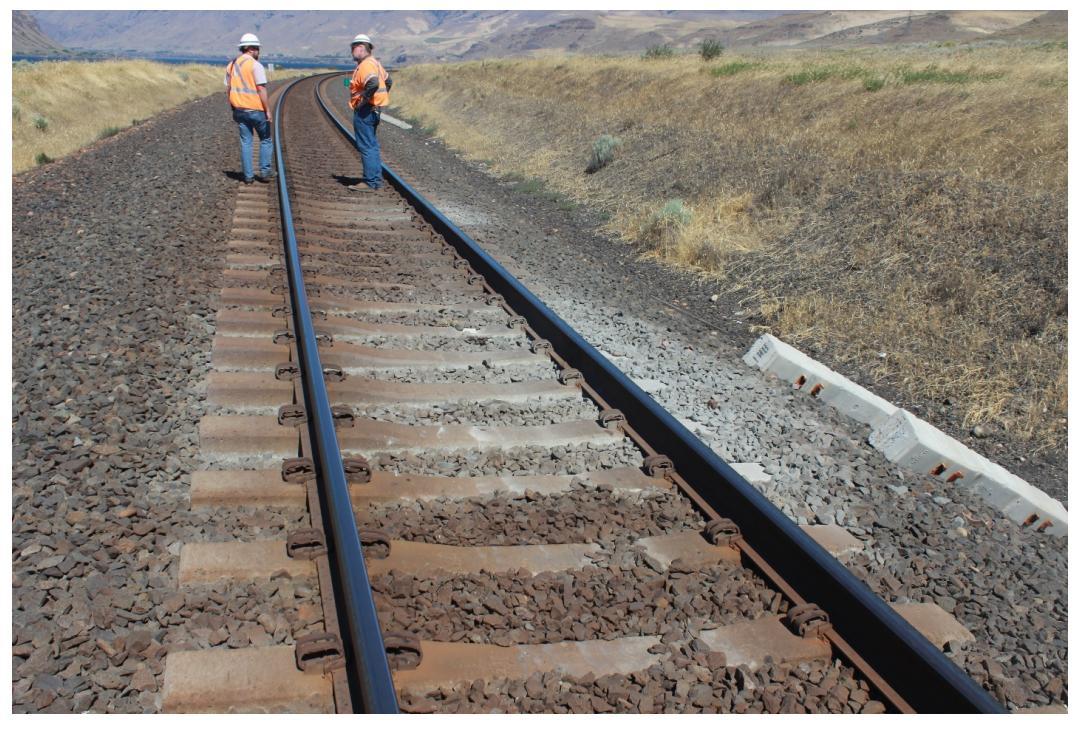
The railroad reported that the ballast was regularly maintained, however the site had not been undercut recently, only built up. Figure D-14 shows a picture of the track site with visible gray fouling present on ballast. The railroad was in the process of replacing individual ties in order to improve track conditions and remove the slow order, see Figure D-15. The tie shown in Figure D-15 has some abrasion damage on the sides. The railroad plans to replace all ties in the future due to center-binding cracking and cracks near of the fasteners. Figure D-16 is an example of the center-binding cracking.

Figure D-14: Gray-colored fouling present on ballast, Curve #3

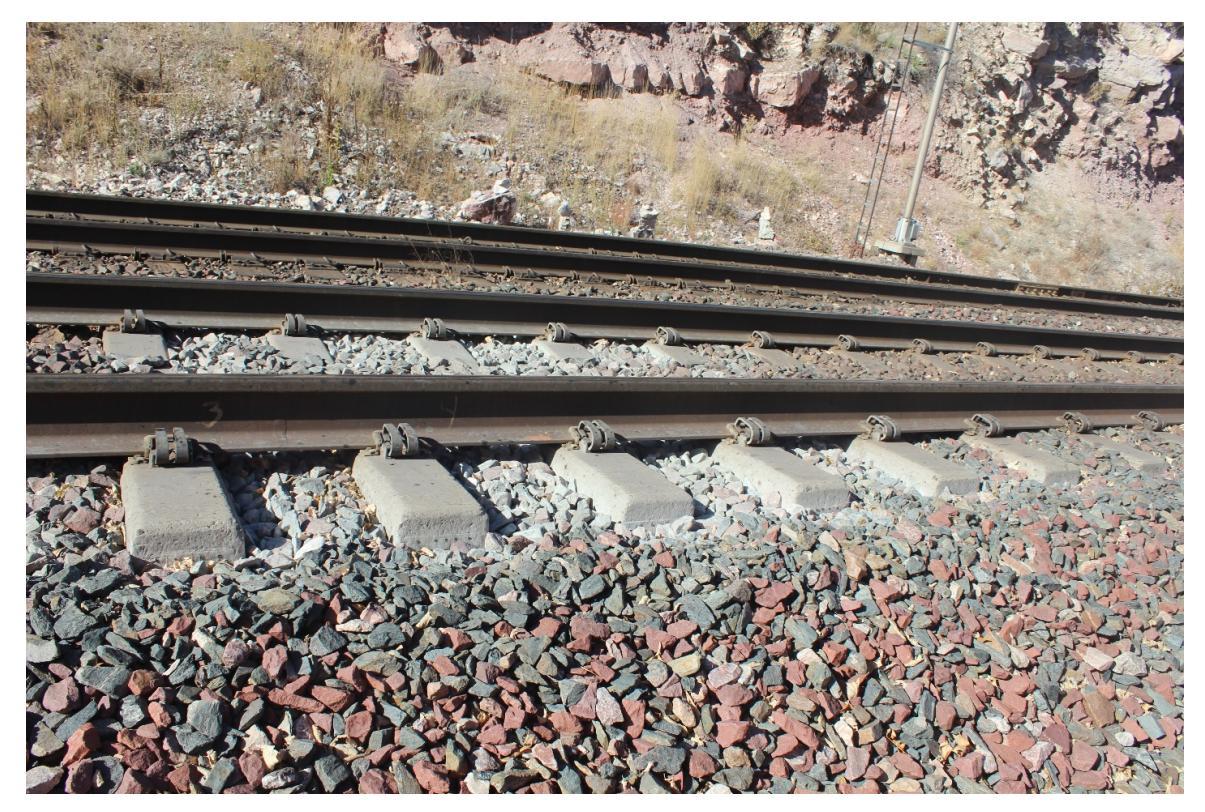
The ties in this location were scheduled for replacement because the track was not maintaining curvature through rail temperature changes. Some lateral and vertical movement was starting to show at one location near an insulated joint, see Figure D-17. Ballast churn seen at the track surface was limited to the area around five ties. There were also fines seen on the side of track were water usually drains out of the track structure, see Figure D-18. Although the team was not able to walk the track due to sight distance issues, the team found discarded ties on the side of the road about a quarter-mile down the track. These ties did not have scallops along their sides. Scallops may help stabilize the track laterally.

Figure D-17: Ballast churn seen on-site

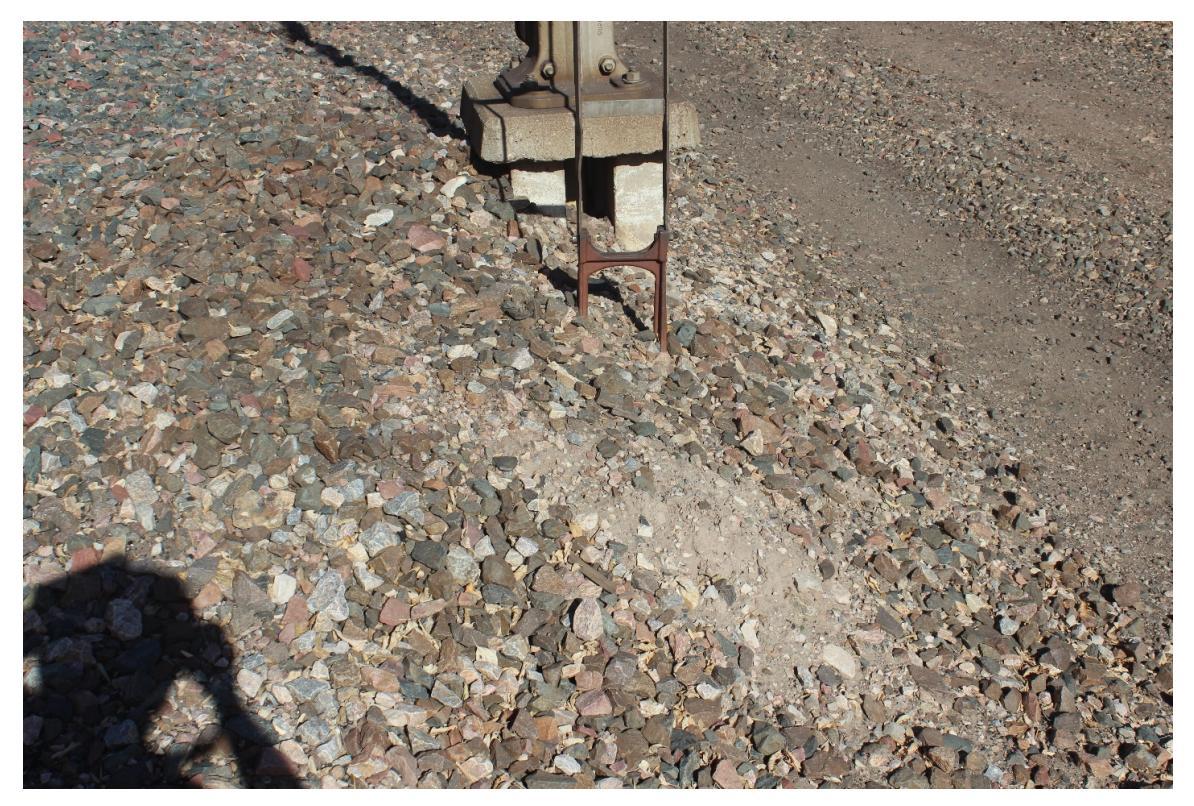
Figure D-18: Fines on the side of the track

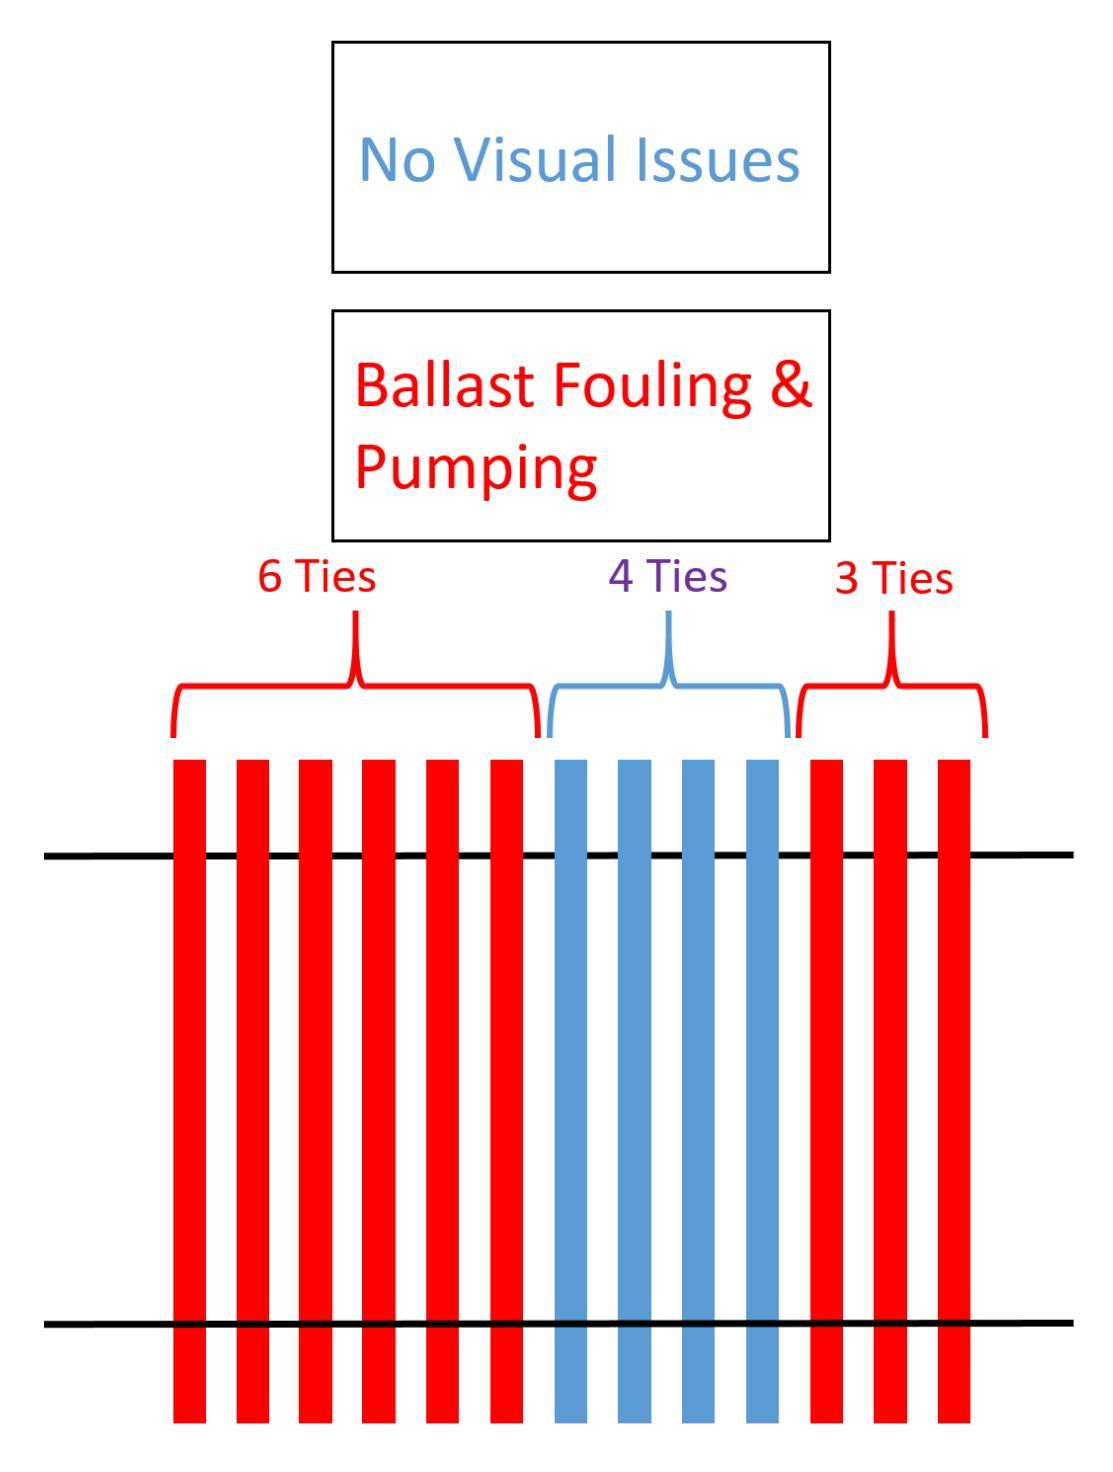
Figure D-22: Schematic of tie condition, Curve #5

The site is an area that frequently has rock slides, as evidenced by the fallen rocks in the drainage ditch and the lack of vegetation on the hillside seen in Figure D-21. Figure D-22 shows a schematic of the tie deterioration in track. There were two sections with surface-visible fouled ballast. The fouled ballast had beige fines from mud pumping around the ties, as shown in Figure D-23 and Figure D-24. The fines were the same color as the surrounding soil, indicating that the majority of fines were from the subgrade. The ties had only minor abrasion wear.

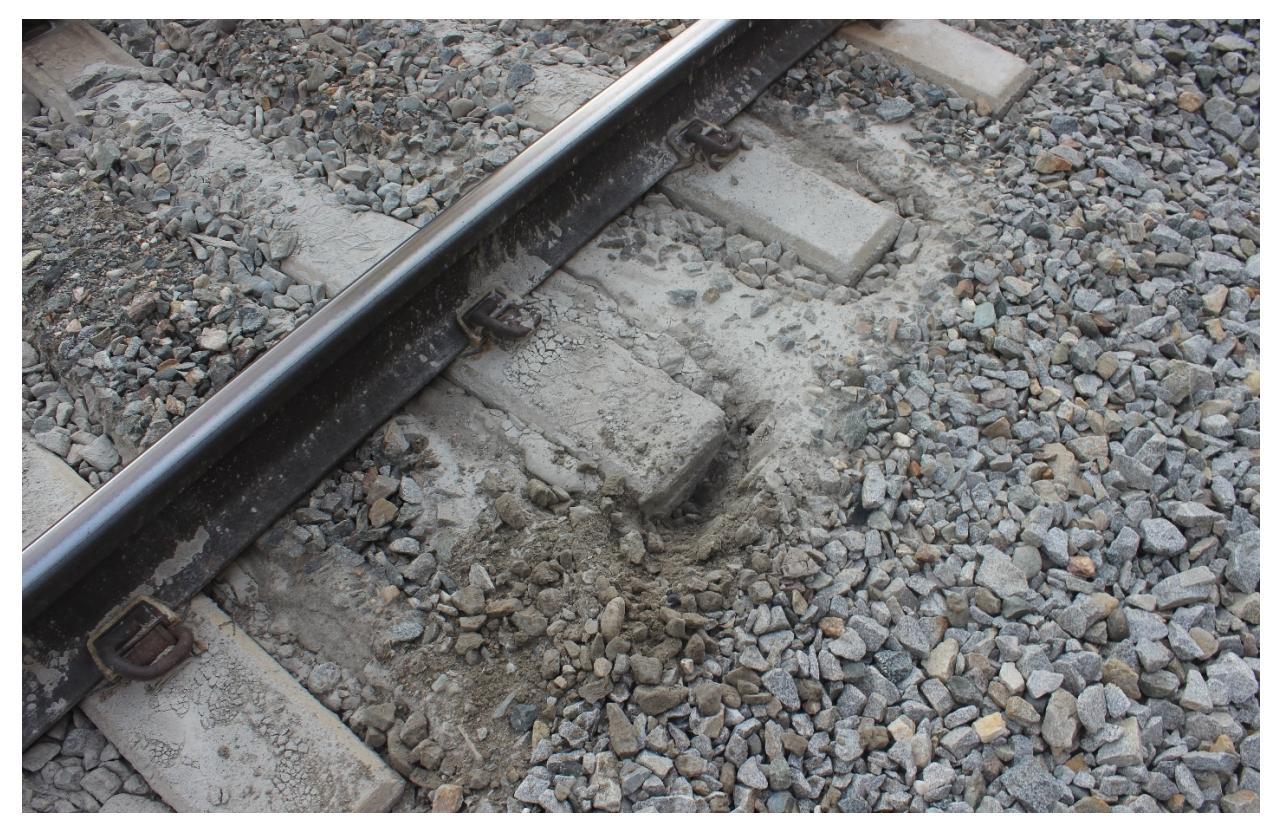
Figure D-24: Fine particles seen at the track surface, Curve #5

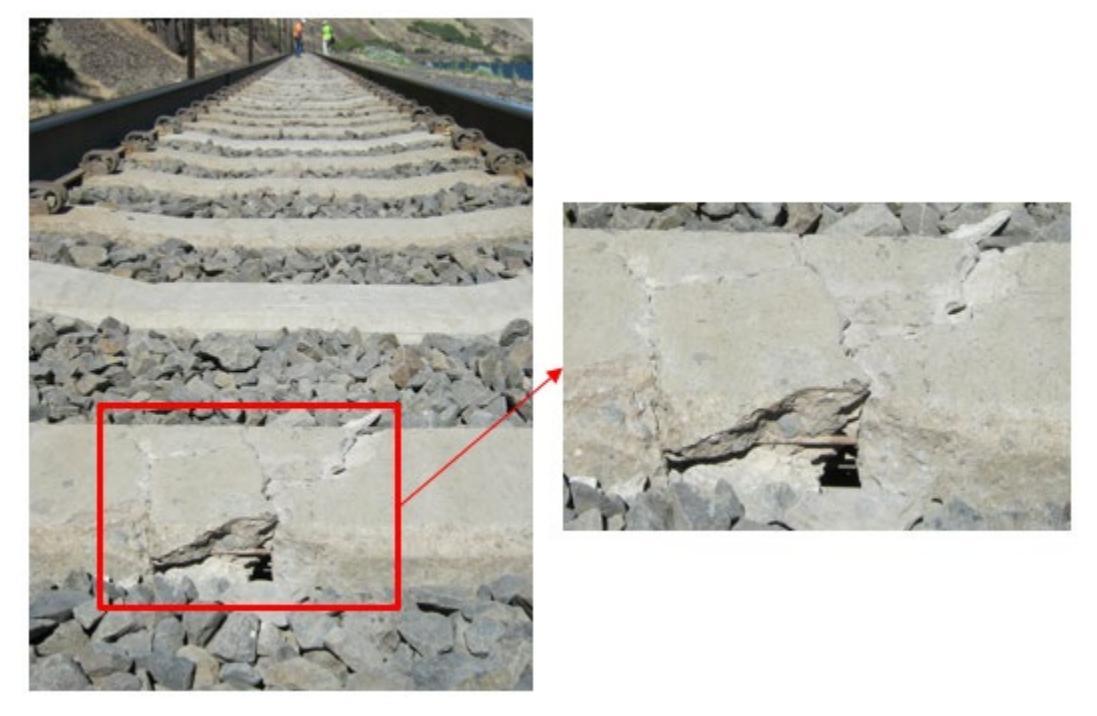
Researchers observed center-binding cracking over a long section of this track as shown in Figure 3-24. Sone ties had severe center-binding cracking that progressed to full delamination, exposing the steel reinforcements, Figure E-3. Some splitting cracks were also seen at this site.

Figure E-3: Severe center binding cracking and exposed reinforcements, Tangent #1

This site was experiencing rapid degradation following a shoulder cleaning operation 1 year prior. The track speed was reduced from 40 mph to 25 mph a couple of weeks before the inspection, and then down to 10 mph immediately following the inspection. Center-binding cracking started within a month after the shoulder cleaning. Track degradation may be the result of a lack of support under the tie ends after shoulder cleaning and/or improper tamping after the cleaning. Figure E-4 shows ties that were removed from track and stored on the side of the road. Very little abrasion was seen on the ties stored on the side of the road.

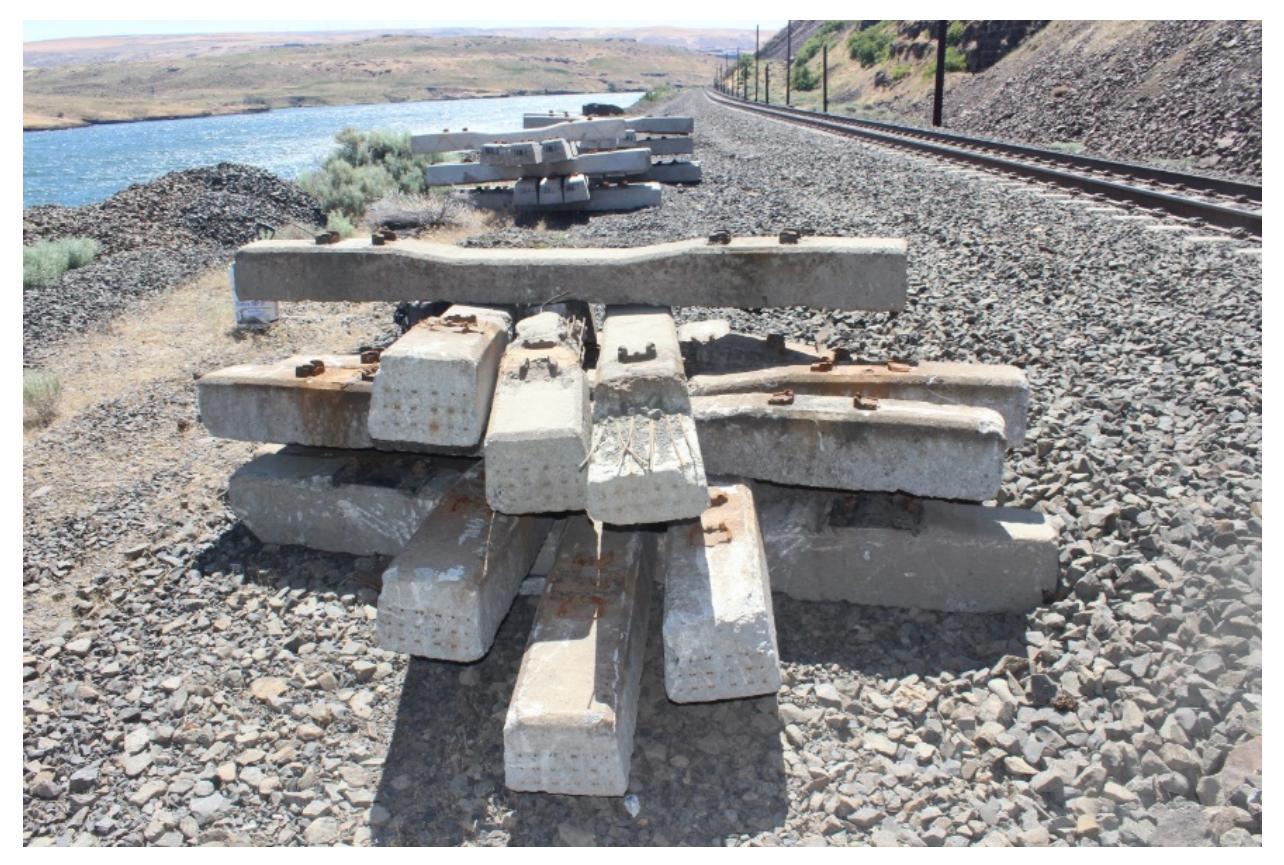
Figure E-4: Ties removed from track and stored on the side of the road, Tangent #1

Ten Schmidt hammer readings were taken on the top of a tie to measure the concrete surface hardness. The average of the Schmidt hammer readings was 48. The thickness of a discarded tie on the side of the road was measured to quantify any abrasion loss. Table E-1 shows the tie thickness data. Very little abrasion damage was measured.

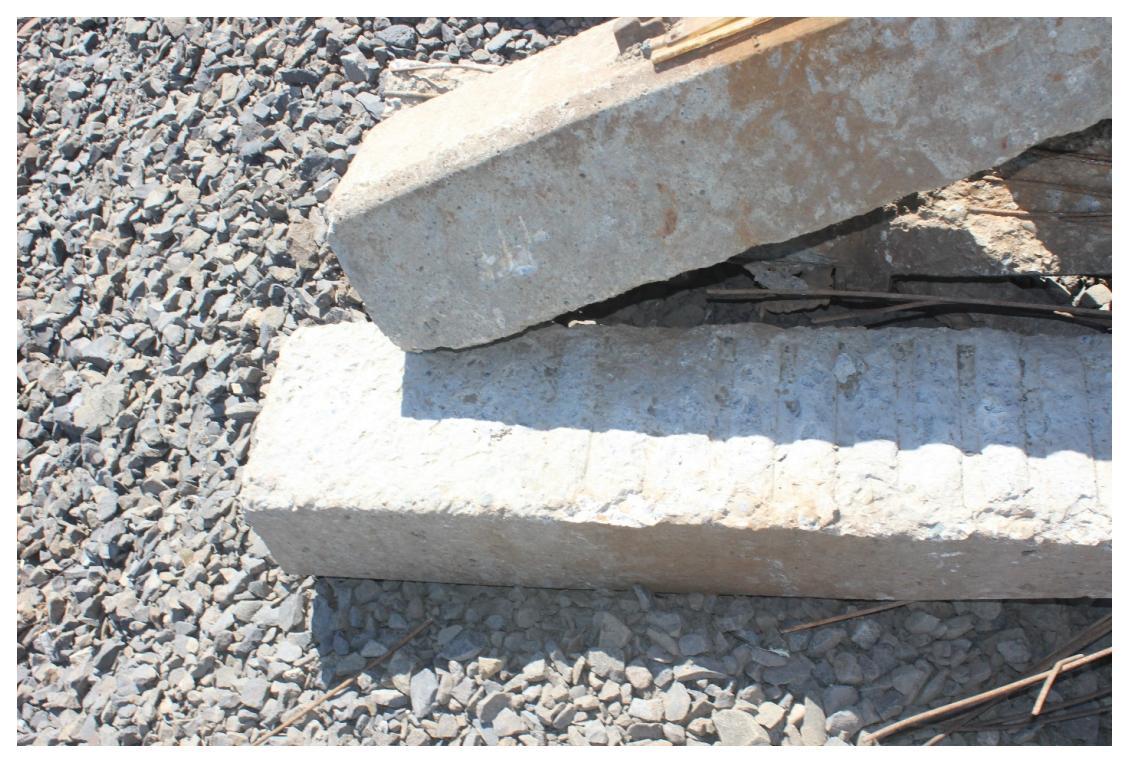
Some ties were removed from track and stacked nearby, see Figure E-6. There were isolated ties found in track that appeared to have side wear and corner rounding from local ballast conditions, as shown in Figure E-7. The tie did not appear to have any loss in thickness. Center binding cracking was seen on many ties in track. The tie shoulder ballast was cleaned a year before inspection of the research team. Center binding cracking appeared within a month after ballast cleaning, likely because of different stiffness in track under center and the end of the tie. Figure E-8 shows concrete ties with some ballast churn and fouling next to a section of wooden replacement ties next to an insulated joint. The track was elevated and had good grading and drainage, except at the signal location as shown in Figure E-9. The site was very arid with dry grass in the area.

Figure E-6: Ties stored on the side of the road, Tangent #2

The thickness of a tie was measured at one location in track. Table E-2 shows the thickness data. Very little change in tie thickness was measured in track, matching the low amount of wear seen on the discarded ties shown in Figure E-6.

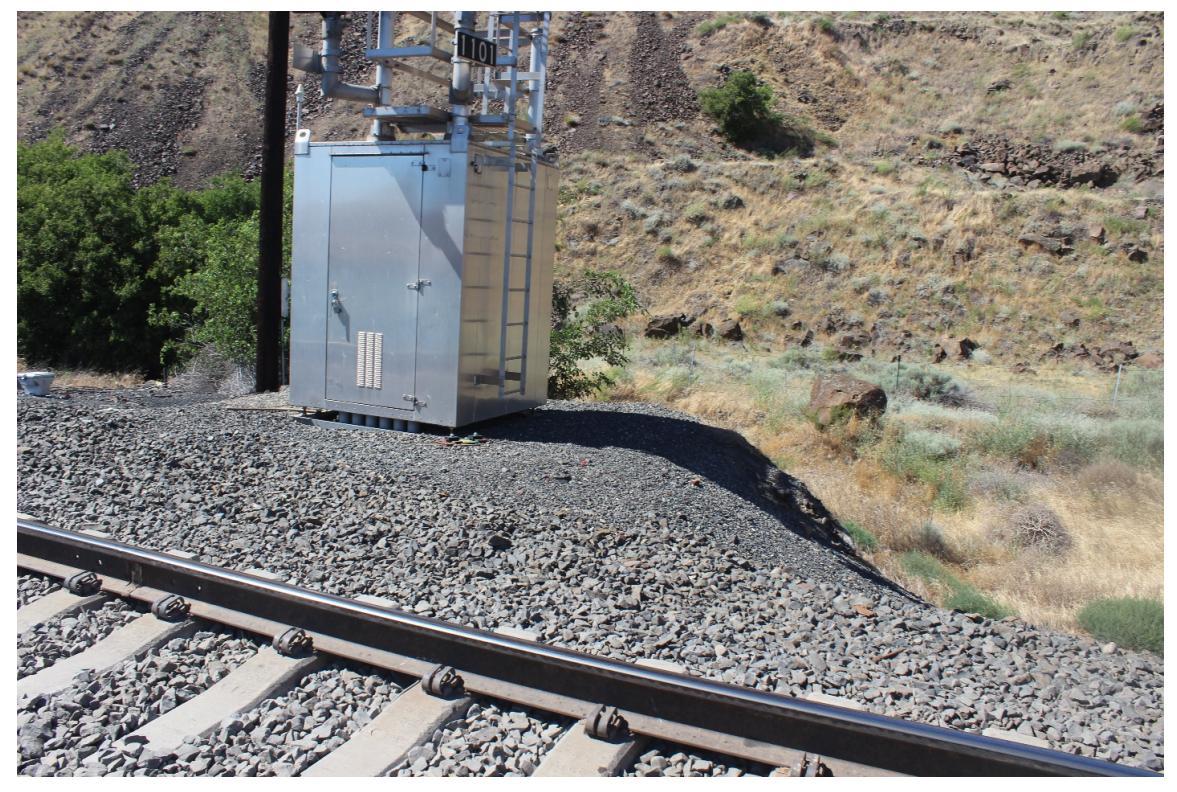
Figure E-9: Poor grading at signal, Tangent #2

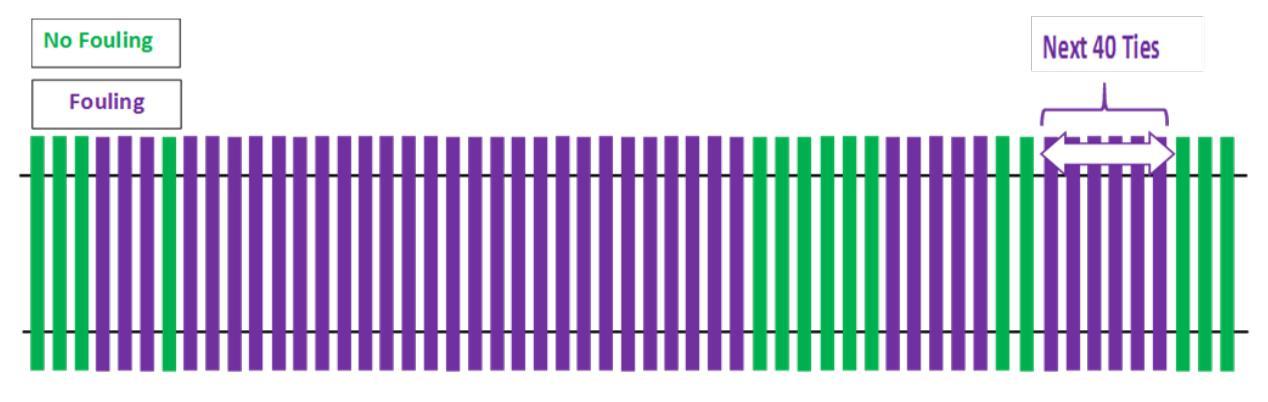
There were ditches on both sides of the track. The ditches were full of vegetation, indicating year-round moisture. The railroad reported that this section of track was undercut about 3 years prior due to surface issues. Significant track fouling was present, as shown in Figure E-11. Figure E-12 shows a schematic of the observed fouling conditions. A potential cause of fouling could be low ballast levels under the ties, leading to high pressures on subgrade and fines infiltration into the track structure.

Figure E-12: Schematic view of fouling, Tangent #3

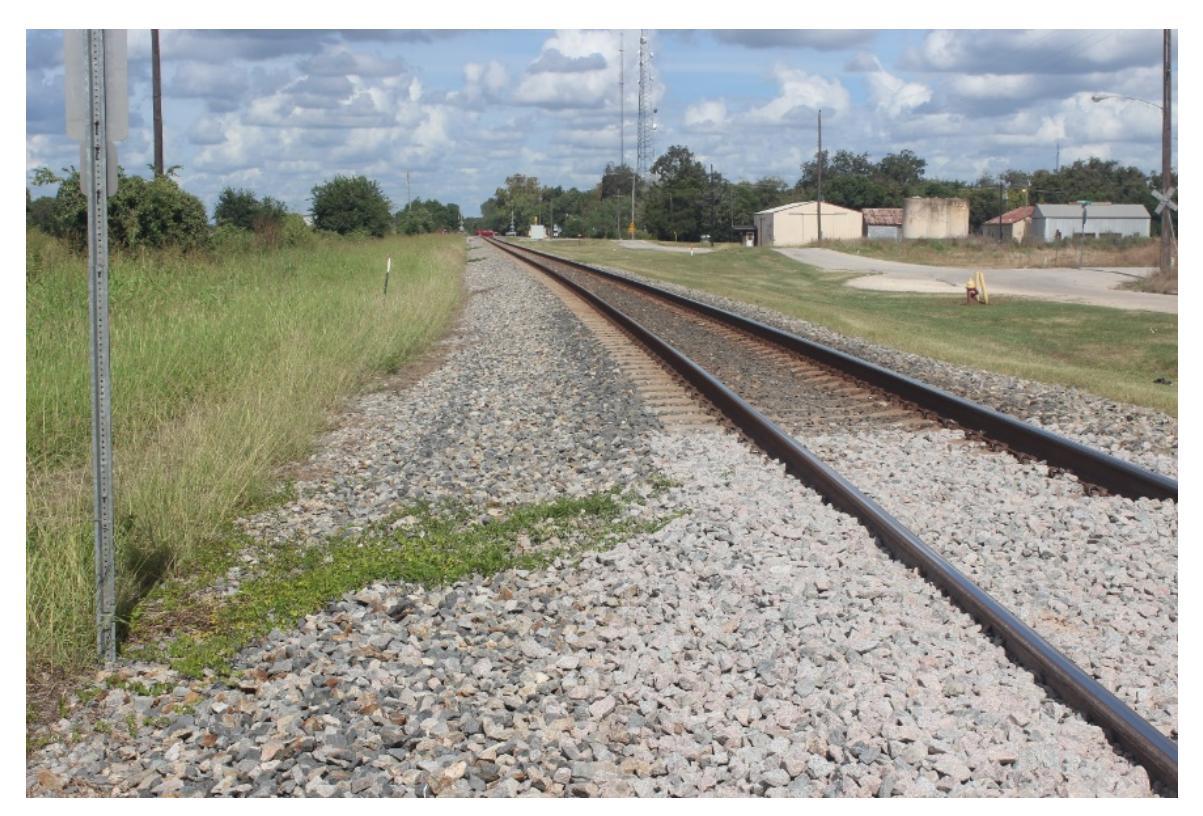
Insufficient tie support was provided by the track structure, causing fines from the subgrade to pump upwards into the track structure. As shown in Figure E-16, the pumped mud had the same color as subgrade, confirming that there was little ballast under the track and that subgrade fines were infiltrating the track structure. Water and fine subgrade particles present at the site allows grass and other vegetation to grow in the ditches and encroach in the track structure, as shown in Figure E-17.

Figure E-17: Vegetation encroaching on track, Tangent #4

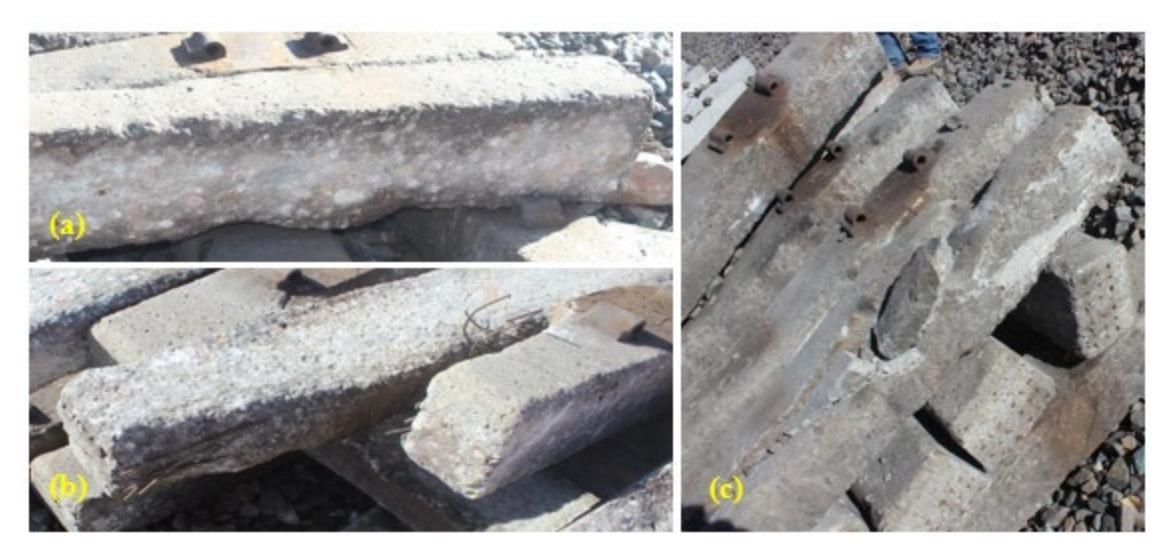
Some of the ties removed from track and displayed various wear conditions, as shown in Figure E-19, where (a) shows bottom abrasion, (b) shows exposed steel reinforcements, and (c) shows ties with spalling. Figure E-20 shows ties that were stored next to replacement ties. Overall, the level of abrasion damage seen in ties taken from track on this site was minor.

Figure E-19: Tie abrasion damage, Tangent #5

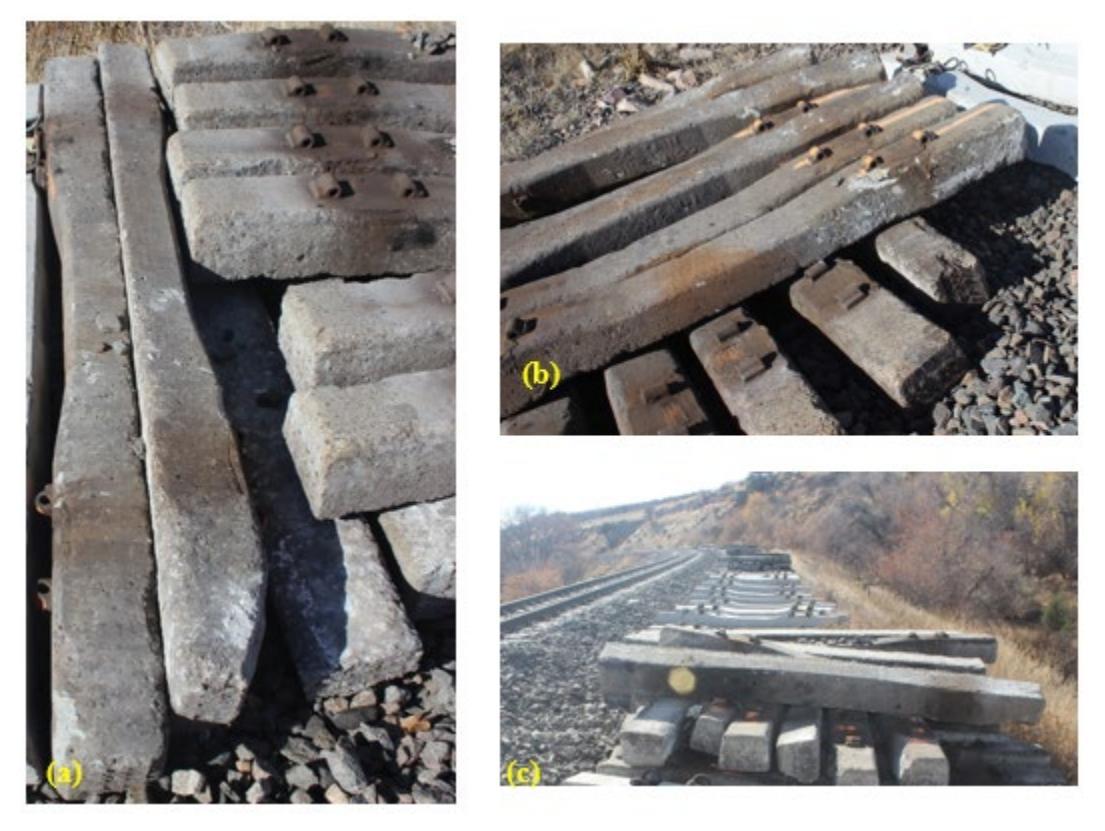
Figure E-20: Old ties pulled from track, Tangent #5

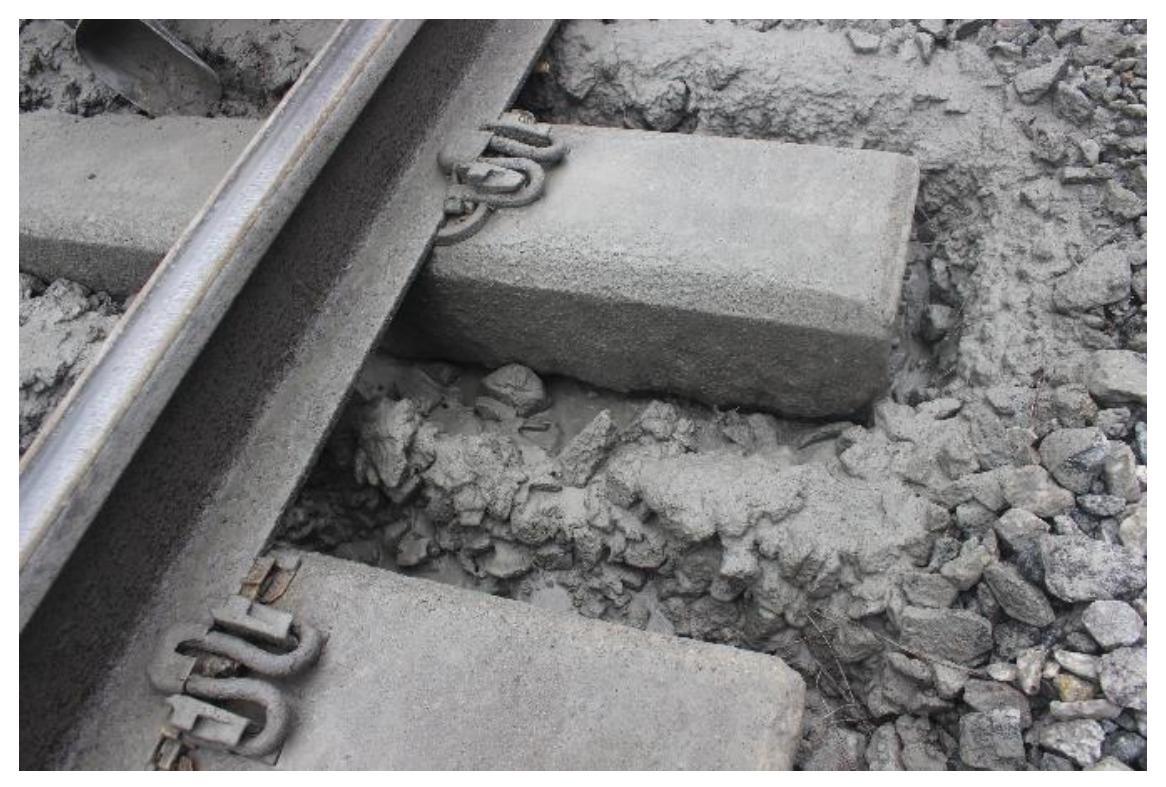
A small section of fouled ballast was found at this location, as shown in Figure E-23. Fouling and pumping was seen at the surface over a length of five ties shown in Figure E-24. The railroad had removed a few concrete ties during a prior maintenance action shown in Figure E-25. Moderate center-binding cracking was seen in the ties near the fouled ballast, Figure E-26. The center-binding cracking is evidence of track support issues. In addition, Figure E-27 shows one tie with unusual damage. This damage may be the result of ballast particles vibrating on the top of the tie during train passes.

Figure E-24: Pumping in track, Tangent #6

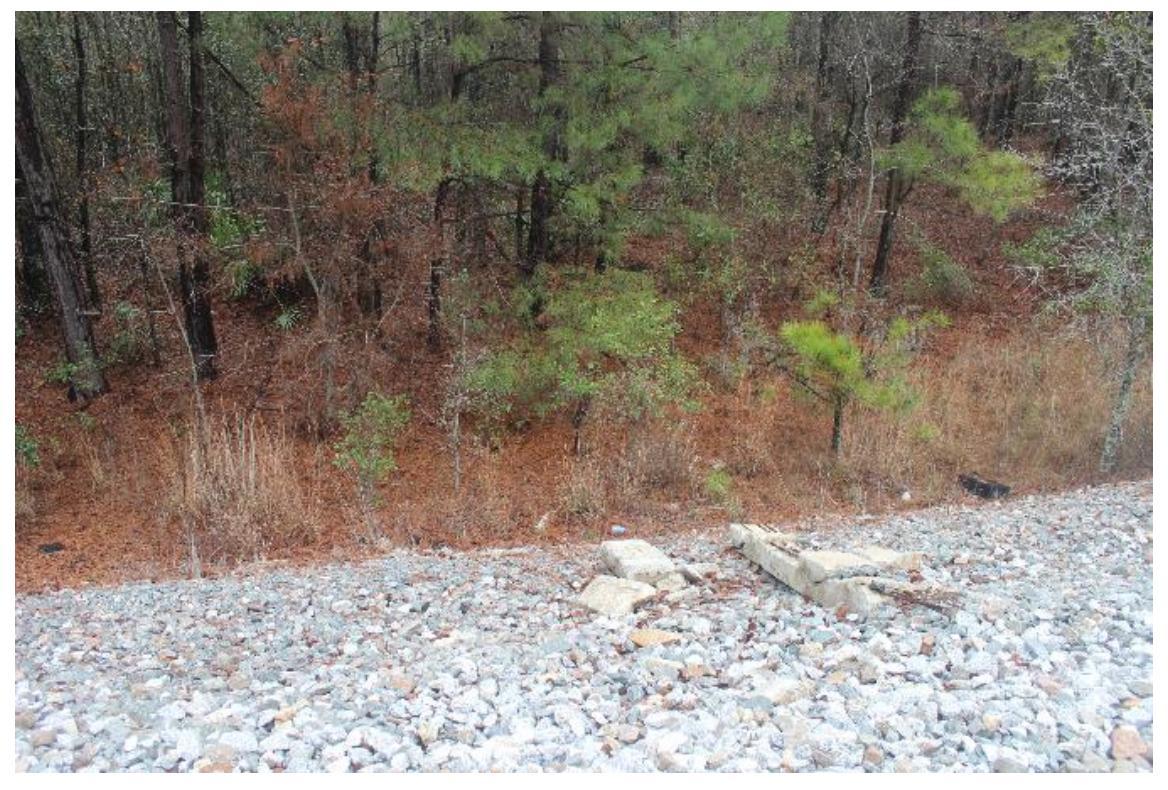
Figure E-25: Discarded ties stored on the side of the track, Tangent #6

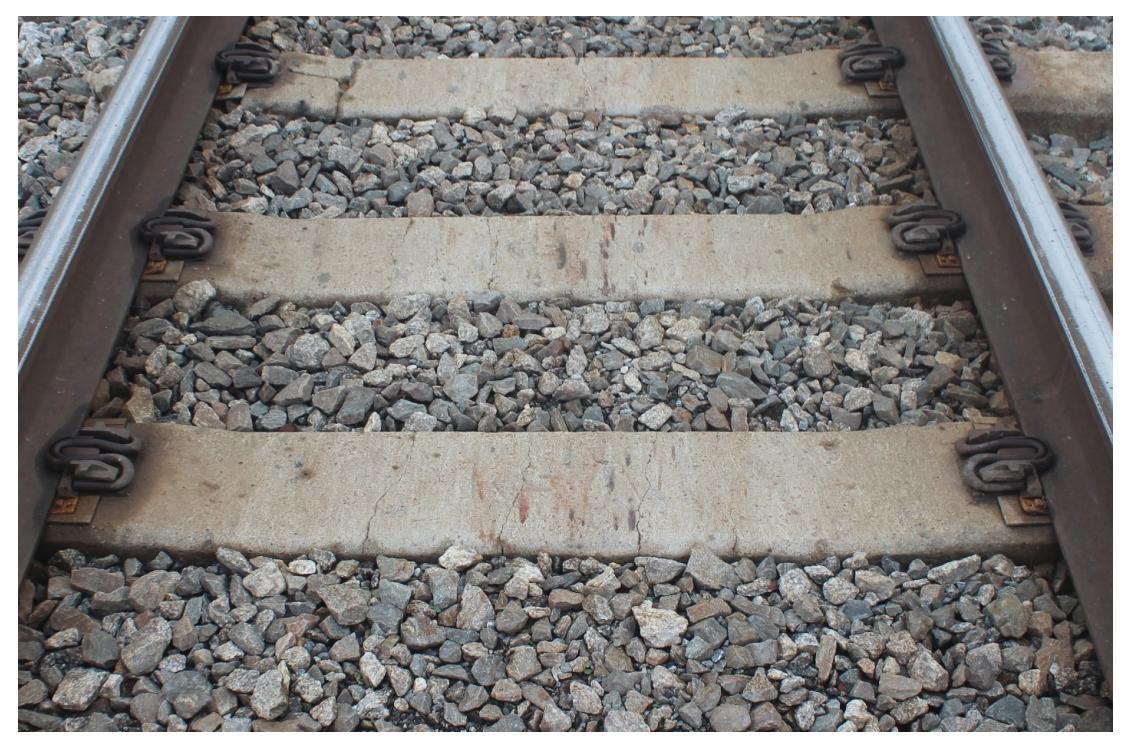
Figure E-26: Center-binding cracking in ties near the fouled ballast location, Tangent #6

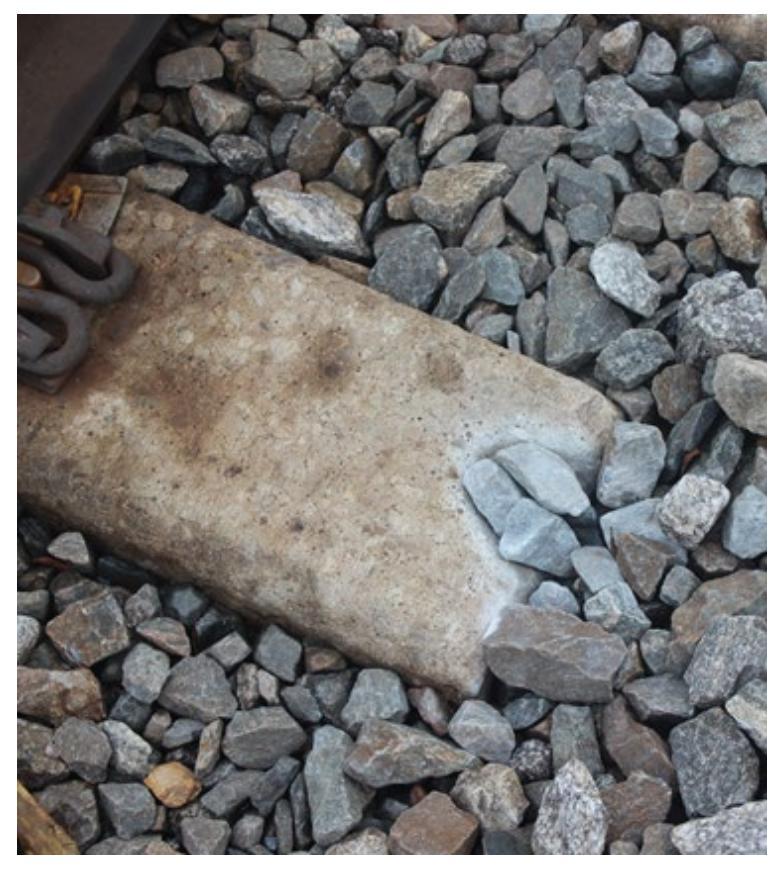
Figure E-27: Abrasion damage at unusual location, Tangent #6
