Federal Railroad Administration

DOT/FRA/ORD-19/38

Final Report October 2019

1. AGENCY USE ONLY (Leave blank)		2. REPORT DATE 3 October 2019		3. REPOR	3. REPORT TYPE AND DATES COVERED Technical Report April 2016 – August 2017	
4. TITLE AND SUBTITLE A Study of Environmental and Track Factors that Contribute to Abrasion Damage of Concrete Ties					5. FUNDING NUMBERS DTFR53-16-C-00009

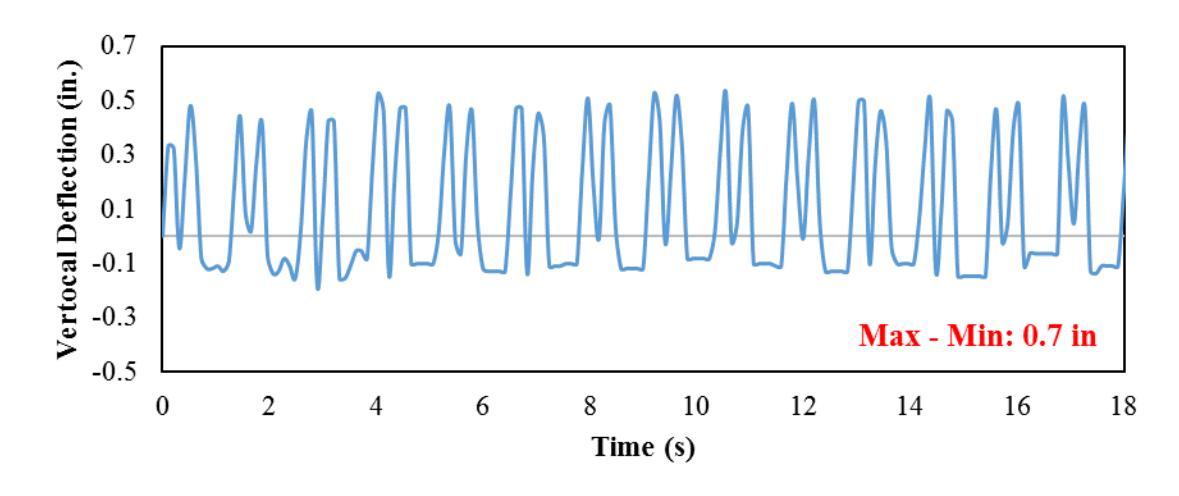
Researchers gathered high definition video of one of the ties in the fouled ballast section during a train pass. Video analysis was performed to estimate the tie deflection during loading shown in Figure E-29. The tie with highest level of pumping had 0.7 inch of deflection.

Figure E-29: Vertical deflection of tie with severe pumping, Tangent #6

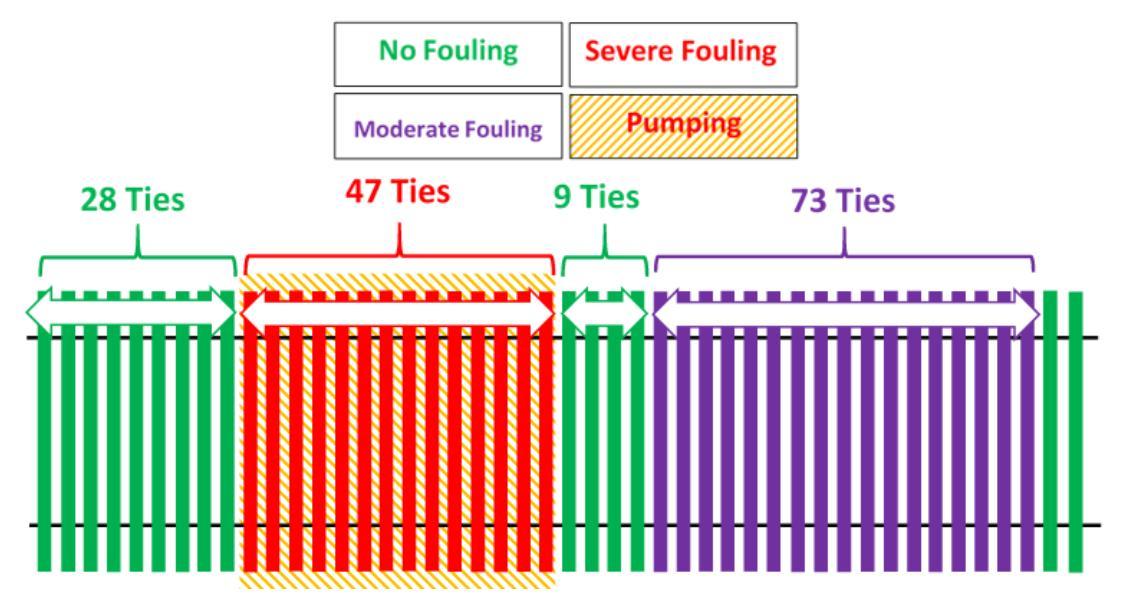
The site had large amounts of ballast fouling. Figure E-32 shows a schematic of the track fouling conditions. Evidence of pumping action was seen in the fine material surrounding the ties. The pore pressure in the fines during loading expels water and fines along the sides of the ties, pushing material away from the tie. Figure E-33, shows the photo of the section of track with severe fouling and pumping action. The fines were removed from the tie top surface as shown in Figure E-34, exposing center-binding cracking. Figure E-35 shows the ties that were shattered from center-binding cracking that delaminated at the top row of reinforcements.

Figure E-32: Schematic view of the fouling, Tangent #7

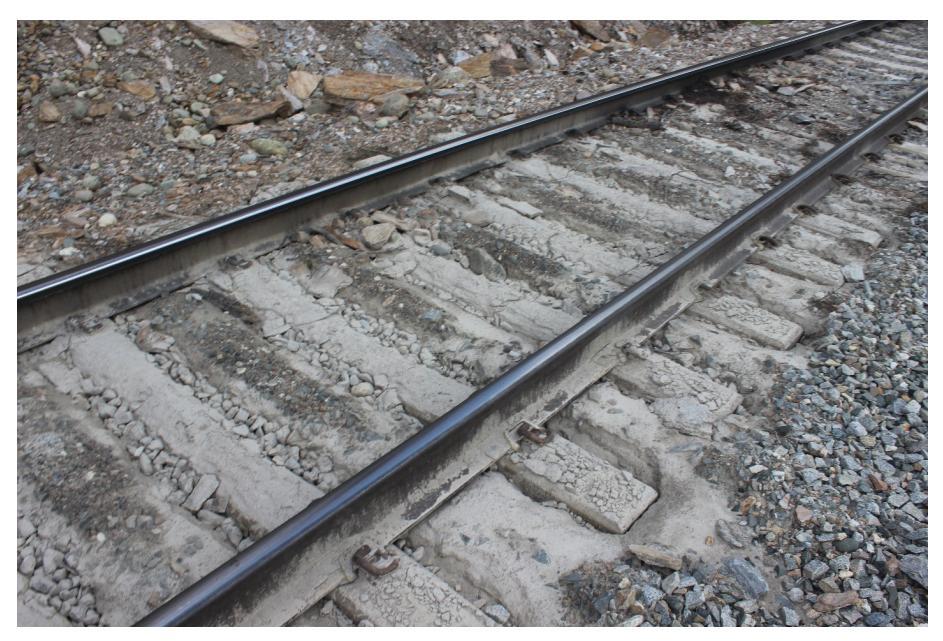
Figure E-33: Severe pumping, Tangent #7

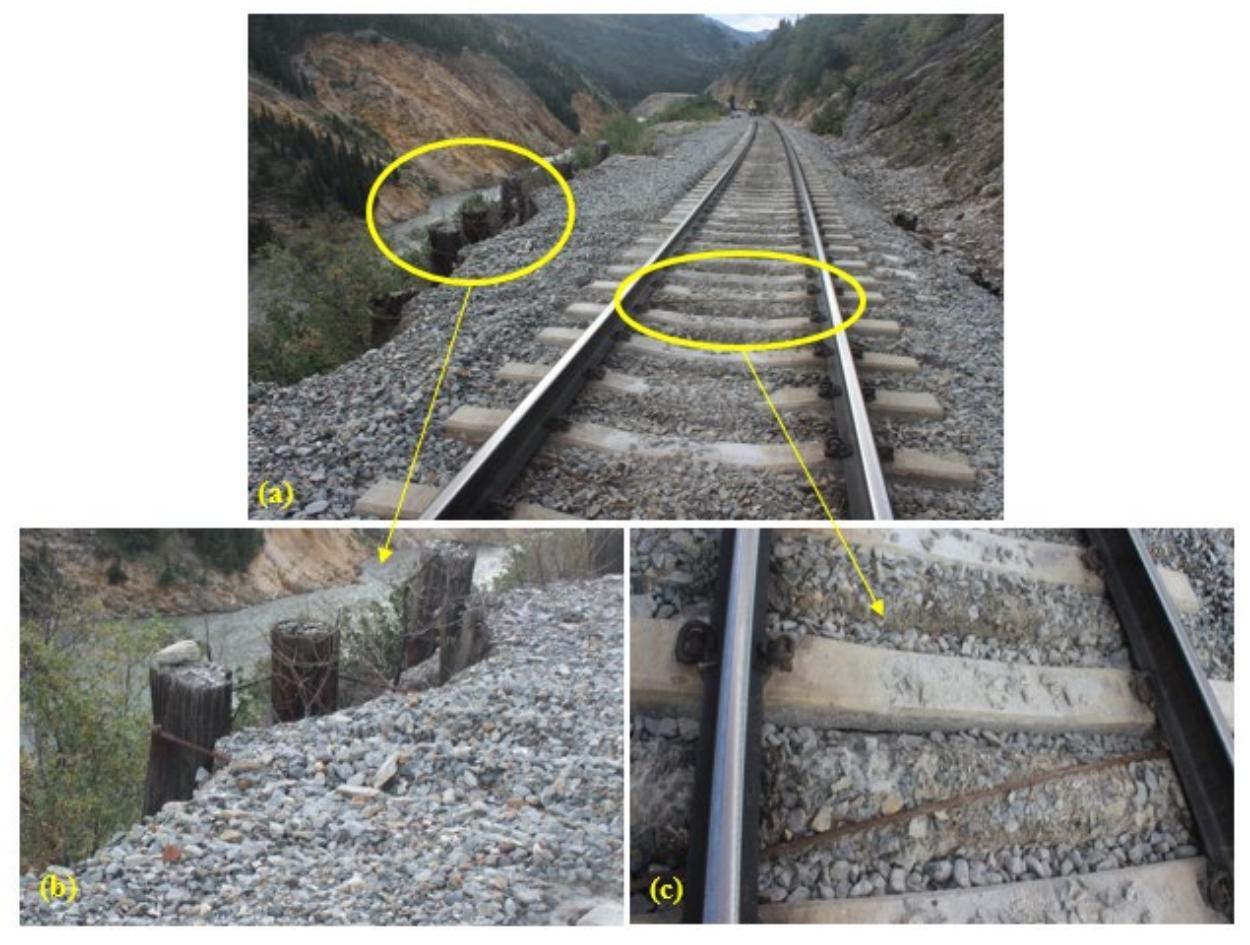
The area surrounding the track did not appear stable. There is evidence of occasional landslides on to the track, and poor slope stability under the track. In one location, wooden piles with steel cable tie-backs had to be installed in track to prevent further slope erosion, Figure E-36. Many ties appeared to have little or no ballast support. Some ties even appeared to be below grade.

Figure E-36: Wooden piles with tie-back cables to stabilize the track, Tangent #7

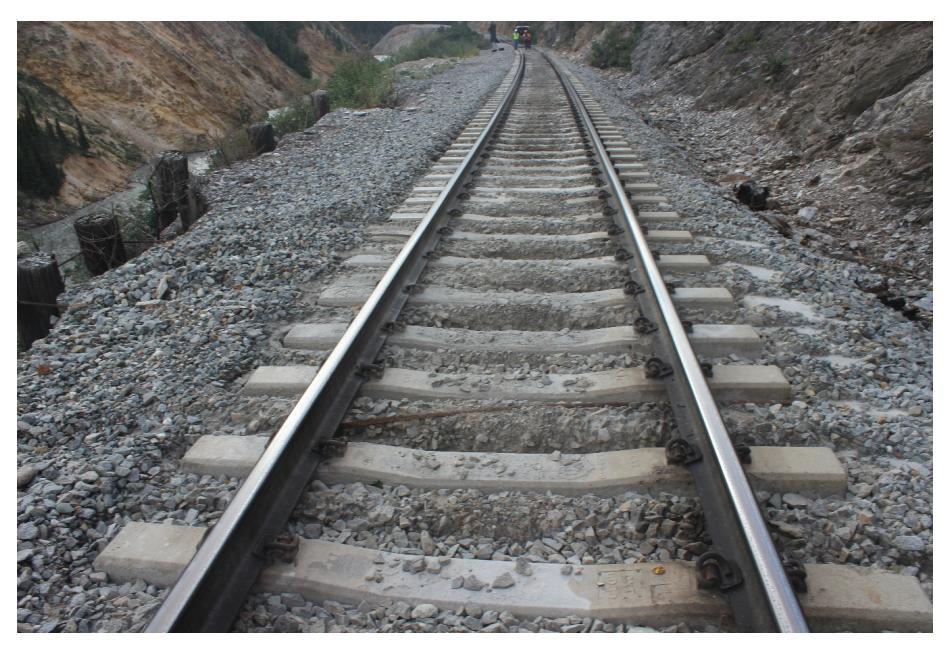
Track drainage issues were apparent. The railroad had dug trenches in track to drain water from the track in pumping locations, Figure E-37. Drainage ditches were clogged by debris in some areas from rack falls, Figure E-38. Algae was also seen covering standing water in the drainage ditch. A drainage pipe was installed in track to further assist with drainage, Figure E-39. One tie was seen with some wear seen on the tie end, as shown in Figure E-40. The damage went up to the ballast level and could have been caused by the ballast movement between the tie and a stiff spot in track to the side of the tie. Track maintenance is difficult in this section due to utility locations.

Figure E-37: Trenches dug in ballast to drain water ponding in track, Tangent #7

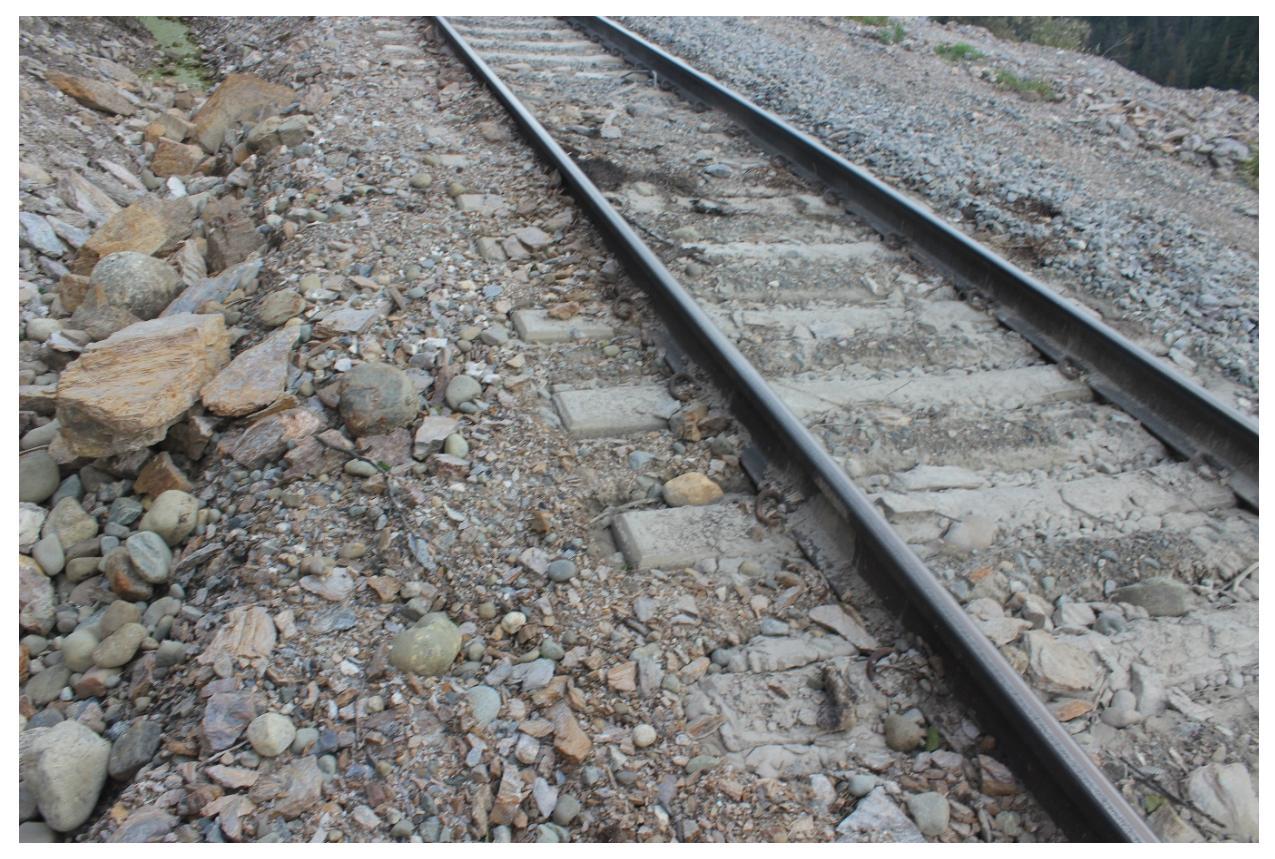
Figure E-38: Debris and algae covering standing water seen in drainage ditch, Tangent #7

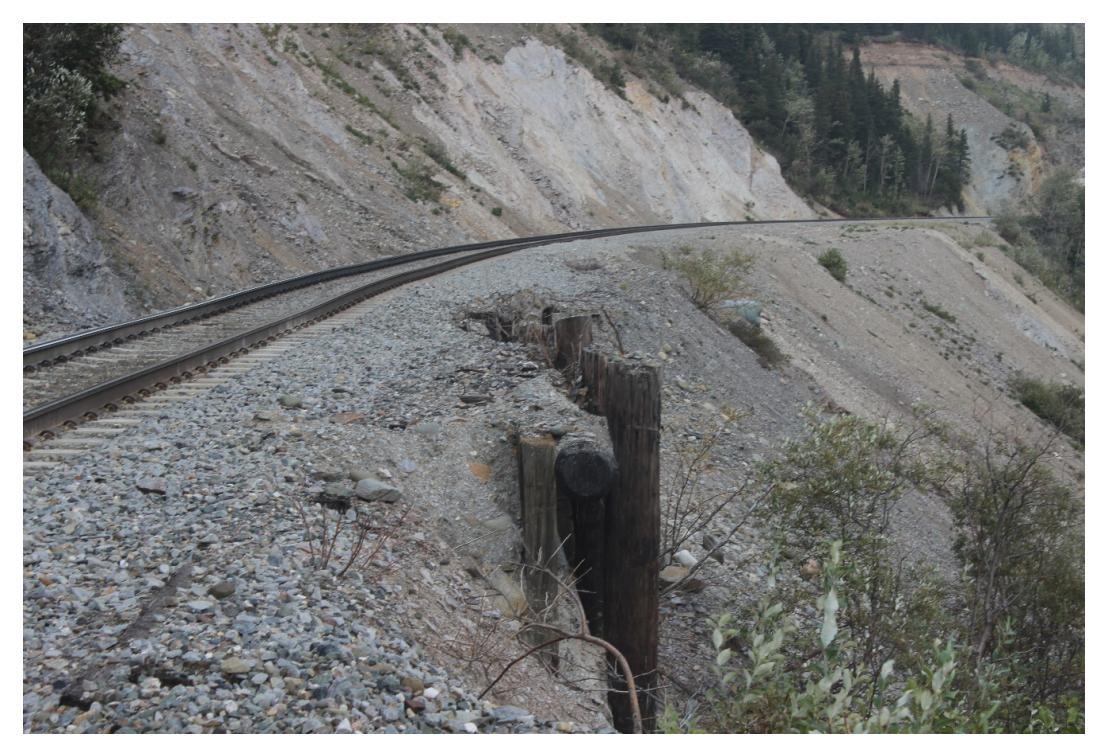
Figure E-39: Drainage pipe crossing under track, Tangent #7

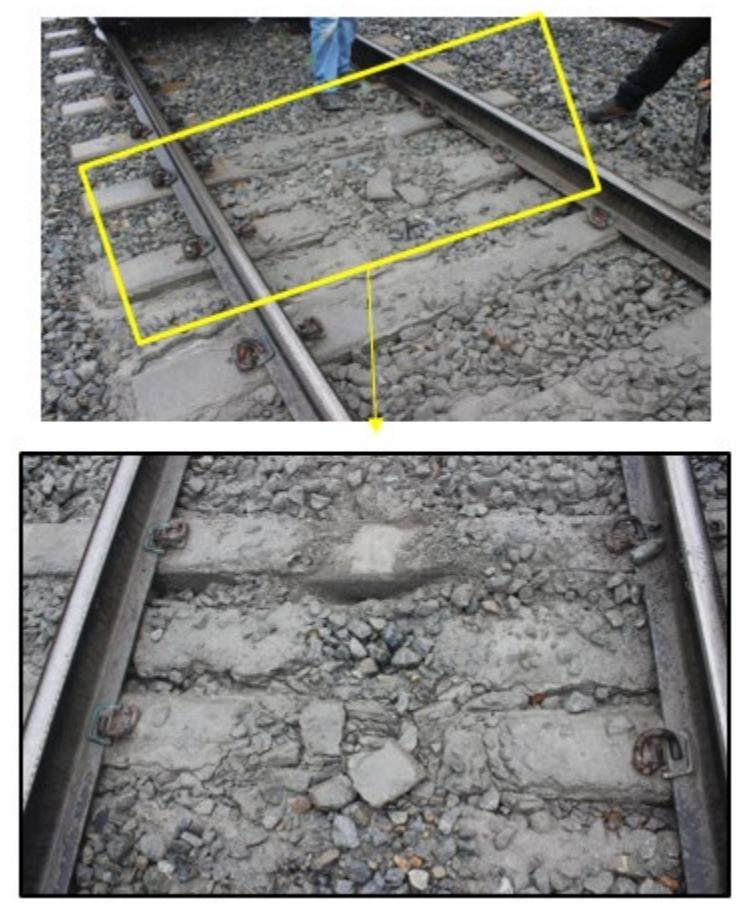
This location was in a tangent track on high embankments. Severe fouling was seen at the surface around six ties at one location. One of the ties was shattered as shown in Figure E-41. Figure E-42 shows the pumping products at one end of the tie. Fines in the track appeared to initiate underneath the surface and come to the top during pumping action.

Figure E-41: Shattered ties, Tangent #8

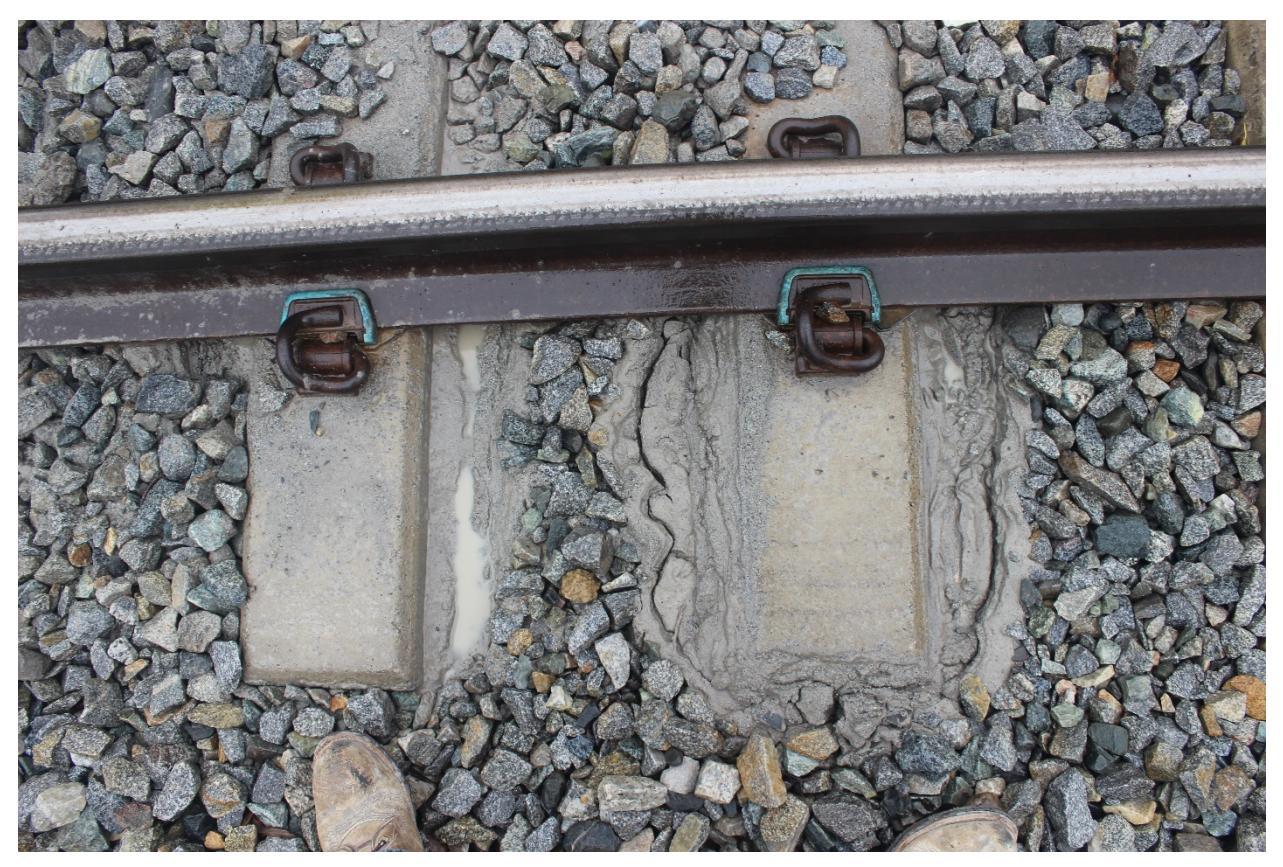
Figure E-42: Pumping produces fine particles around the tie, Tangent #8

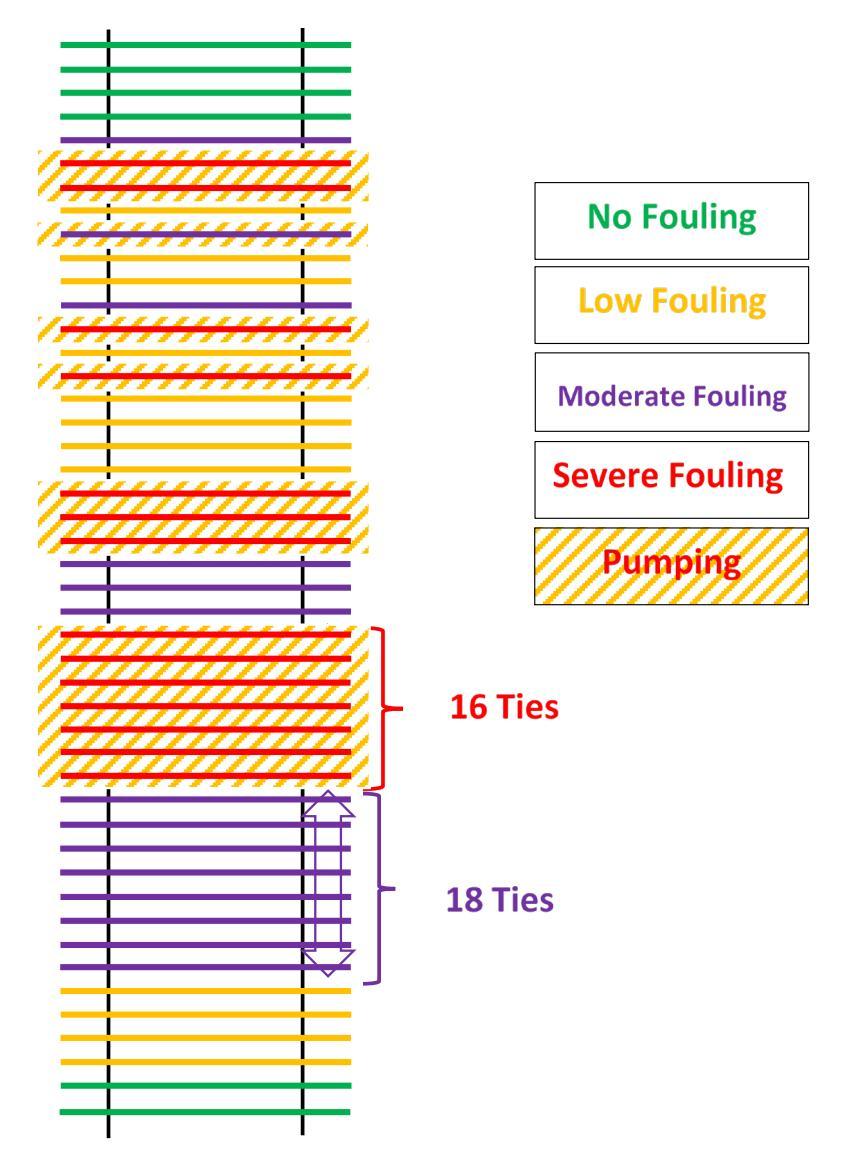
Railroad personnel reported that this location requires routine maintenance. Ballast fouling was seen in track beginning on the sixth tie after the wood-to-concrete tie transition. Figure E-45 shows a schematic of the ballast fouling visible on the track surface. Evidence of severe pumping was also seen in track, as shown in Figure E-46. The fouling had a different color than the typical gray mud typically seen in track locations with concrete abrasion damage. The color of the fines was like that of the soil next to the track. This is most likely because the track had only a thin layer of ballast underneath the ties and was in a low spot. Some ties with shattered top sections were seen in track, as shown in Figure E-47. In areas with excessive fouling and pumping, center-binding cracking was seen after the ties were uncovered as shown in Figure E-48. Figure E-49 shows a picture of welds in the rail after a section of the rail had to be replaced in 2010, only a few years after the concrete ties were installed. There were also small rock slides on the hill above the track, interfering with drainage and causing fouling in track.

Figure E-45: Schematic view of fouling condition, Tangent #9

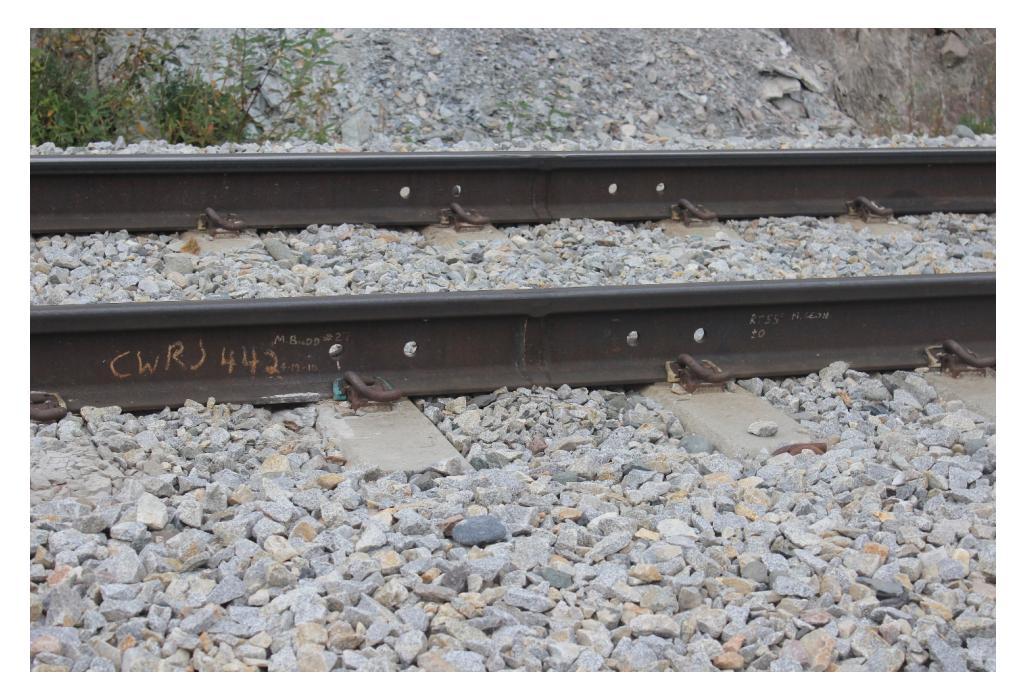
Figure E-49: Rail welds, Tangent #9

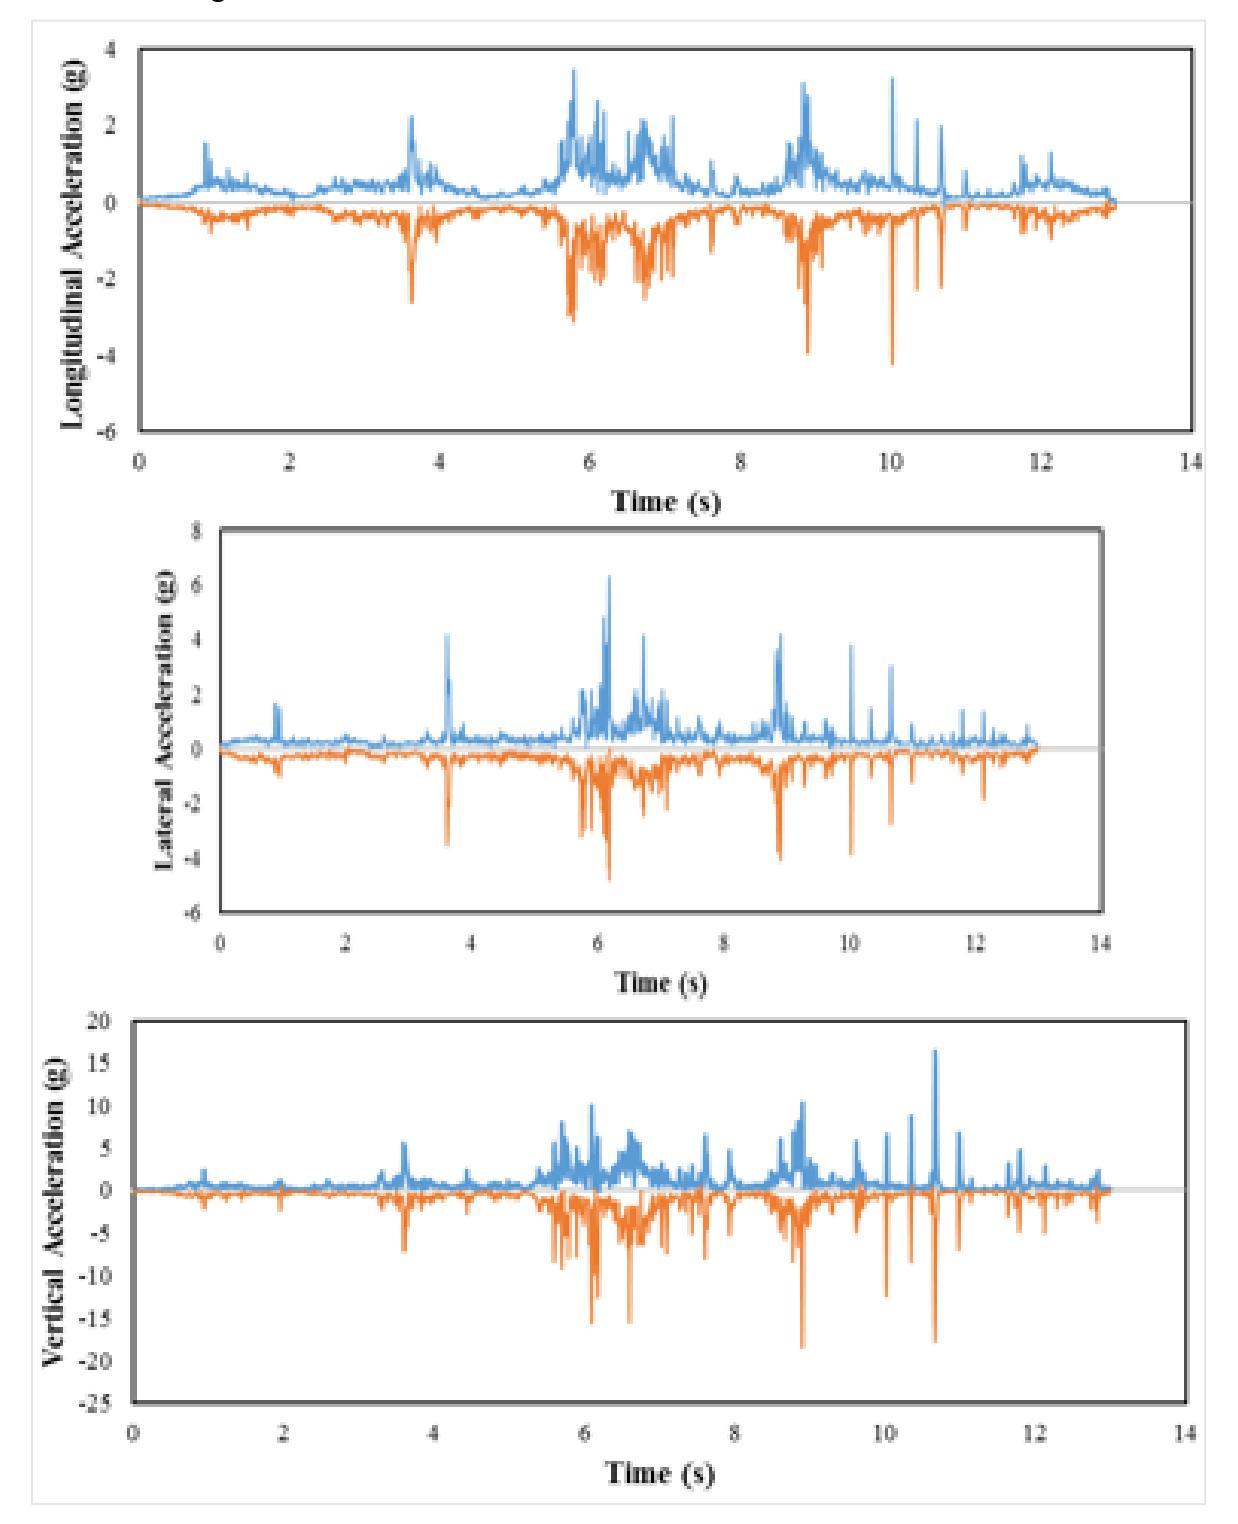
Tie acceleration measurements were taken on the UPV tested tie UPV during two train passes. A three-directional accelerometer was attached to the tie shoulder using hot glue. The tie acceleration was measured at a 20-kHz sample rate. Figure E-51 shows the acceleration as a passenger train passed, while Figure E-52 shows the tie acceleration as a freight train passed. High accelerations were measured in the vertical direction, indicating poor support under the tie.

Figure E-51: Measured tie acceleration during a passenger train pass, Tangent #9

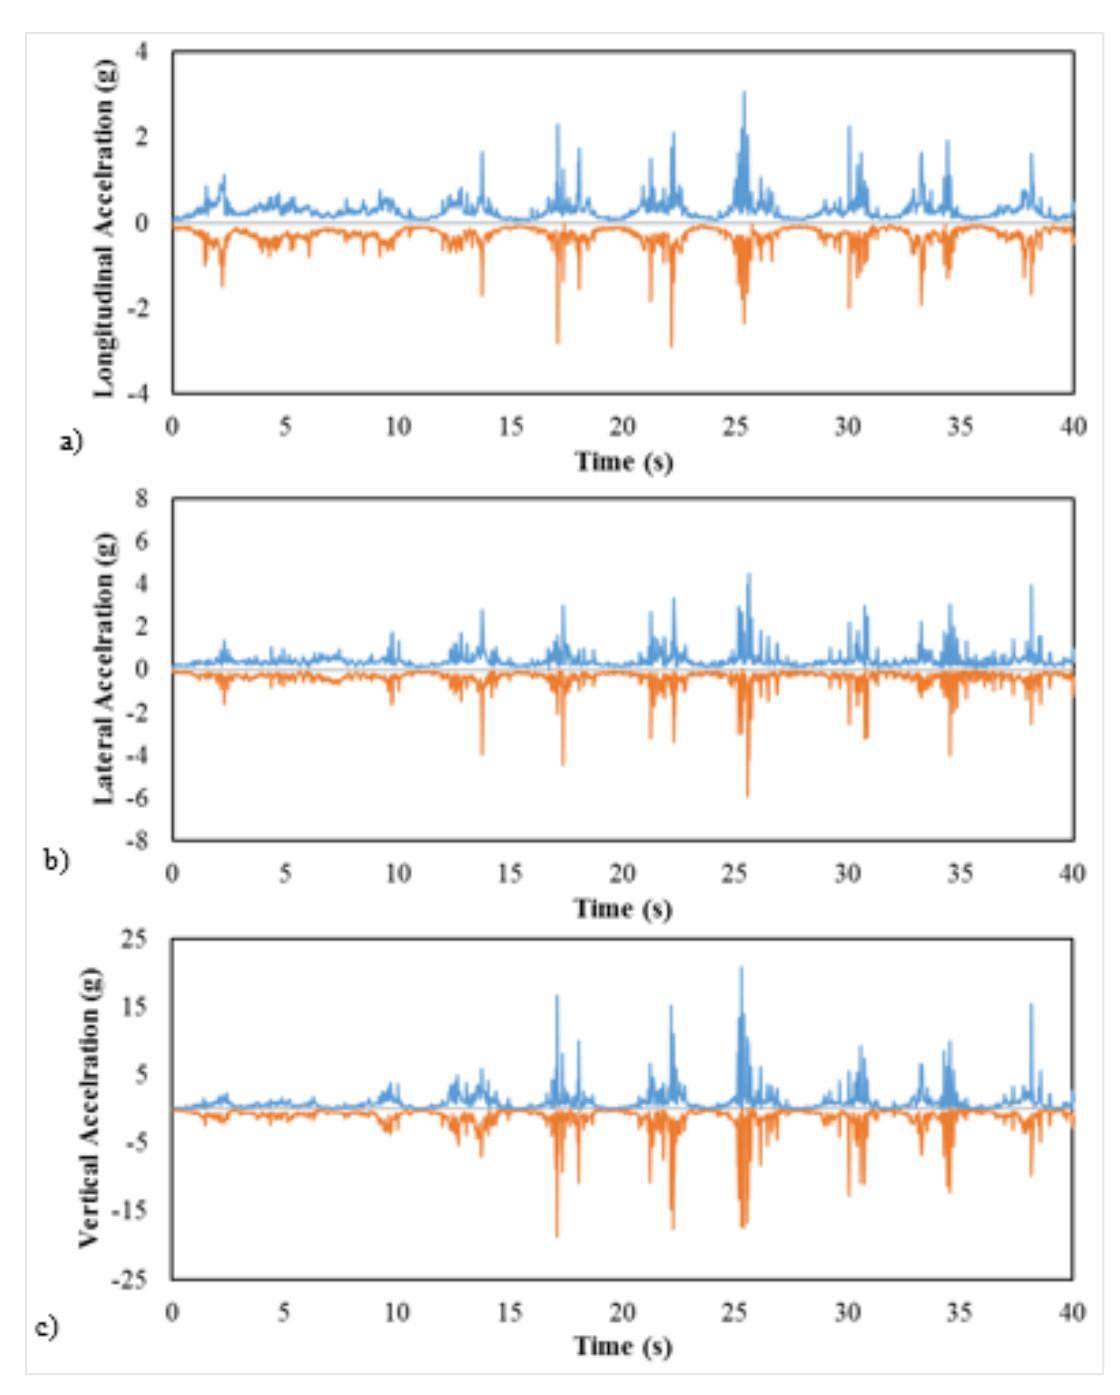
The tie showed slightly higher accelerations in the vertical direction from the freight train likely because of the higher loads.

Figure E-52: Measured tie acceleration during a freight train pass, Tangent #9

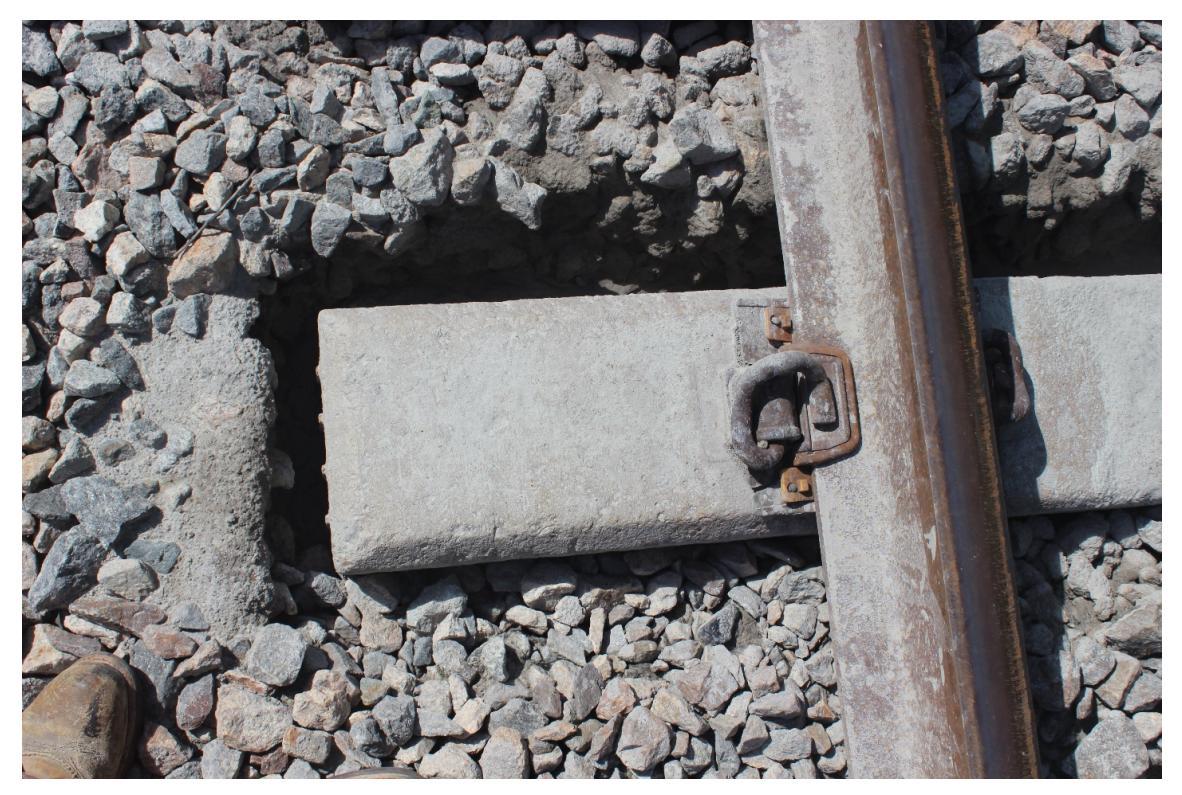
Recent mud pumping was evident from examining the track conditions, Figure E-56. Moderate center binding cracking was seen on the site. Fines were seen deposited on the edge of the ballast on the side of the road where the water drains out of the track structure, as shown in Figure E-57. Vegetation was also seen encroaching on the track structure, indicating that water is available at least during the summer season. The railroad indicated that they had been stacking trains to run at night. The weather patterns in this region showed that it was more likely to rain while the trains were running at night, increasing the amount of mud pumping.

Figure E-56: Tie pumping, Tangent #11

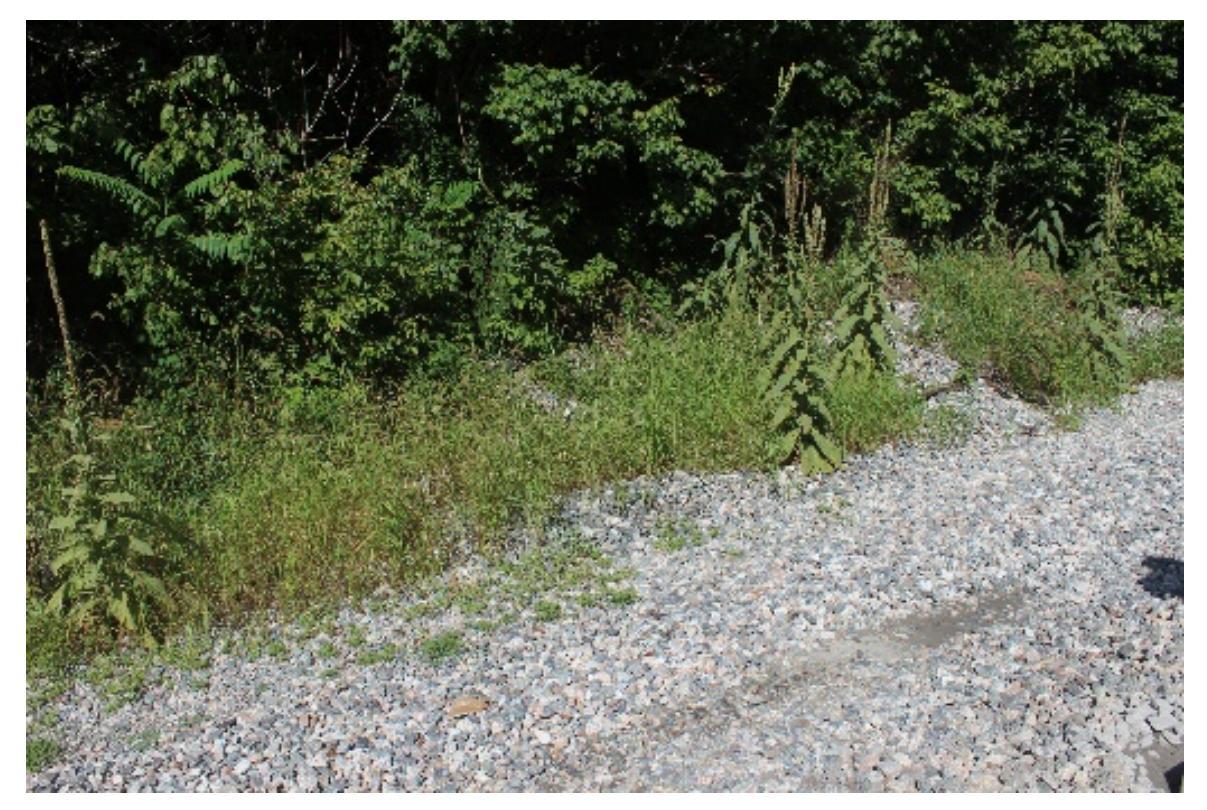
Figure E-57: Fines and vegetation adjacent to track, Tangent #11

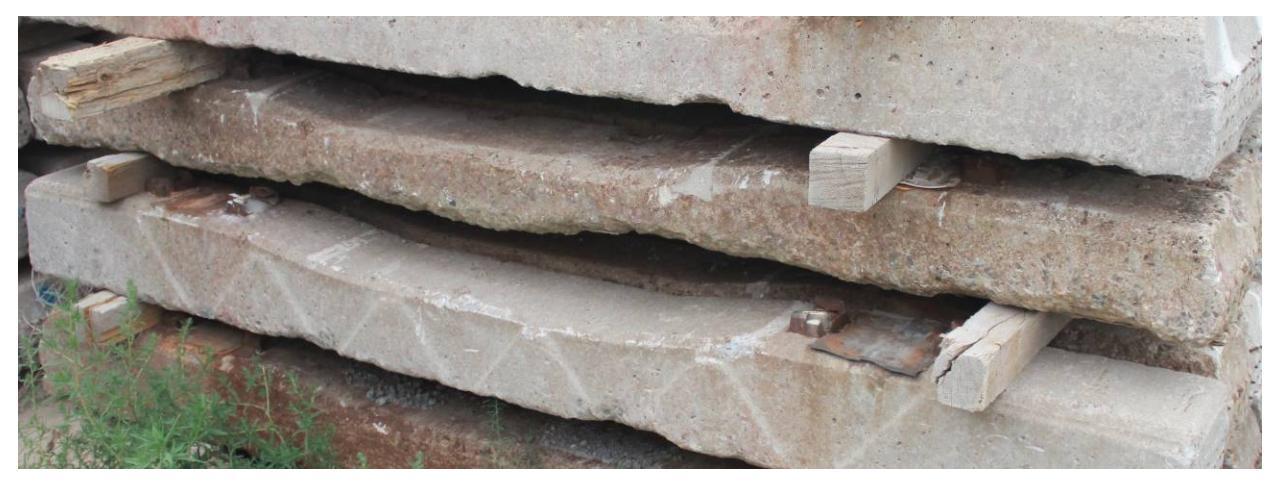
Figure F-2: Tie with significant non-uniform abrasion damage, Boneyard #1

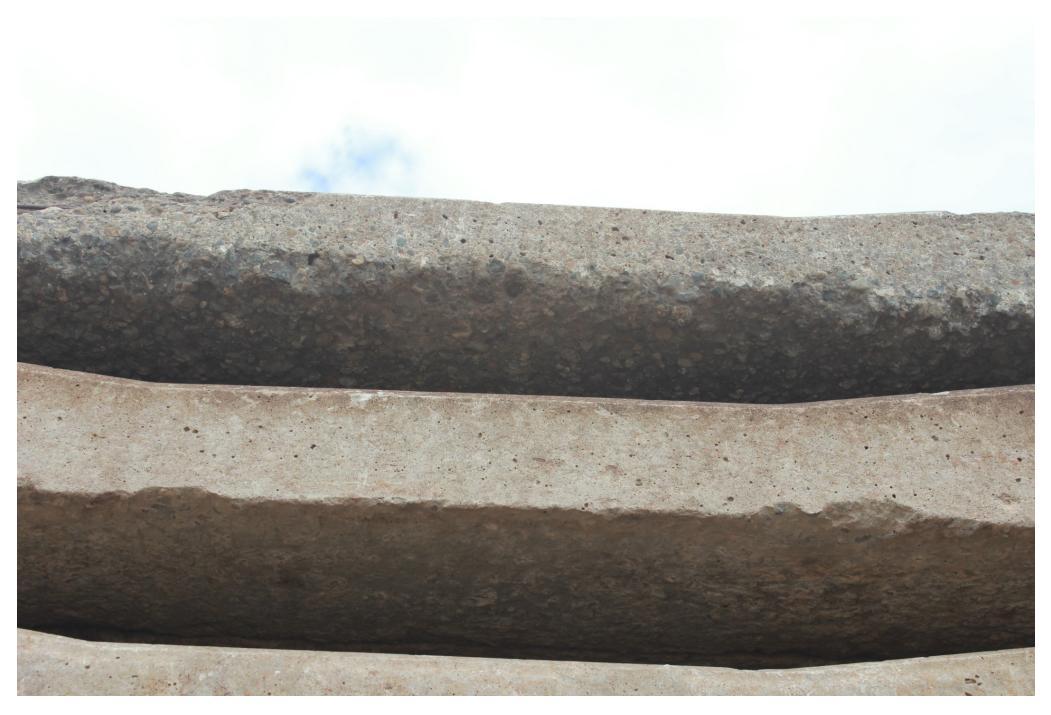
Figure F-3: Picture of tie bottom with severe abrasion damage, Boneyard #1

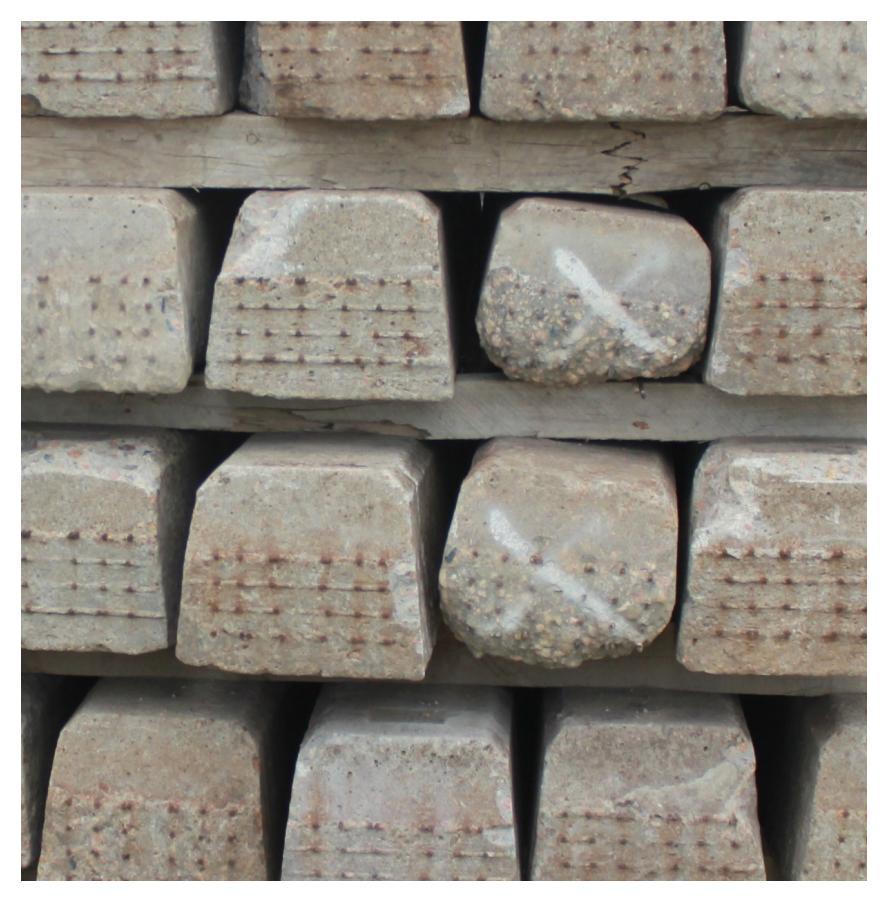
Figure F-4: Tie ends with moderate-to-severe abrasion damage, Boneyard #1

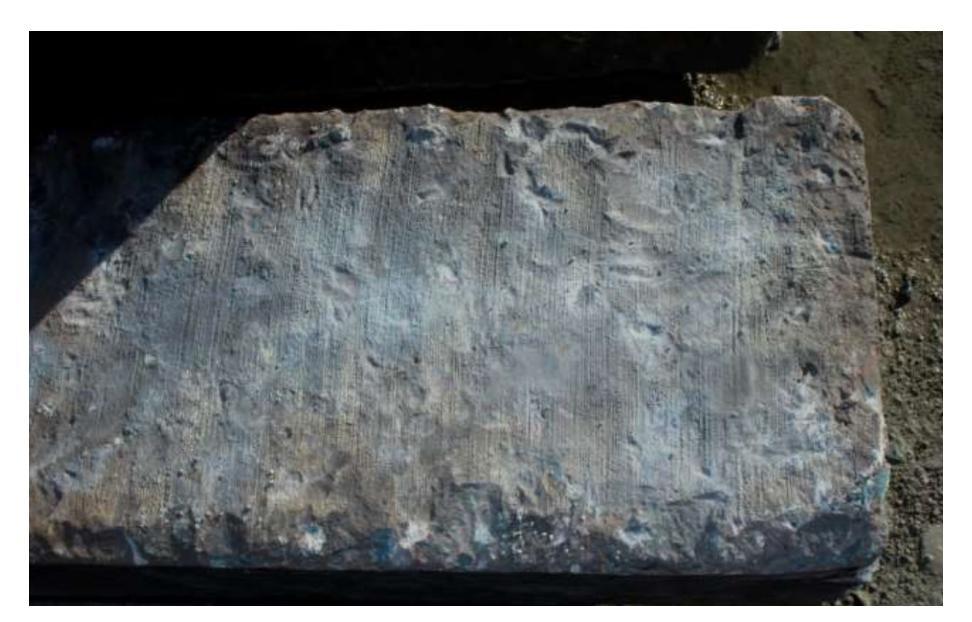
The ties in stack 1 consisted primarily of ties made in 1995 with eight smooth reinforcement strands. Most of the ties in stack 1 were in good condition, with very little abrasion damage. Many of the ties still had the original broom finish visible on the bottom, as shown in Figure F-7. Some ties showed a moderate amount of abrasion, such as the tie shown in Figure F-8. Some minor rail seat deterioration was present on several ties. Longitudinal splitting cracks were more common in ties in stack 1 stack than abrasion damage. The cracking extended to the top row of strands, Figure F-9. Cracking was observed in 5–7 percent of the ties in stack one, however, it is not known is these cracks were the result of tie removal and handling process or in-service conditions.

Figure F-7: Broom finish still visible on bottom of many ties in stack 1, Boneyard #2

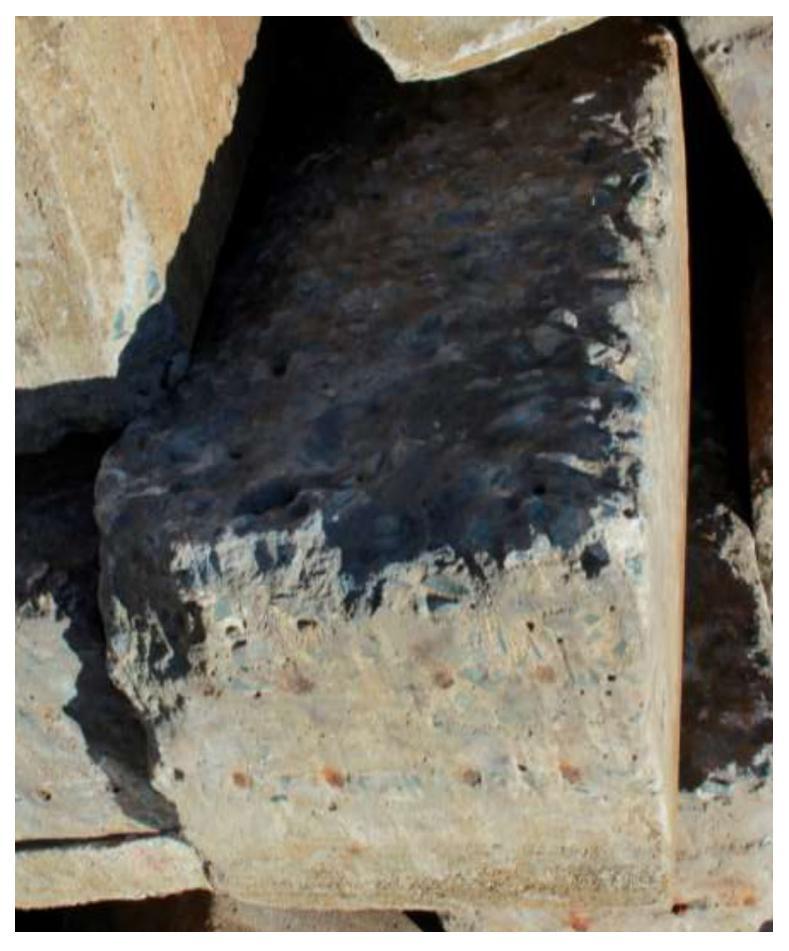
Figure F-8: Minor abrasion present in tie in stack 1, Boneyard #2

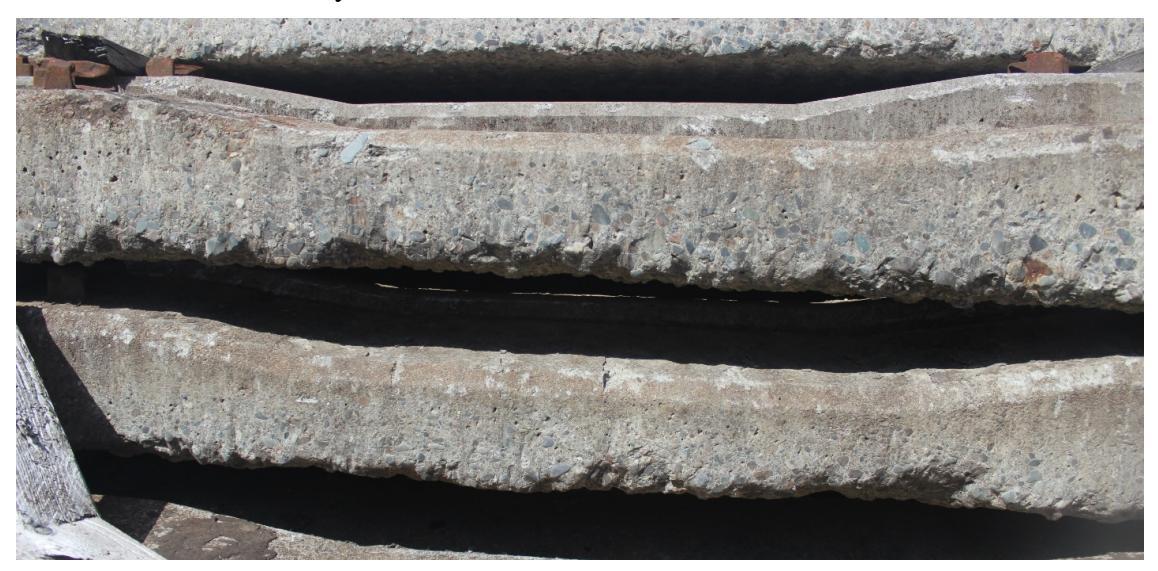
Figure F-11: Abrasion on the bottom of the tie, Boneyard #3

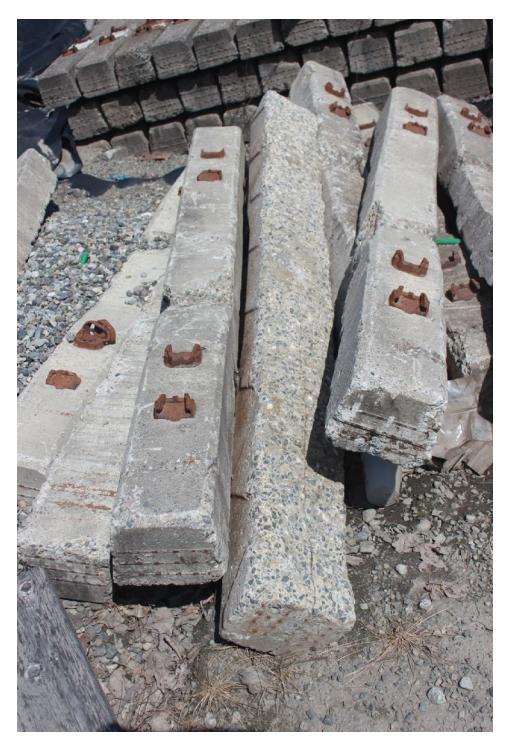
Figure F-12: Tie with some abrasion damage, Boneyard #3

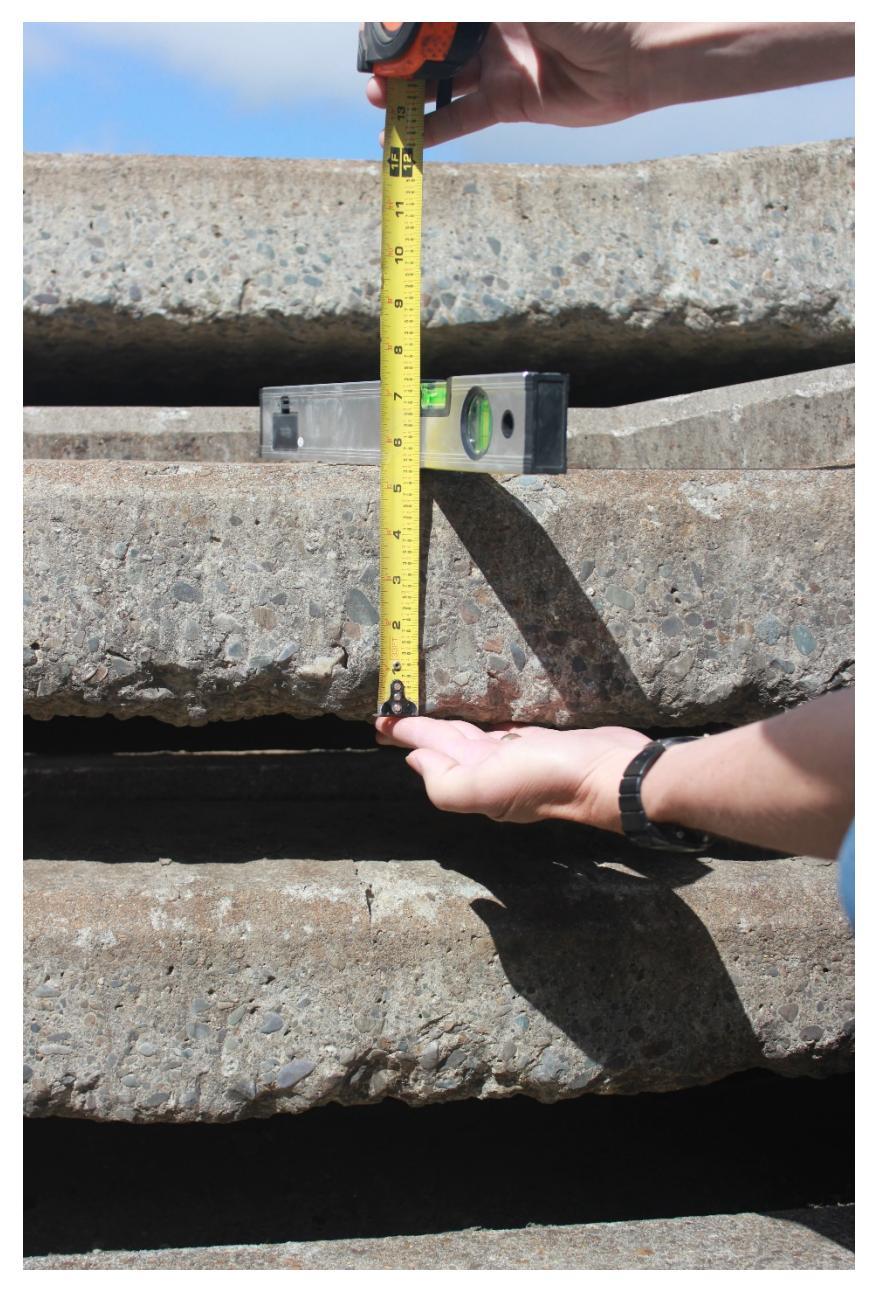
Figure F-14: Tie thickness measurement, Boneyard #3

Location	Design thickness at location (in.)	Measured thickness (in.)	Estimated wear (in.)
Center	6.25	5.625	0.625
Center	6.25	5.125	1.125
