Federal Railroad Administration

DOT/FRA/ORD-19/38

Final Report October 2019

1. AGENCY USE ONLY (Leave blank)		2. REPORT DATE 3 October 2019		3. REPOR	3. REPORT TYPE AND DATES COVERED Technical Report April 2016 – August 2017	
4. TITLE AND SUBTITLE A Study of Environmental and Track Factors that Contribute to Abrasion Damage of Concrete Ties					5. FUNDING NUMBERS DTFR53-16-C-00009

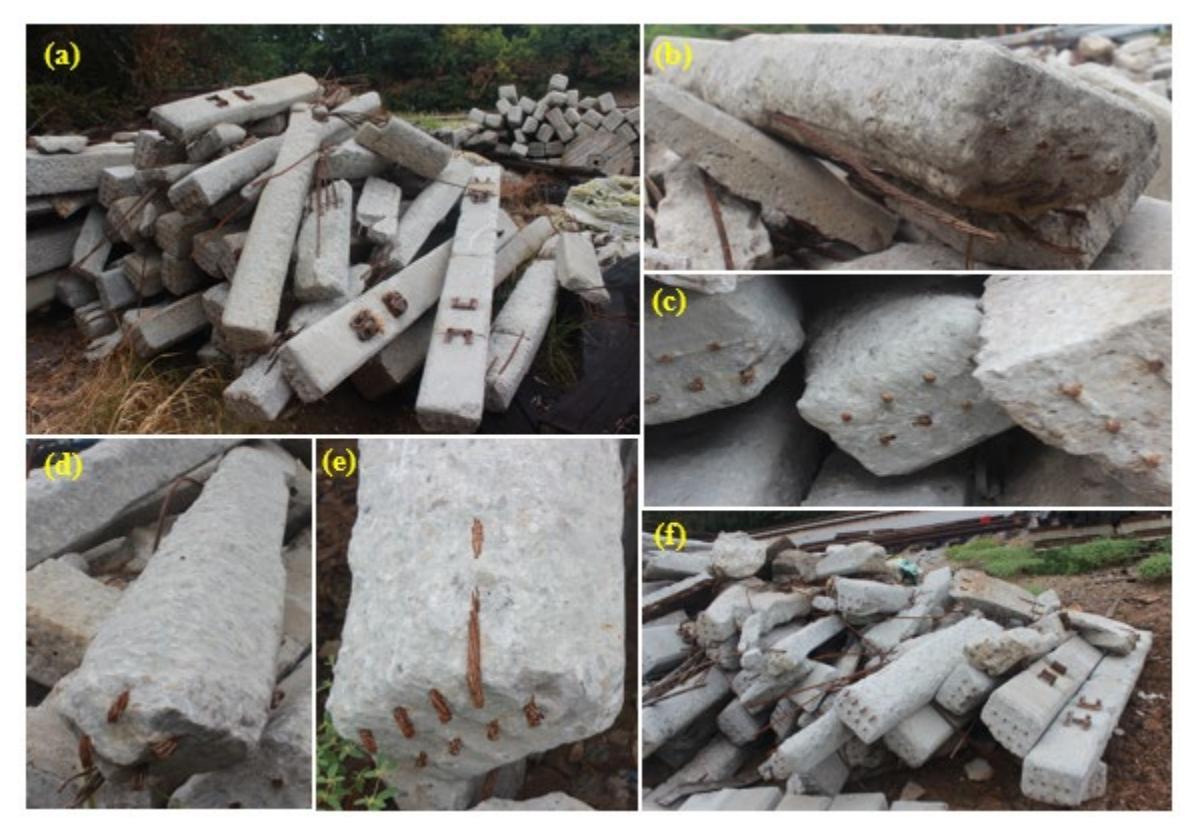
Many of the ties stored here had large amounts of bottom and side abrasion. Figure F-15 shows ties with abrasion damage that were stored in the boneyard. As shown in Figure F-15e, abrasion often rounds the bottom of the ties.

Figure F-15: Concrete ties found in the boneyard at a maintenance yard in the U.S. Southeast, Boneyard #4

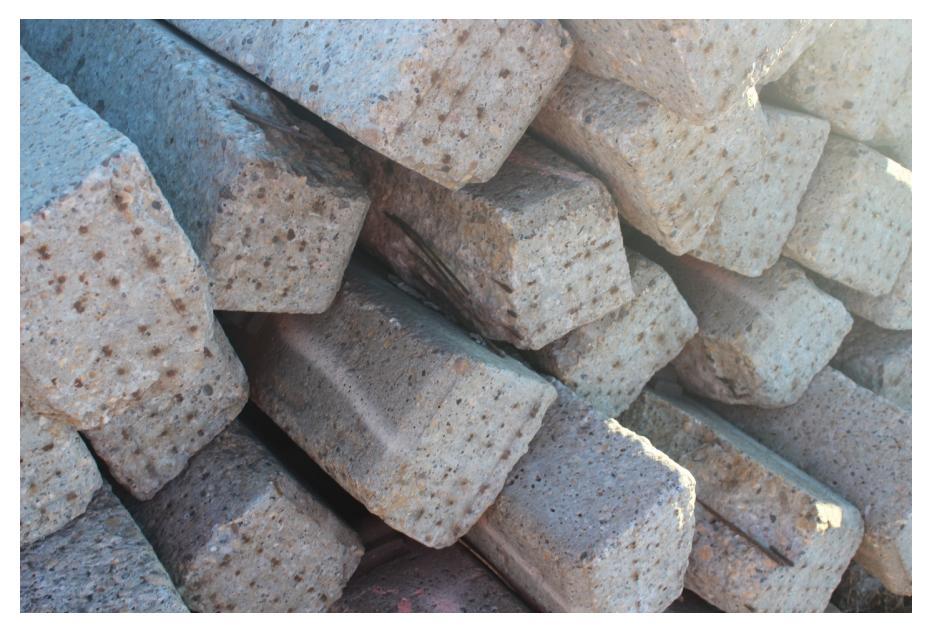
Figure F-16: Ties with minor abrasion, Boneyard #5

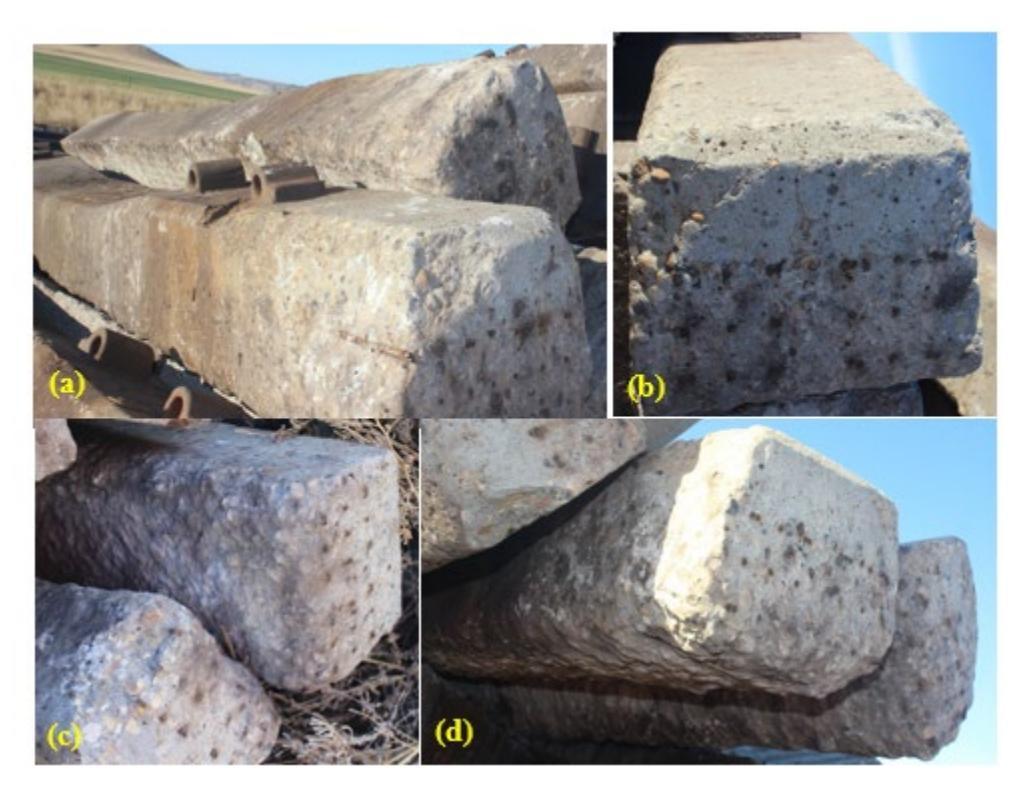
The nearby track carries large quantities of high-value commodities annually and is economically important to the railroads. Per the local road master, the track receives regular maintenance and has good ballast. The boneyard ties had only minor bottom-tie abrasion. Figure F-17 shows different ties with minor abrasion.

Figure F-17: Ties with minor abrasion, Boneyard #5

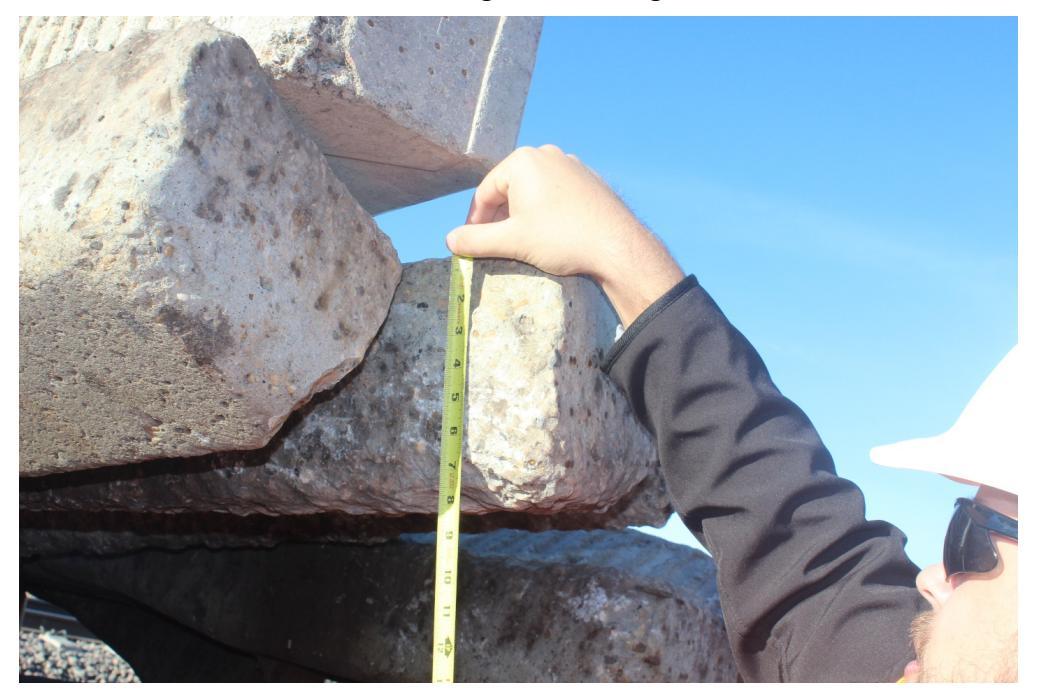
Figure F-18: Abrasion measurement, Boneyard #5

Location	Design thickness at location (in.)	Measured thickness (in.)	Estimated wear (in.)
Tie End	8.1875	7.5	0.6875
Tie end	8.1875	7.75	0.4375

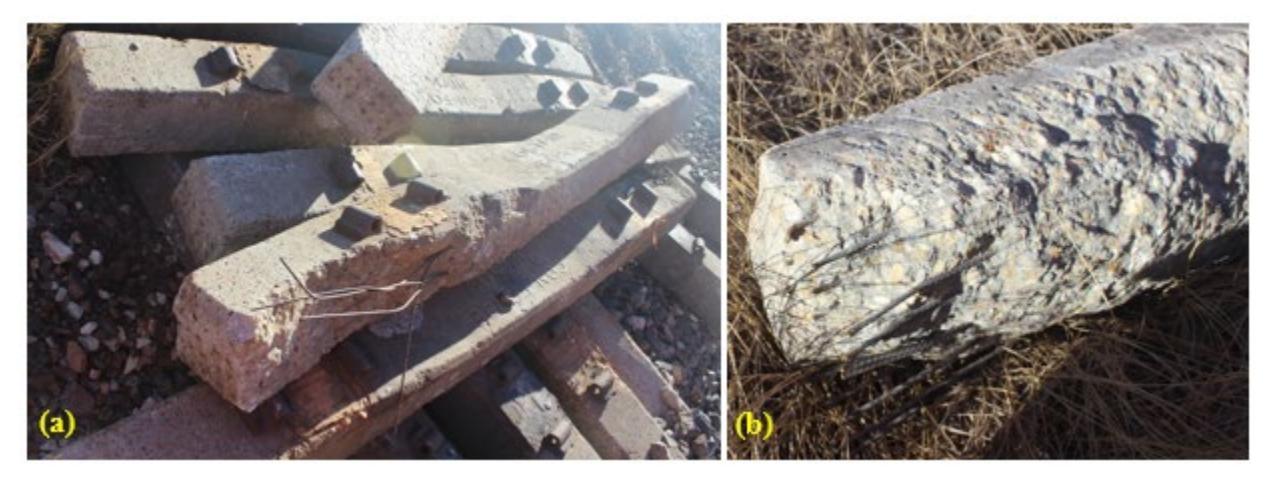
One tie examined had severe abrasion damage on one end, as shown in Figure F-21. The rest of the ties had no abrasion damage or some minor abrasion damage with corner rounding. Some concrete ties had minor center-binding cracking. The track was in very good condition with good ballast thickness under the ties and proper drainage. Some dry grass was seen at the site,

Figure F-21: Highly abraded concrete tie, Boneyard #6
