RR 20-04 | May 2020

FIRE RESISTANCE TESTS OF REDUCED SCALE RAIL CAR FLOOR ASSEMBLIES

SUMMARY

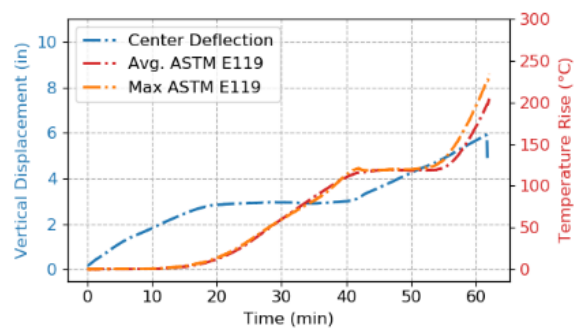
Figure 6: Test 3a deflection and temperature rise

Tests 3a and 3b were conducted simultaneously. Temperature rise and deflection measurements for Tests 3a and 3b are shown in [Figure 6](#) and [Figure 7](#), respectively. Test 3a supported the load for the test duration but failed the average temperature rise requirement at 57 minutes. The test was terminated at 62 minutes due to flaming ignition on the unexposed surface. Test 3b failed due to exceedance of the average temperature rise criterion at 20 minutes and exhibited structural failure due to exponential increase in deflection at 49 minutes.

assembly, resulting in an identical thermal resistance for both scaled specimens. Both tests were expected to have similar deflection, but there was more deflection in Test 2 than Test 3a, see [Figure 5](#) and [Figure 6](#). While the structural design and distributed load of these were the same, the edges of the assemblies were partially shielded from the furnace exposure with the thermal blanket to prevent hot gasses from escaping. This may be more pronounced in Test 3a since this may have partially shielded the transverse beams on the edges in the assembly.
