FULL-SCALE SHELL IMPACT TEST OF A DOT-113 TANK CAR SURROGATE

SUMMARY

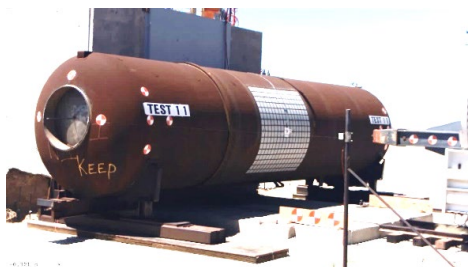
On June 11, 2020, the Federal Railroad Administration (FRA) conducted a full-scale shell impact test (Test 11) of a surrogate DOT-113 specification tank car at the Transportation Technology Center (TTC) in Pueblo, CO. This test was the second DOT-113 impact test in a planned series of four. A DOT-113 is a double-walled tank car (i.e., tank-within-a-tank) designed to transport authorized cryogenic liquids by rail. The test “surrogate” was purpose-built for this test with the essential features of a DOT-113 and an outer tank of a thicker, higher-grade steel than required by specification. The tested surrogate did not feature all the equipment required of a tank car (e.g., couplers and trucks). The shell of the outer tank was struck by a 297,000-pound ram car equipped with a 12-inch by 12-inch impactor at its mid-height and longitudinally offset 2 feet towards the A-end. This offset impact location was intended to be consistent with the impact location in the previous DOT-113 impact test in November 2019 (Test 10). [Figure 1](#) shows the tank car in its pre-test position against the impact wall at the TTC.

Figure 1. Pre-test Photo of DOT-113 Surrogate

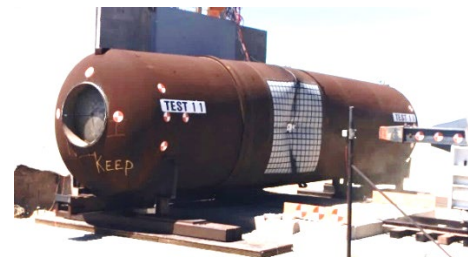
The tank car resisted the impact without tearing either the inner or the outer tank. After making contact, the impactor indented the DOT-113 surrogate to a maximum depth of ~61 inches before stopping and rebounding. The impact reached a maximum force of ~1.1 million pounds. [Figure 2](#) shows the tank car outer shell immediately following rebound of the ram car.

Figure 2. Post-test Photo of the Surrogate

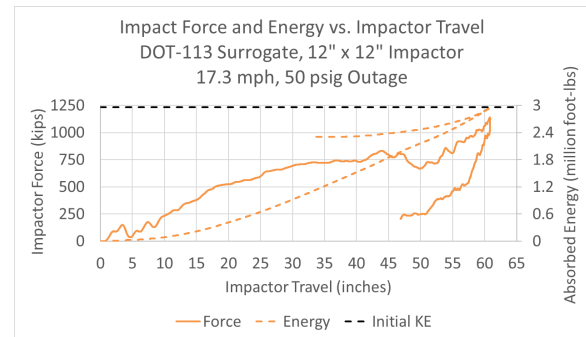
The impact occurred at 17.3 mph and resulted in the ram car coming to a stop and rebounding without puncturing either tank. The force-displacement and energy-displacement results from the test are shown in [Figure 4](#). The force results are calculated by the average of the five longitudinal accelerometers on the ram car multiplied by the mass of the ram car. A CFC-60 filter has been used on these results in accordance with the Society of Automotive Engineers (SAE) J211-1.

Figure 4. Test Force-displacement Results at 17.3 mph (CFC-60)

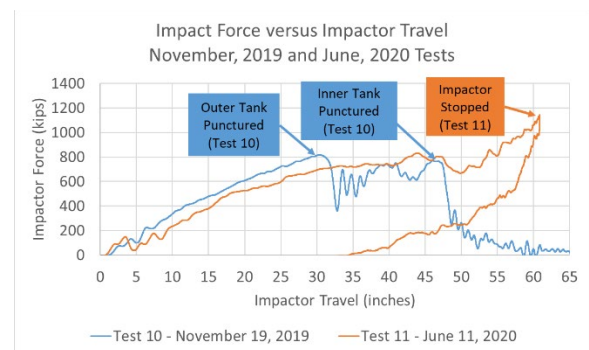
[Figure 5](#) shows a comparison between the force-displacement responses measured in Test 10 and Test 11. Both tests were performed using the same impactor, lading outage, and initial outage pressure. Test 10 had an impact speed of 16.7 mph and resulted in puncture of both the inner and outer tanks. Test 11 had an impact speed of 17.3 mph and did not result in puncture of either tank.

Figure 5. Force-displacement Results from Test 10 and Test 11 Tests (CFC-60)

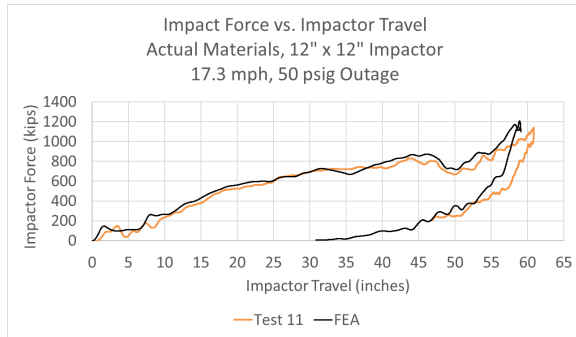
[Figure 6](#) shows a comparison between the force-displacement response measured in the June 2020 test and the force-displacement results from the pre-test FE model updated with the measured impact speed of 17.3 mph. While the model included material behaviors that would allow both the inner and outer tank to puncture in the simulation, the model did not experience tearing in either tank under the simulated test conditions.

Figure 6. Test and FE Model Force-displacement Results at 17.4 mph (CFC-60)
