BNSF Railway

Safety Culture

Assessment Report

August 26, 2024

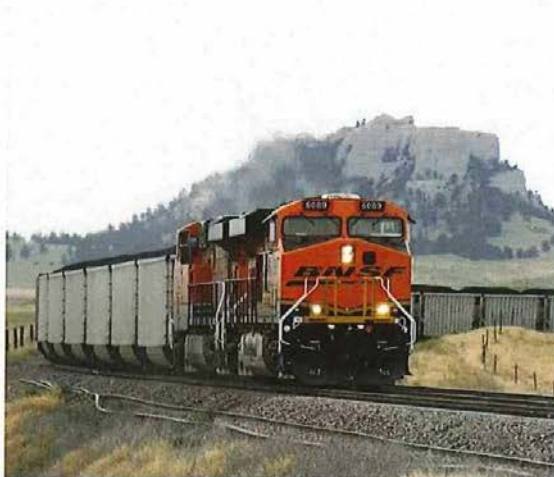
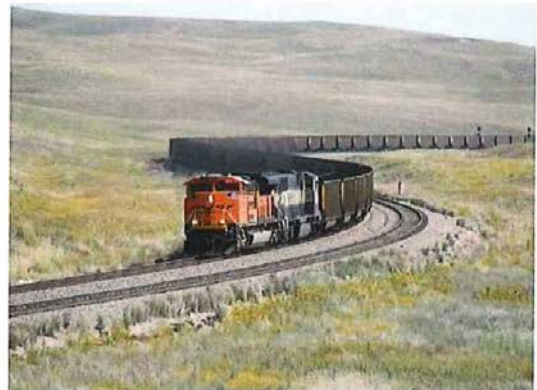
Use of Distributed Power Set Out Mode to Prevent Unintended Movement

Distributed power (DP) is a long-standing, proven technology widely in use by railroads around the globe. More importantly, DP is recognized as a safe technology enabling numerous benefits when properly utilized.

It is important that Engineers ensure **Remote Mode Set Out (S/O)** is used properly to prevent DP remote(s) from unintended movement when separated from the front portion of the train. The train crew is responsible for securing the equipment left standing before cutting away to mitigate the risk of exposures from undesired movement.

When properly used, **S/O** mode does the following:

- Independent brakes on remote(s) are set when **S/O** mode is initiated.
- Remote throttle remains in idle and dynamic brake functions are not enabled.
- Emergency brake application is enabled for control.
- All other functions are disabled, and brake valve is cut out. **Exception:** If lead and remote unit(s) are equipped with LXA the brake valve will remain Cut-in on the DP remote unit.

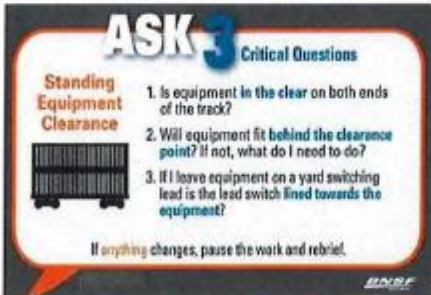
Standing Equipment Clearance

Leaving on-track equipment, railcars and/or engines clear of adjacent track is vital for the safety of workers who may be riding the side of equipment to perform their duties.

In most cases, railroads require equipment intentionally left standing on track to be left beyond a **clearance point**. This is the location closest to a switch where it is safe for equipment and a person riding the side of equipment (unless prohibited) to pass equipment on an adjacent track. Not all tracks have a clearance point; some adjacent tracks are positioned so that a person **should not** ride the side of equipment in

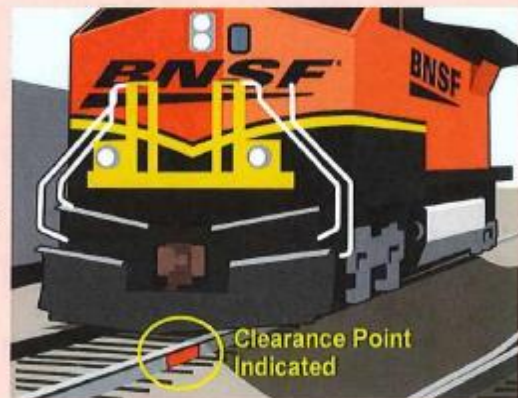
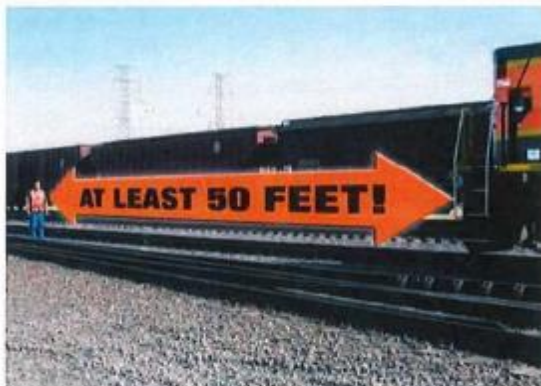
Unmarked Clearance Points

The clearance point is the location closest to a switch where it is safe for equipment and a person riding the side of equipment (unless prohibited) to pass equipment on an adjacent track.

Not all tracks have a clearance point; some adjacent tracks are positioned so that a person **should not** ride the side of equipment in those tracks.

- If the clearance point is not **indicated** or **visible**, stand outside the rail of adjacent track and extend an arm toward the equipment to be left on track until unable to touch the equipment.
- When unable to touch the equipment, leave the equipment **at least an additional 50 feet** beyond the clearance point or more if handling cars greater than 50 feet, due to swing out of longer cars while moving through turnouts.
- **DO NOT** guess or estimate whether or not equipment is in the clear of adjacent track. Misjudgment could lead to a serious outcome.

- If the clearance point is **not indicated** or **visible**, stand outside the rail of adjacent track and extend an arm toward the equipment to be left on track until unable to touch the equipment.
- When unable to touch the equipment, leave equipment **at least an additional 50 feet** beyond the clearance point or more if handling cars greater than 50 ft., due to swing out of longer cars while moving through turnouts.
- **DO NOT** guess or estimate whether or not equipment is in the clear of adjacent track. Misjudgment could lead to a serious outcome.

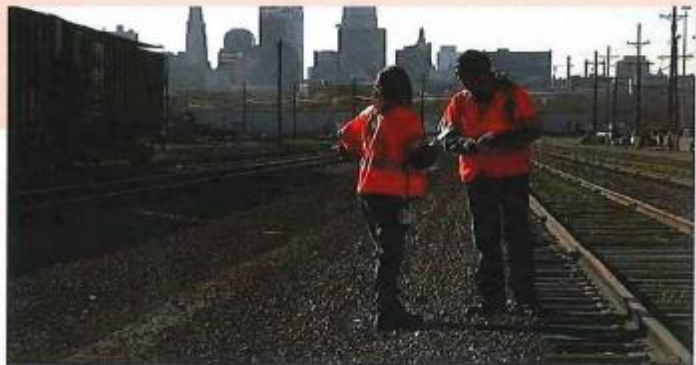
Employees Fouling Track

- Remain alert and attentive at all times.
- Look in both directions, watch for moving equipment on adjacent tracks, and cross in front of approaching equipment only when sufficiently ahead of the movement to do so.
- Don't lose focus of movement on adjacent tracks.

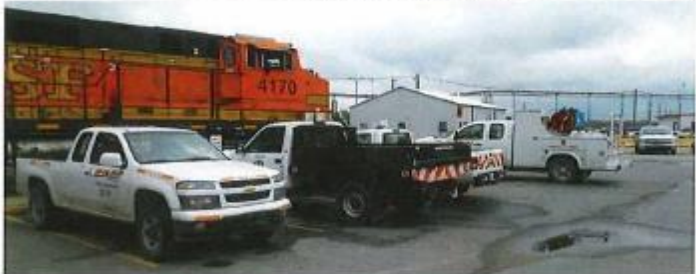
Fouling Track When Operating Vehicles

- Do not park so that the vehicle is fouling a track or roadway.
- If fouling is necessary to perform duties, do so only if proper protection has been established.
- When at non-public crossings, stop before crossing the track(s), unless the vehicle is foul of a previously crossed track. Yield to trains, engines, railcars, and on-track equipment and ensure the way is clear before proceeding across the track(s).

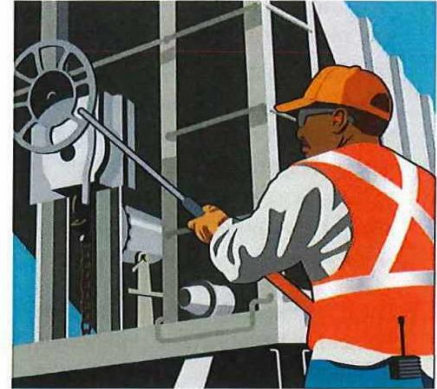
Crew members are responsible for securing standing equipment with handbrakes to prevent undesired movement. The air brake system must not be depended upon to prevent an undesired movement (ABTH 102.1). Transportation employees use handbrakes on a daily basis.

Understanding how handbrakes operate and using proper body positioning/mechanics to operate handbrakes (TYSR 13.6.3) is essential to your safety and the safety of others.

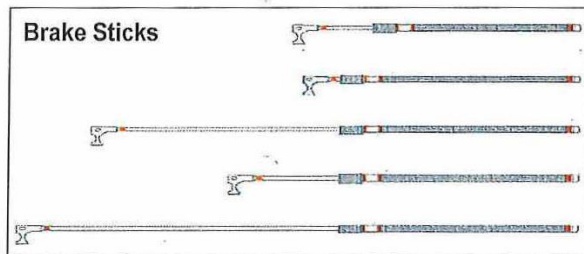
❑ What are some ways to mitigate/lower the risk of exposure when using a brake stick?

- Inspect the brake stick for defects before and after each use.
- Do not use a brake stick that is defective or has an unreadable serial number. Notify your supervisor.
- Do not walk backward while carrying a brake stick to avoid a slip, trip and fall exposure.
- Remain alert/attentive while carrying a brake stick and keep the long handle clear of adjacent tracks/out of the foul and away from striking another person.
- Wear gloves while operating a brake stick.
