U.S. Department  
of Transportation  
**Federal Railroad  
Administration**

RR 14-29 | August 2014

## FULL-SCALE SHELL IMPACT TEST OF A DOT-111 TANK CAR

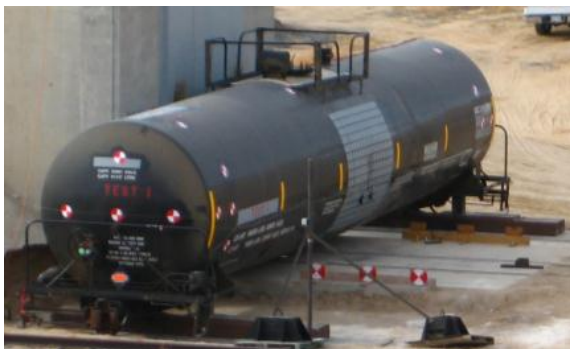
On December 18, 2013, FRA conducted a full-scale shell impact test of a DOT111A100W1 specification tank car (DOT111) at the Transportation Technology Center, Inc. (TTCI) in Pueblo, CO. The tank car selected for this test was a jacketed DOT111 (general purpose) tank car with heating coils and sloping shell rings. The shell of the car was struck at its mid-length by a 297,125 pound ram car equipped with a 12-inch by 12-inch impactor. Figure 1 shows the tank car in its pre-test position against the impact wall at TTCI.

Figure 1. Pre-test Photo of DOT111

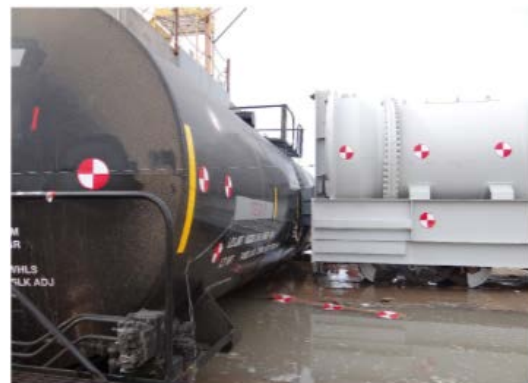
The objective of this test was to evaluate the structural performance of the DOT111 and provide data to validate existing computer models. The car was filled to approximately 97 percent of its capacity with water and it was not pressurized. The impact occurred at 14.0 mph, corresponding to an impact energy of approximately 1.95 million foot-pounds. This test resulted in puncture of the tank car's jacket and shell. Figure 2 shows the post-test position of the tank car and the ram car.

Figure 2. Post-test Photo of Tank Car and Ram Car

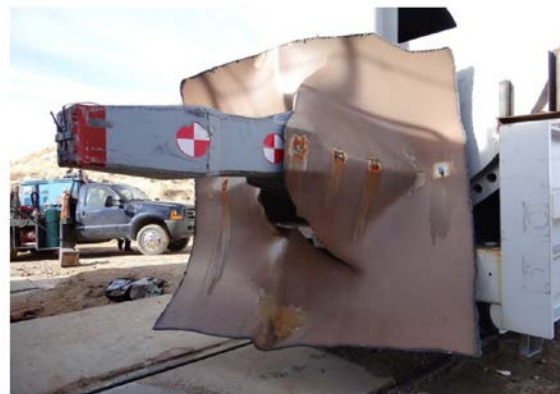
The peak impact force measured during the test was approximately 960 kips. The energy to just cause puncture was calculated to be 1.45 million foot-pounds, or the energy of a 12.1 mph impact with this impact vehicle. The interior of the puncture zone is shown in Figure 3, following removal of a portion of the tank's shell post-test.

Figure 3. Post-test Photo of Interior Shell Impact Zone
