U.S. Department  
of Transportation

**Federal Railroad  
Administration**

# **Locomotive Crashworthiness Research: Locomotive Crew Egress Evaluation**

| 1. Report No.<br>DOT/FRA/ORD-02/03 | | 2. Government Accession No. | | 3. Recipient's Catalog No. | |

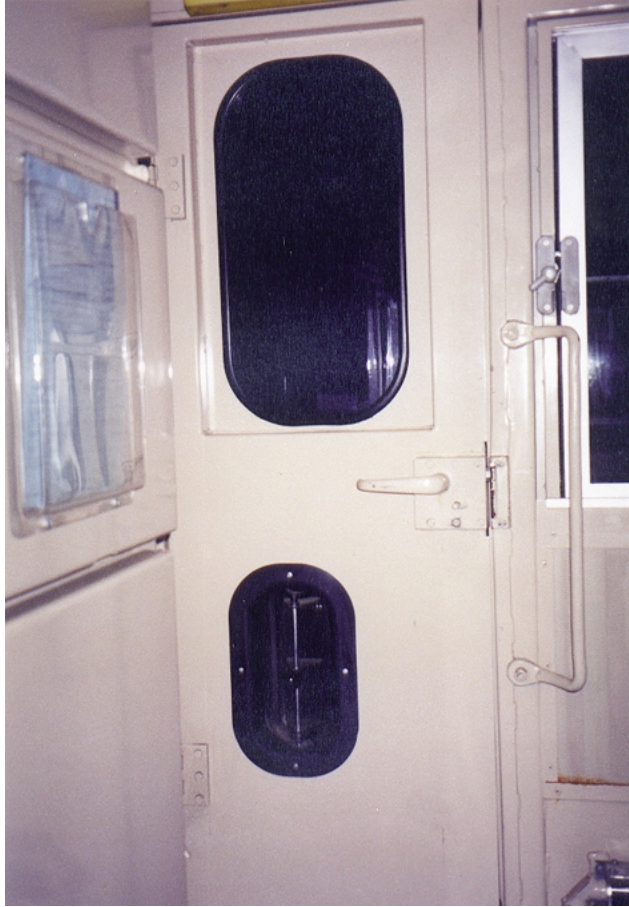
***Figure 2. Cab door latching device - F59 rebuild***

- Cab seats shall be securely mounted and braced and that cab doors shall be equipped with a secure and operable latching device. Section 238.233 further states that seats must be attached to withstand loads of 8-4-4 g’s (longitudinal, lateral and vertical, respectively) (Figures 1, 2).

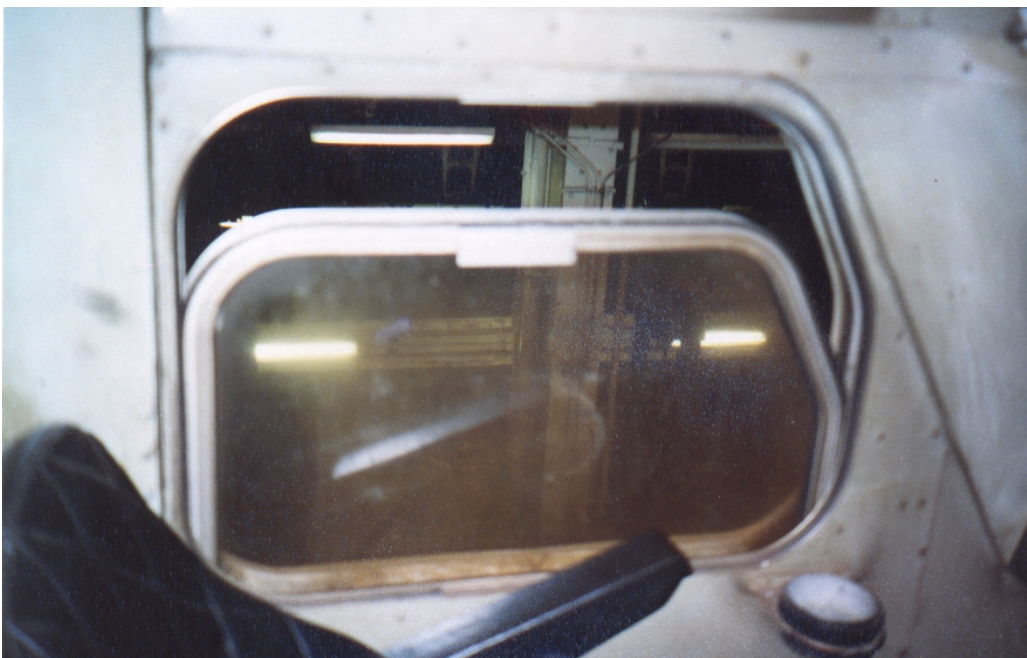
*Figure 8. FL9M side window slides up and down (29 x 22)*

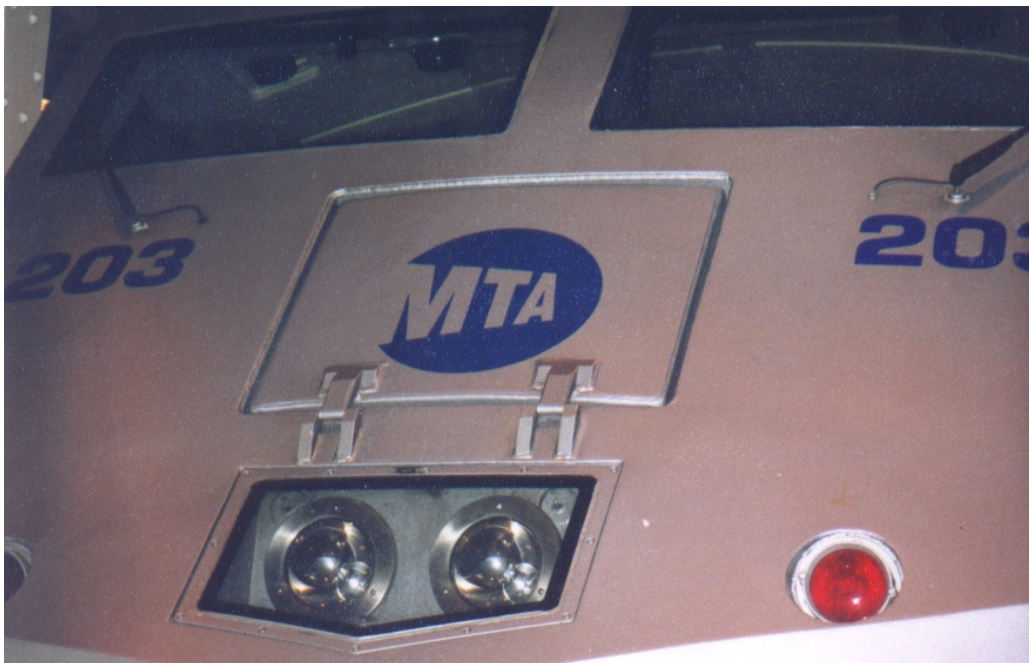
*Figure 10. Close-up view of nose hatch*

Metro North's P32AC-DM, manufactured by GE has a flat, angled front (Figure 9) with two side doors, and a nose hatch hinged at the bottom edge opening out (Figure 10). Access to the emergency nose hatch, however, is impeded by the location of a refrigerator that would have to be moved in order to exit via this route (Figure 11).

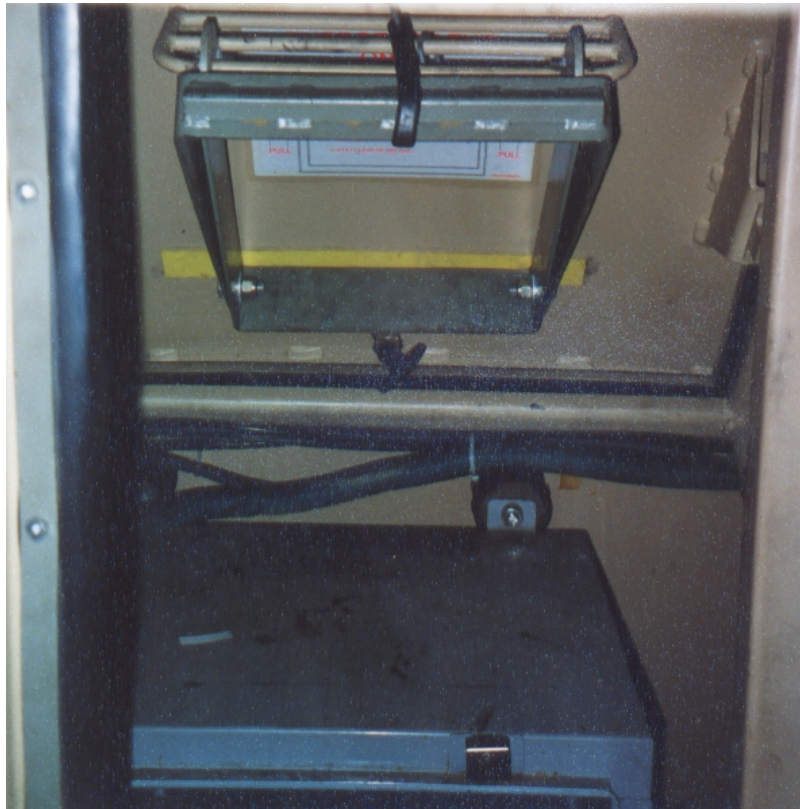
***Figure 11. Interior view of nose hatch (refrigeration unit located below)***

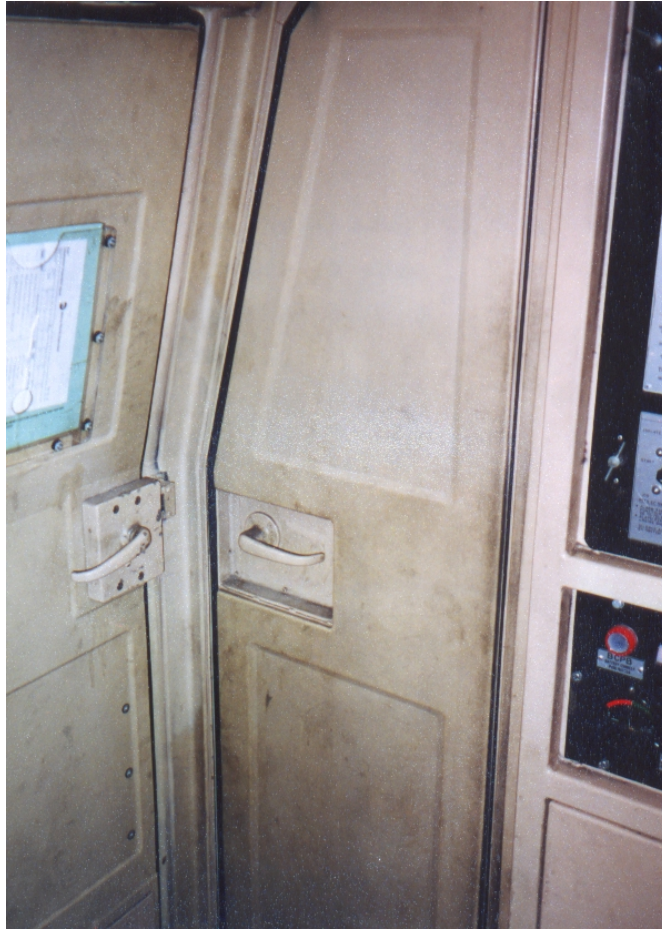
*Figure 12. Side cab entry/exit door on left of photo: handle on right side of door, pull open into cab. Engine room door on right: handle (recessed) on left side of door, push to open into engine room*

The door to the engine room, located adjacent to the side door on the engineer's side, behind the engineer's seat and the side doors had inconsistent door handle placement, where the side door handles are located to the right, while the engine room door handle is located to the left. Also, both doors open differently, the side door by pulling towards you to open (into the cab occupied space) while the engine room door opens by pushing outward (into the engine room) (see Figure 12).

This arrangement comes about because doors (or any other hardware) cannot open outward into the section envelope; therefore side doors open inward. But, the adjacent engine room door would then interfere if it also opened inward, so it opens outward into the engine room.

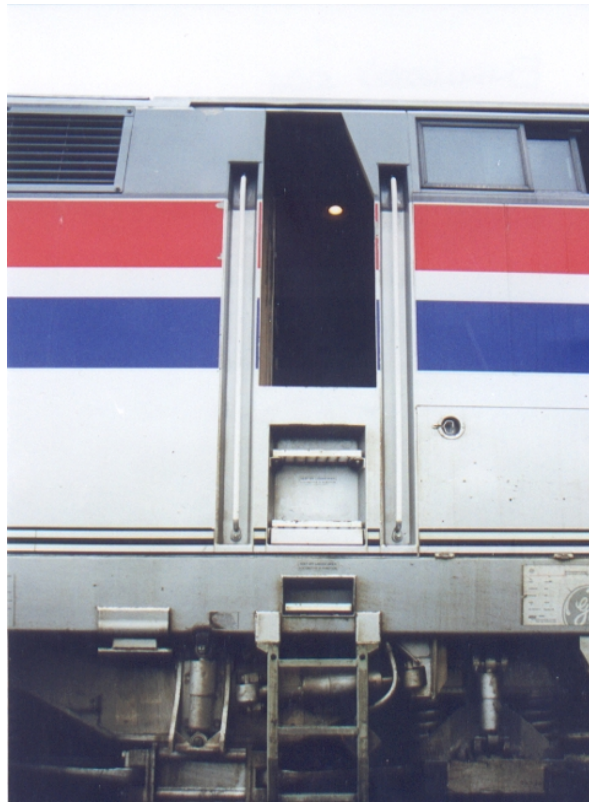
**Figure 14. GE Genesis P42 side view**

- On the sides of the locomotive with ladder-like steps (Figure 14)
- At the nose of the locomotive and behind the engineer's seat (Figures 15, 16), or

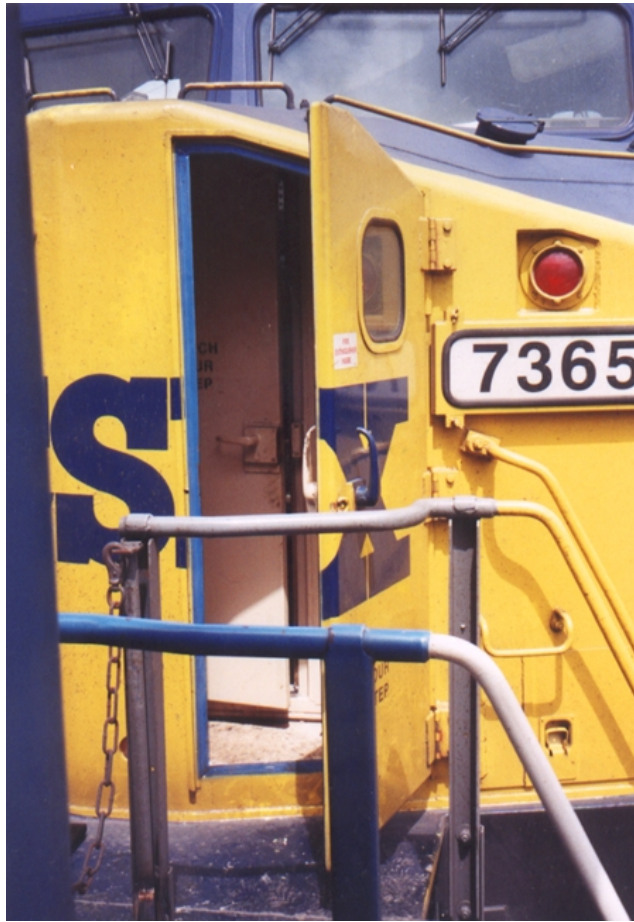
*Figure 15. SD 70 MAC nose door to platform, stairs on either side*

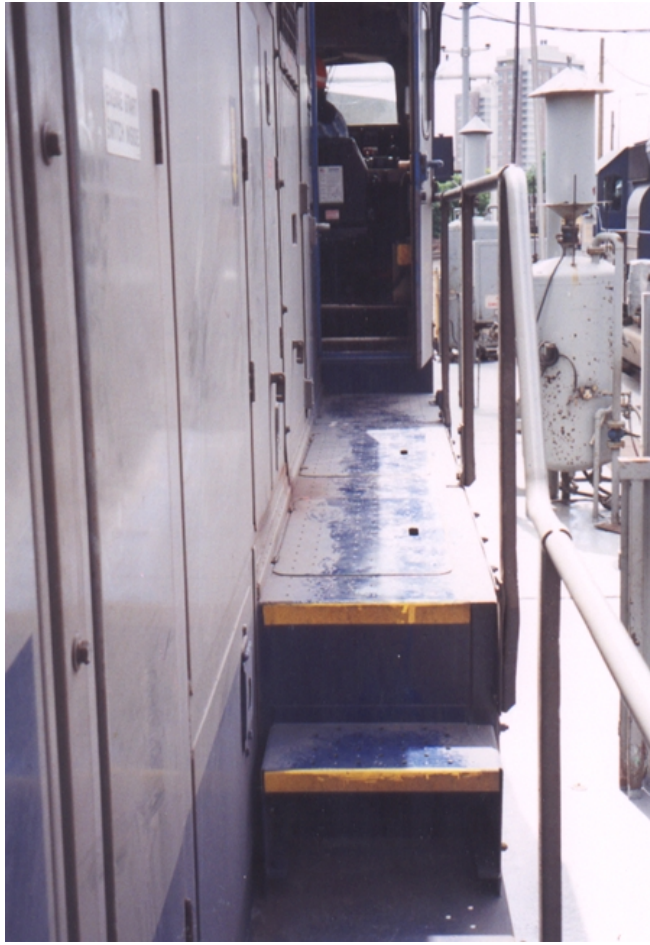
*Figure 16. Door to rear of engineer's seat, to walkway*

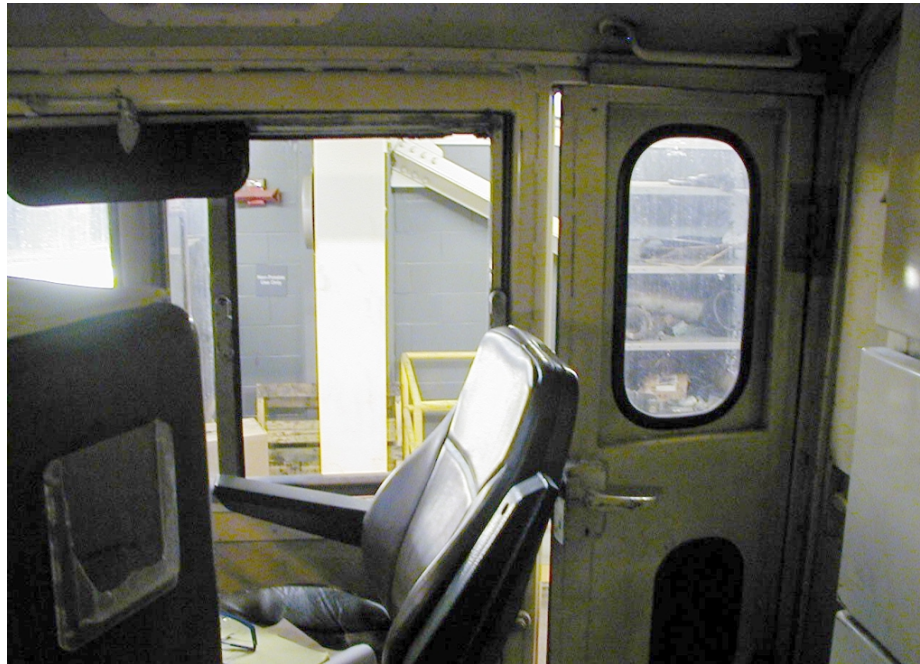
***Figure 66. Cab view of side window and door for F40-PH locomotive***

Examples of windows in passenger and freight locomotives are shown in the following figures. Figures 66 and 67 are the side window and front windshield of an F40-PH type passenger locomotive. The 23 inches wide x 9 inches high side window is opened by horizontally sliding it forward. The front of the locomotive has two barred and relatively large windshields. Figures 68 and 69 show the side window and windshield for a Dash 8 type freight locomotive, manufactured by General Electric. The side window for this unit contains two windowpanes, but only one of which is movable. As seen in Figure 69, this unit is a wide-nose locomotive and has two relatively large windshields and an outward opening nose door.

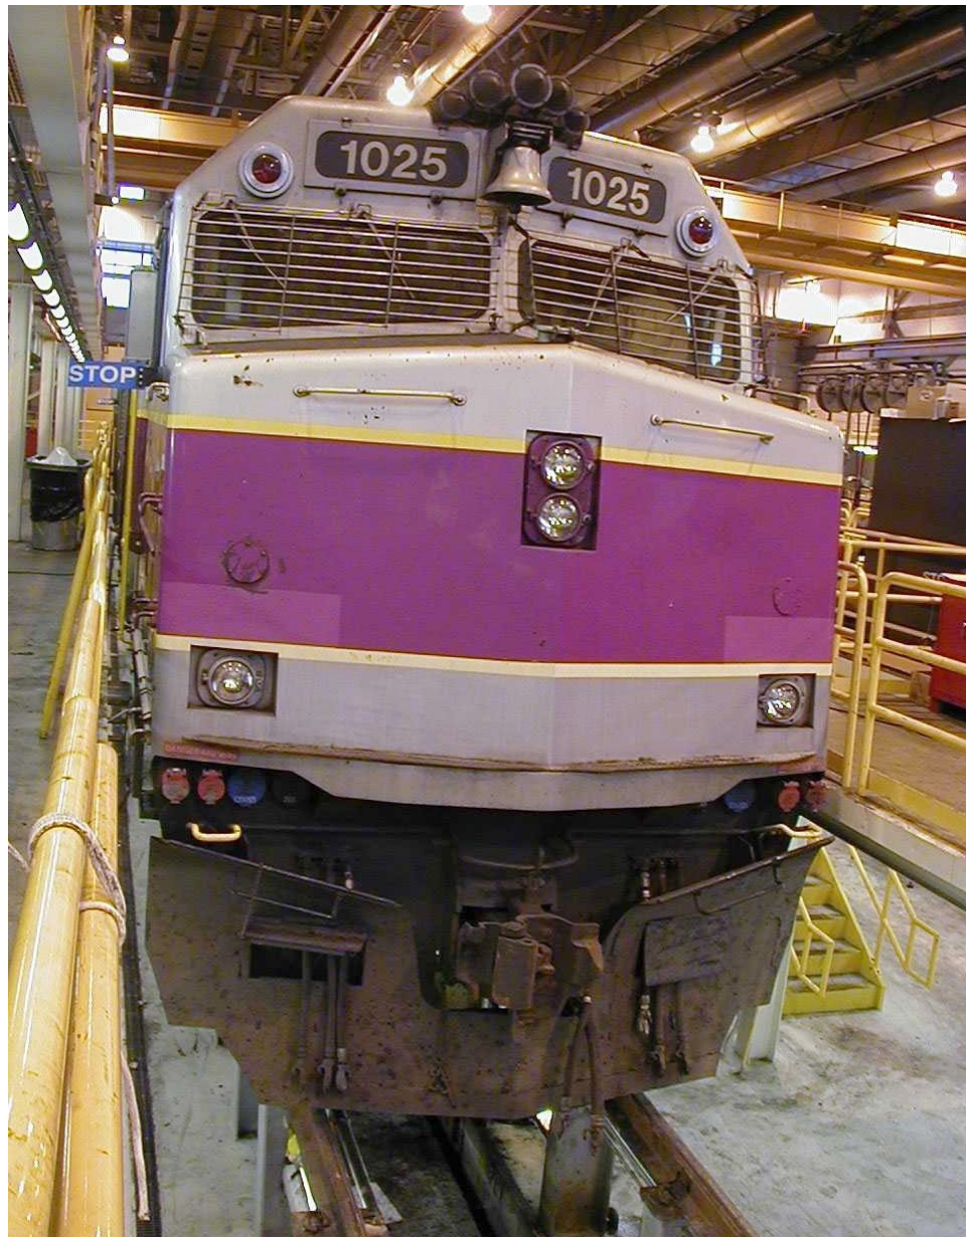
*Figure 67. Front view of F40-PH locomotive*

Double-window sliders typically have window openings of up to about 24 inches in width, although in some older versions, the window width can be as large as 36 inches. Locomotive windshields have varying shapes and sizes as can be seen in Figures 67, 69 and 71. They are typically narrow in height with vertical dimensions of about 20 inches or less. The widths depend on specific locomotives. For example, most wide nose units have a windshield width of about 50 inches. These are almost always sealed units and in some cases they are externally barred for protection, as in Figure 67. Because of the proximity of control consoles and other cab equipment, front windshields on the engineer's side of the cab can have limited access from inside of the cab.

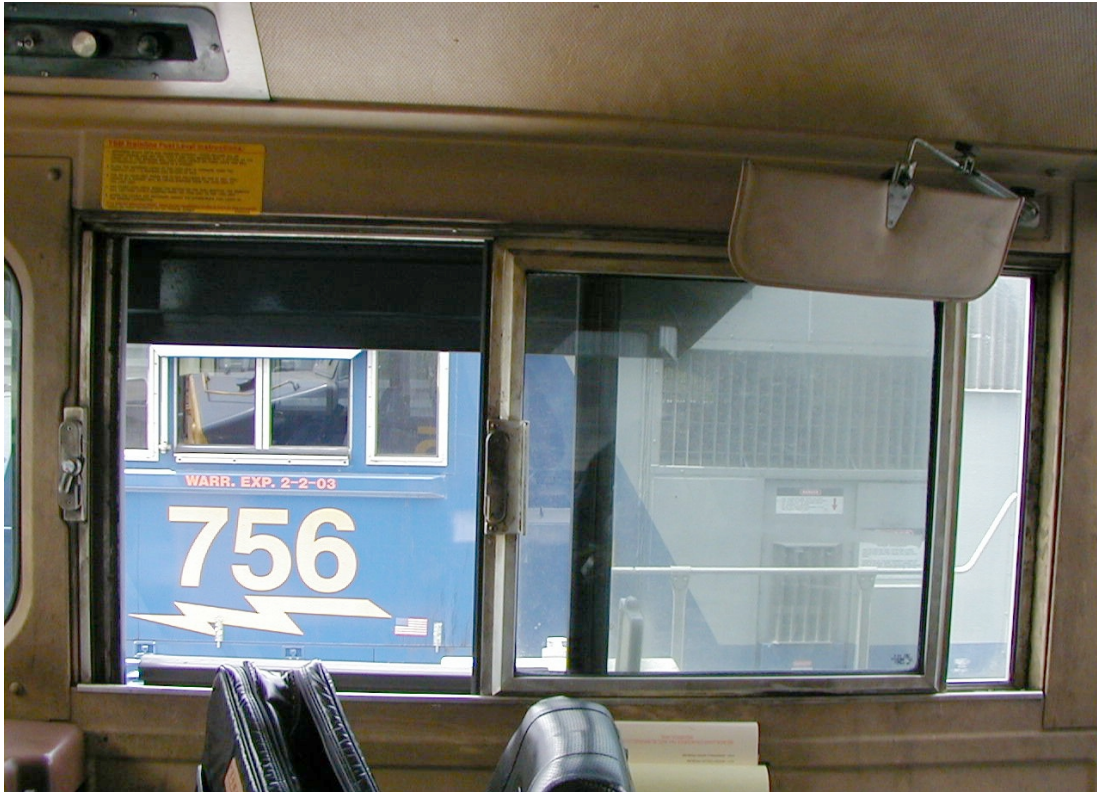
*Figure 68. View of side window (Dash 8 locomotive) from inside cab*

The current design practice for modern locomotive side windows is to use horizontally sliding windows of the type seen in Figures 68 and 77. Some installations make use of a single-window slider while others make use of a double slider. The typical operation for opening requires that a lever or handle be depressed and then the window physically slid open. Observations from our survey showed that while some windows opened with ease, other windows required a moderate amount of force in order to open them. This was sometimes an uncomfortably large effort, since tracks can collect dirt or become stiff with disuse.

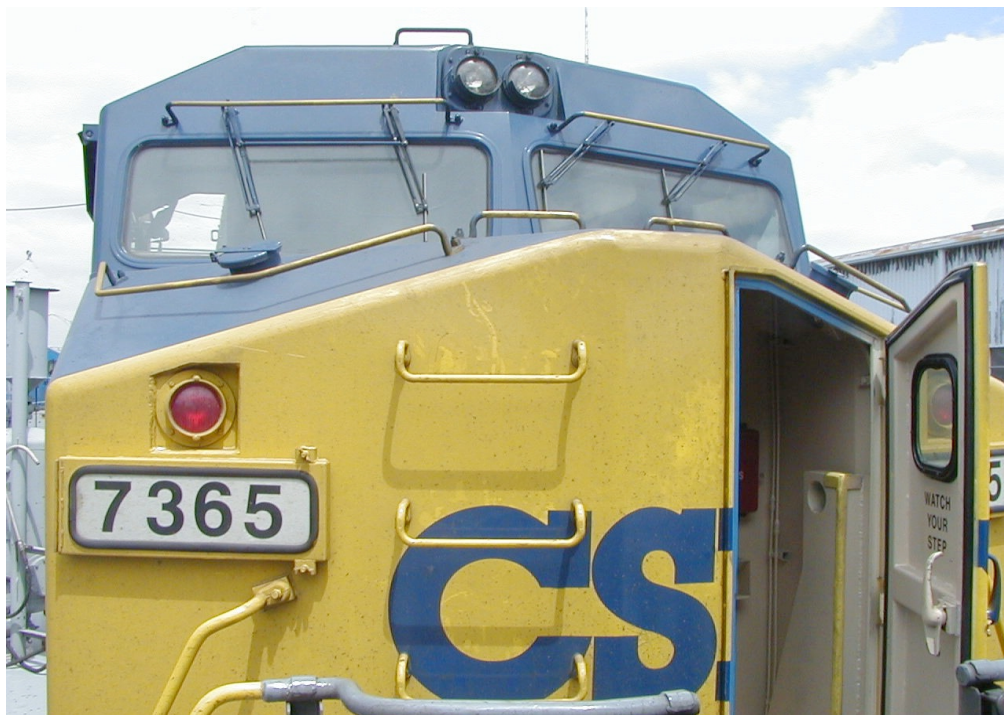
*Figure 69. Front view CW40-8 (General Electric) (Dash 8)*

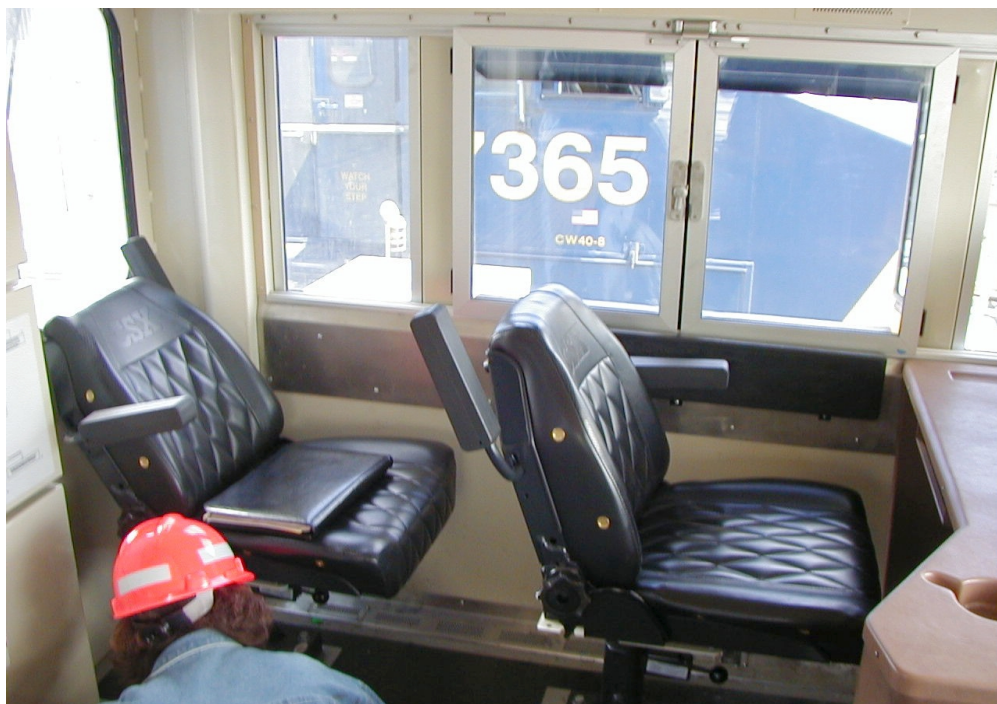
*Figure 70. View of side window (SD-70 MAC) from inside cab*

Figures 70 and 71 show the side window and windshields, respectively, of a SD-70 MAC freight locomotive manufactured by EMD. The side window is a double sliding unit that opens from the center and has an approximate opening size of 33 x 22 inches. (These can vary depending on the railroad ordering the locomotive.) The two large contoured windshields, each are 17 inches (minimum) high and 55 inches wide.

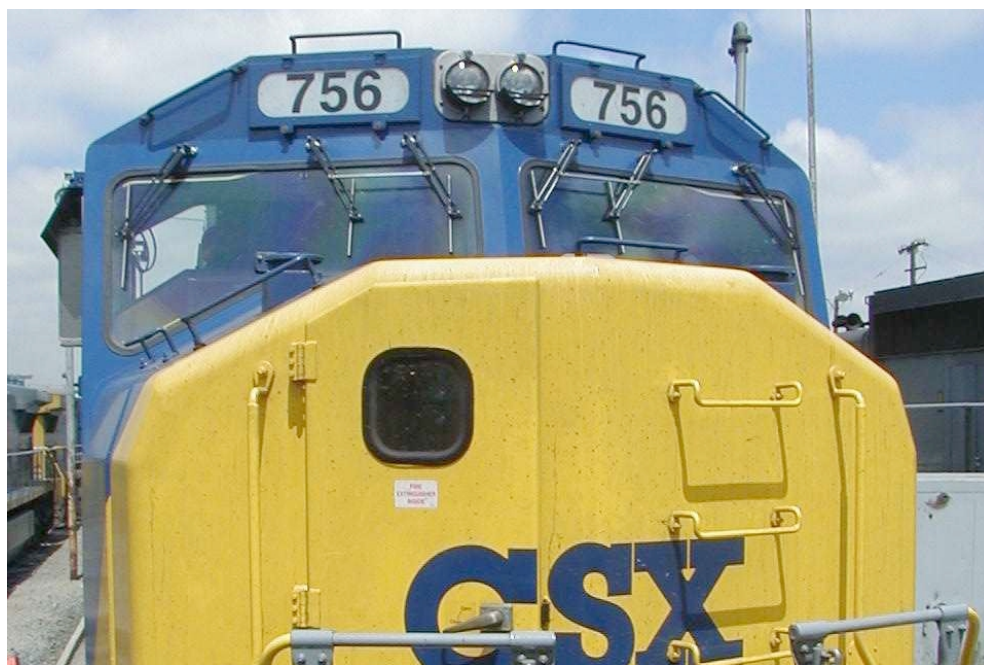
*Figure 71. Front windshield area of SD-70 MAC locomotive*

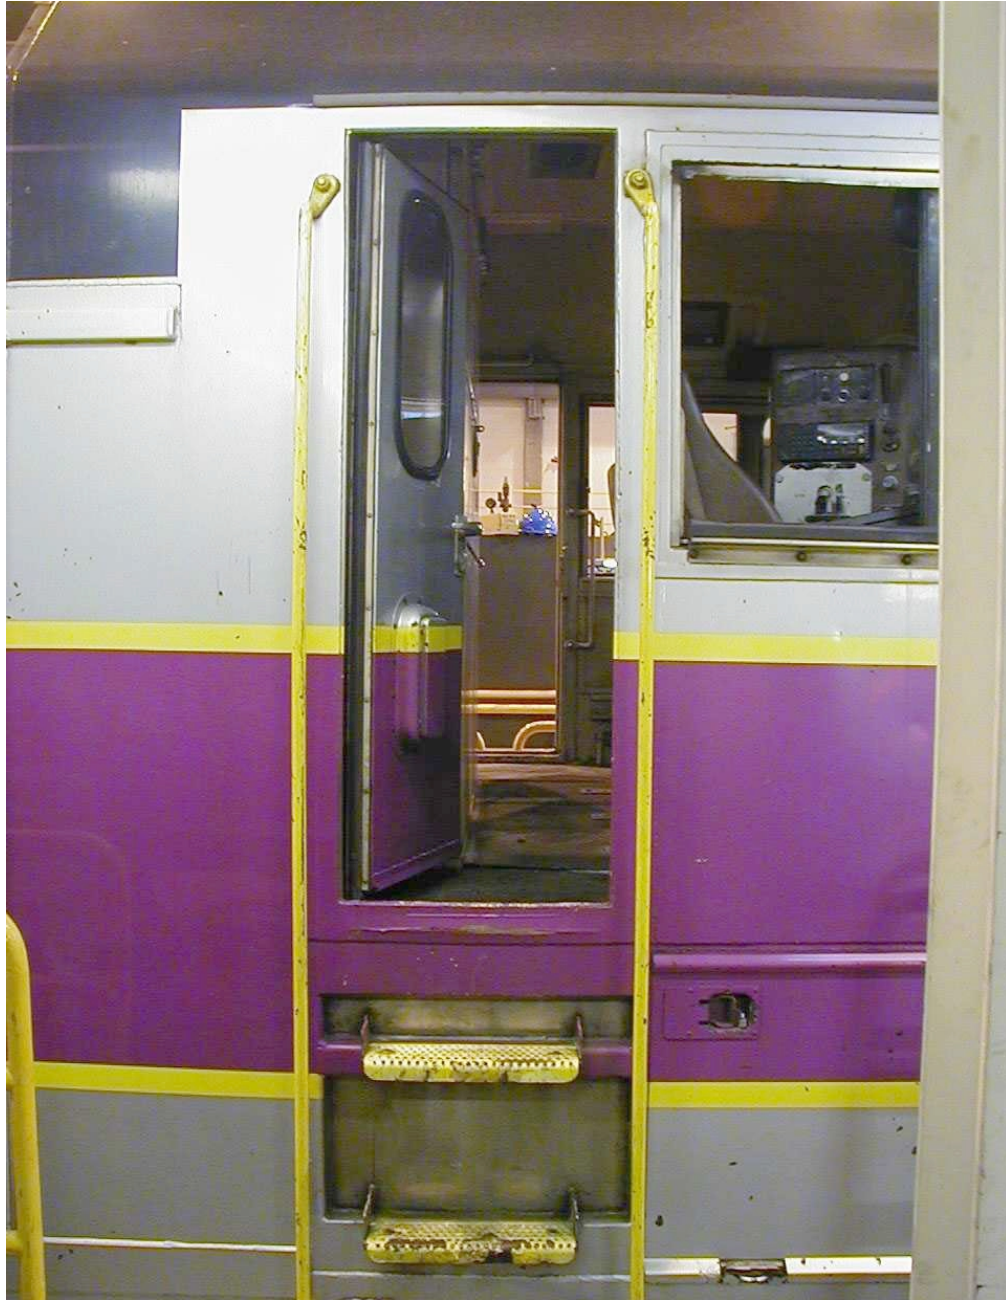
*Figure 72. Side entry door of the F40-PH locomotive*

Some examples of egress doors used in locomotives are shown in the following figures. Figure 72 shows the side entrance door as seen from the exterior of a F40 passenger locomotive. This door is about 19 inches wide and is accessed by a set of vertical steps. A view of this door from inside the cab is shown on the right side of Figure 66. Figure 73 shows the front hood door of the SD-70 locomotive; note that egress from the cab itself would involve descending the interior steps and proceeding forward within the hood. Figure 74 shows the rear cab door for the SD-70 (only provided on the right side). This has a clear opening of approximately 16 inches wide. Figure 71 also shows the nose door for the SD-70 MAC locomotive, also an outward opening door. The door handle configuration shown here is typical for a locomotive installation.

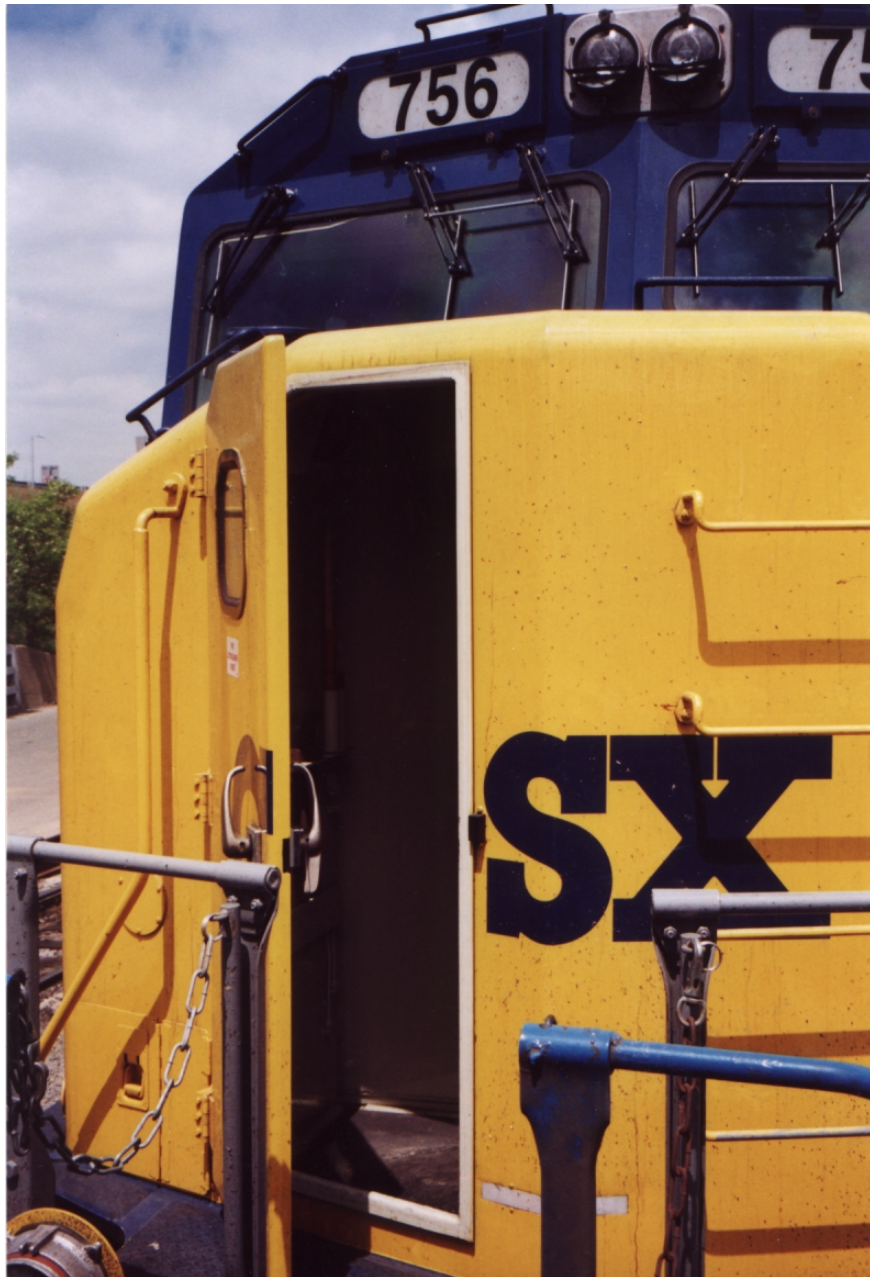
*Figure 73. Nose entry door of SD-70 MAC freight locomotive*

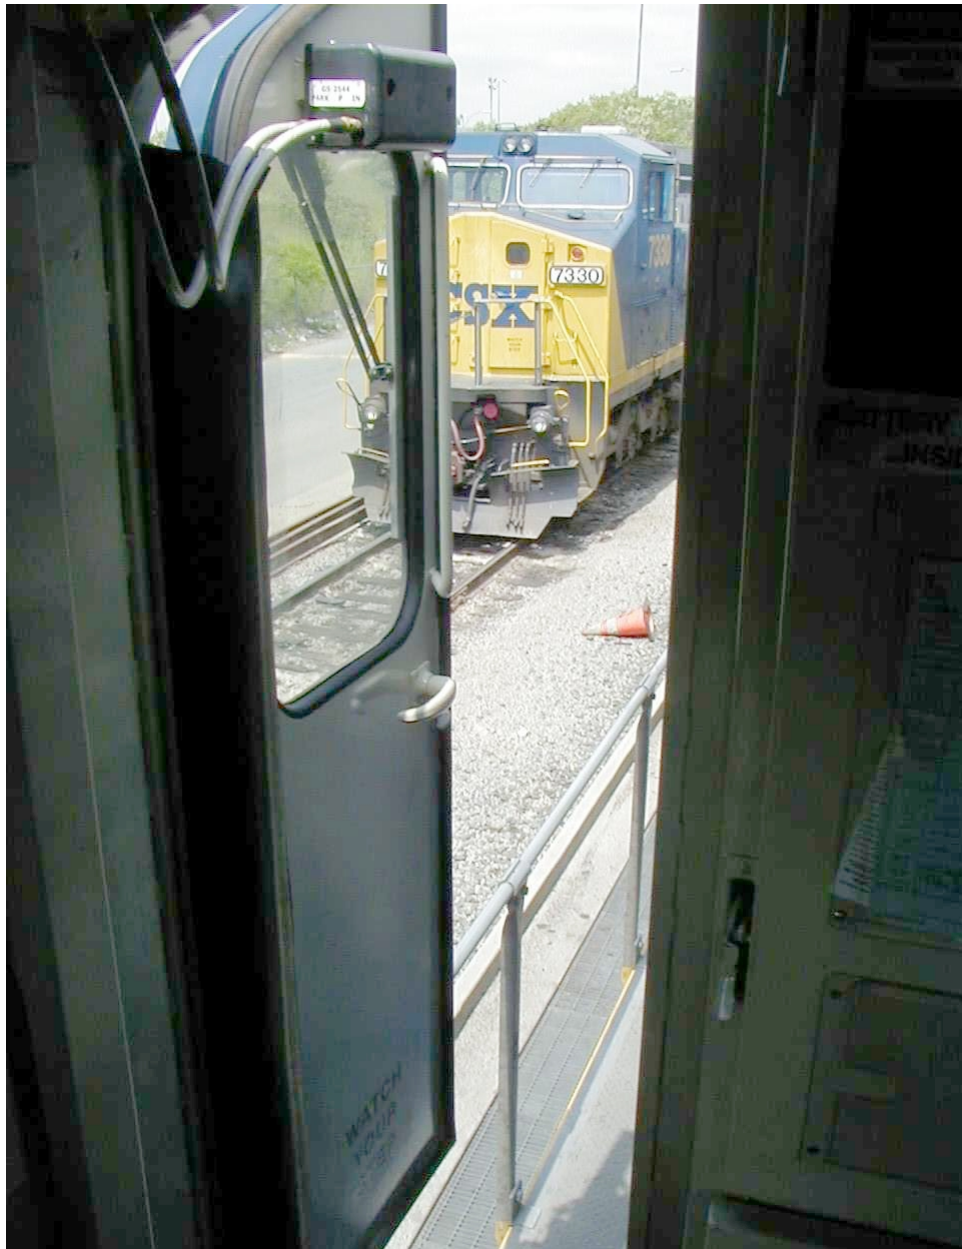
*Figure 74. Rear cab door of SD-70 MAC freight locomotive*

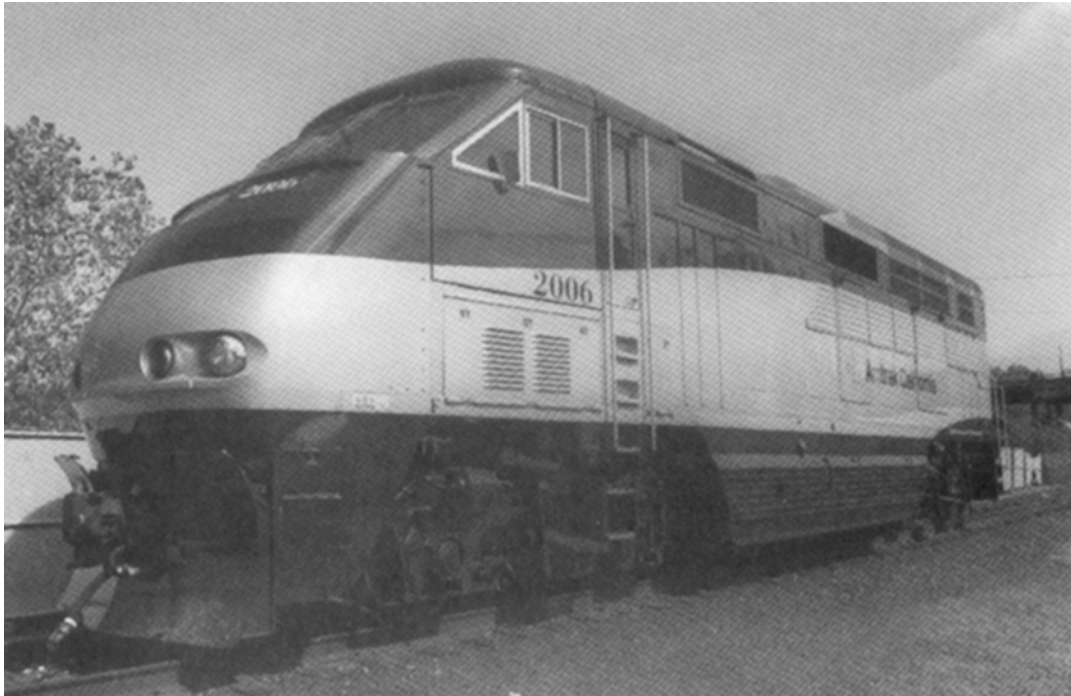
*Figure 75. Exterior view of F59 passenger locomotive*

Figure 75 shows an exterior view of the recently introduced F59-PHI passenger locomotive. The side window has two panes having a total width of about 25 inches. It is designed to have only one pane that can be opened in normal operation. The side window for this unit has been specifically designed for emergency egress. Figure 76 shows a view of that window as seen from the interior of the cab. The emergency egress features of this window will be further discussed later in this section. The inward-opening entrance door shown in Figure 75 is located on the side of the locomotive and is reached by a set of vertical steps.

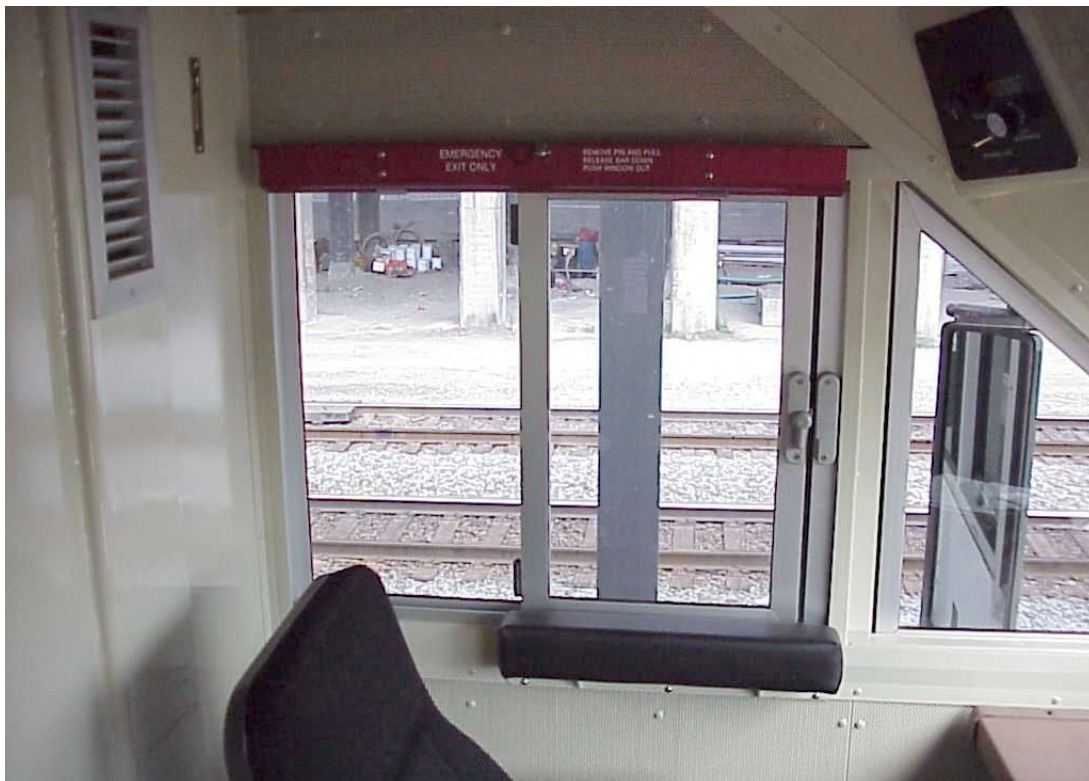
*Figure 76. Interior view of F59 cab emergency exit window*

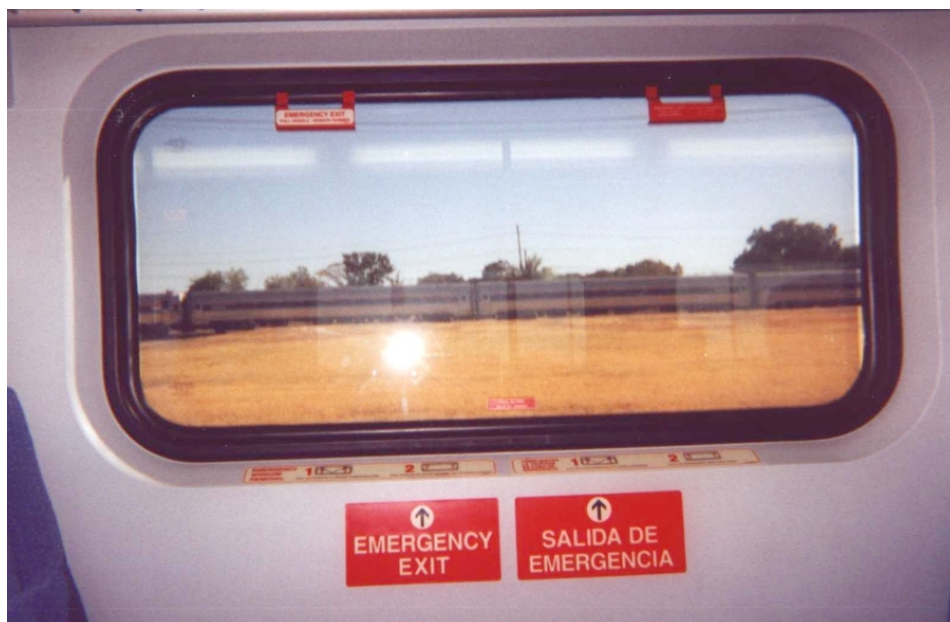
***Figure 80. Emergency exit window on rail passenger car***

The provision of window emergency egress has been made for some time in passenger rail car equipment. For example, with sealed windows, an emergency deployment arrangement using a strippable gasket has been available, as seen in Figure 80. This capability is now required by the newly issued 49 CFR Part 238, Passenger Equipment Safety Standards, Section 238.113, Emergency Window Exits. Passenger rail cars must be equipped with a minimum of four emergency exit windows. Further, the regulation requires that all cars ordered or first placed into service on or after September 8, 2000, have emergency exit windows with an unobstructed opening of 26 inches horizontally and 24 inches vertically.

Figure 80 is an example of an emergency exit window used in a passenger rail car. This window is a sealed unit. It has the design feature of being able to remove one of the gasket seals and thus remove the window in the event of an emergency. Its operation involves the use of a handle that enables the removal of the inner gasket of the window. This gasket is sometimes referred to as a “zip strip.” Upon removal of the gasket, the window can then be removed from its frame. For the case of a sealed locomotive cab window that would be of sufficient size to warrant its usage for emergency egress, the use of removable gaskets should be investigated.

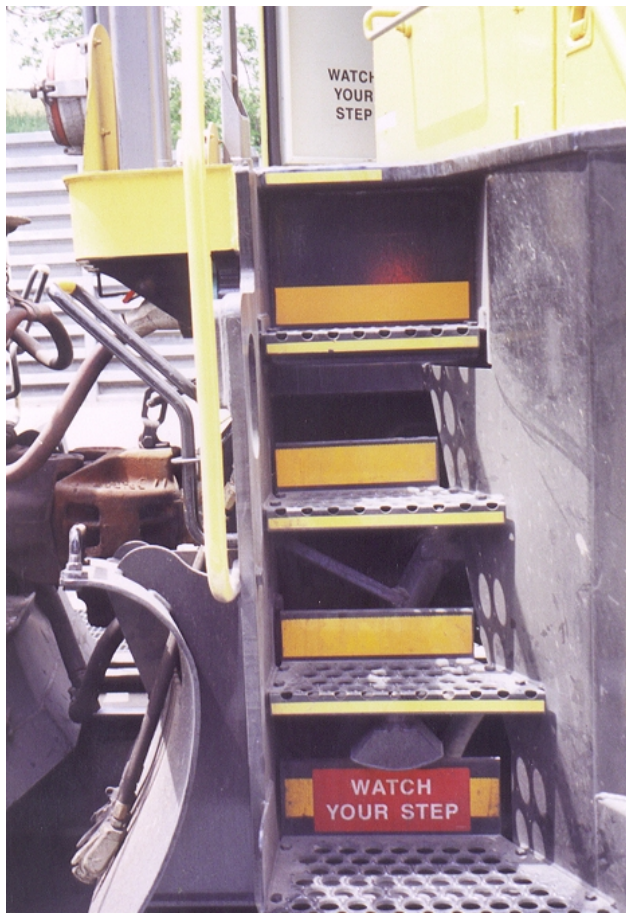
**Figure 83.** *SD-70 MAC retroreflective step markings*

Marking of the outside perimeter of locomotive egress/access doors and emergency windows with retroreflective material could make for expedited identification of the means of access to locate cab crewmembers in an emergency. Additionally, step visibility could be enhanced by marking steps with retroreflective and/or luminescent markings (see Figure 83).

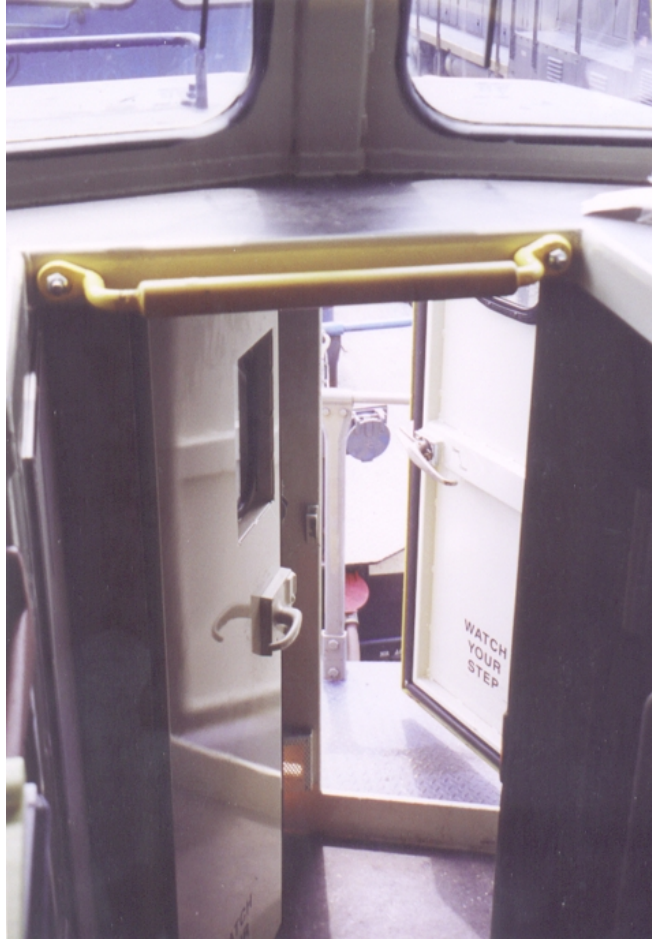
***Figure 85. View from locomotive cab of SD-70 MAC to nose door (door sill 3 to 4 inches high)***

The F-59 locomotives have a succession of doors (leading to the exit door in the nose of the locomotive). All of these doors have raised sills of 2 to 3 inches in height. This presents a tripping hazard, particularly in low-level lighting conditions and in an emergency situation, where haste and panic may be factors in evacuation. Designing interior doors so that sills are flush or nearly flush with floor could help to prevent tripping hazards. Figures 85 and 86 show raised door sills.

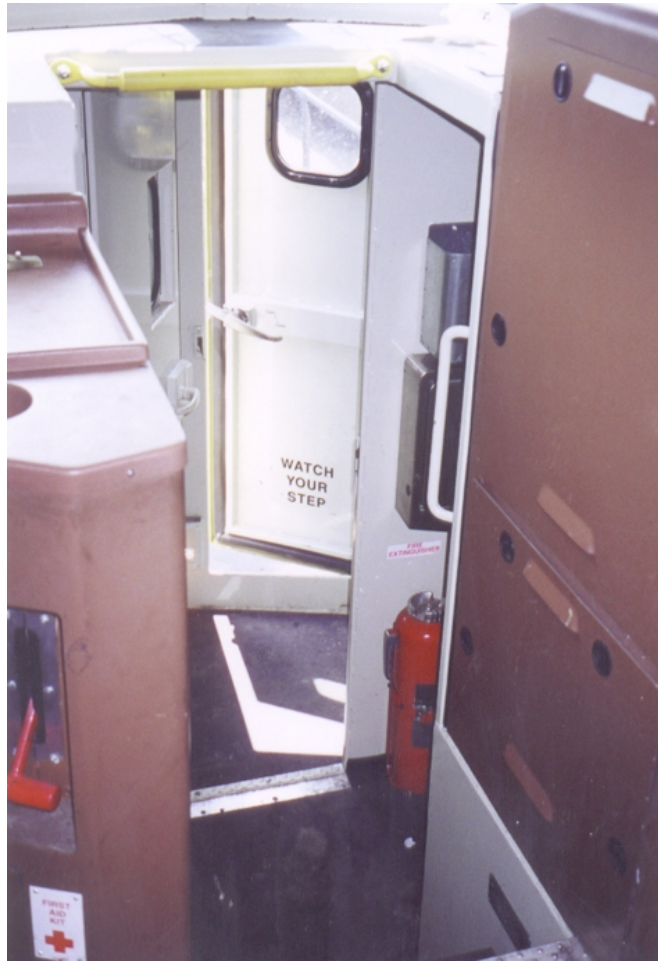
*Figure 86. Door sill height*

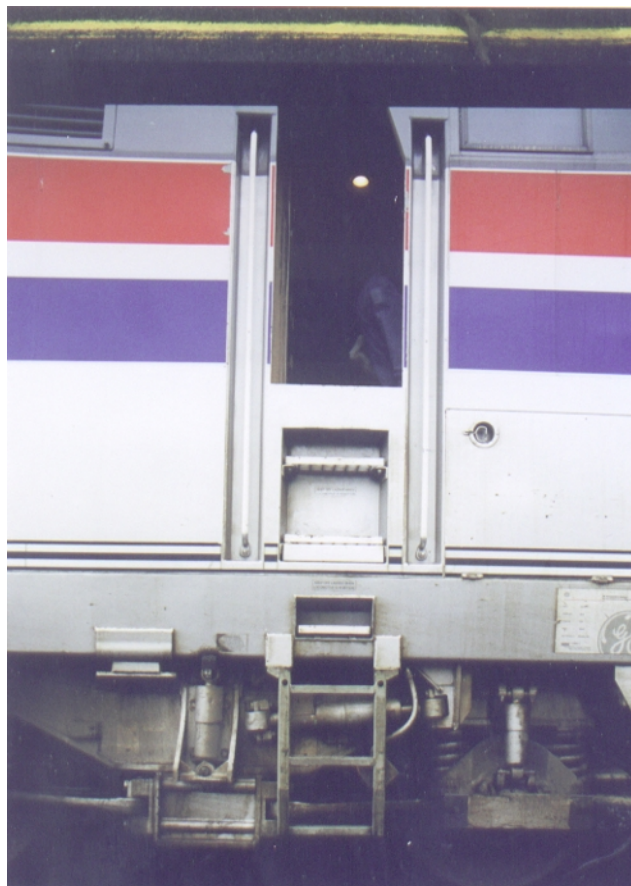
*Figure 87. View of side door ladder-type steps*

markings on these steps as discussed earlier adds to the problem. Figures 87 and 88 show steps of a Genesis locomotive.

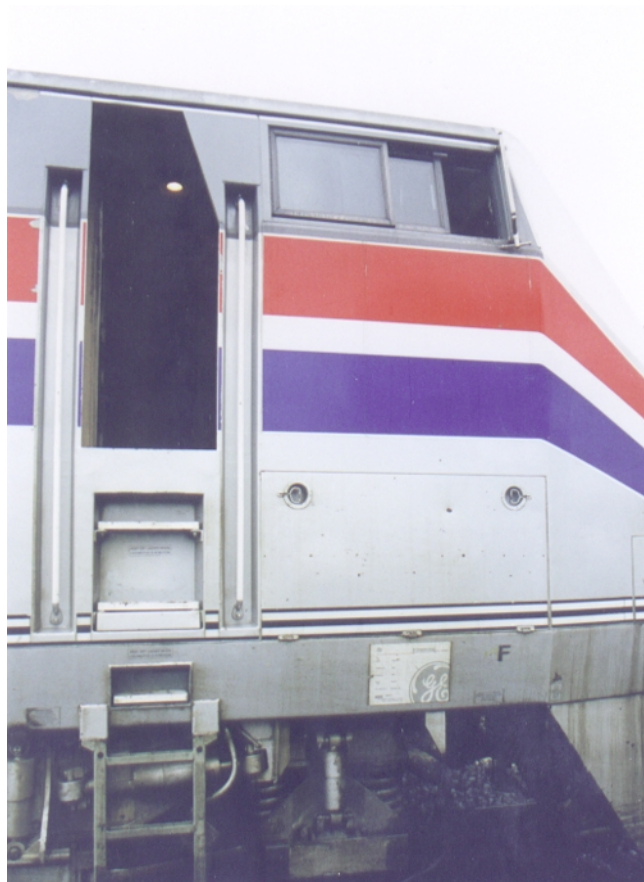
**Figure 88.** *Angled view of steps*

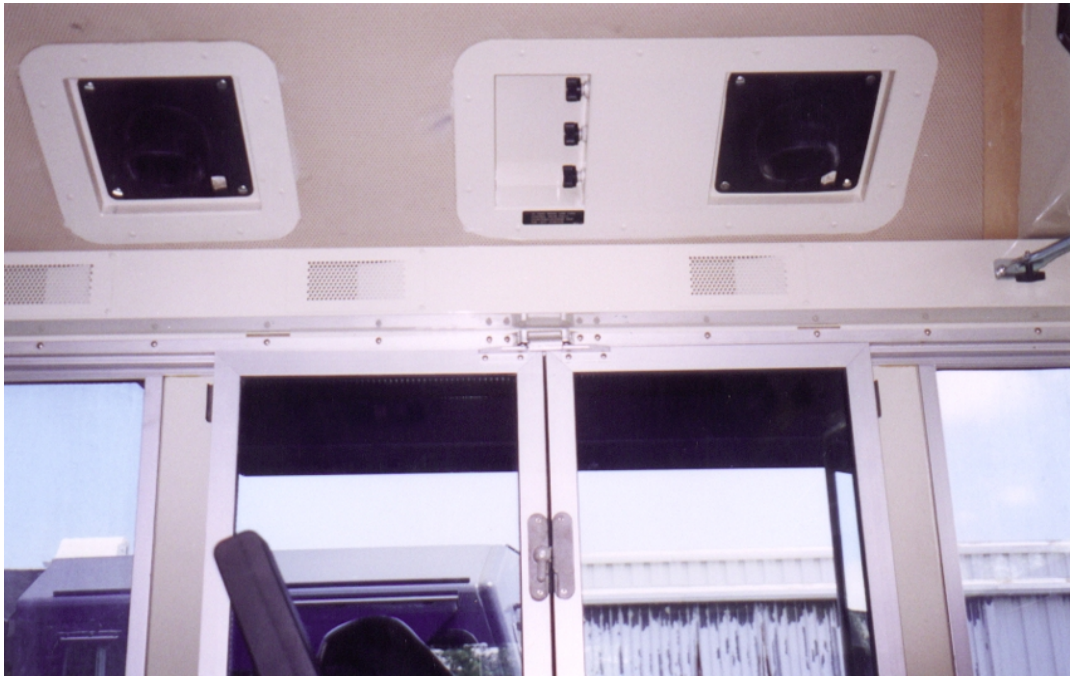
**Figure 91.** *Overhead cab lighting, over the seat opposite engineer's seat (SD-70 MAC)  
(Note double-opening window)*

Improvements have been made to locomotive cab lighting such as those observed on a new SD-70 MAC, with the placement of continuously illuminated directional lighting, aimed at illuminating potential tripping hazards. Figures 89 and 90, SD-70 MAC show low location lighting and improvements to overhead cab lighting as well, Figure 91.

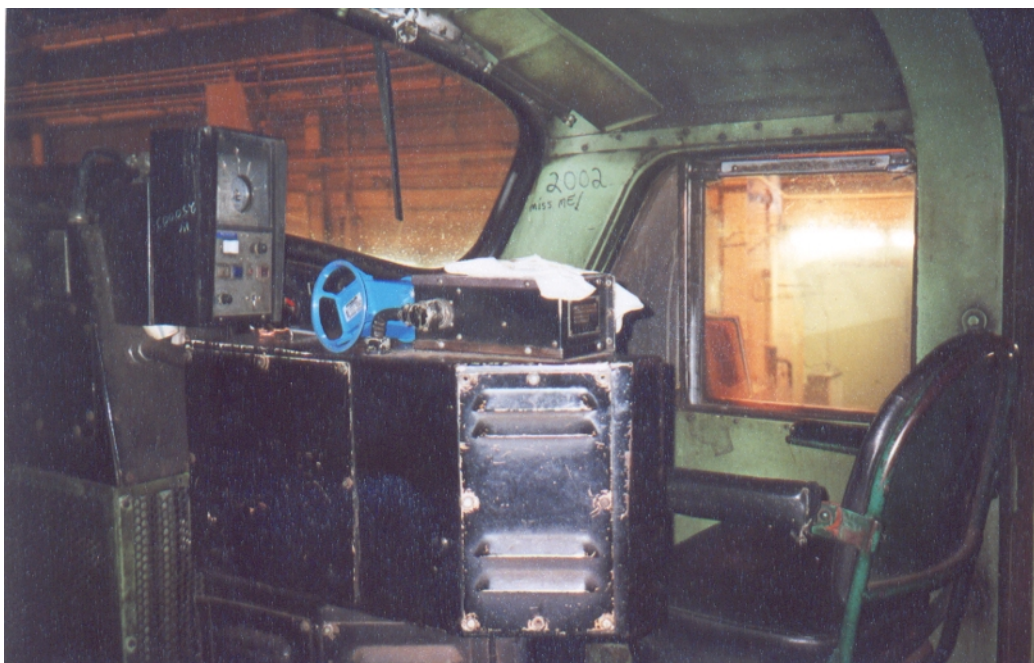
*Figure 100. AAR type control stand in front of engineer*

integral skin. For the second type of improvement, a breakaway design for the levers should be used: see Figure 100 for the old-style control stand, and Figure 101 for the newer console or desk-type station. This would either be a literal breakaway type of lever or a load-limit-release type joint for the lever, designed to fold up at high loads not normally reached in operation. These would typically fall in the 50 to 100 pounds range, applied normal to the lever. Also, the ball-end on later console levers reduced lethality.
