U.S. Department  
of Transportation

**Federal Railroad  
Administration**

# **Locomotive Crashworthiness Research: Locomotive Crew Egress Evaluation**

| 1. Report No.<br>DOT/FRA/ORD-02/03 | | 2. Government Accession No. | | 3. Recipient's Catalog No. | |

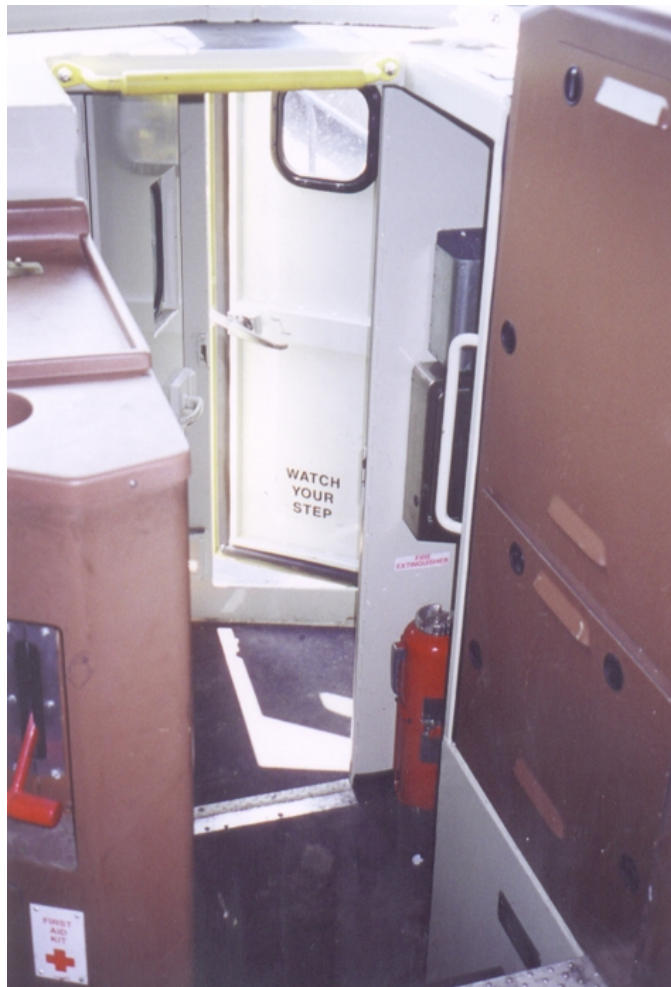
**Figure 103.** *SD-70 MAC fire extinguisher located on cab side wall near the observer's station*

Wide nose locomotives similar to the SD-70 MAC have a closed off foyer in the nose section. This area would appear to offer a good place for the storage of portable cab mounted equipment in that it is isolated from the occupant portion of the cab. Figure 103 is a view of the foyer as seen from the cab for the SD-70 MAC. As seen from this figure, a fire extinguisher is located adjacent to the stairway down to the nose. Its location here would appear to be based on the need for immediate access. Also shown in Figure 103 directly below the emergency brake lever is the first aid kit. A close-up view of this is shown in Figure 104, which shows the kit installed behind a flush-mounted cover on the conductor's console. The emergency tools and other components are located in the nose side of the foyer. Figure 105 shows the fusee and torpedo box, which for this locomotive is mounted on the nose interior door. Figure 106 shows the location and mounting arrangements for other emergency tools. The location appears to be ideal from the perspective of eliminating the potential for flying projectiles. Some of the collision scenarios we analyzed shows that this portion of the locomotive could experience severe damage, thus preventing access.

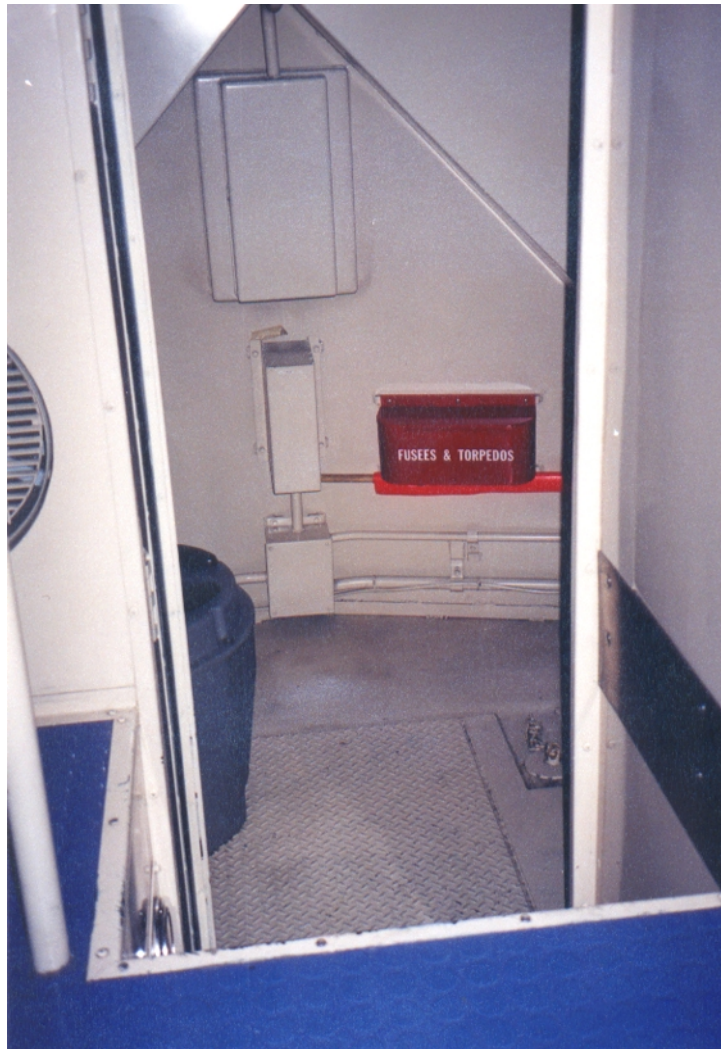
**Figure 107.** *F40-PH3 fusees and torpedos located in nose compartment*

Figure 107 shows the location of some of the cab-mounted equipment for the F40-PH passenger locomotive. For the same rationale as above, the fire extinguisher is mounted on the front bulkhead near the conductor's station, while other equipment, such as the fusees and torpedoes are located in the nose compartment. Figures 108 and 109 are for the more modern P32-AC passenger locomotive. These figures show the bulkhead immediately located behind the engineer's seat. Both the first aid kit and fire extinguisher are anchored to the bulkhead with a fastening mechanism. Figure 110 shows the location for some of the emergency tools. These are located on the rear wall near the door to the engine room.

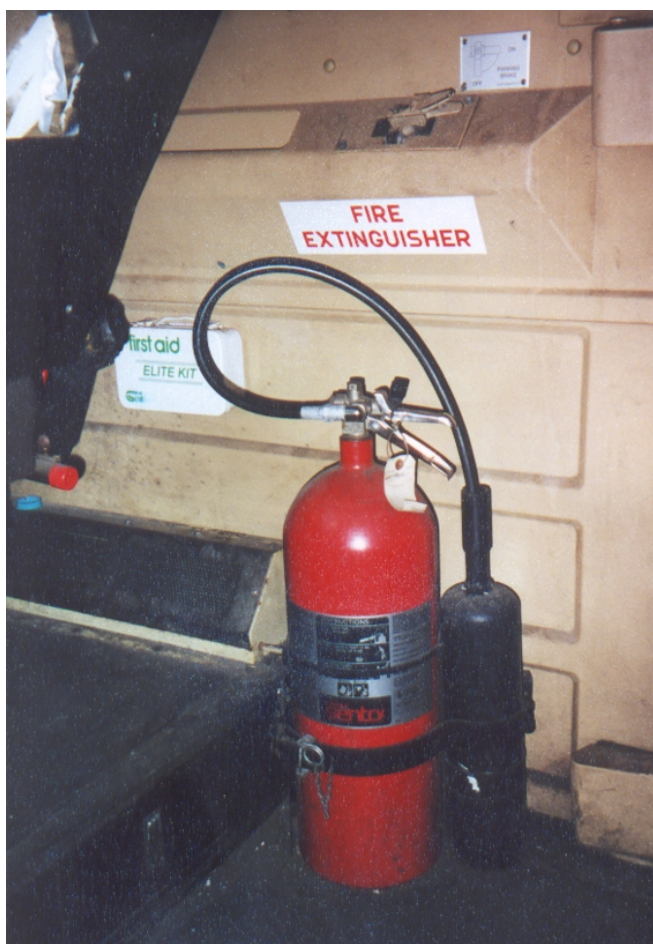
*Figure 109. P32-AC fire extinguisher located immediately behind engineer's seat*

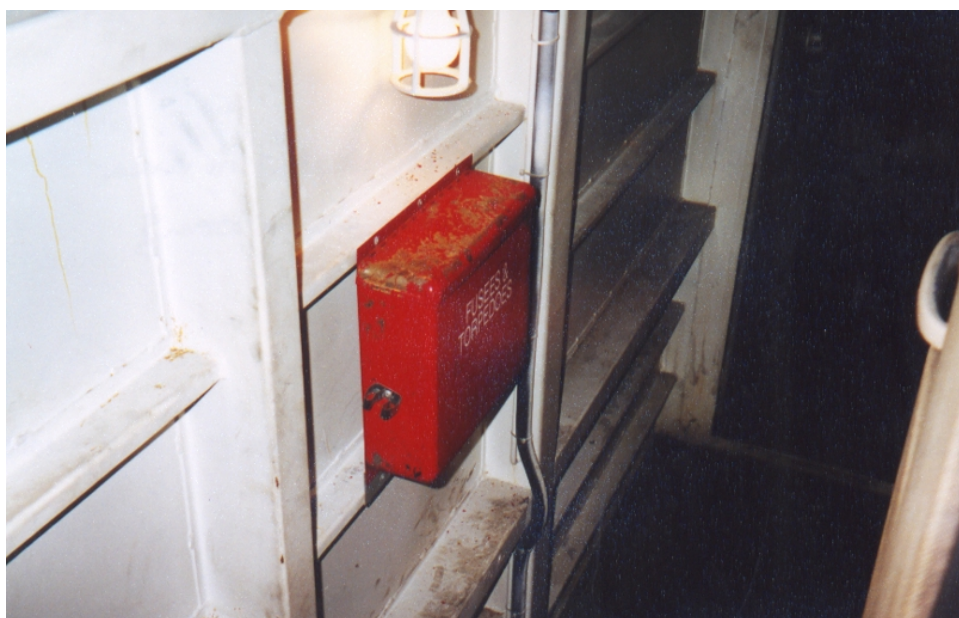
*Figure 110. P32-AC emergency tools located on wall behind cab near door to engine room*

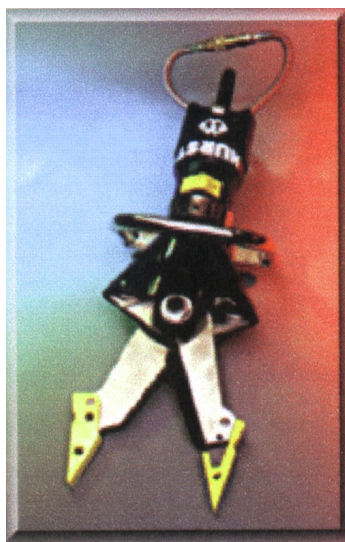
***Figure 111. Cutter and hydraulic bracing unit  
(for automotive extraction)***

or as combination units. An example of a combination cutting and bracing tool is shown in Figure 111. The device shown weighs about 33 pounds and is about 33 inches long. It is built specifically for automotive extraction applications. The device has both cutter and hydraulic bracing built into the same unit. It can create an opening of about 16 inches and has a spreading force capability of about 13,000 pound-force (57.8 kN). They are available in larger and heavier sizes for making openings as much as 3 feet wide. Devices of this type would have to be evaluated to determine their ability to breach the skin of a locomotive as well as their ability to be successfully used in the confined spaces of a locomotive cab.
