# Switching Operations Fatality Analysis

**Findings and Advisories  
of the SOFA Working Group  
Volume I:  
SOFA Report with Appendix A**

**March 2011 Update**

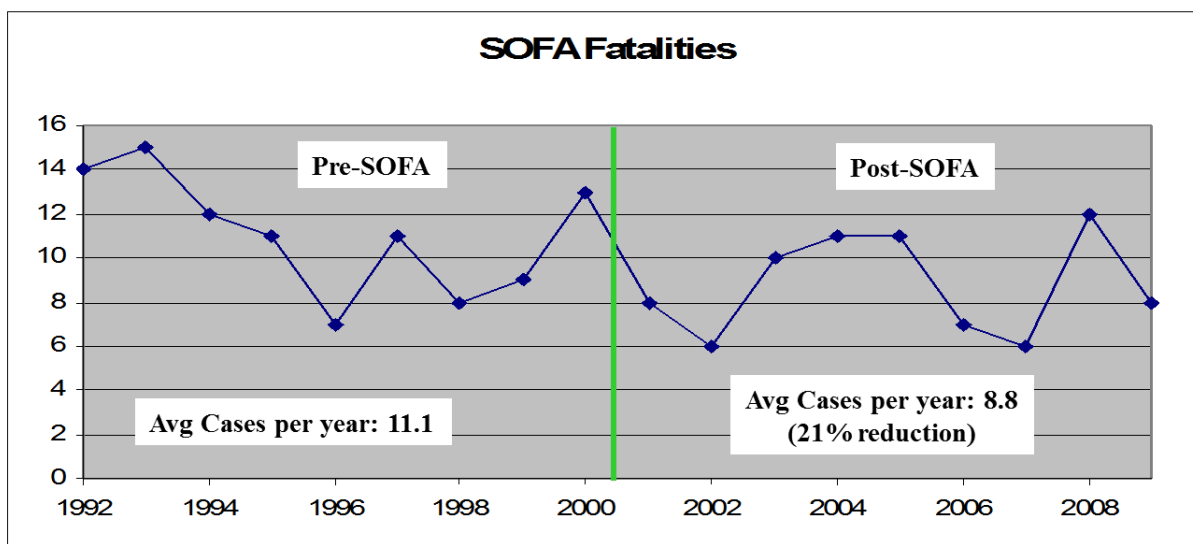
Figure ES-2 SOFA Fatalities

The SOFA Working Group (SWG) has reviewed 179 switching fatality cases from 1992 through 2009, an 18-year period. Figure ES-2 shows a year-by-year graph of those fatalities. There is a line in the middle of Figure ES-2 which divides the graph into two nine-year periods: the period from 1992 through 2000 and the period from 2001 through 2009.

The SWG believes 2001 was the first year that the *1999 SOFA Report* could have had full effect on reducing fatalities. That means one way to interpret Figure 3-1 is to regard the first nine-year period (1992 – 2000) as the Pre-SOFA period and the second nine-year period (2001 – 2009) as the Post-SOFA period.

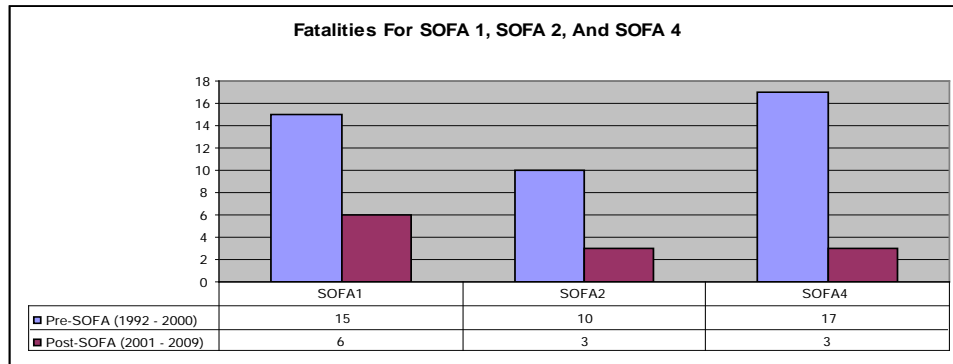
**Figure ES-3 Fatalities for SOFA 1, SOFA 2, and SOFA 4**

Figure ES-3 shows a paired bar chart displaying the number of SOFA 1, 2, and 4 fatalities over two nine-year periods (Pre-SOFA versus Post-SOFA).

The paired bars for each case show an impressive reduction for SOFA 1, 2, and 4. SOFA 1 fatalities are down 60% from in the Pre-SOFA period to the 6 fatalities in the Post-SOFA period. SOFA 2 fatalities have declined 70% from 10 in the Pre-SOFA period to 3 in the Post SOFA period. The biggest improvement is in SOFA 4 where there has been a decline of over 80% from 17 fatalities in the Pre-SOFA period to 3 in the Post-SOFA period.

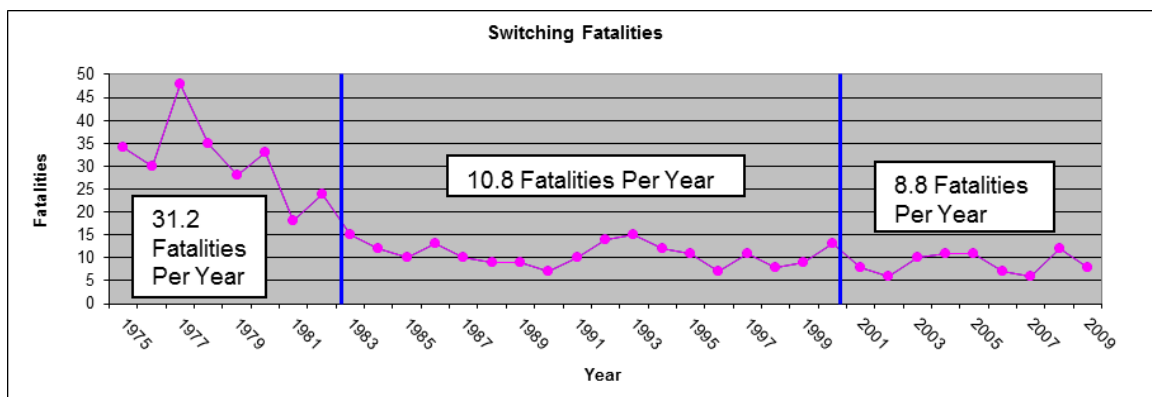
**Figure 1-1. Switching Fatalities, 1975 through 2009**

The SWG switching fatality review dates back to 1975. From 1975 through 1982, fatalities averaged 31.2 per year, far higher than in the years following. After 1982, fatalities began to decline, moving within a range of 7 to 15 per year through year 2000. During this period, the average fatalities-per-year was 10.8. 2001 was the first year that the SWG's recommendations could have resulted in noticeable change. From 2001 through 2009<sup>1</sup>, fatalities moved within in a range of 6 to 12 per year, averaging 8.8 fatalities-per-year. Although there has been some improvement, the need for immediate, preventive action is still urgent. Figure 1-1 provides a line chart that shows the number of switching fatalities from 1975 through 2009.

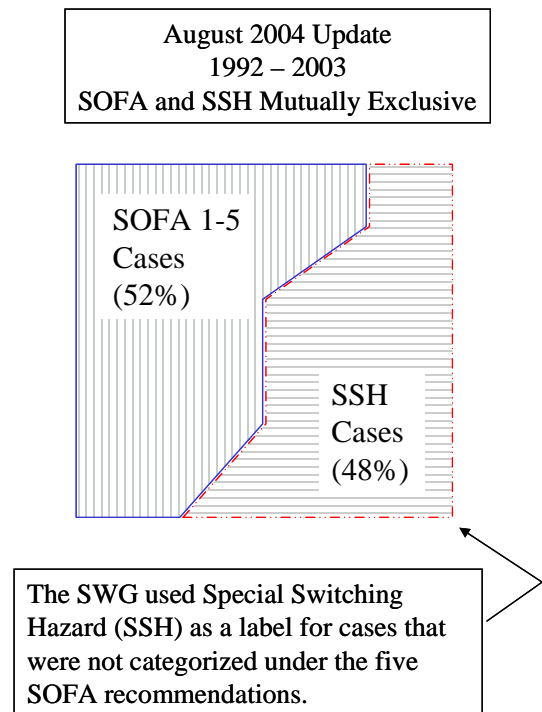
**Figure 2-1 August 2004 Update**

However, the August 2004 Update took SOFA case classification a step further. The SWG wanted a way to characterize the cases which did not meet the criteria for the SOFA 1-5 cases; this amounted to 60 of the 124 cases reviewed (48%). These cases were classified into 11 categories called Special Switching Hazards (SSH). Figure 2-1 illustrates the idea that the two groups, the SOFA 1-5 cases and the SSH cases, were mutually exclusive.

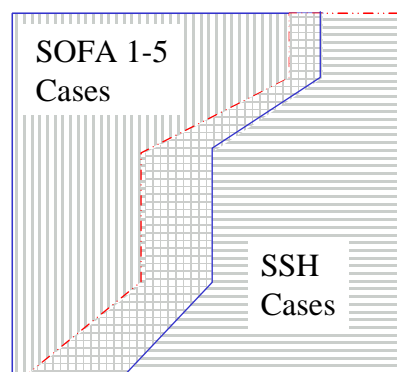
**Figure 2-2 December 2010 Update**

Figure 2-2 shows the two groups (the five SOFA categories and the SSH) are no longer mutually exclusive and can overlap. In particular, it shows the number of cases categorized as an SSH grows because SOFA 1-5 cases can qualify as SSH.

December 2010 Update  
SSH categories applied to all  
cases (SOFA and non-SOFA)

The number of Special Switching Hazards grows.

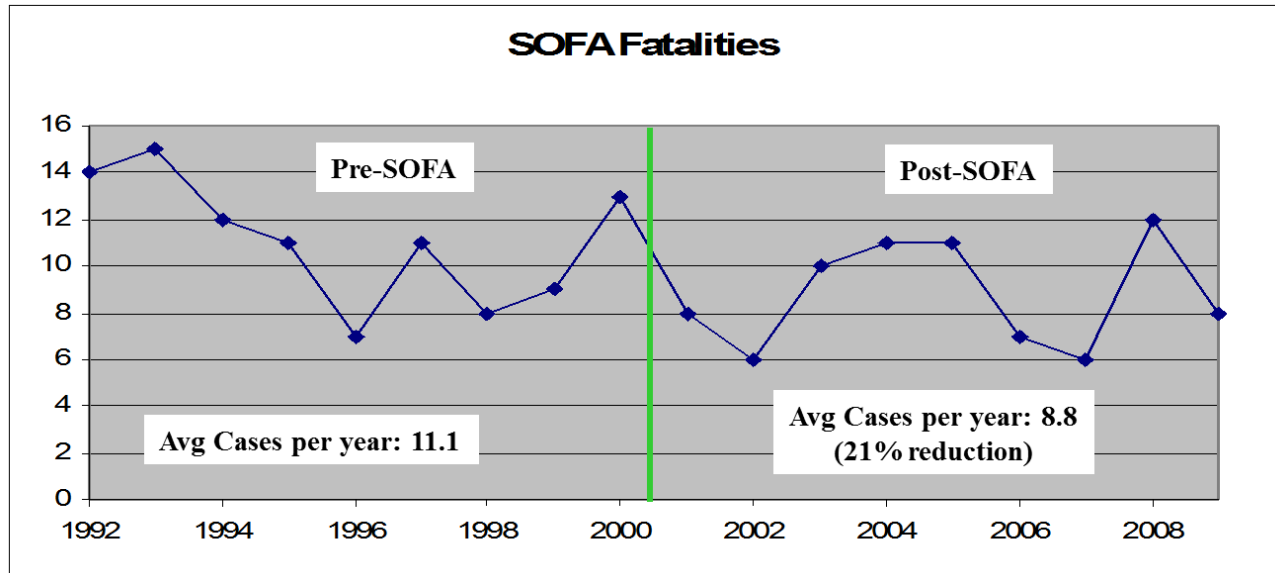
Figure 3-1: SOFA Fatalities by Year

The SOFA Working Group (SWG) has reviewed 179 switching fatality cases from 1992 through 2009, an 18-year period. Figure 3-1 shows a year-by-year graph of those fatalities. There is a line in the middle of Figure 3-1 which divides the graph into two nine-year periods: the period from 1992 through 2000 and the period from 2001 through 2009.

The SWG issued its first SOFA report in October 1999, too late to influence the number of fatalities for 1999. During 2000, the SWG raised SOFA awareness through presentations at railroad industry meetings and forums. Also during 2000, the railroad industry educated its workforce about SOFA and the Five Lifesavers. SOFA efforts had little opportunity to have an effect during this roll-out period in 2000. This means 2001 was the first year that SOFA could have had full effect on reducing fatalities. One way to interpret Figure 3-1 is to regard the first nine-year period (1992 – 2000) as the Pre-SOFA period and the second nine-year period (2001 – 2009) as the Post-SOFA period.

The average number of cases in the Pre-SOFA period is 11.1. During the next 9 years, the Post-SOFA period, the average number of cases dropped to 8.8, about a 21% reduction. Therefore, the railroad industry achieved some success in reducing SOFA fatalities since the first efforts to raise SOFA awareness.

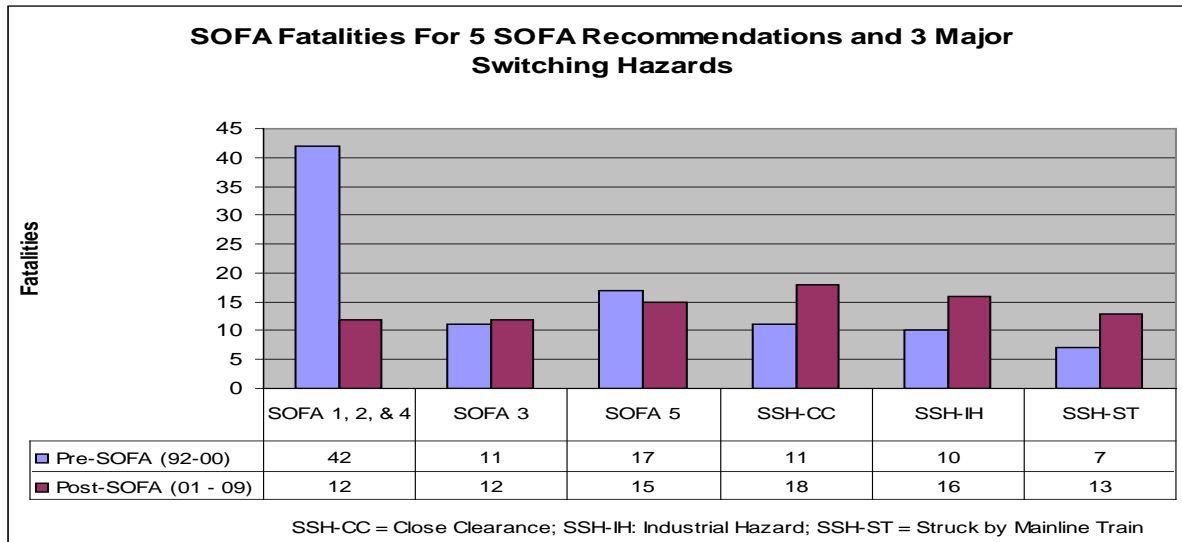
**Figure 3-2: SOFA Fatalities in Six Areas**

Figure 3-2 is a paired bar chart which provides a picture of where progress has been made in reducing SOFA fatalities and where more attention is needed. The first set of paired bars represents fatalities collectively for SOFA 1, 2, and 4. The reduction from 42 fatalities in the pre-SOFA period to 12 in the Post-SOFA period is a substantial 71% reduction. This substantial reduction runs across the board for SOFA 1, 2, and 4. This report will discuss SOFA 1, 2, and 4 in more detail below.

The other five sets of paired bars in Figure 3-2 show areas where improvement can be made by the railroad industry. The paired bars for both SOFA 3 and SOFA 5 show little or no progress and a discussion of those fatalities follows below. There are three SSH that are growing issues.

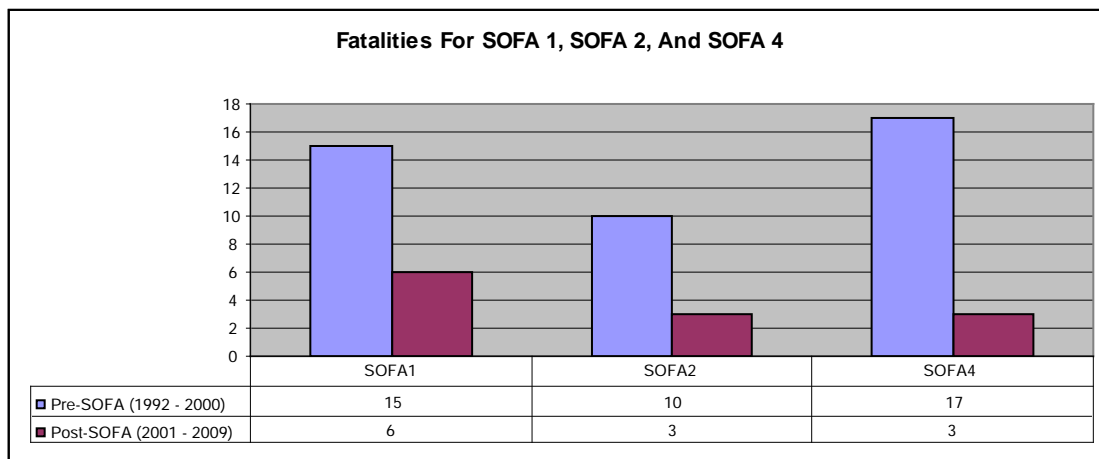
**Figure 3-3: Fatalities for SOFA 1, SOFA 2, and SOFA 4**

Figure 3-3 shows a paired bar chart displaying the number of SOFA 1, 2, and 4 fatalities over two nine-year periods (Pre-SOFA versus Post-SOFA).

The paired bars for each case show an impressive reduction for SOFA 1, 2, and 4. SOFA 1 fatalities are down 60% from 15 fatalities in the Pre-SOFA period to the 6 fatalities in the Post-SOFA period. SOFA 2 fatalities have declined 70% from 10 in the Pre-SOFA period to 3 in the Post SOFA period. There has not been a SOFA 2 fatality since 2004. The biggest improvement is in SOFA 4 where there has been a decline of over 80% from 17 fatalities in the Pre-SOFA period to 3 in the Post-SOFA period.

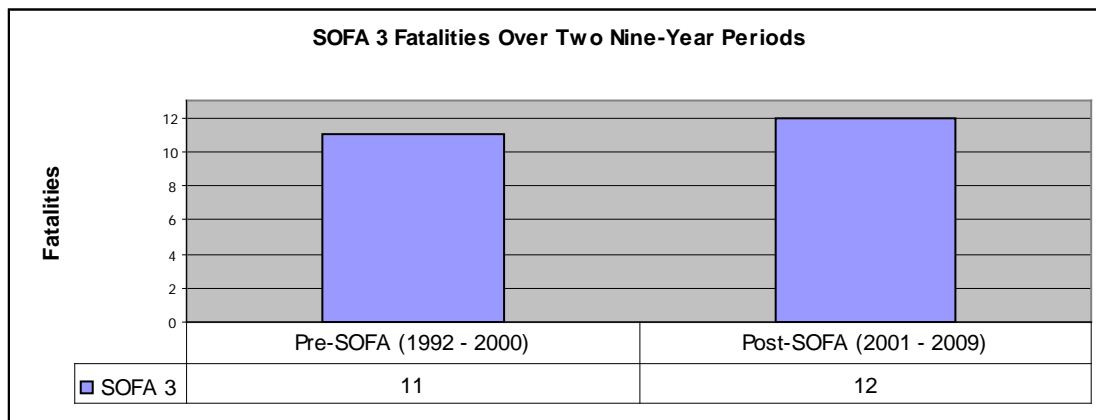
**Figure 3-4: SOFA 3 Fatalities Over Two Nine-Year Periods**

There has been no substantial progress on reducing fatalities related to SOFA 3 incidents since the SOFA Operating Recommendations were released in the 1999 SOFA report. SOFA 3 is the fourth largest category of SOFA fatalities. Figure 3-4 illustrates SOFA 3 fatalities over two nine-year periods (Pre-SOFA versus Post-SOFA) and an increase from 11 to 12 fatalities between the two periods. Appendix G provides a more detailed comparison between the Pre-SOFA and Post-SOFA periods for SOFA 3.

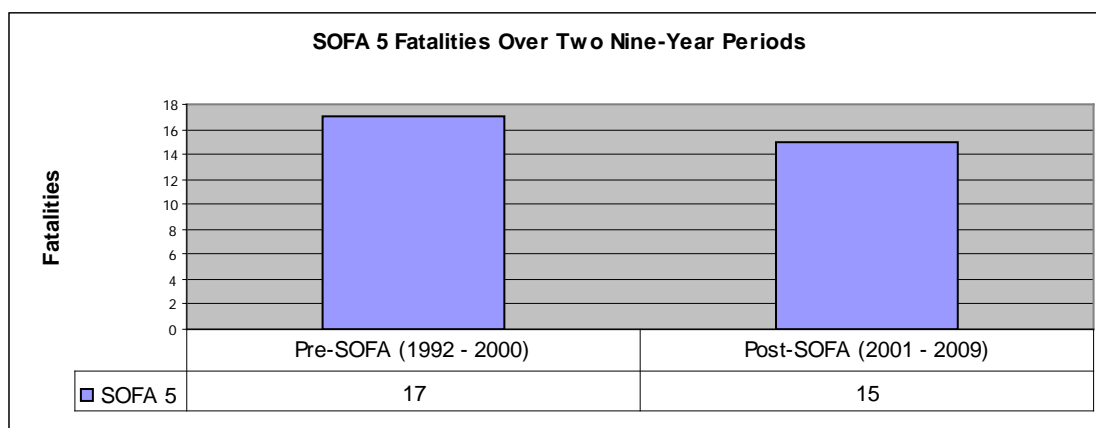
Figure 3-5: SOFA 5 Fatalities Over Two Nine-Year Periods

There has been little progress on reducing fatalities for SOFA 5 incidents since the SOFA Operating Recommendations were released in the first SOFA report in October 1999. With 32 cases, SOFA 5 is the largest category of SOFA fatalities. Figure 3-5 shows a bar chart displaying the number of SOFA 5 fatalities over two nine-year periods (Pre-SOFA versus Post SOFA). It shows little progress has been made on reducing SOFA 5 fatalities between the two nine-year periods.

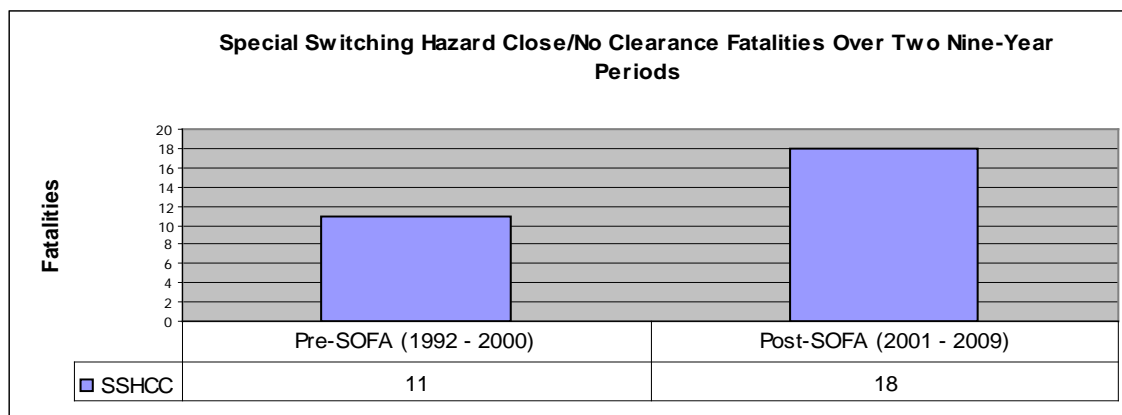
Figure 3-6: SSH Close/No Clearance Fatalities Over Two Nine-Year Periods

Close/No clearance is the second largest category of SOFA fatalities. Figure 3-6 displays the number of close/no clearance fatalities over two nine-year periods, pre-SOFA versus post-SOFA. It shows fatalities due to close/no clearances are a growing issue and could imply the guidance provided in the August 2004 SOFA Update (See Section 3.5.2 immediately below) has had little or no effect.<sup>16</sup>

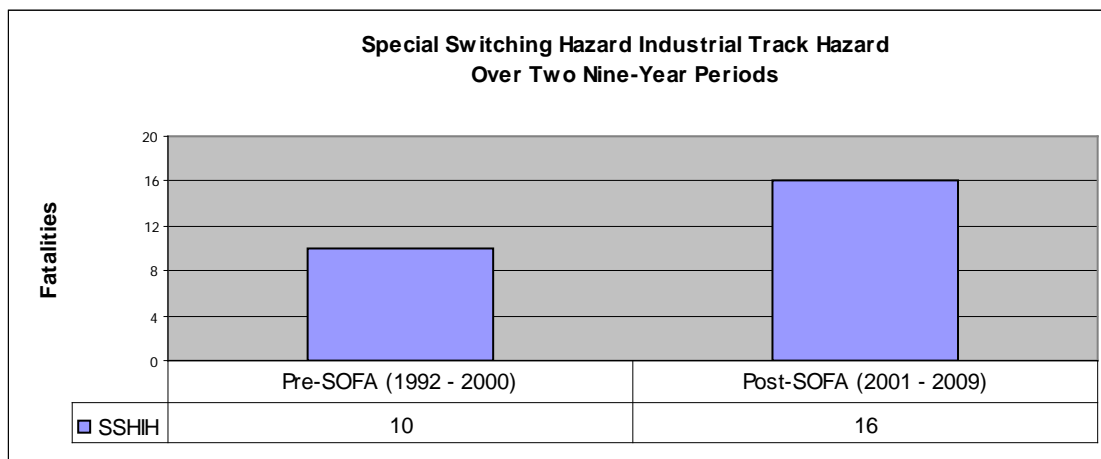
**Figure 3-7: Special Switching Hazard Industrial Track Hazard Over Two Nine-Year Periods**

Industrial Track Hazard is the third largest category of SOFA fatalities. Figure 3-7 shows a bar chart displaying the number of fatalities involving industrial track hazards over two nine-year periods (Pre-SOFA versus Post SOFA). It shows fatalities involving industrial track hazards are a growing issue.

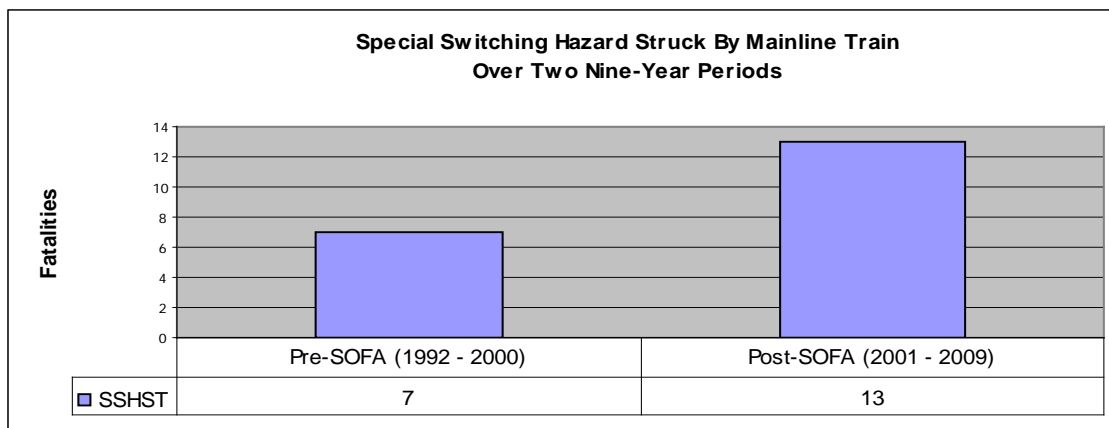
**Figure 3-8: Special Switching Hazard Struck By Mainline Trains Over Two Nine-Year Periods**

Struck by Mainline Trains, with 20 cases, is tied for the sixth largest category of SOFA fatalities. Figure 3-8 displays the number of struck by mainline train fatalities over two nine-year periods (Pre-SOFA versus Post-SOFA). It shows fatalities for TY&E employees who are struck by mainline trains is a growing issue and a cause for concern. It implies the guidance provided in the August 2004 SOFA Update (see Section 3.7.2 below) has had little or no effect.

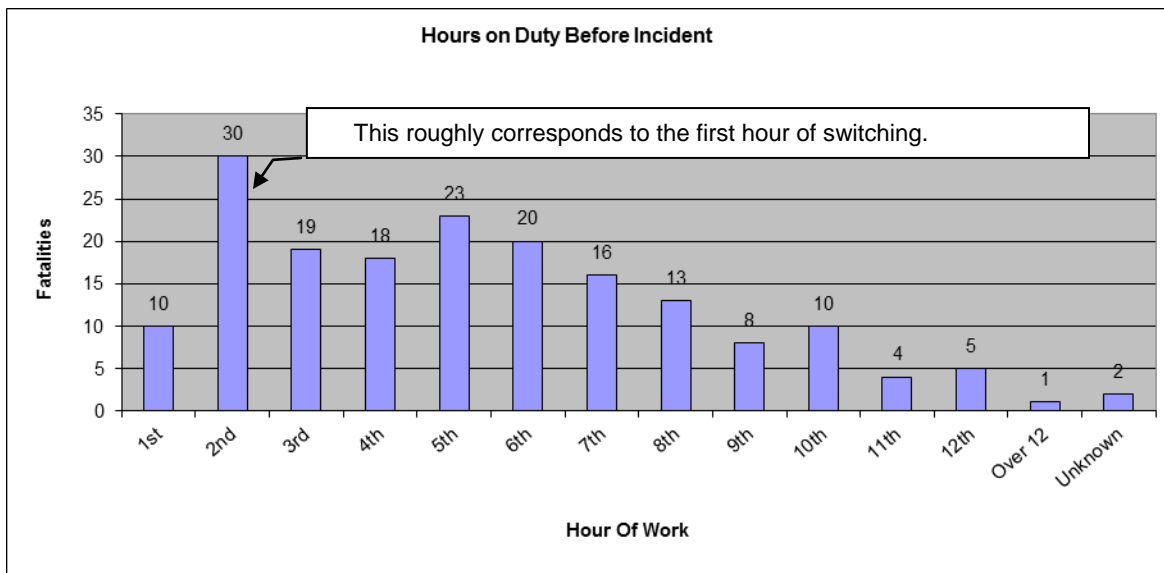
Figure 3-9: Hours on Duty Before Incident

The number of SOFA fatalities during the second hour of duty is higher than any other on-duty hour. The number of fatalities (30) occurring during the second hour of duty is surpassed by only one SOFA category, SOFA 5. Figure 3-9 shows a bar chart displaying the number of fatalities against the number of hours the FE was on duty. The number of fatalities during the second hour is clearly the largest. The second hour of duty may correspond to the first hour of actual switching operations, considering, the first hour on duty is generally consumed with assembling the crew, reviewing paperwork, job and safety briefings, and traveling to the work site.

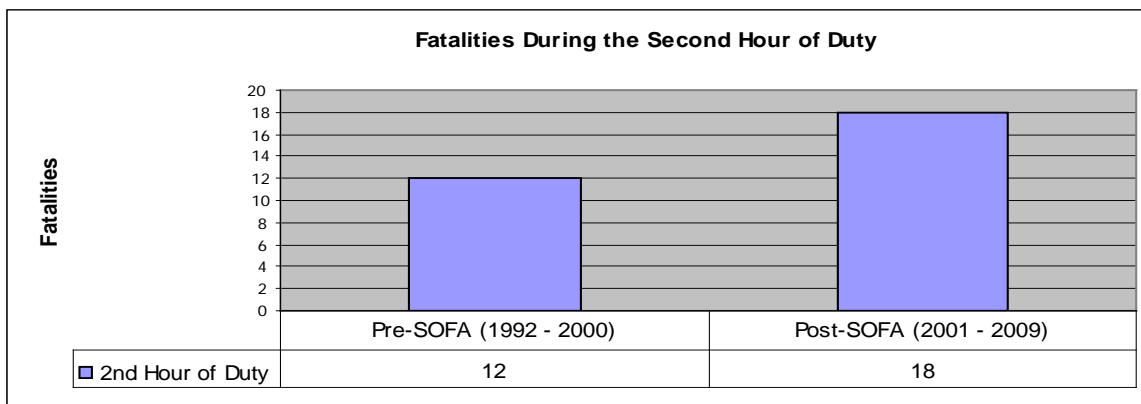
Figure 3-10: Fatalities During the Second Hour of Duty Over Two Nine-Year Periods

Figure 3-10 suggests that this type of fatality is a growing issue.

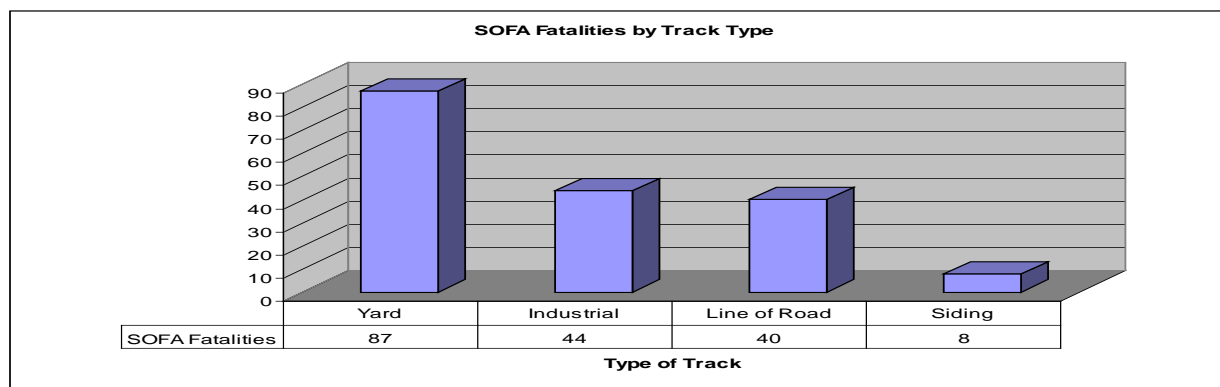
**Figure 4-1: SOFA Fatalities by Track Type**

Figure 4-1 shows 87, almost half of the 179 SOFA fatalities, occurred on yard track.

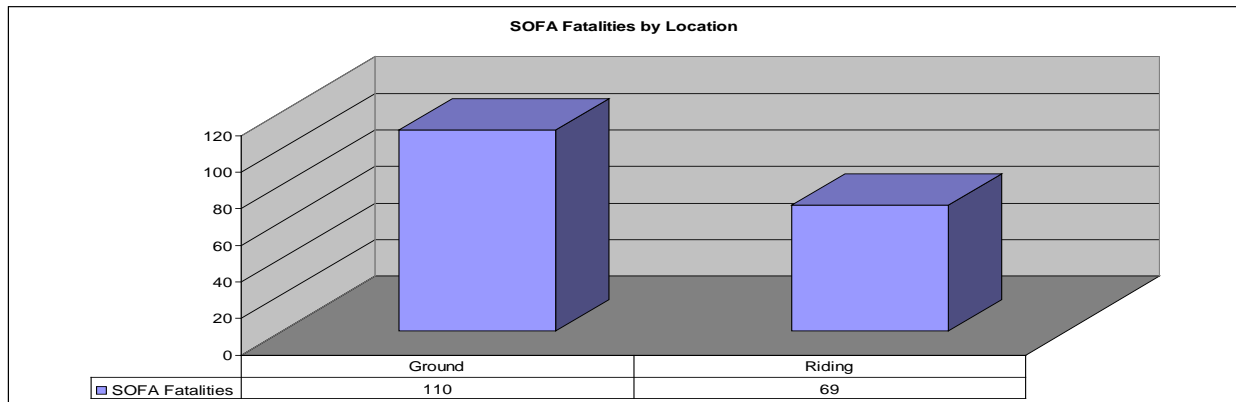
**Figure 4-2: SOFA Fatalities by Location**

Figure 4-2 shows an FE was more likely on the ground than riding when fatally injured. However, there were 69 cases when the FE was riding, 38.5% of the total.

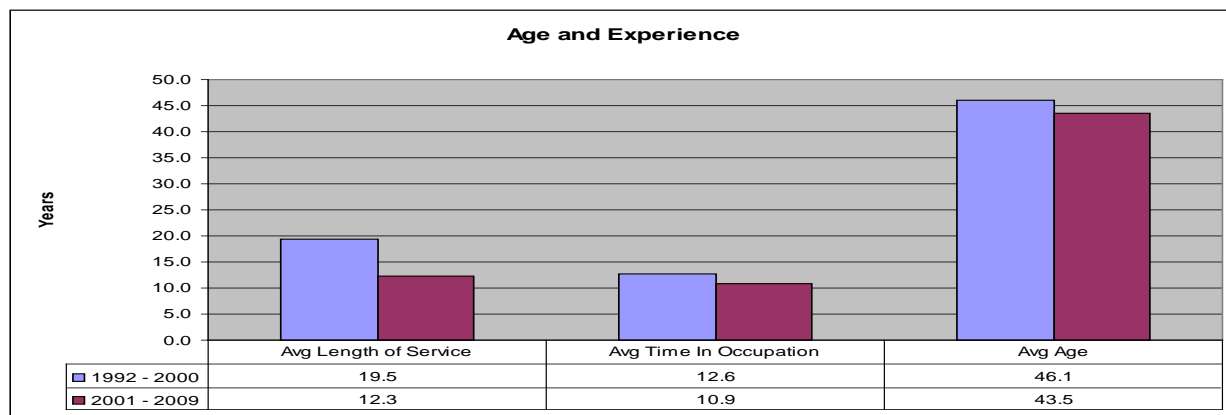
**Figure 4-3: Age and Experience**

Figure 4-3 shows that age and experience for fatally injured employees has declined from the Pre-SOFA period to the Post-SOFA period. The gap for the two periods is especially large for length of service. The chart suggests that issues with SOFA 5<sup>26</sup>, employees with 1.5 years of experience or less, continue to present challenges to the railroad industry.

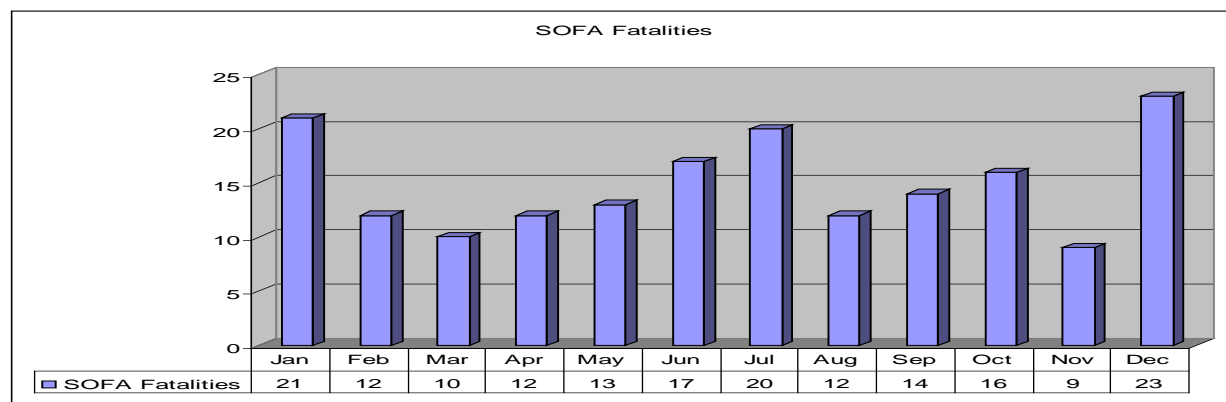
**Figure 4-4: SOFA Fatalities By Month**

Figure 4-4 illustrates SOFA fatalities by month. January, July, and December are the only months with 20 or more fatalities. The SWG decided to look at these monthly statistics for cold weather states<sup>27</sup> and other states (i.e., states not classified as cold weather states).

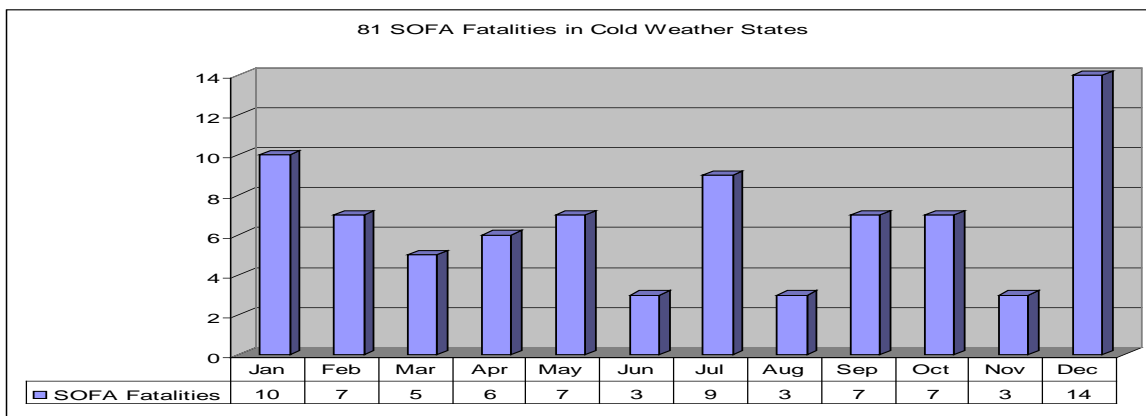
Figure 4-5: SOFA Fatalities By Month For Cold-Weather States

Figure 4-5 shows there were 31 fatalities in cold-weather states during meteorological winter<sup>28</sup> (December, January, and February). Notice the bars for winter are relatively higher than other times during the year. The spike in December, the first month of winter, is almost five times

higher than the low months in June, August, and November. Table 4-4 compares the fatalities in these states to other months of the year. Cold-weather states accounted for more than half (55%) of the fatalities in winter and less than half (41%) during other months of the year. This difference suggests there is increased risk in cold-weather states during winter. The median temperature for these incidents was 21 degrees Fahrenheit. July, the hottest month of the year, also has a relatively high number of fatalities compared to other months.

The above Figures 4-5 and 4-6 suggest the onset of cold weather (December in cold-weather states and January in other states) may create conditions for increased risk of fatalities. Figures 4-5 and 4-6 also suggest the onset of hot weather (June in other states and July in cold-weather states) may create conditions for increased risk of fatalities. The railroad industry may want to consider additional preparation and education of the workforce on adapting to changing conditions in summer and winter. Appendix H provides additional information on fatalities in winter and summer.

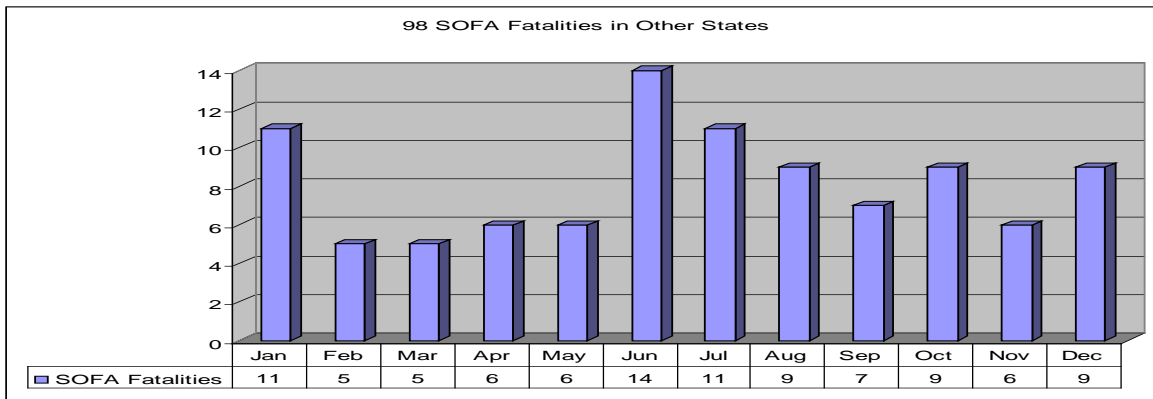
**Figure 4-6: SOFA Fatalities By Month For Other (Non-Cold-Weather) States**

Conversely, Figure 4-6 shows there were 34 fatalities in other states (i.e., states not classified as cold weather states) during meteorological summer<sup>29</sup> (June, July, August). The bars for summer are relatively higher than other times during the year. The spike in June, the first month of summer, is almost three times higher than the low months in February and March. Table 3-36 compares the fatalities in these states to other months of the year. Other states accounted for more than half (69%) of the fatalities in summer and less than half (49%) during other months of the year. This difference suggests there is increased risk in other states during summer. The median temperature for these incidents was 80 degrees Fahrenheit. January, the coldest month of the year, also has a relatively high number of fatalities compared to other months.

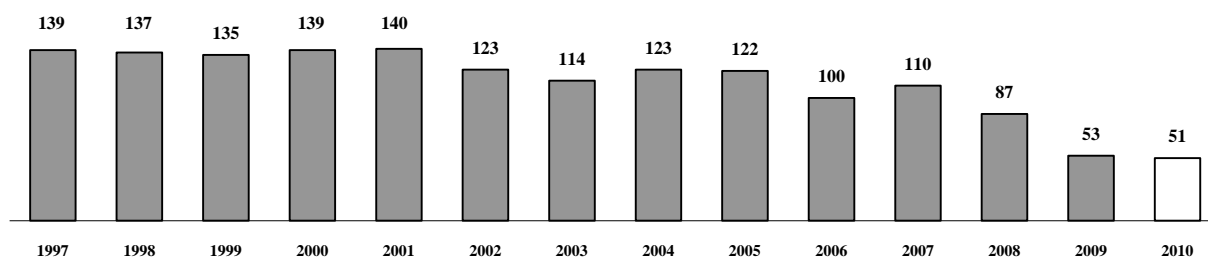
**Figure 5-1: SOFA-defined Severe Injuries by year, 1997 through October 2010**

Incidence has declined over the years, with the appearance of stages, as shown by three shaded sections in Figure 5-1. In 2010, there were 51 severe injuries January through October v. 42 in the corresponding period of 2009. (Ten months of 2010 was the most up-to-date period available at time of publication.) However, based on ten months, it would be premature to make any prediction about the number of injuries that will occur in 2010, full-year. Or years after.

(Note: 1997 is the first year these injuries can be defined based on the interests of SWG)

In 2002, SOFA-defined severe injuries began to decline although not consistently year-to-year (Figure 5-1). For the years, 1997 through 2001 severe injuries averaged 138.0 per year. For 2002 through 2007, an average of 115.3 per year occurred. In 2008, there were 87 severe injuries. Then in 2009 injuries declined to 53, a 13-year low.

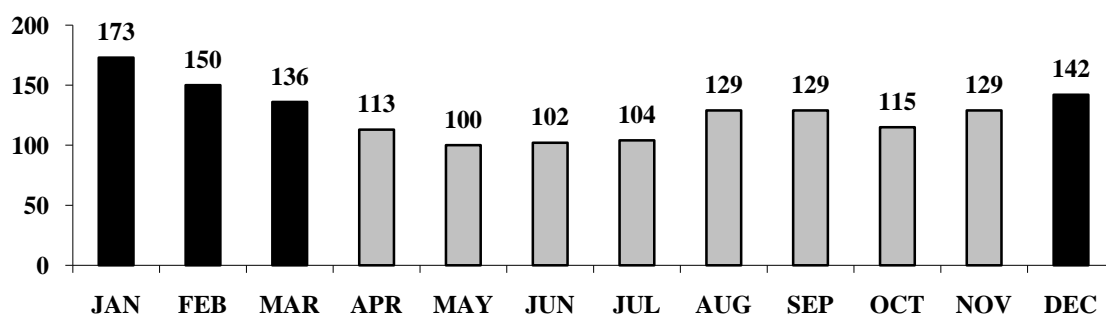
Figure 5-3: SOFA-defined Severe Injuries, by month, 1997 through 2009

December, January, February, and March historically have relatively high counts of severe injuries, but all months have risk for SOFA-defined severe injuries (Figure 5-3). While likely winter conditions play a role, all of the reasons for increases in these months are not known.

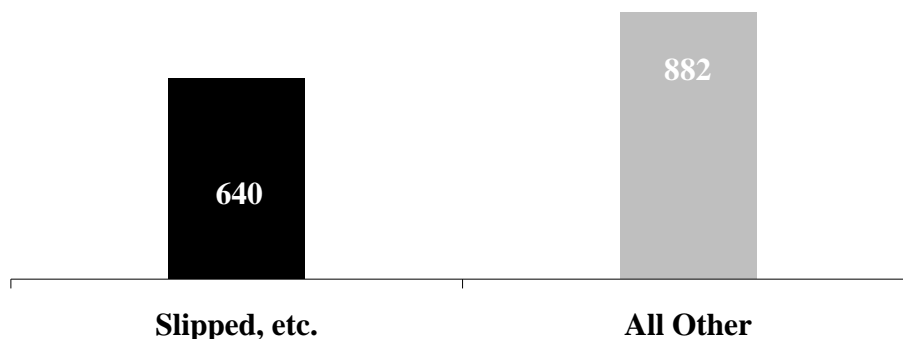
**Figure 5-4: Composition of 1,522 Severe Injuries: Slipped, Fell, Stumbled, etc. v. All Other Types, 1997 through 2009**

The composition of severe injuries by event type contains a large cluster. There were 640 SOFA-defined severe injuries, 1997 through 2009, resulting from ‘slipped, fell, stumbled, etc.’ (FRA Event Codes #51-54, and 70) -- 42 percent of the total 1,522 injuries occurring during this period (Figure 5-4). Other clusters of severe injuries by event types are much smaller (Table J-9).

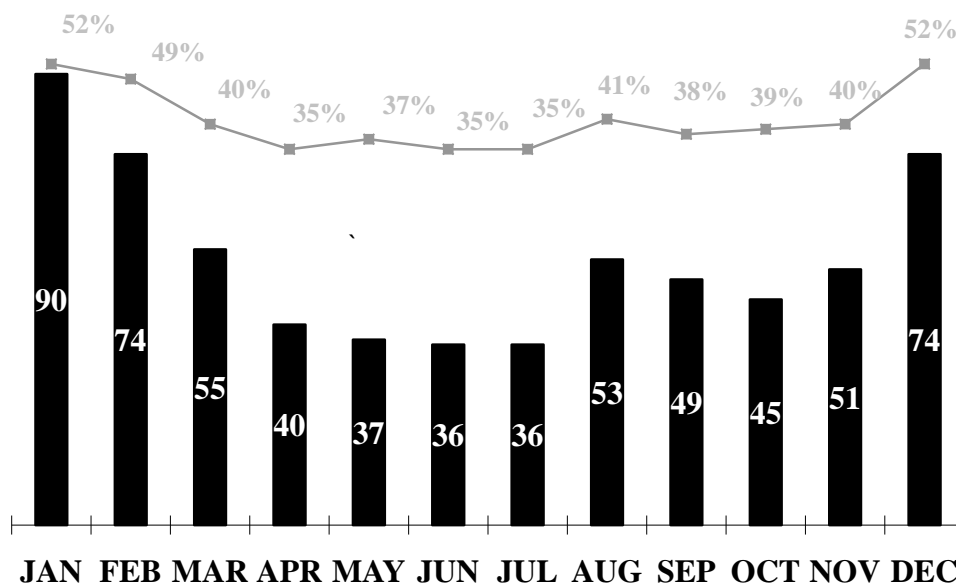
**Figure 5-5: Severe Injuries Attributable to Slipped, Fell, Stumbled, etc., by month, 1997 through 2009**

Winter appears to be a factor in ‘slipped, fell, stumbled, etc.’ events. During December, January, February, and March, 1997 through 2009, the percent of this injury type is 48 v. 38 percent for other months (Figure 5-5).
