**Federal Railroad  
Administration**

# Memorandum

Subject: Frog Guard Rails - Cracks or Breaks  
and Spiking Requirements

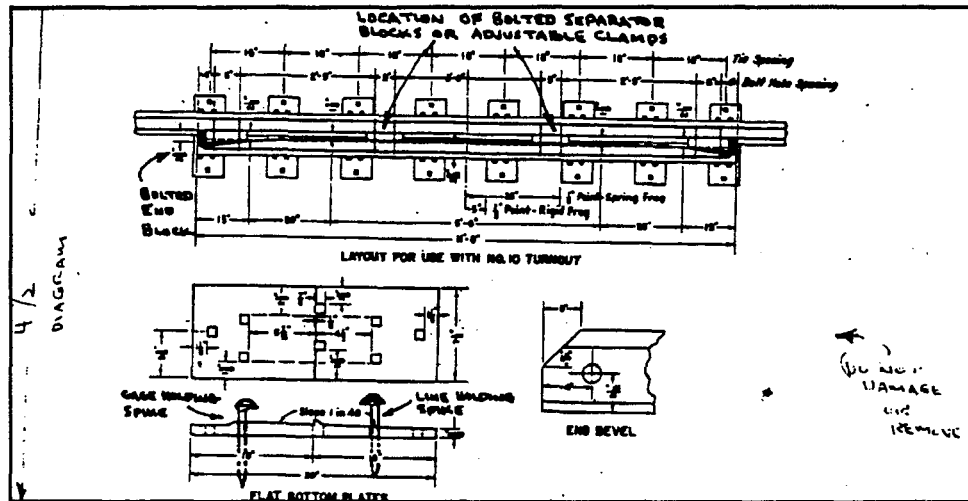
Figure 1 Guard rail with bolted separator blocks or adjustable clamps with plates that are punched for spikes on the gage side of the running rail.

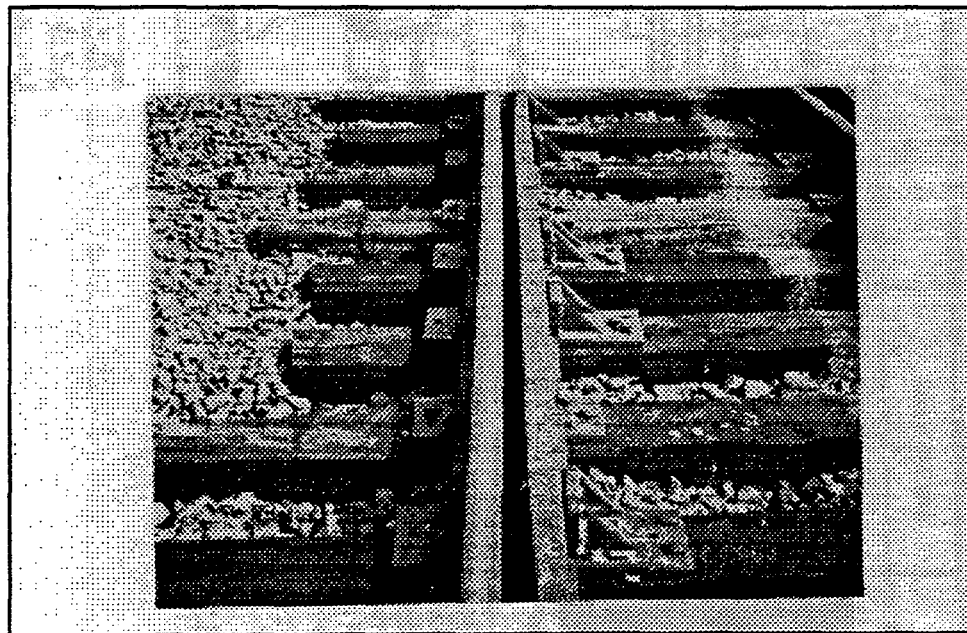
Figure 2 Photograph of new style guard rail with no spike holes punched on the gage side of the running rail.

The photograph in Figure 2 shows a new design on one railroad where there are no spike holes on the plates on the gage side of the running rail. Note the heavy bracing which is intended to prevent overturning of the guard rail.
