U.S. Department of
Transportation

**Federal Railroad
Administration**

Effects of In-Pavement Lights on Driver Compliance with Grade Crossing Safety Equipment

Office of Research,
Development
and Technology
Washington, DC 20590

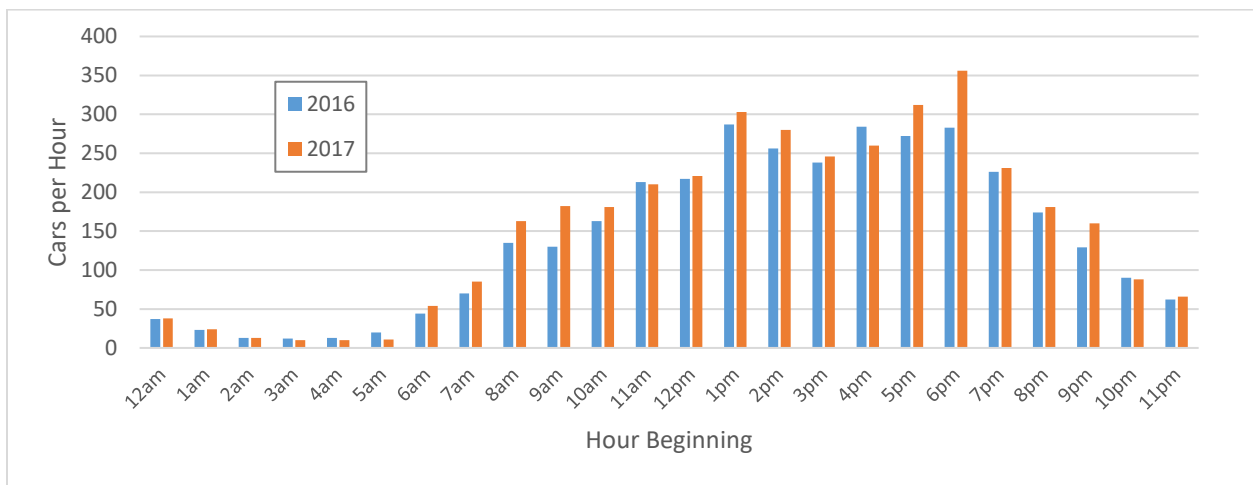
Figure 2 – Comparison of traffic volumes on East 7th Street (first Thursday in November, 2016 and 2017)

Researchers found it interesting that most of the increases in traffic occurred during rush hours in the morning and late afternoon. Since there was a slightly higher level of traffic in the post-deployment phase of this task, it was more likely for vehicles to have been present during crossing events. However, this should have had no significant impact on compliance rates.

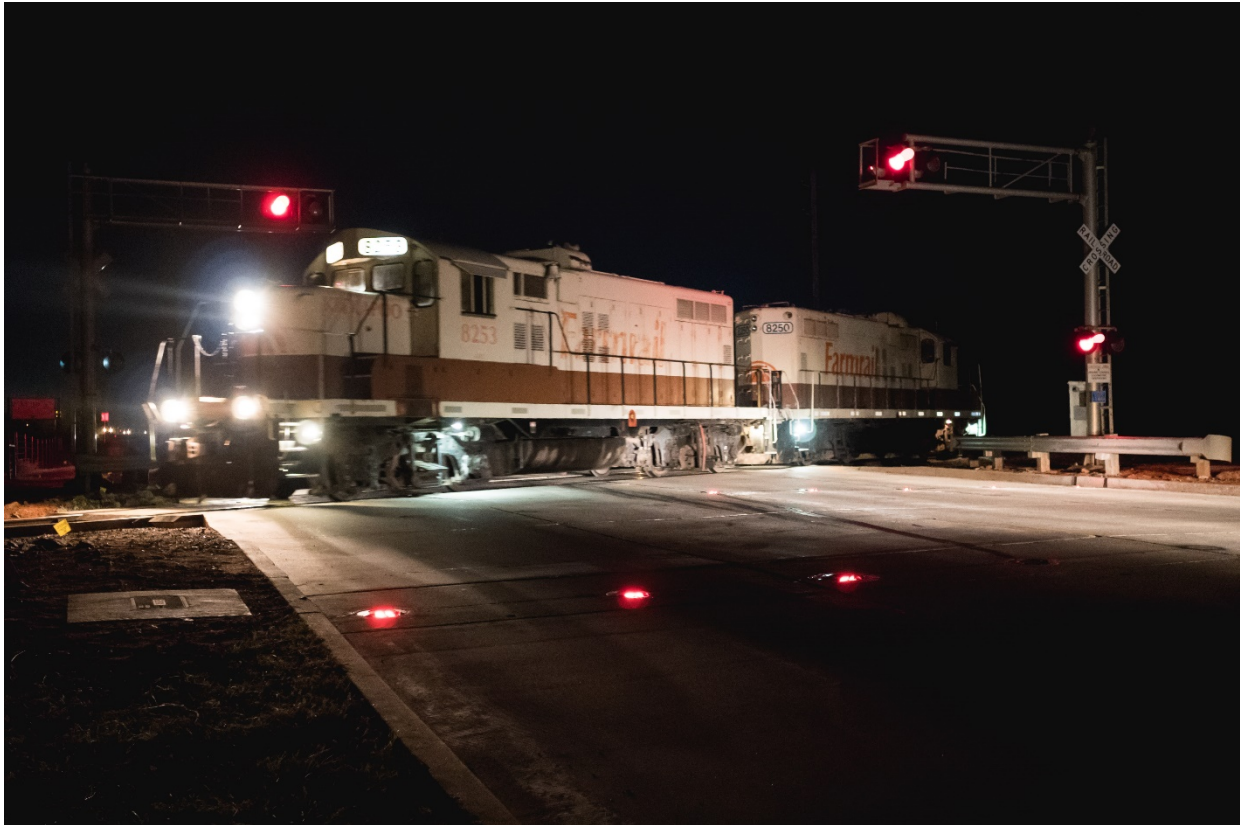
Figure 3 – Elk City in-pavement lights, looking west

Below are two photos of the in-pavement lights in Elk City. [Figure 3](#) shows a nighttime view of the in-pavement lights, and [Figure 4](#) shows a close-up of one of the light fixtures as embedded in the pavement.

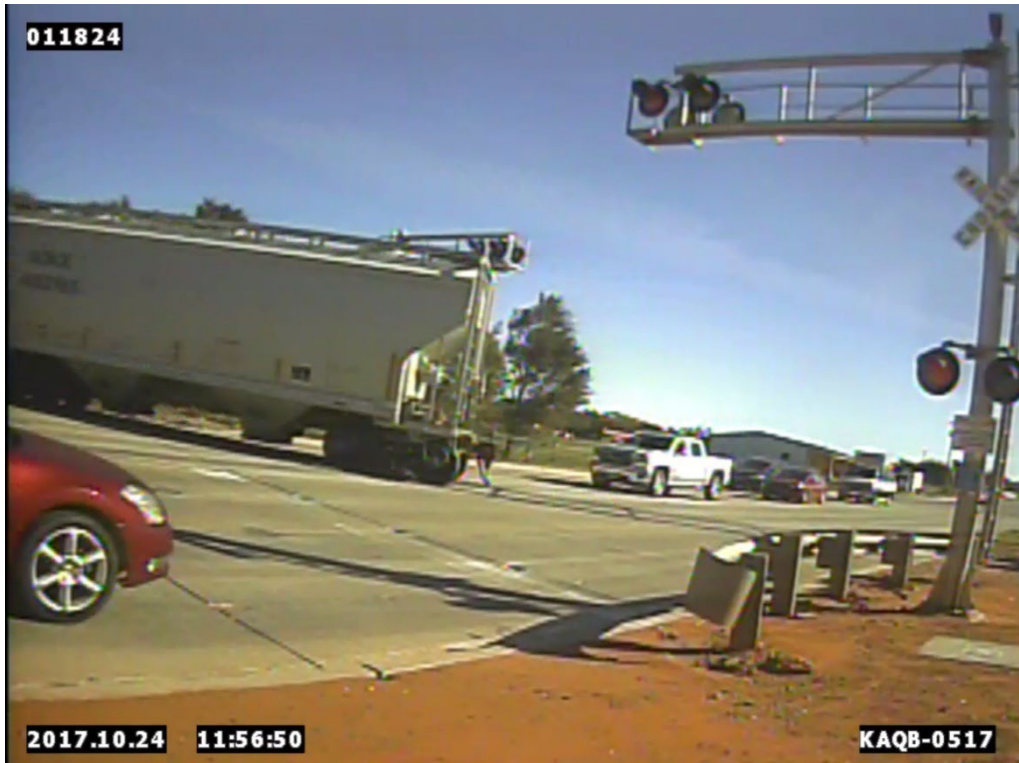
Figure 5 – Example of the video camera’s field of view

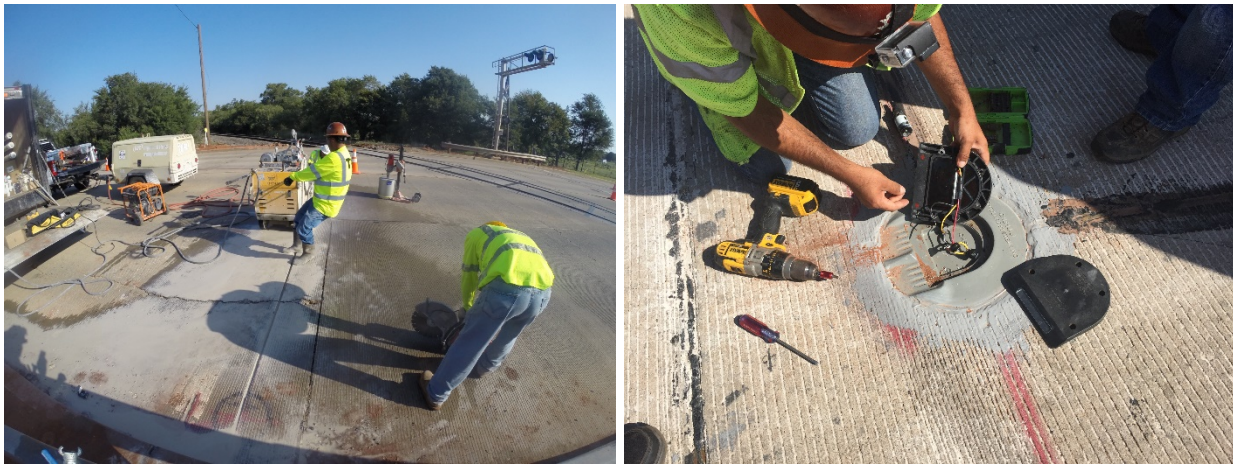
The in-pavement lighting system was installed during the second week in September, 2017. Photos of the installation are shown below in [Figure 7](#).

Figure 7 – Installation photos

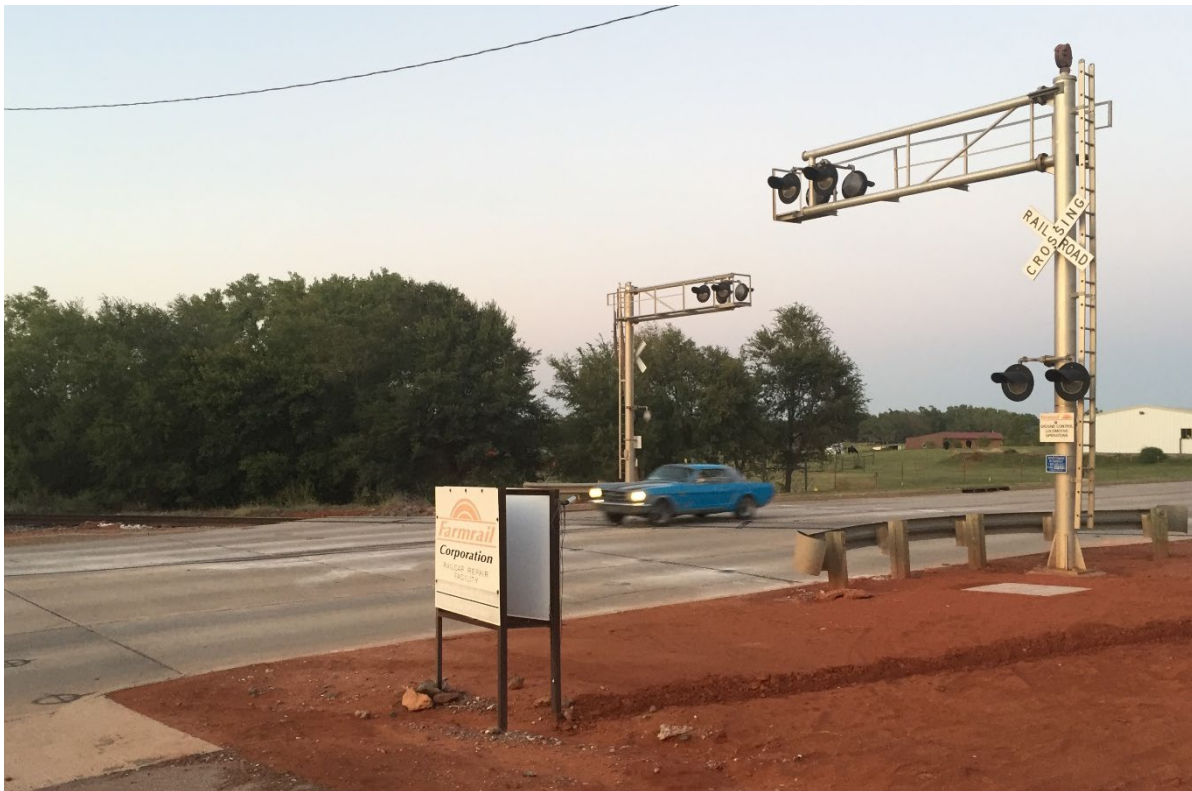
Figure 8 – Camera Mounted on Farmrail Sign

Video data was collected using an analog video camera with a wide-angle lens mounted on a Farmrail sign on the west side of the crossing, shown in [Figure 8](#). As mentioned earlier, the camera could not be mounted further west due to a paved driveway adjacent to the sign. This proved to be a limitation because researchers observed that vehicles stopping for trains sometimes stopped more than one car length from the stop line, and were not visible to the camera. This reduced the number of vehicles counted as being present during crossings and in compliance with the signals. Those that violated the signals were, of course, visible. However, this condition was the same for the pre-deployment data set as for the post-deployment data set, so the net effect on the results is believed to be negligible.

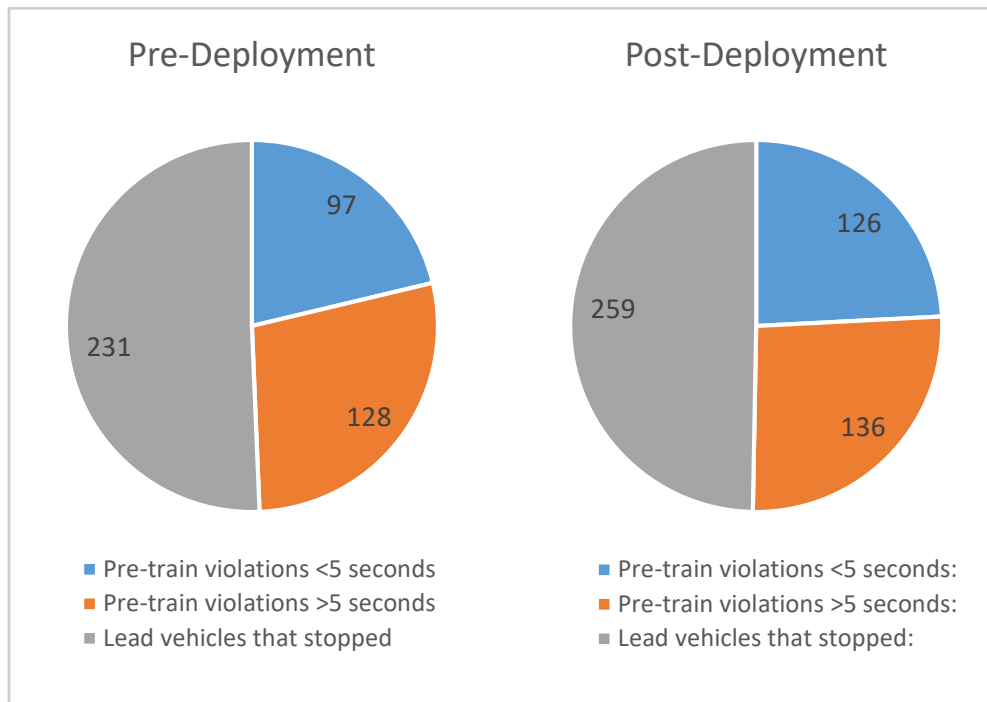
Figure 11 – Comparison of Pre- and Post-Deployment Vehicle Behavior

In the post-deployment phase, there was a total of 473 train events assessed. There were 262 pre-train violations, with 136 occurring 5 or more seconds after signal activation, which makes for an average violation rate of 28.75 percent. This was a decrease of 2.62 percent. These numbers are shown in [Figure 11](#).

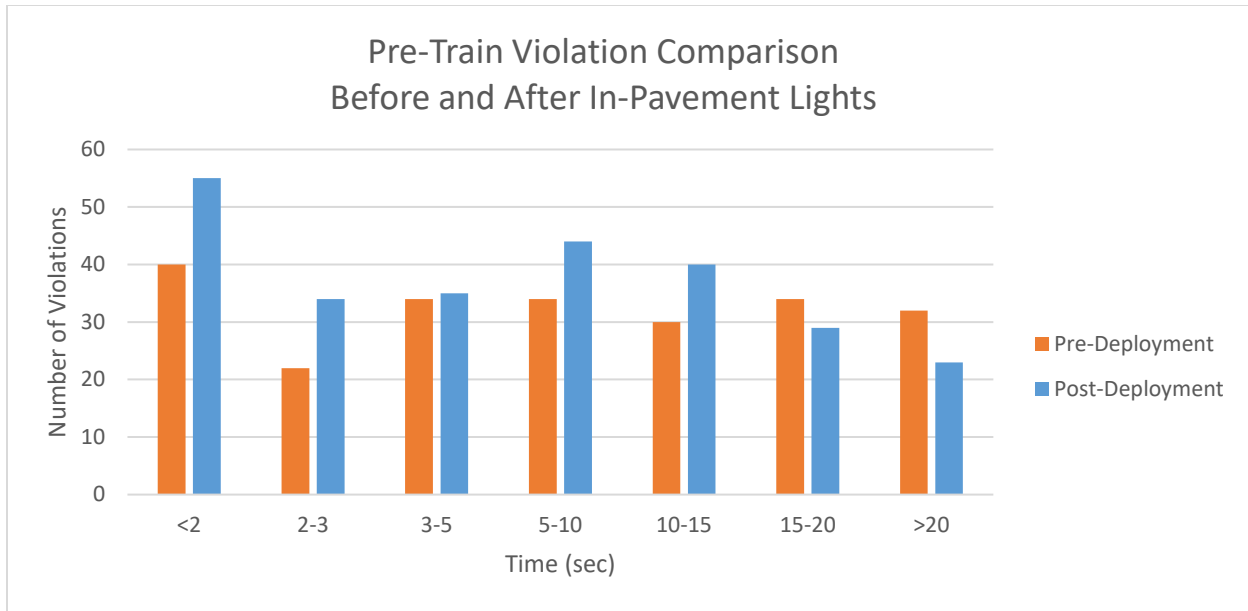
Figure 12 – Comparison of Violation Times Before and After In-Pavement Lights

Keeping in mind there was a 26.2 percent increase in the number of train events in the post-deployment phase, it was clear that the number of late violations (vehicles crossing more than 15 seconds after the signals were activated) decreased after the in-pavement lights were installed. This suggested the in-pavement lights were helpful in deterring the most dangerous types of grade crossing violations.

In [Figure 12](#) below, the number of vehicles crossing the tracks after selected amounts of time elapsing between signal activation and vehicles crossing the tracks is shown.

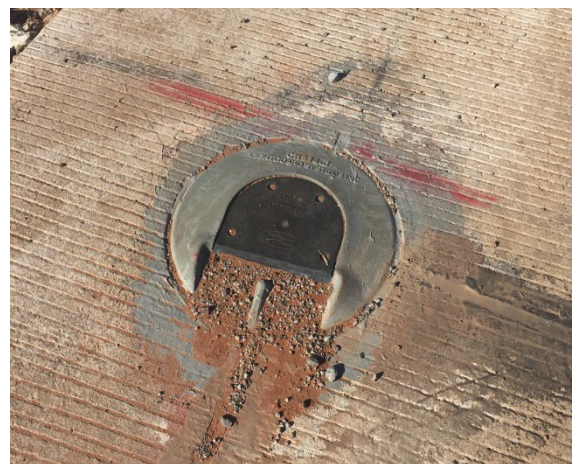
- A few weeks after installation, Elk City experienced heavy rains which caused a significant amount of soil to accumulate on the roadway. Some of this soil accumulated on the lights, obstructing them. After sweeping them off, they remained mostly clear, but over time they periodically become obstructed again. LightGuard stated that traffic passing over the lights should blow the dirt off them; however, the lights are situated mid-lane and between lanes, where tires rarely strike them. The lights closest to the shoulder and those on the east side of the crossing tended to accumulate the most dirt.

Figure 13 – Example of dirt accumulating on in-pavement light fixture

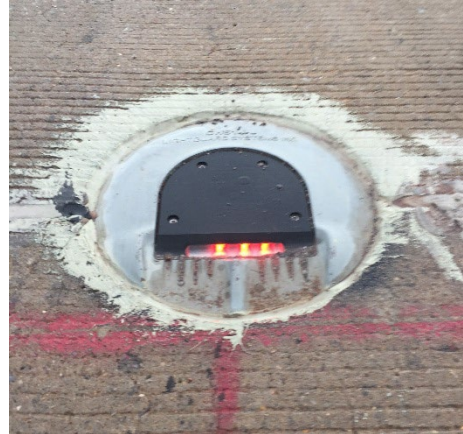
- On two occasions, one of the lights needed to be replaced. The first one occurred in November 2017 and was believed to be a faulty connection made during installation. The other was related to LEDs that burned out in one of the fixtures. Each light is comprised of about eight high intensity LEDs, and by June, 2018, one of the lights had lost five of them. Because the system was still under warranty, LightGuard arranged to replace the light free of charge. Two other fixtures had only lost one of the eight. Strangely, none of the fixtures on the west side of the crossing have lost any LEDs.

Figure 14 – Light with Burned out LEDs
