Office of Research, Development and Technology Washington, DC 20590 Laser Triangulation for Track Change and Defect Detection

DOT/FRA/ORD-20/08

Final Report March 2020

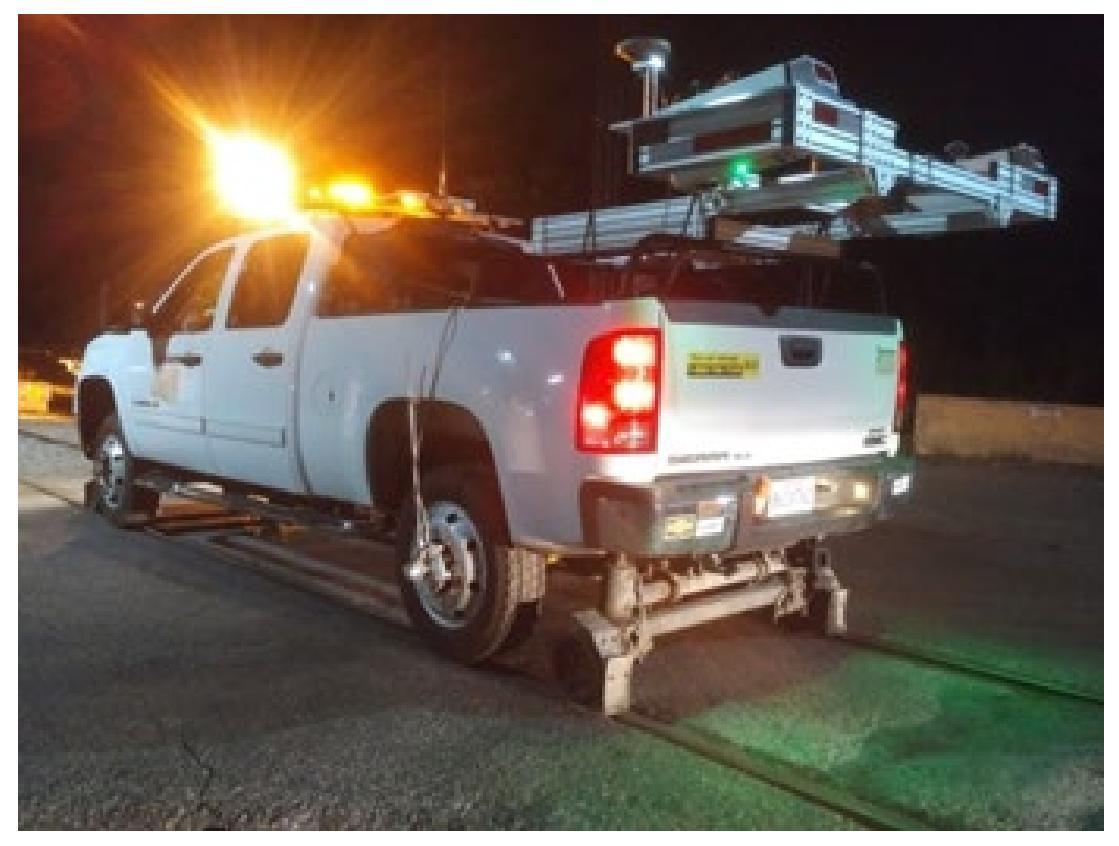
Figure 1 – Primary Sensor Configuration

During the data collection phase, Pavemetrics brought a hi-rail vehicle equipped with LRAIL sensors and associated hardware to Amtrak's facility for testing. The hardware package included a wheel-mounted encoder (for distance measurement), a GPS receiver, a DC to AC power invertor, and an industrial computer. Two different sensor mounting configurations were utilized; a top-down setup, (Figure 1) with one sensor directly over each rail and a two-sensor setup with one sensor above one rail and another sensor scanning the gauge-side face of that same rail (Figure 2).

The top-down setup was the primary configuration used for the project and for all change detection tasks. The side-scanning setup was specifically used to capture rail stamping on the side of the rail, and was not used for change detection.

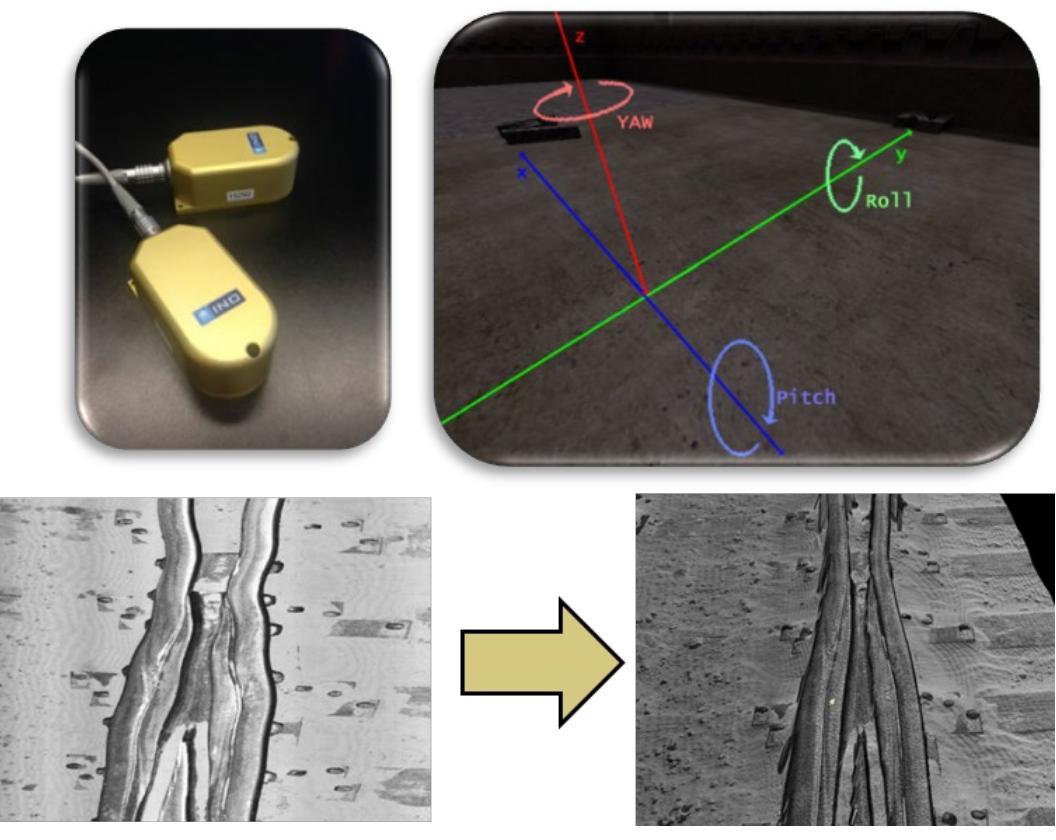
Figure 3 – Correction for Vehicle Motion

An inertial measurement unit is enclosed in each sensor head and used to track small changes in the pitch, roll and heading for each sensor. These orientation data were later used by a computer algorithm to remove vehicle motion artifacts from 2-dimensional and 3-dimensional data (Figure 3).

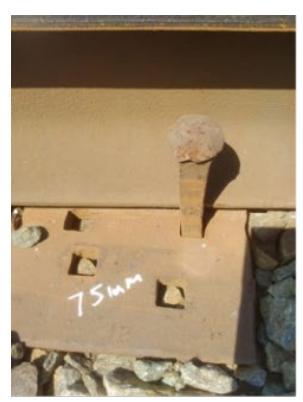
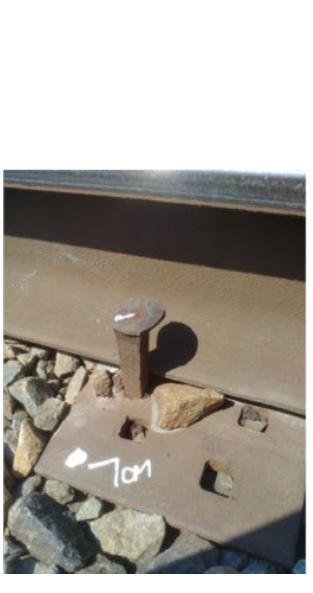
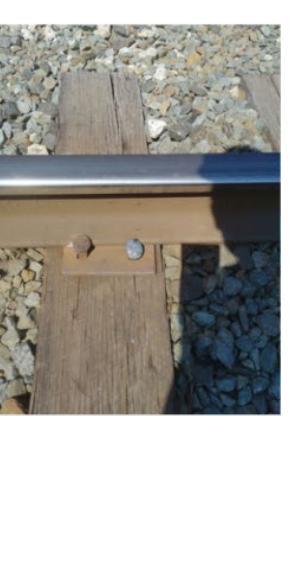
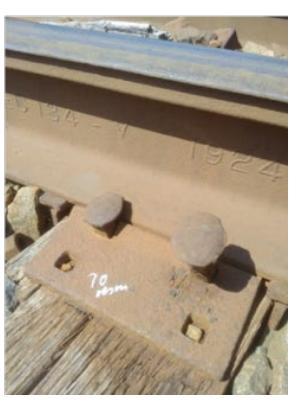
Figure 8 – Spike Changes

To test the detection sensitivity of the LRAIL system, a variety of changes were made to assets in the field, including spikes, anchors, fasteners, ballast, tie-skew, and joints. These changes are shown in the following figures.

The ground-truth for spike detection included the addition and removal of spikes as well as the raising and lowering of spikes. However, change detection for this project was primarily focused on detecting added or removed spikes. Ground-truth examples consisted of small, isolated cases of change (one or two spike changes made on a single tie) instead of a series of changes being made to adjacent ties (e.g., removing spikes from three or four ties in a row). This design was challenging for change detection, and may not reflect a detection condition of high value to a field inspector. In future testing this study recommends changing spikes on a series of adjacent ties.

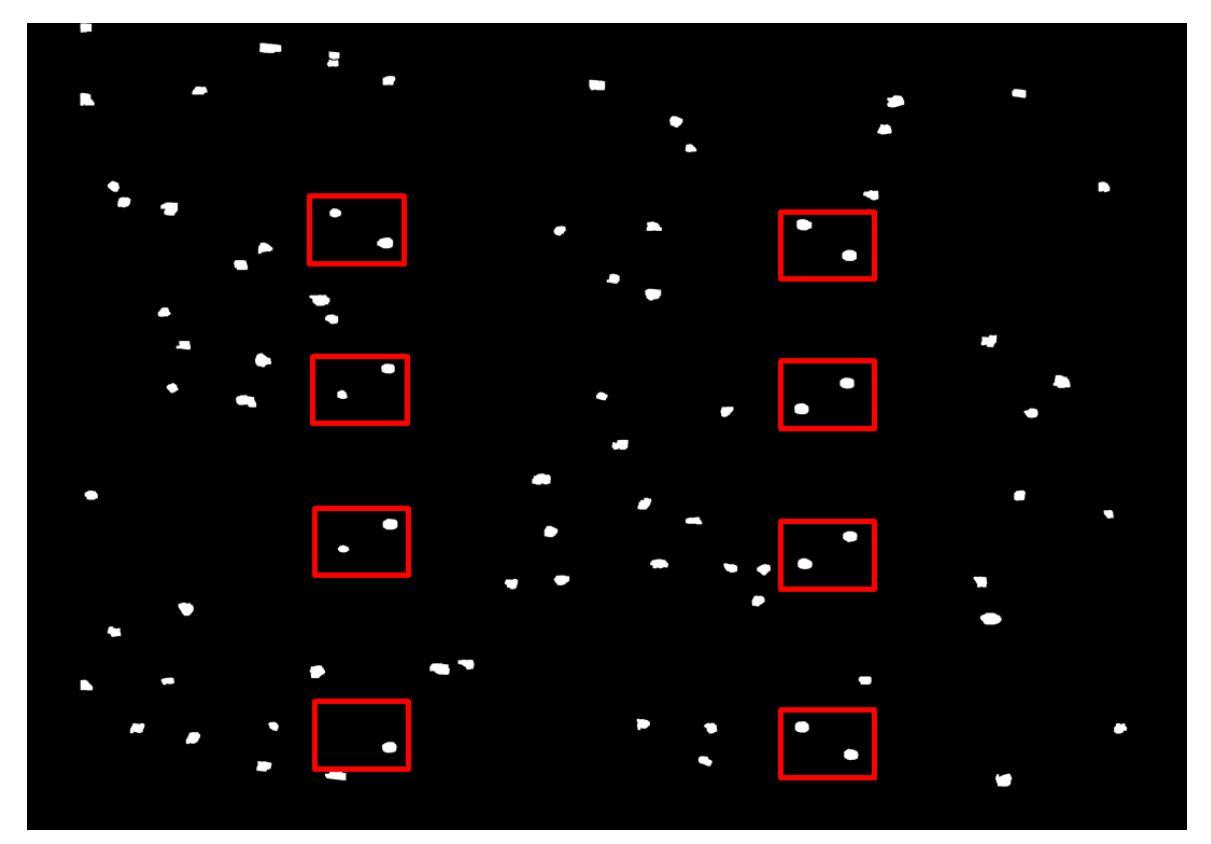
The change detection process involves first detecting the ties and rails, and then defining four regions of interest (ROI) at each intersection point (two on the gauge side and two on the field side). Each ROI was then inspected for the presence of spike heads using a 3-dimensional model (Figure 14). Spike count and average spike height was reported for each ROI and run-to-run comparison was performed on those same metrics.

Figure 14 – Regions of Interest Containing Heads of Spikes

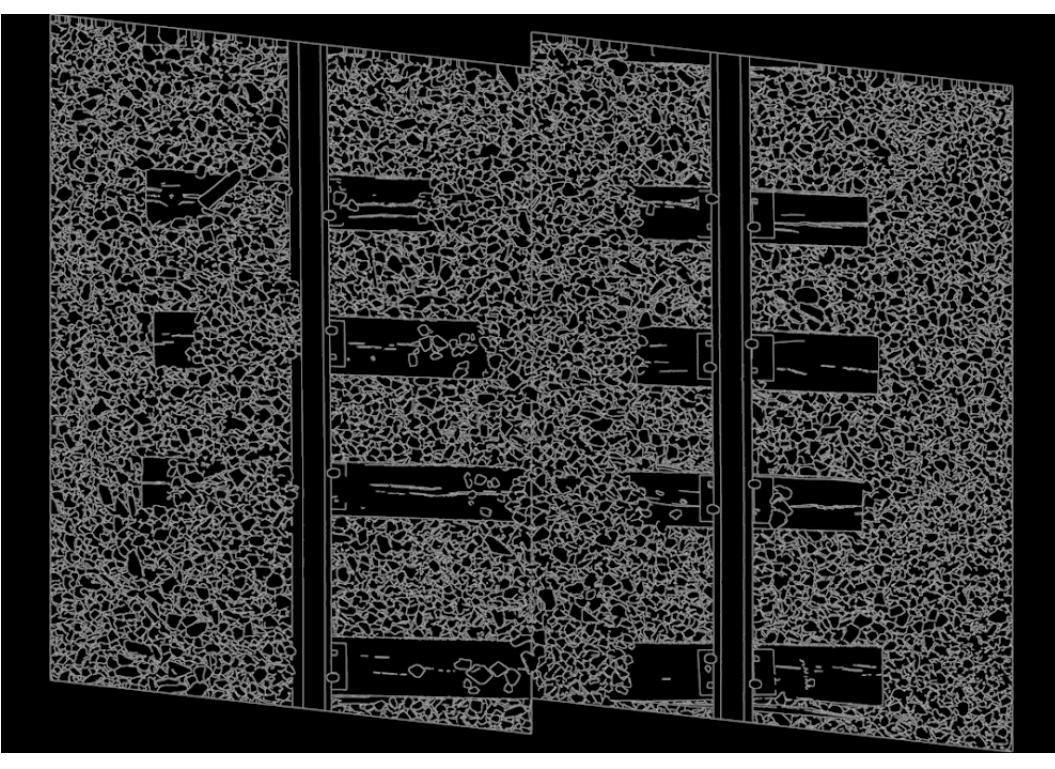
There was a similarity in size and shape between ballast particles and spike heads (Figure 15) that required the use of a high threshold for comparing candidate spikes against the 3-dimensional model for a genuine spike—to avoid erroneously labeling ballast particles in the ROI as spikes.

Figure 15 – Similarity Between Ballast Particles and Spike Heads

There was a tendency for the system to inconsistently detect spikes near the threshold value and generate a false change. These false positives were eliminated by applying a filter to limit change reporting to cases involving a minimum of two adjacent ties.

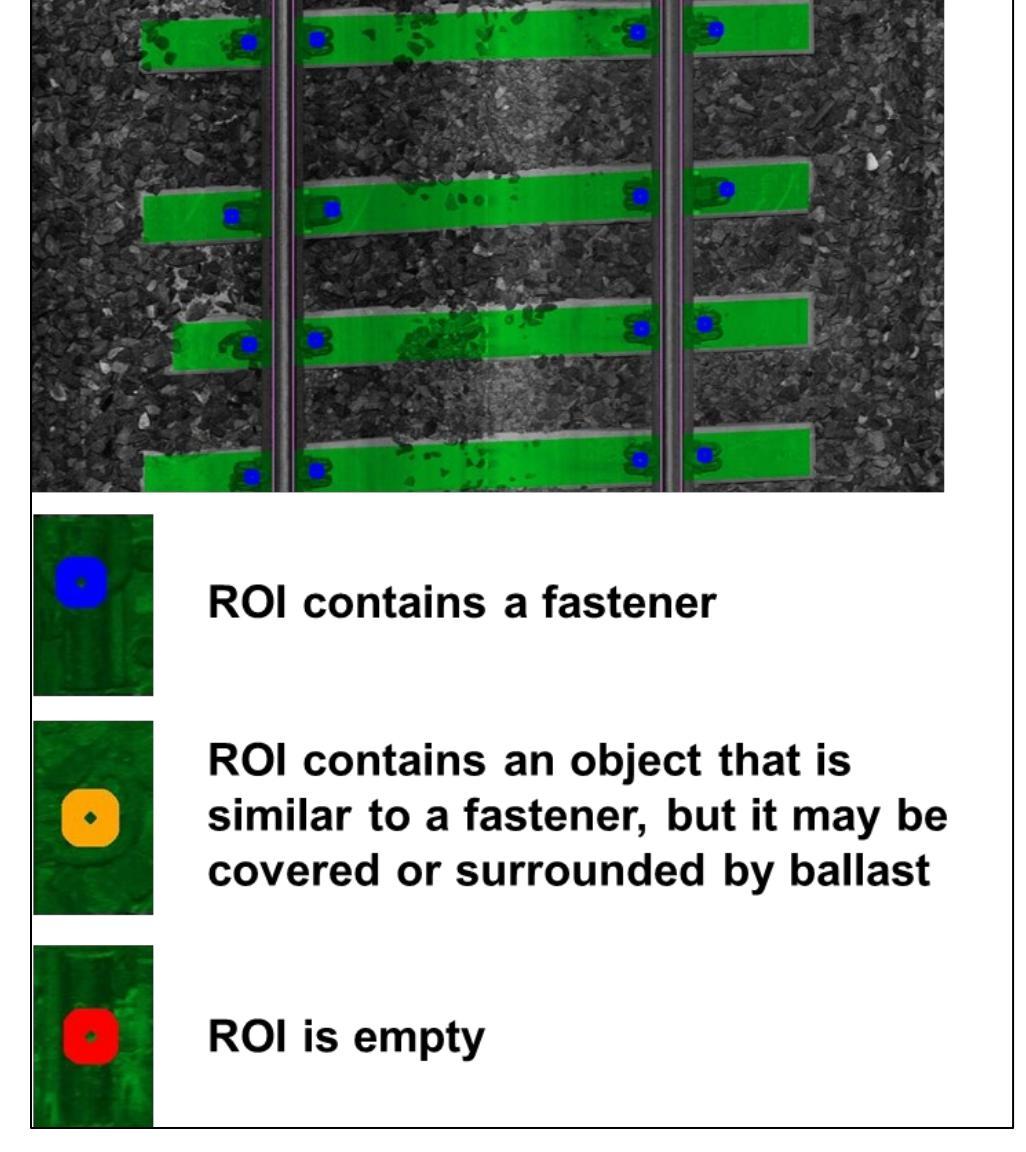
The change detection process first detects the ties and rails, and then defines four regions of interest (ROI) at each intersection (two on the gauge side and two on the field side). Each ROI is then inspected for the presence of fasteners using a three-dimensional model. The status of each ROI was reported in three states: a) fastener present, b) ROI contained an object that resembles a fastener, and c) ROI was empty (Figure 16).

Figure 16 – Fastener Detection Algorithm

Filtering was applied to report fastener changes only for cases where two or more adjacent ties contained changes. Ground-truth examples consisted of isolated cases of change (one or two fasteners on a single tie), instead of a series of changes being made to adjacent ties. Change detection was found to be feasible for the detection of added and removed fasteners. Results for fastener change detection are presented in Table 3.

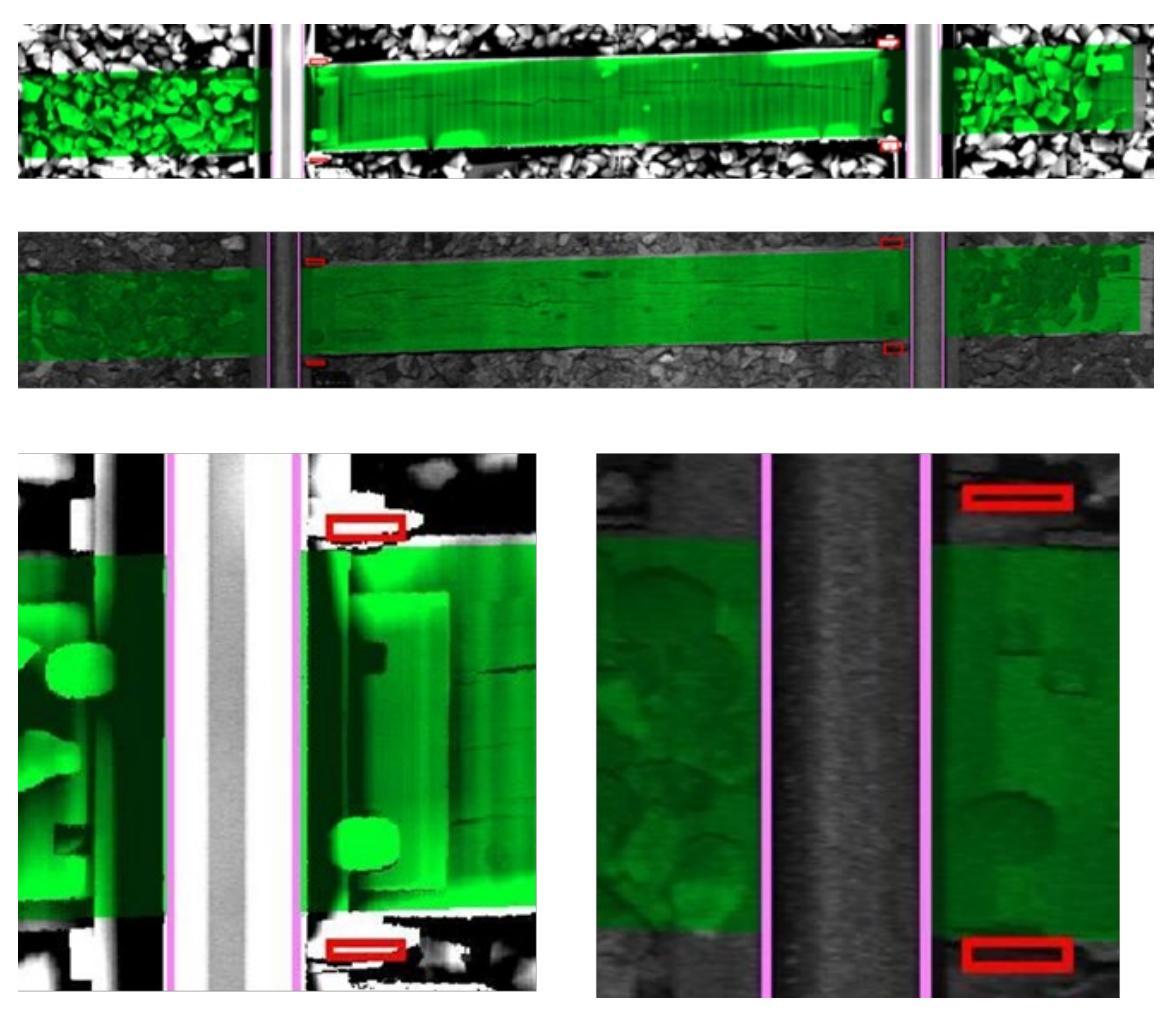
For change detection of anchors, each ROI was inspected for the presence of anchors using a 3dimensional model before a run-to-run comparison was completed to detect changes (Figure 17).

Figure 17 – Anchor Change Detection

Ground-truth examples consisted of isolated cases of change (one or two anchors on a single tie) instead of a series of changes being made to adjacent ties. Change detection was found to be feasible for the detection of added and removed anchors. Results for anchor change detection are presented in Table 4.

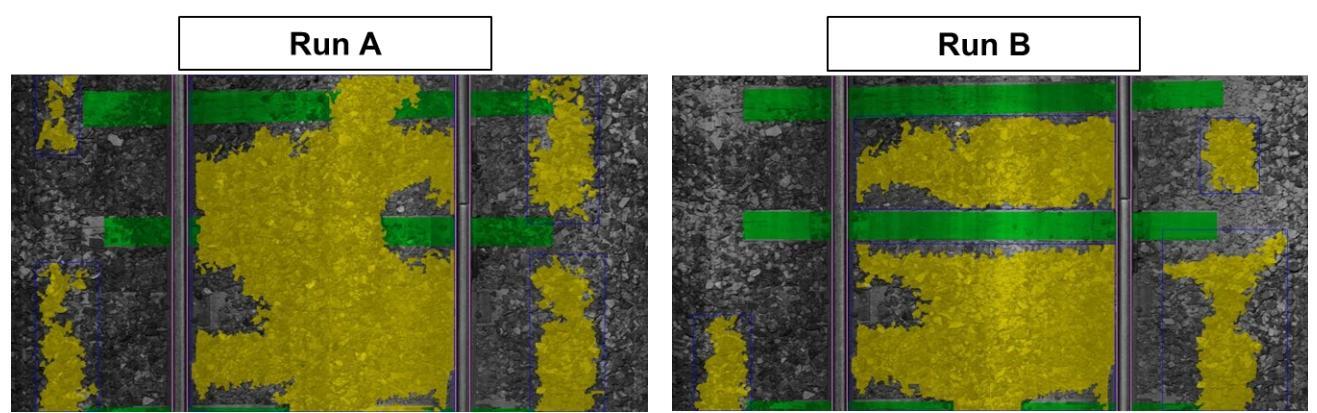
The ballast change detection process involved first detecting the rails to use as a reference point and then measuring ballast volume in relation to the position of the rails. Run-to-run comparison was then performed to flag changes. The program included a user-definable ballast volume threshold (Figure 18).

Figure 18 – Ballast Change Detection Algorithm

Ground-truth examples included both adding ballast as well as removing ballast. Change detection was found to be feasible for both conditions. Results for ballast change detection are presented in Table 5.

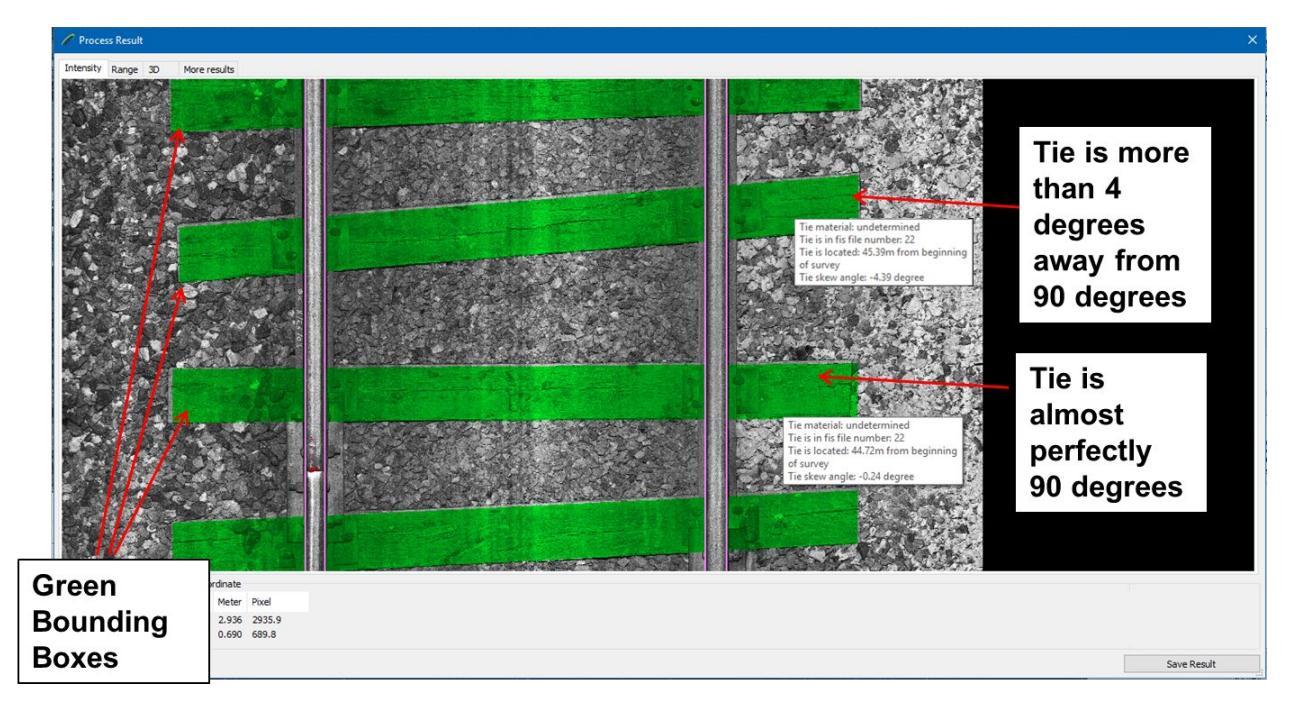
The tie skew change detection process involved first detecting the ties and rails. A bounding box was then drawn around the detected tie and the angle of the bounding box compared to the angle of the rails. Run-to-run comparison was then used to detect changes (Figure 19).

Figure 19 – Tie Skew Change Detection

Small changes in skew angle between runs were observed for ties which were significantly covered by ballast, so filtering was applied to report skew angle changes only for ties with at least 50 percent of their surface visible. Ground-truth consisted of a single change where the skew angle of a tie was increased from approximately 90 degrees to approximately 93 degrees. Change detection was found to be feasible, and results are presented in Table 6.

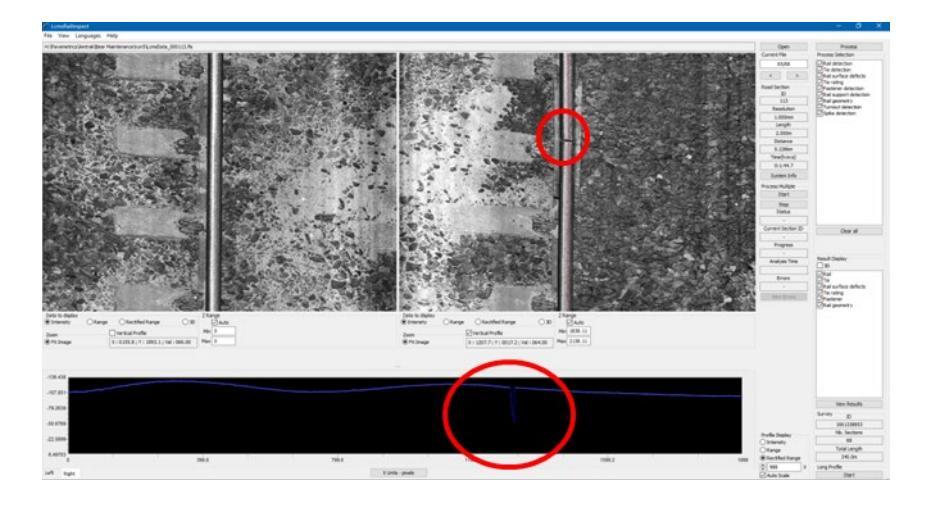
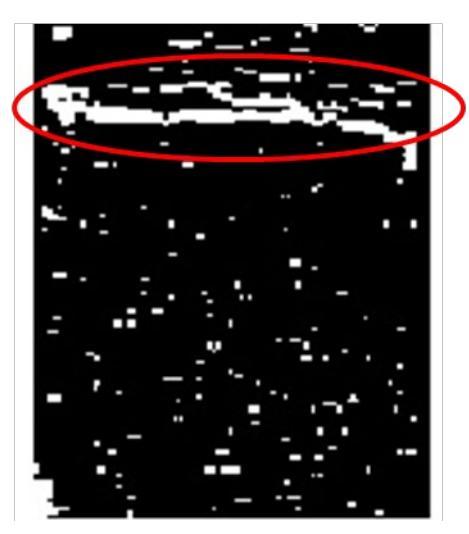
The joint change detection process involved first detecting the rails. The longitudinal profile of each rail was analyzed to locate gaps in the rail and joint-gap range images were produced for each location. Finally, a run-to-run comparison was then used to detect changes between runs (Figure 20).

Figure 20 – Rail Joint Range Image and Change Detection

Ground-truth consisted of a total of four cases. Three cases included a joint-gap increase and one case used a gap decrease. Changes were simulated by adding or removing putty from joints. All four change conditions were detectable, but the simulation method was not ideal for a few reasons. First, the putty tended to be displaced from the joint as the inspection vehicle passed the location. This resulted in the reporting of small gaps in joints designed for a zero-gap result. The system reported a gap of a few millimeters versus the expected zero-millimeter result. Second, the putty sometimes produced an abnormal geometry between vertically misaligned rails, which produced unexpected gap measurements. For these reasons, this study recommends not using putty for future testing. Additionally, small changes in gap size due to changing thermal conditions at the test site were also detected, but these results were filtered by applying a 4-mm gap width threshold. Change detection results for joint-gap are presented in Table 7.

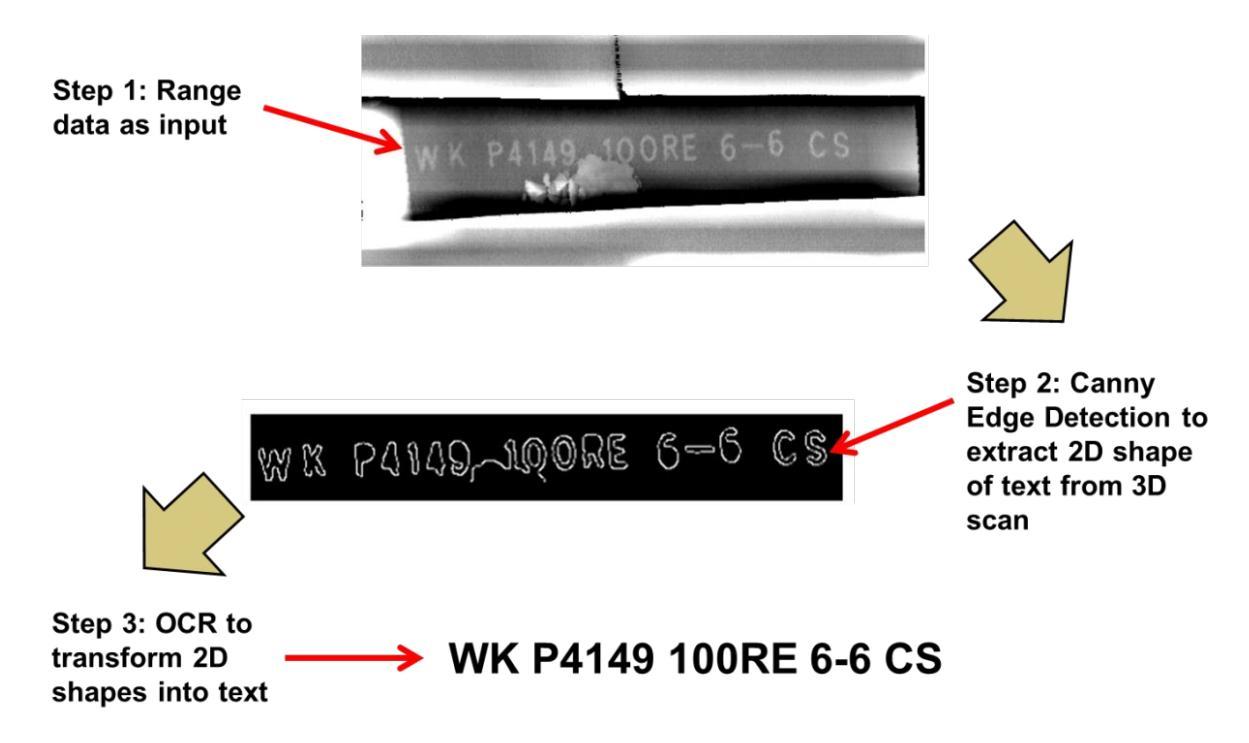
For rail stamping detection, Canny edge detection was used to extract the outline of rail stamping information from range data and an optical character recognition (OCR) algorithm is used to transform shapes into letters and numbers (Figure 21).

Figure 21 – Rail Stamping Information Detection

Range data from both the top-down and side-scan sensor configurations were analyzed. In general, the results showed promise. It was possible to extract reasonable shapes from range data and to translate shapes into characters using OCR. However, surface corrosion and contamination affected the system's accuracy. Both conditions contributed poor edge detection as well as poor OCR results (Figure 22).

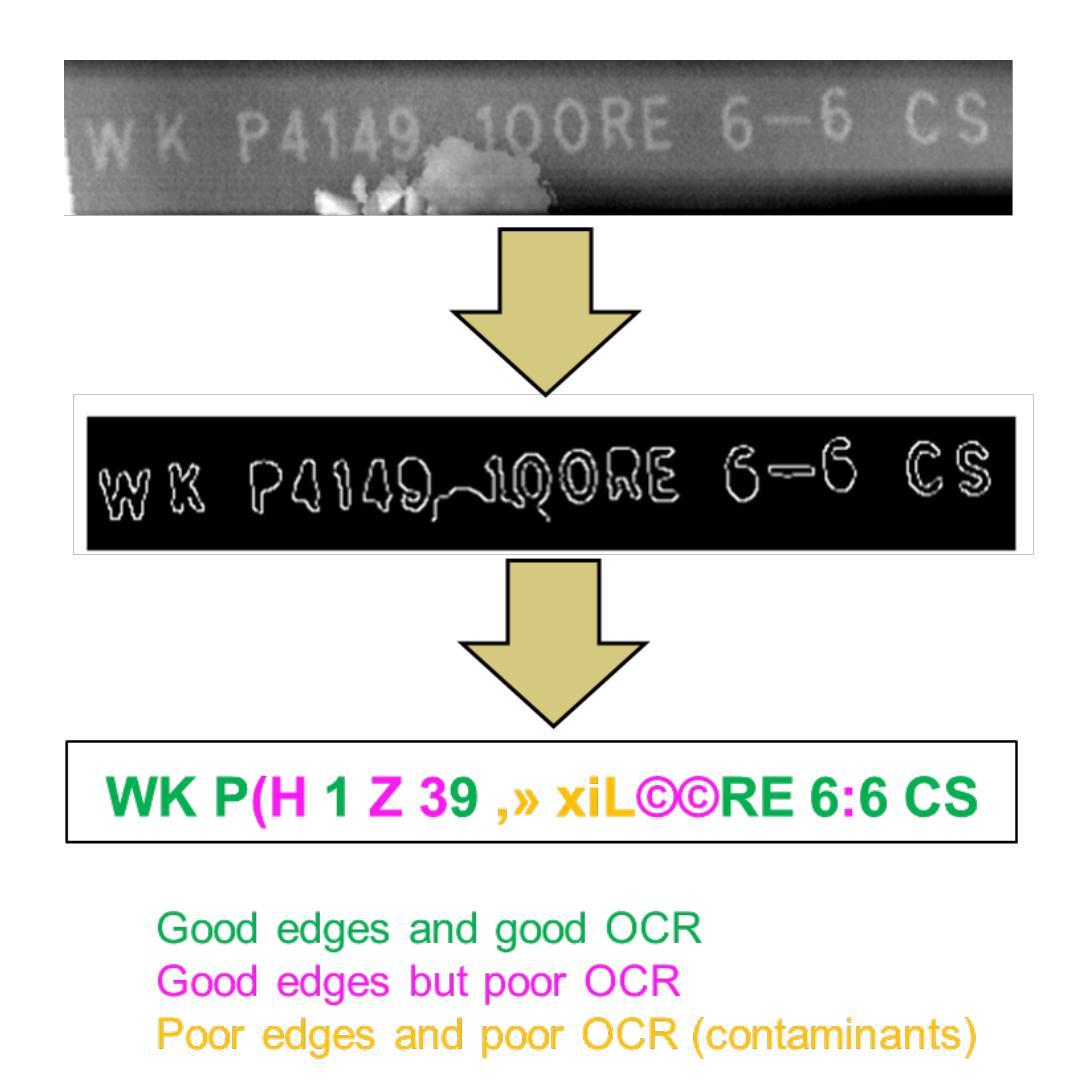
Figure 22 – Impact of Corrosion and Surface Contamination on OCR Results

These results could be improved by filtering the Canny edge detection image to remove the outline of contaminants and by using an improved OCR algorithm. Researchers determined that the side-facing sensor setup was not ideally positioned to capture high-quality range data. The top-scanning equipment performed better. The stamping was clearly visible in range and intensity data from the top-scanning equipment and could be processed by OCR, while the side-scan data sets were poorly resolved.
