Federal Railroad Administration Office of Safety Headquarters Assigned Accident Investigation Report HQ-2008-29

Burlington Northern Santa Fe (BNSF) Marysville, MT March 17, 2008

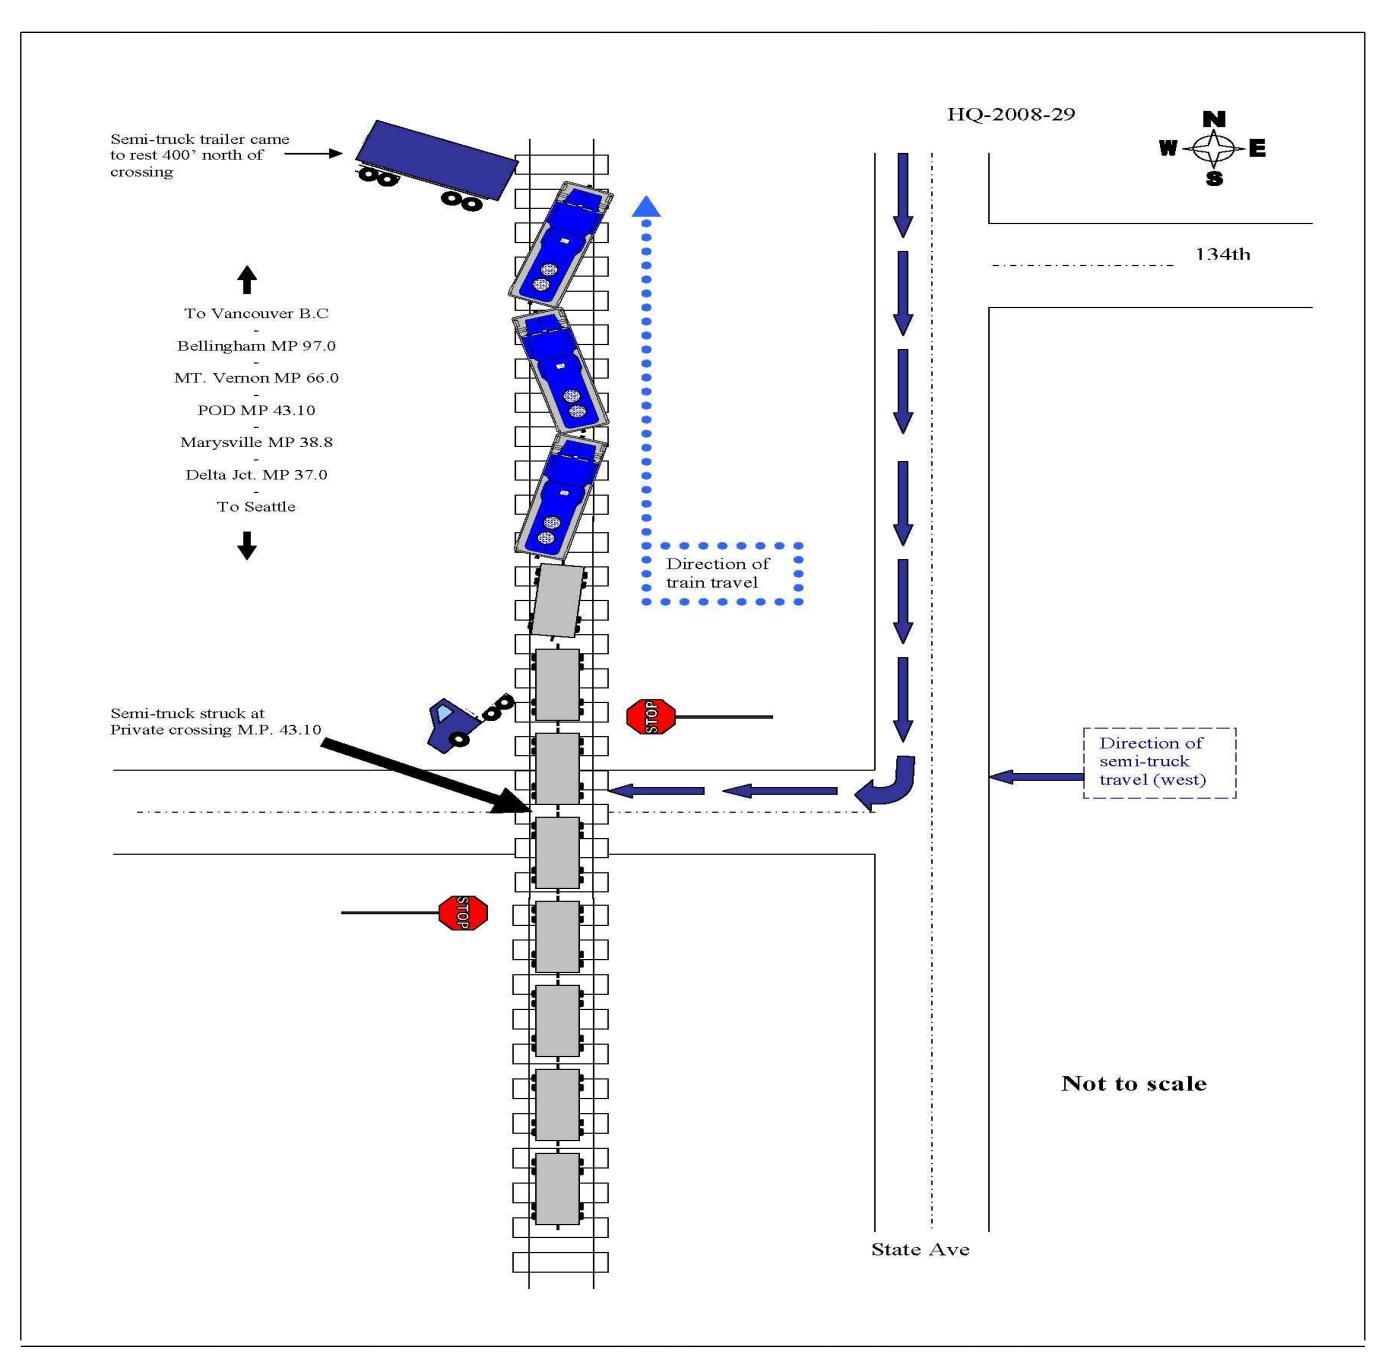
136. DRAW A SKETCH OF ACCIDENT AREA INCLUDING ALL TRACKS, SIGNALS, SWITCHES, STRUCTURES, OBJECTS, ETC., INVOLVED.

Private crossing US DOT 084661A. The crossing is an elevated paved private highway/rail grade crossing that crosses the single main track at a 90-degree angle. The crossing is equipped with stop signs, private crossing signs, and no cross bucks. The crossing provides access to an industrial facility called Pacific Grinding Wheel and there is no other access to this facility. Amtrak is the only scheduled passenger service that operates over this crossing. Ten to fifteen freight trains operate over this crossing daily. Large amounts of various hazardous materials are transported over this crossing by BNSF. Records from FRA and Washington State Utilities and Transportation Commission show there have been eight grade crossing accidents at this crossing since February 11, 1975. The most recent was August 14, 2001 which resulted in a fatality. At the time of the accident, BNSF was in the process of upgrading the crossing with active warning devices, lights and gates. However, completion of the upgrade was not expected for two to three weeks.
