Federal Railroad Administration Office of Safety Headquarters Assigned Accident Investigation Report HQ-2008-33

Massachusetts Bay Transit Authority (MBTA) Canton, MA March 25, 2008

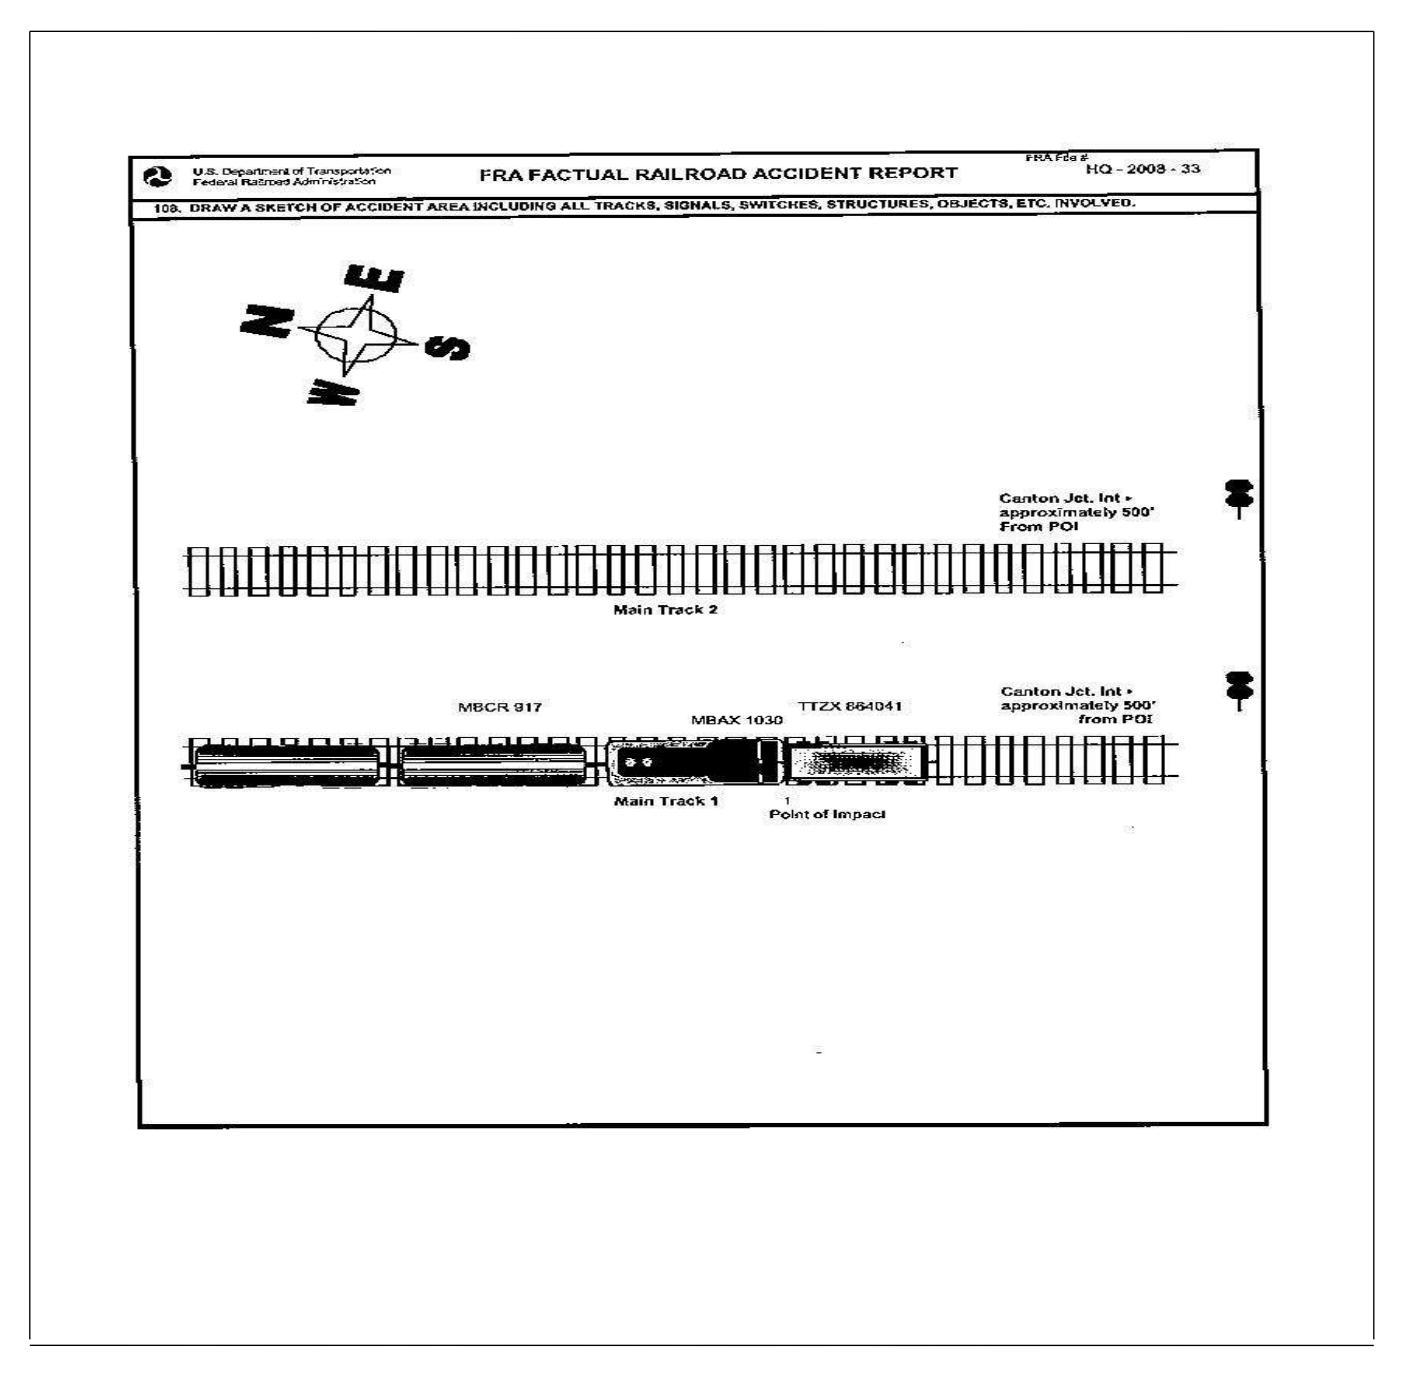
136. DRAW A SKETCH OF ACCIDENT AREA INCLUDING ALL TRACKS, SIGNALS, SWITCHES, STRUCTURES, OBJECTS, ETC., INVOLVED.

CSX Transportation (CSX) loaded lumber car (TTZX 864041) impacted a westbound Massachusetts Bay Commuter Railroad (MBCR) train on March 25, 2008 at 5:15 p.m. EST. The accident occurred near Canton, Massachusetts, at milepost 214 of the National Railroad Passenger Corporation (ATK) Northeast Corridor. CSX Train B710-25 delivered the lumber car to Cohenno Terminal Inc. located at milepost 17.6 on the MBCR Stoughton Branch at 12:00 p.m. At 5:09 p.m. the car rolled out of the facility, over a derail, through an electrically locked switch, and traveled northward along the Stoughton branch through three highway-rail grade crossings without incident. It then continued onto the Northeast Corridor at Junction Interlocking, in a reverse direction of the route lined for the commuter train, and continued east until it impacted the MBCR Train 917. Three train crew personnel and 140 passengers suffered injuries. The commuter train sustained approximately \$875,796 dollars in equipment damage. Amtrak reported the track damage was approximately \$3,000. The lumber car received \$58,755 in damage, however no rail cars derailed. CSX chose to not file a form FRA 6180.54 Rail Equipment Accident/ Incident Report and as a result, the damage to TTZX 864041 was not reported.
