Federal Railroad Administration Office of Safety Headquarters Assigned Accident Investigation Report HQ-2007-44

Burlington Northern Santa Fe (BNSF) Sikeston, Missouri July 19, 2007

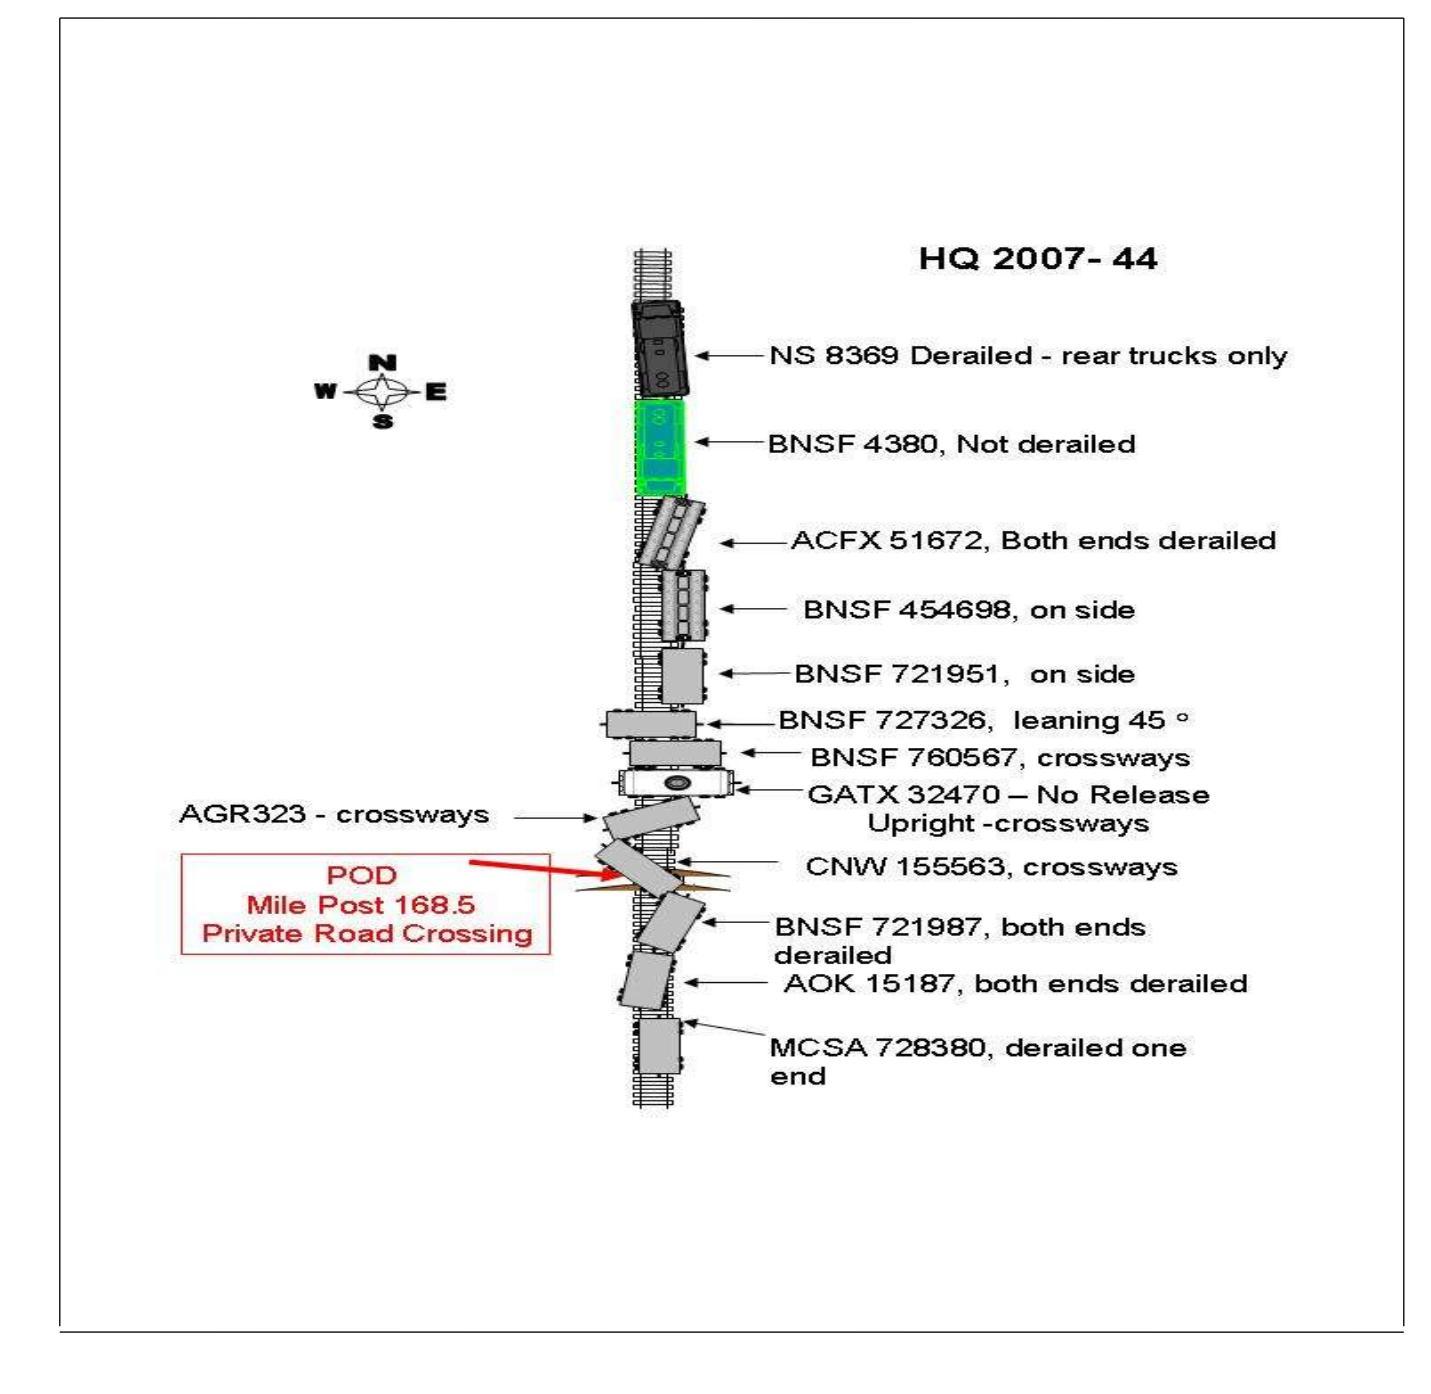
136. DRAW A SKETCH OF ACCIDENT AREA INCLUDING ALL TRACKS, SIGNALS, SWITCHES, STRUCTURES, OBJECTS, ETC., INVOLVED.

The BNSF determined this derailment was most probably caused by a broken rail, "Detailed fracture from shelling or head check", with a major contributing factor of "Roadbed settled or soft." A severe profile deviation had developed just a few feet south of the private road crossing at MP 168.50. The profile measurements at this location were taken by BNSF track supervisors. They determined the profile deviation measured three and one-quarter inches, which is below Class 1 track standards. This pumping action caused rail fatigue, resulting in rail failure. The severe profile caused lead Locomotive No. NS 8369 to bottom out, bounce up, then back down, striking the crossing boards, subsequently derailing the rear end of the lead locomotive and the 11 head cars.
