Federal Railroad Administration Office of Safety Headquarters Assigned Accident Investigation Report HQ-2005-45

> Canadian National (CN) Mikoma, Mississippi May 30, 2005

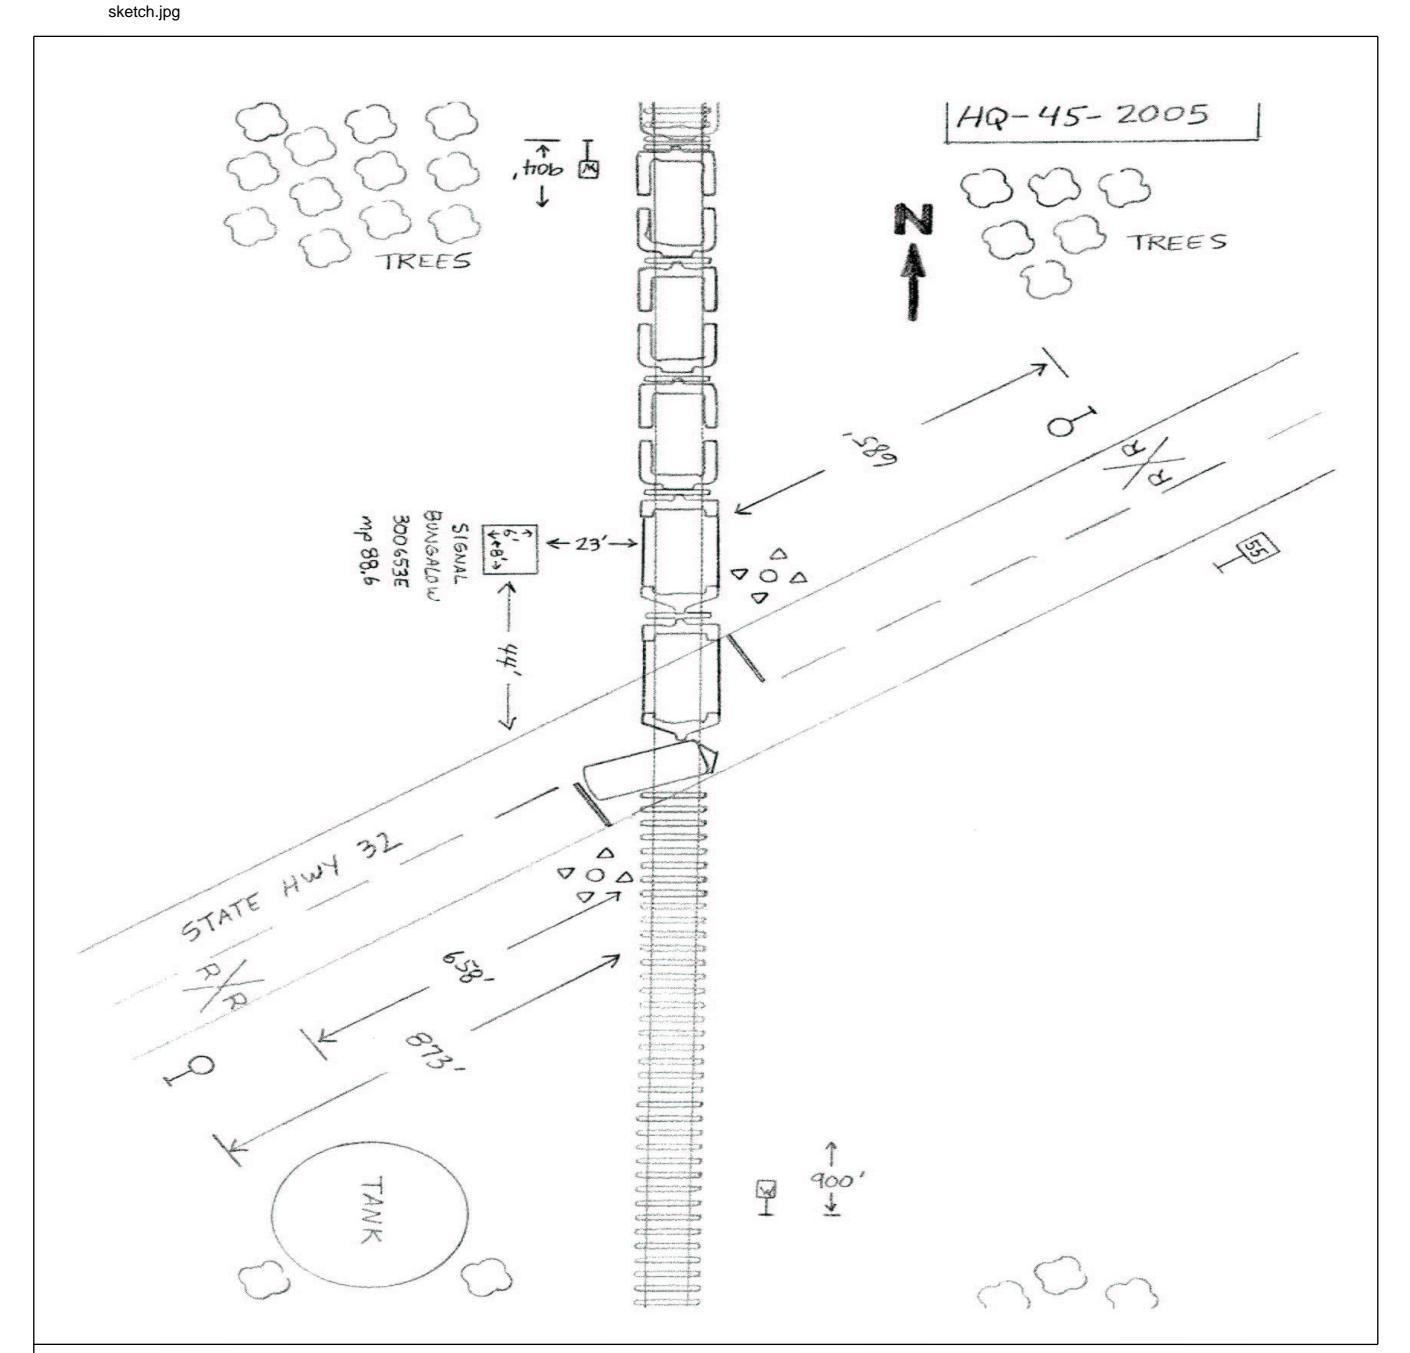
108. DRAW A SKETCH OF ACCIDENT AREA INCLUDING ALL TRACKS, SIGNALS, SWITCHES, STRUCTURES, OBJECTS, ETC., INVOLVED. HQ-45-2005 sketch.jpg

A southbound Canadian National (CN) mix freight train collided with a Tallahatchie County Road Department extended cab pickup truck at a highway-rail grade crossing on May 30, 2005, at 6:25 a.m Central Standard Time (CST). The accident occurred at Mikoma, Mississippi (MS), at Canadian National Milepost (mp) 88.61 on the CN Yazoo Subdivision. Mikoma is near the town of Webb, MS.

The motor vehicle carrying the four occupants was traveling west to east on State Highway 32. Motor vehicles traveling from west to east on State Highway 32 would observe a railroad advance warning sign located 873 feet from the highway-rail grade crossing. At 658 feet from the track there are also pavement markings clearly marked, warning drivers of an approaching highway-rail grade crossing. The road is level and straight for 1,000 feet approaching the grade crossing and the road grade is practically level at this point.

The freight train was operating at a recorded speed of 50 mph approaching State Highway 32 at mp 88.6. The conductor said the engineer was sounding the locomotive horn and ringing the bell. The engineer had a clear view of the grade crossing, but could not see motor vehicles approaching the grade crossing because of trees parallel with the railroad right-of-way until arriving at a point about 300 feet north of the crossing. Upon reaching this point the engineer observed a vehicle approaching the grade crossing from west to east at a high rate of speed. The conductor saw the engineer looking out his window and the conductor stood up to see what the engineer was looking at. The conductor then also observed the motor vehicle approaching the grade crossing at a high rate of speed. The conductor sat back down and estimated the speed of the approaching motor vehicle to be somewhere between 50 to 55 mph. The engineer put the train in emergency north of the crossing about 50 to 100 feet. The engineer said the motor vehicle driver side dow. At that time, he immediately veered the motor vehicle to the right. The train struck the motor vehicle at the rear of the driver's side dow. The motor vehicle was forced southward in front of the locomotive before coming to rest 120 feet south of the grade crossing. The train came to a stop 1,800 feet south of the grade crossing.

On approach to the State Highway 32 highway-rail grade crossing, the flashing light signals located in the southwest and northeast quadrants are clearly visible to a motorist 1,000 feet from the grade crossing when activated by the approach of a train. State Highway 32 and the railroad track intersect at a 60-degree angle. The stop line pavement marking at State Highway 32 is located 19 feet from the main track and at this point the view of the track is unobstructed. The highway-grade crossing warning devices are installed in the northeast and southwest quadrants of the highway-rail grade crossing intersection. The warning devices are back to back flashing light signals on both sides mounted on signal masts with an audible bell located on top of the mast in the northeast quadrant. The flashing light units are facing east and west for motor vehicular traffic.
