## Impact Test Data Analysis for Load Environment Characterization of Tank Car Stub Sill During Yard Operations

1. AGENCY USE ONLY (Leave blank)		2. REPORT DATE March 2020		3. REPORT TYPE AND DATES COVERED Technical Report
4. TITLE AND SUBTITLE Impact Test Data Analysis for Load Environment Characterization of Tank Car Stub Sill During Yard Operations			5. FUNDING NUMBERS 693JJ6-18-F-000117

6. AUTHOR(S) Sajjad Meymand, Ph.D.				
7. PERFORMING ORGANIZATION NAME(S) AND ADDRESS(ES) ENSCO, Inc 5400 Port Royal Rd Springfield, VA 22151			8. PERFORMING ORGANIZATION REPORT NUMBER SERV-REPT-0002336

9. SPONSORING/MONITORING AGENCY NAME(S) AND ADDRESS(ES) U.S. Department of Transportation Federal Railroad Administration Office of Railroad Policy and Development Office of Research, Development and Technology Washington, DC 20590			10. SPONSORING/MONITORING AGENCY REPORT NUMBER DOT/FRA/ORD-20/09

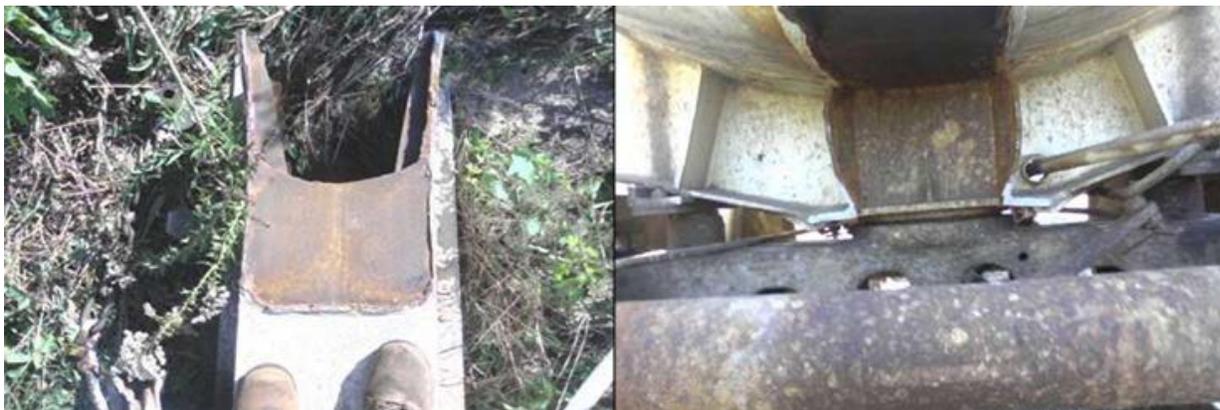
**Figure 1. Stub Sill Fracture Observed in Callahan, FL, from December 2009 (Sundaram, 2014)**

Examples of stub sill fractures observed by CSX Transportation are shown in [Figure 1](#) and [Figure 2](#). As can be seen, these fractures are catastrophic in nature. The tank car industry has design controls in place as specified by the Association of American Railroads’ Manual of Standards and Recommended Practices, Section C Part II–Design, Fabrication and Construction of Freight Cars to ensure that the stub sill to tank reinforcing pad attachment welds fail prior to the reinforcing pad to tank attachment welds.

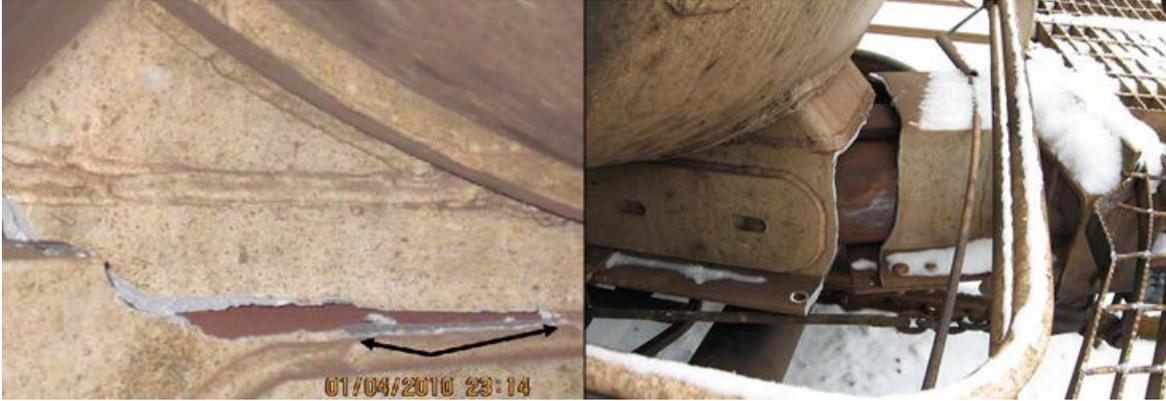
**Figure 2. Stub Sill Fracture Observed in Charleston, WV, from January 2010 (Sundaram, 2014)**

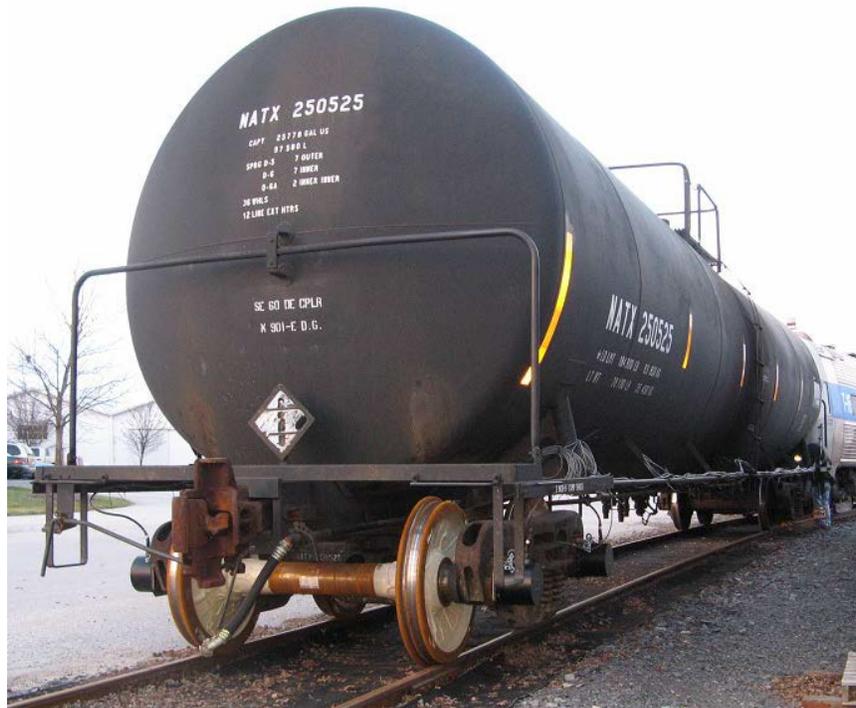
**Figure 3. Instrumented Tank Car**

To better characterize the load environment of the tank car operations in yards, Union Tank Car loaned a tank car to FRA that was instrumented with multiple transducers and a data collection system that supported high sampling rates required for conducting impact testing. Impact data for different car configurations, end-of-car units, and coupling speeds were collected. The tank car used for this effort, provided by Union Tank Car, is shown in [Figure 3](#). A detailed view of the end of the tank car with the stub sill attachment is shown in [Figure 4](#).

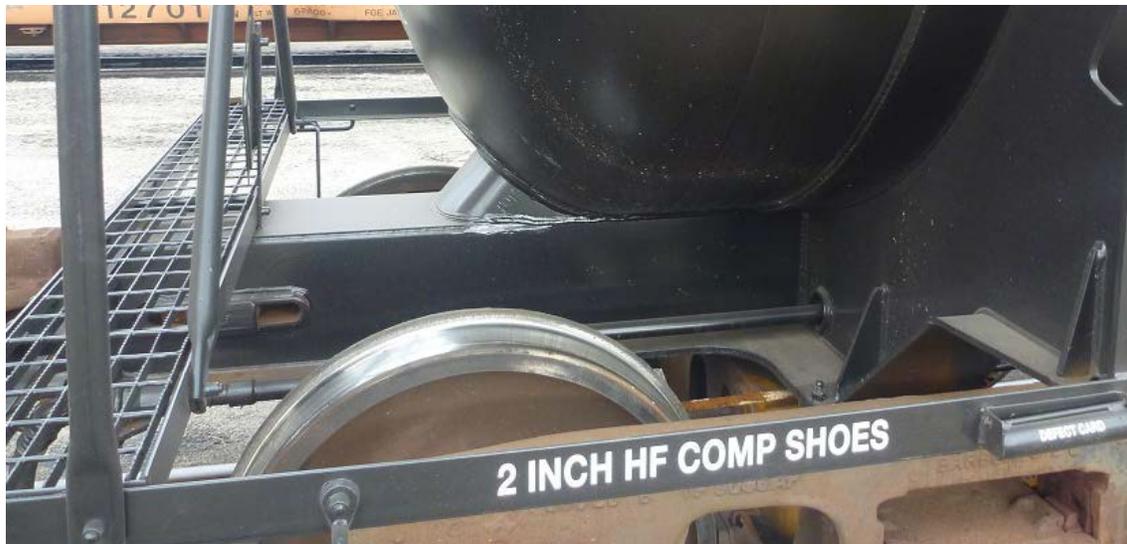
**Figure 4. Detail View of the Stub Sill and Head Brace Attached to the Tank of the Instrumented Tank Car**

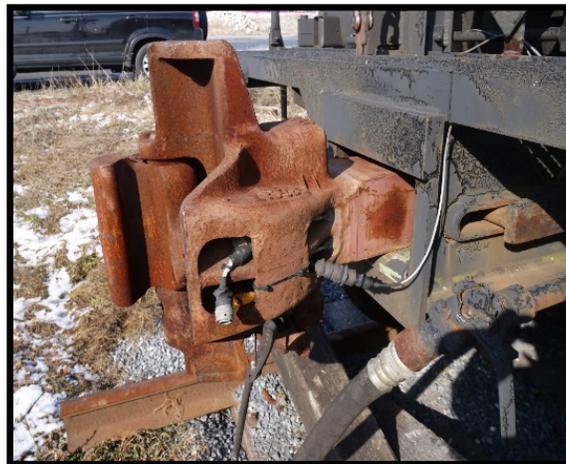
Figure 6. Instrumented Coupler for Measuring Longitudinal Coupler Forces

Longitudinal coupler forces were measured on both the A-end and B-end of the tank car. Two instrumented couplers outfitted with strain gauge bridges were used to measure the longitudinal forces. [Figure 6](#) shows an image of instrumented coupler installed on the A-end of the car.

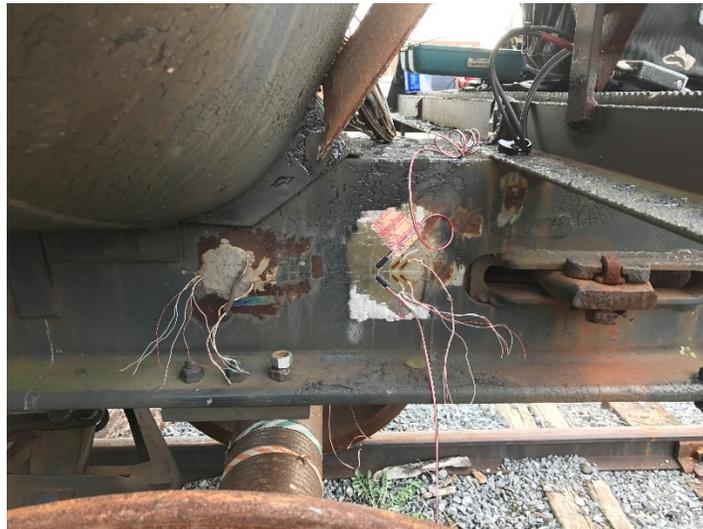
**Figure 7. Shear Strain Gages Installed on the Stub Sill for Measuring Vertical Coupler Force**

To measure vertical forces, a pair of shear strain gauges were mounted on each side of the stub sill, as shown in [Figure 7](#). The shear strain gauges were wired using a completion card to form a full bridge. The mounting process included grinding and polishing the coupler surface to provide a smooth area to which the strain gauges were welded. Room temperature vulcanized (RTV) silicone rubber coatings were used as protective and waterproofing coatings. These shear strain gauges were applied only on the A-end of the instrumented tank car. The black gauges on the left were used during this testing. The gauges on the right installed during previous phases of testing were not used for this impact testing.

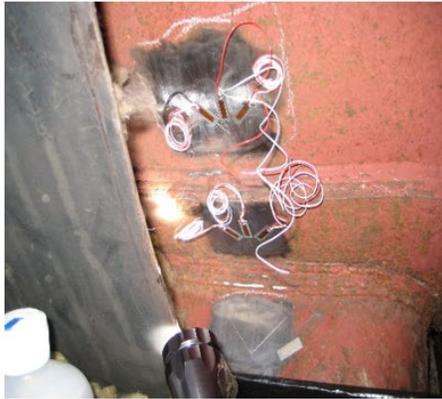
**Figure 8. Shoulder Pad Strain Gage Installed Above the Head Shoe at the A-End of the Instrumented Tank Car**

Five sets of rosette strain gages were installed on various locations around the stub sill on the A-end (striking end) of the car. These locations were identified as the high stress areas during a consultation with FRA and Union Tank Car's subject matter experts. To determine the principal stresses, three individual strain gauges were installed 45 degrees apart to form a rosette. [Figure 8](#) shows the rosette strain gage installed on the shoulder pad centered above the head shoe. The bottom three gauges were used during this testing. The top three gauges were installed during previous testing and were not used for this investigation.

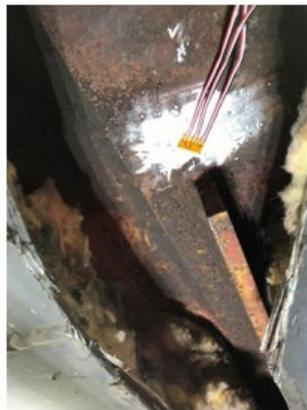
**Figure 9. In-Board Strain Gage Installed Under the Car at the End of the Stub Sill Beam**

Figure 9 shows the rosette strain gage installed under the car at the end of the stub sill. This gage is referred to as the in-board strain gage.

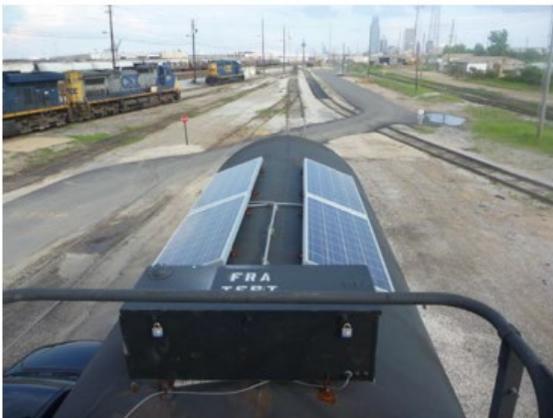
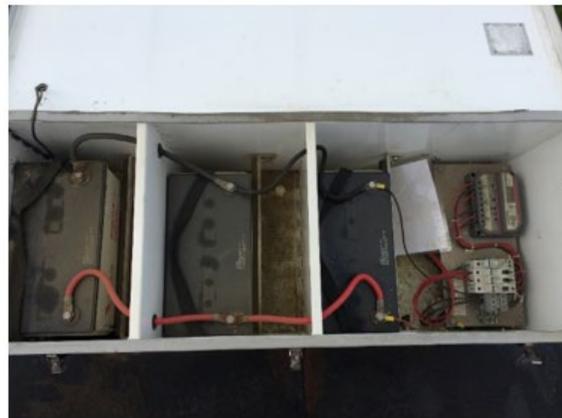
**Figure 16. Solar Panel and Battery Box on Top of the Instrumented Tank Car**

Four 115 W, 12 V solar modules solar panels and a set of 110 Ah, 12 V AGM batteries were used to power the system. Figure 16 shows the solar panels and the battery box. The battery box also contained the electronics that controlled battery charging.

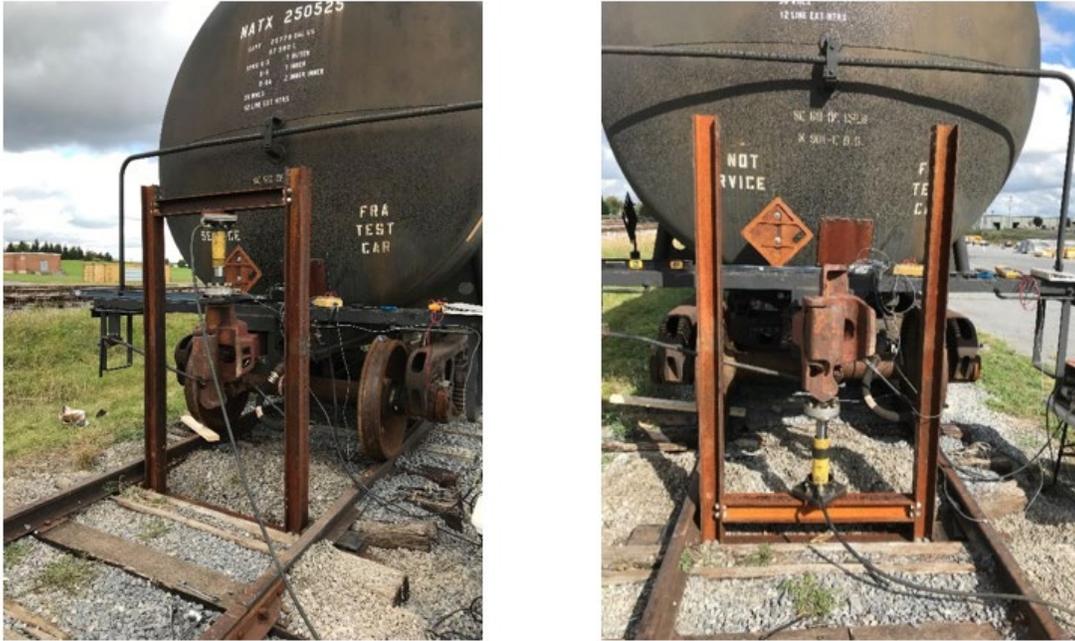
Figure 17. Vertical Coupler Force Calibration Setup

The vertical coupler force was calibrated in the field using a custom load fixture consisting of a metal frame, a calibrated load cell and a hydraulic ram to apply vertical loads. Figure 17 shows the calibration fixture when downward (left) and upward (right) vertical forces were applied.

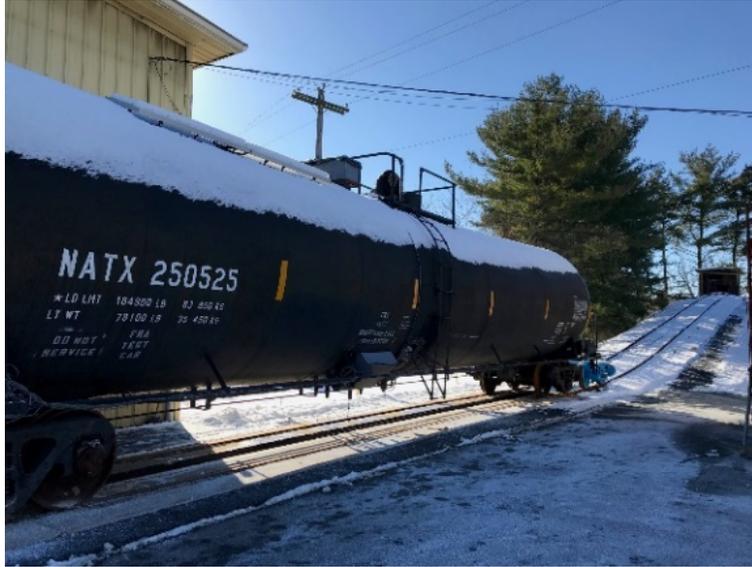
**Figure 19. Instrumented Tank Car at the Amsted Test Track**

To initiate the impact, the blue bogie coupled to the tank car was attached to a winch that was used to pull the vehicle up a hill. When the car reached the proper position for the intended impact speed, it was released sending the car into the rest of the test vehicles. This simulated the real-world hump yard operation used for making up trains. In impact testing of this nature, the striking car that is in motion is referred to as the hammer and the stationary cars that are parked down the hill are referred to as the anvil.

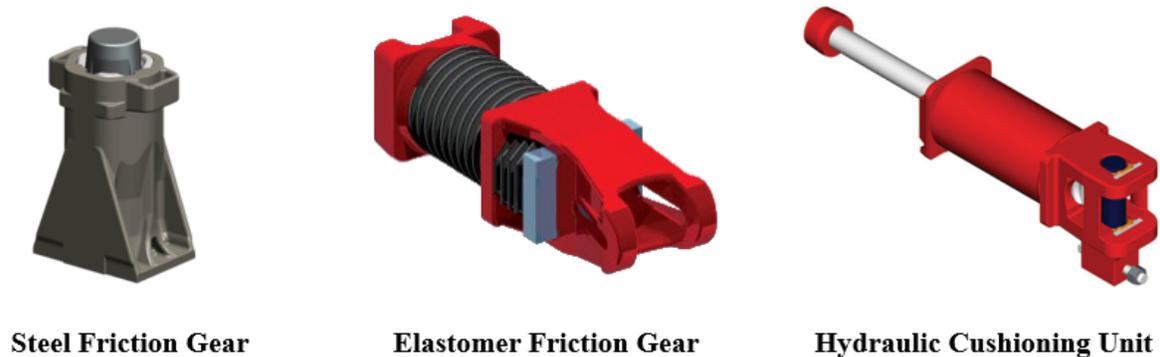
Figure 20. Draft Gears Used During Impact Test Program

Figure 20 illustrates the three types of draft gears used during the test program. 901E steel friction draft gear (left) contains steel wedges that are geometrically arranged to absorb the coupler force using the stick-slip phenomena. The steel friction gear provides a maximum travel of 3 inches. 901G elastomer friction gear (middle) consists of elastomer pads that absorb energy via hysteresis. The elastomer friction gears also provide a maximum travel of 3 inches. Hydraulic cushioning units (right) absorb energy by pushing hydraulic fluid through specially designed valves based on viscous friction. The hydraulic units provide travel of more than 10 inches.
