U.S. Department
of Transportation
Federal Railroad
Administration

Integrity of Rail Passenger Equipment Glazing Systems

11. SPONSOR/MONITOR'S REPORT NUMBER(S) DOT/FRA/ORD-22/21	
12. DISTRIBUTION/AVAILABILITY STATEMENT This document is available to the public through the FRA website .

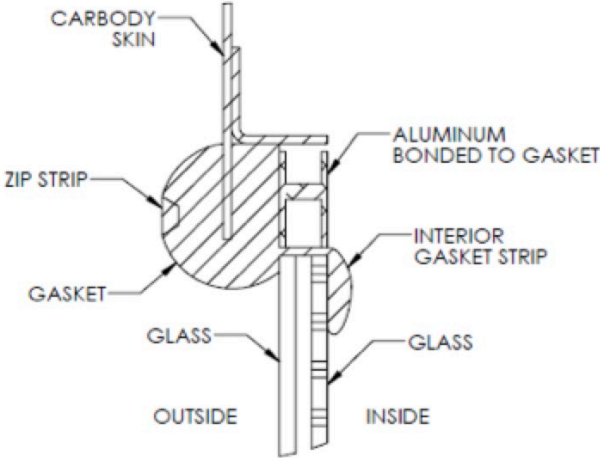
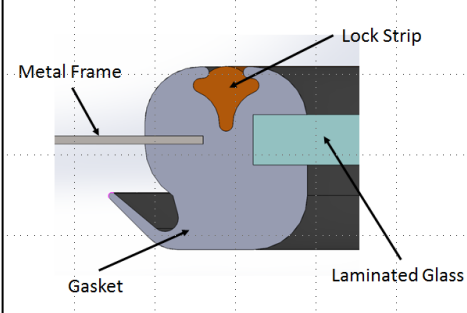
Type	Example	Applications
Gaskets & Seals

Amtrak
Gaskets & Seals

U.S., Single-pane France (Metro)

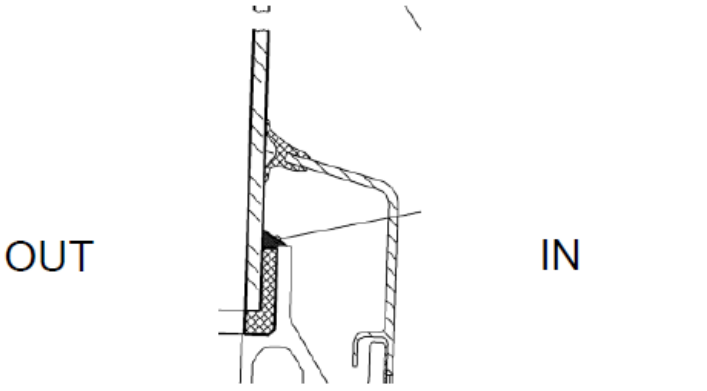
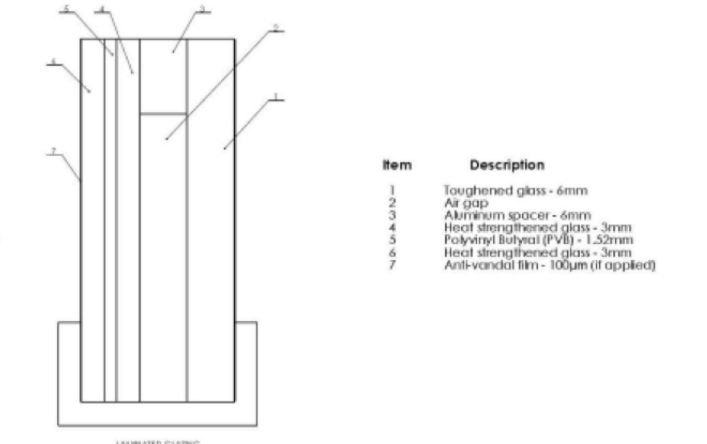
Type	Example	Applications																
Bonded (with frame)

Germany (Metro) [8]																
Bonded (with frame)

Item	Description	1	Toughened glass - 6mm	2	Air gap	3	Aluminum spacer - 6mm	4	Heat strengthened glass - 3mm	5	Polyvinyl Butyral (PVB) - 1.52mm	6	Heat strengthened glass - 3mm	7	Anti-vandal film - 100µm (if applied)	U.K. – RSSB Study (adhesive – Dow Betamate)[7]
Item	Description																	
1	Toughened glass - 6mm																	
2	Air gap																	
3	Aluminum spacer - 6mm																	
4	Heat strengthened glass - 3mm																	
5	Polyvinyl Butyral (PVB) - 1.52mm																	
6	Heat strengthened glass - 3mm																	
7	Anti-vandal film - 100µm (if applied)																	
Fastened

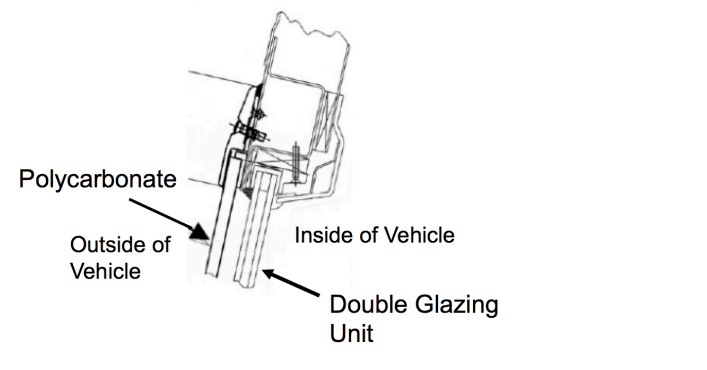
Japan [9]																
Clamped

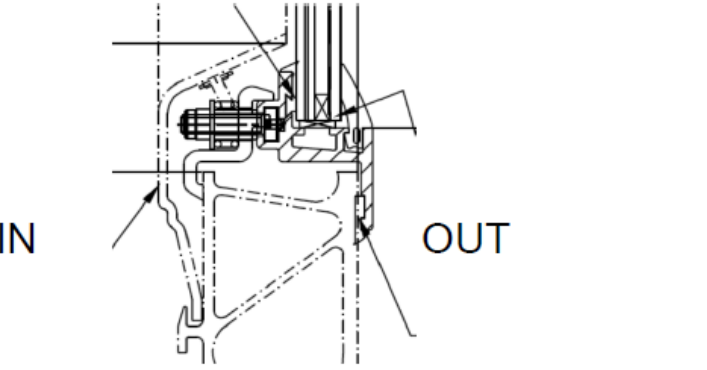
U.K. (commuter) France (commuter) Germany (commuter) [8]

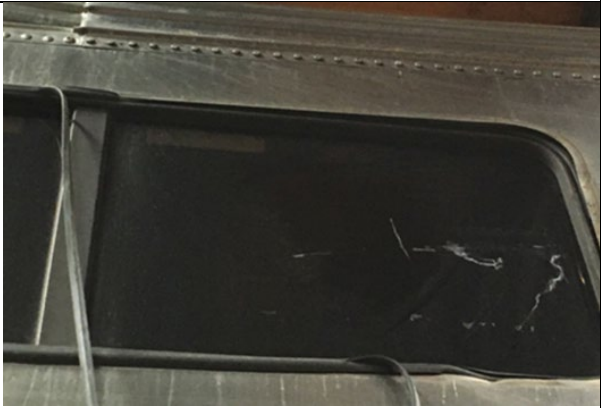
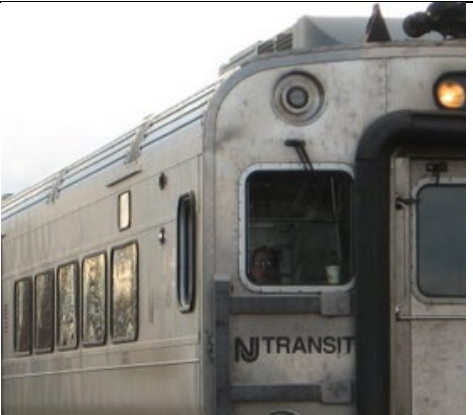
Type		
<p>Protruding</p> <p>Left – Amtrak</p> <p>Right – NJT</p>

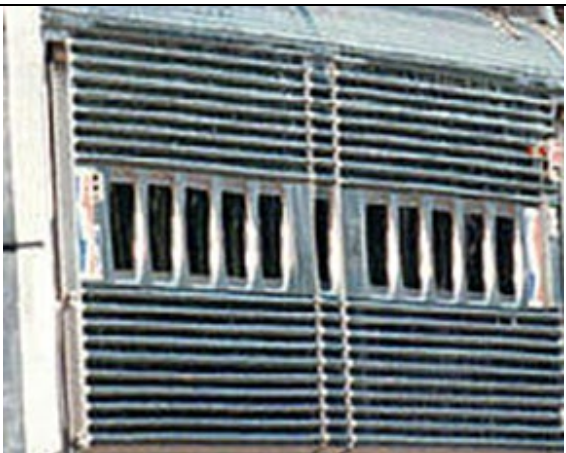
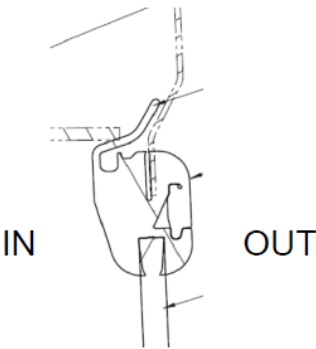
<p>Recessed</p> <p>Left – SEPTA (window area is recessed)</p> <p>Right – CTA (glazing is recessed) [8]</p>

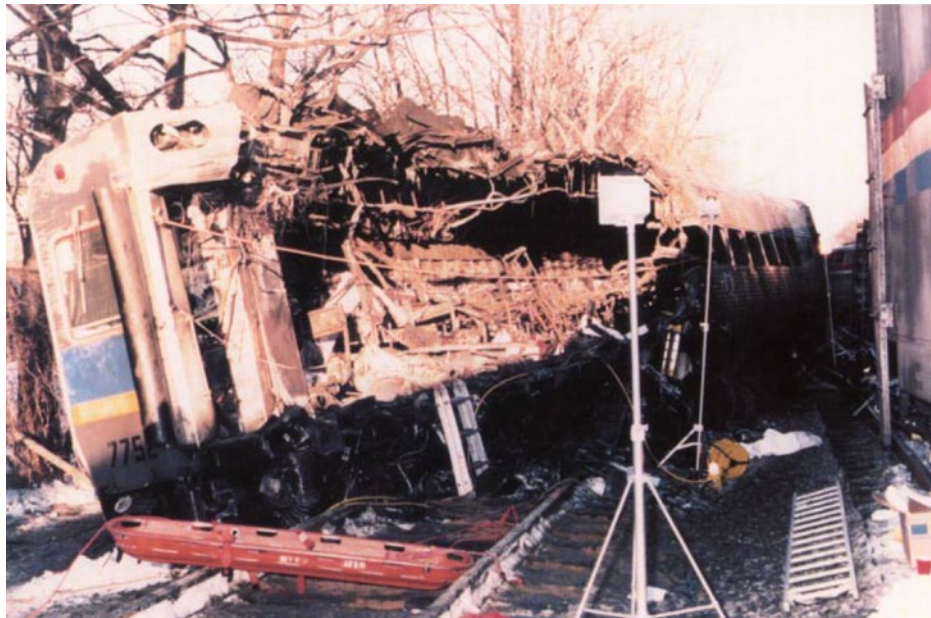
Figure 1. Result of collision and fire in Silver Spring accident [10]

A collision between a Maryland Area Rail Commuter train and an Amtrak train just north of Washington, DC, caused a derailment [10] that resulted in 11 fatalities and 26 injuries in the accident and subsequent fire (see [Figure 1](#)) in 1996. Surviving passengers escaped primarily through misaligned cars as a result of the collision. This was out of sheer necessity – passengers reported experiencing difficulty removing emergency exit windows, and the door exits were rendered unusable by the force of the collision.

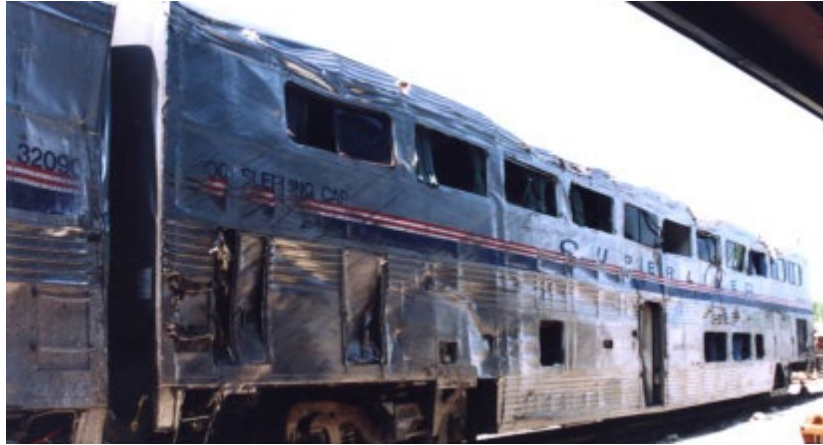
Figure 2. Result of derailment and rollover accident in Crescent City, FL

This 2002 accident, caused by a track buckle, derailed an Amtrak passenger train in Florida[11]. The train subsequently slid across the ground on its side, resulting in four fatalities and two serious injuries. These six passengers were found either partially or fully outside of the train after

the derailment, leading to the conclusion that inadequate passenger containment by the glazing systems (see [Figure 2](#)) was to blame.

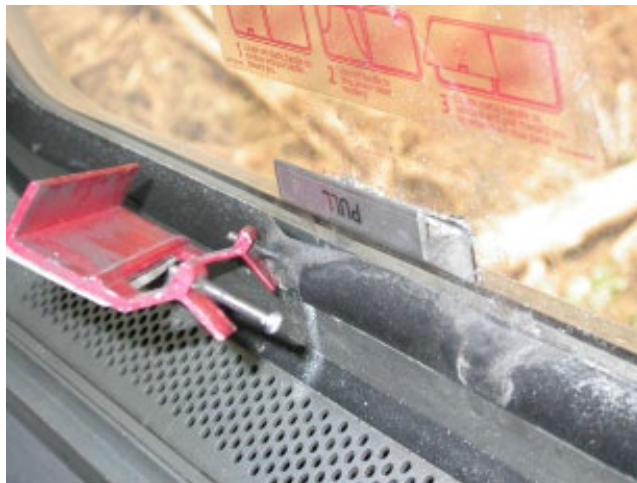
Figure 3. Example of malfunctioning emergency egress features from accident in Flora, MS

It was noted that in at least one instance, the emergency window handle had partially pulled free from the rubber grommet (zip-strip) as a result of accident forces, making emergency egress virtually impossible (see [Figure 3](#)).

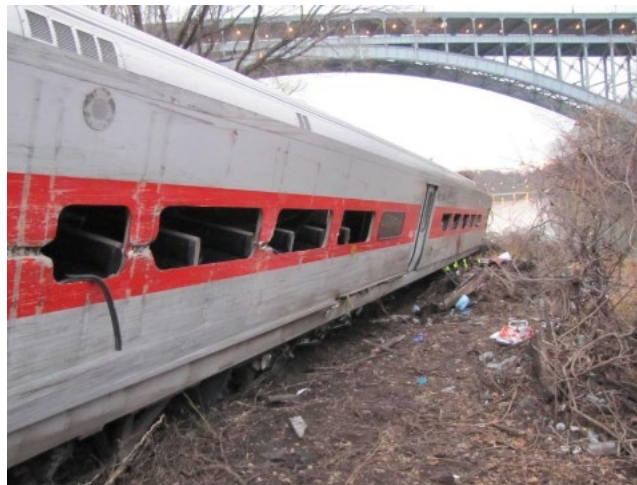
Figure 4. Result of derailment accident in Spuyten Duyvil, NY

During the accident, many of the train cars slid on their sides in the direction of travel, and the window glazing detached from the cars (see [Figure 4](#)). Due to the extent of dirt and plant matter in the car interior and the locations where the four fatally injured passengers were found, investigators concluded that all four were completely or partially ejected from the train through window openings. Two of the seriously injured passengers also sustained injuries consistent with contacting the ground as the cars slid along the ballast.

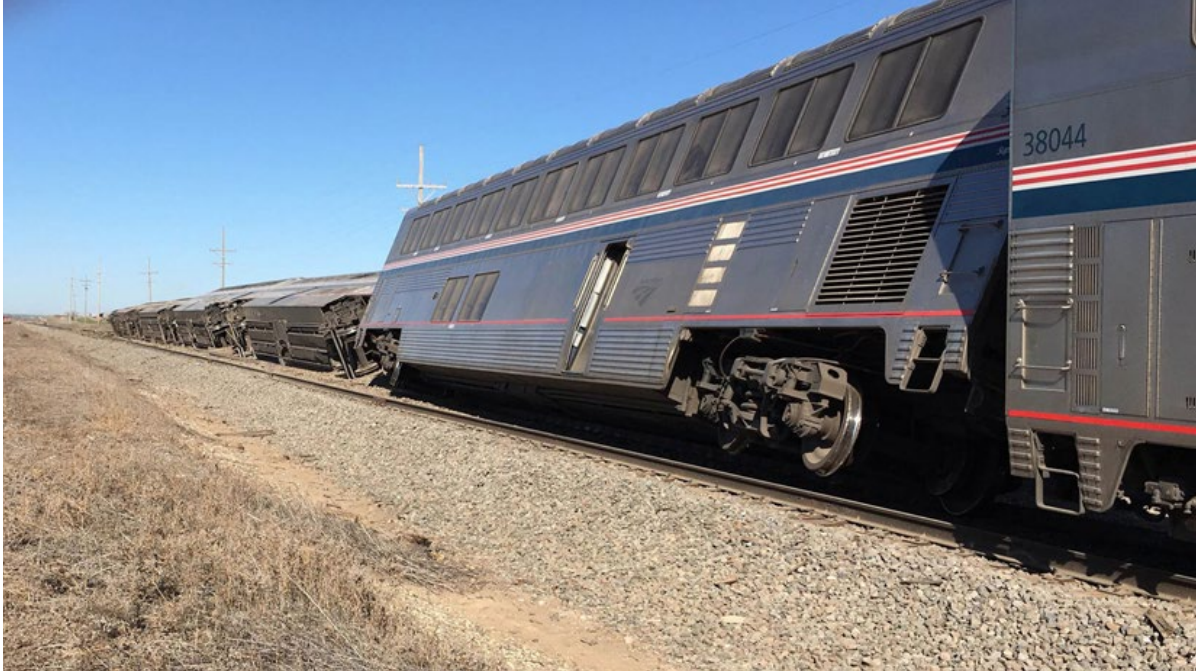
Figure 5. Configuration of cars after accident, Cimarron, KS

The research team visited the Amtrak repair facility to inspect four of the derailed cars. The following figures show the extent of the damage to the cars’ glazing systems. All the railcar windows had the same design, with removable zip-strips inside and outside the windows.

Results of this inspection indicated the window failures were caused by exterior gasket failures, mostly when the exterior zip-strip was damaged or removed during the derailment, though some failures were also noted with the zip-strip still in place. In most cases, the windows were pushed to the inside of the car. The interior zip-strips and gaskets did not fail and were still attached to the windows.

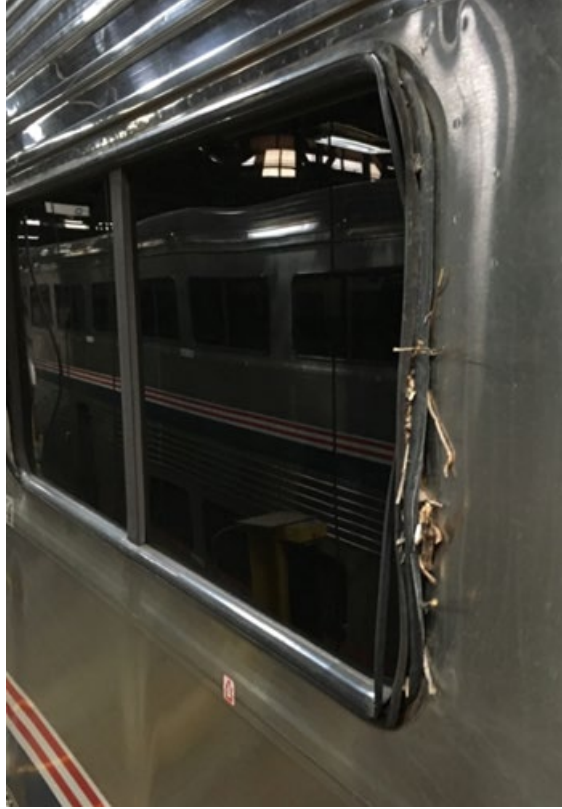
Figure 7. Debris collected from sliding along the ground, Cimarron, KS

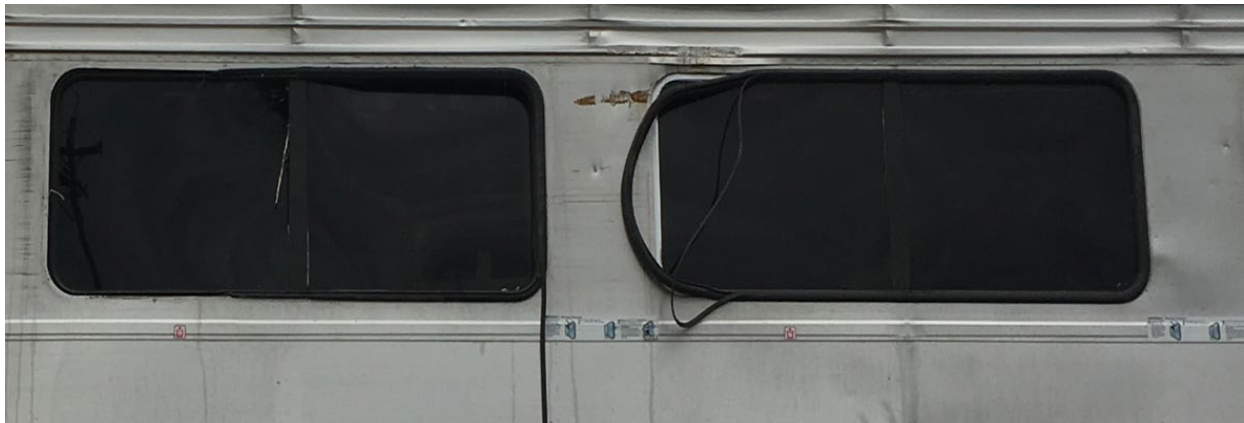
Figure 8. Condition of car after accident, Cimarron, KS

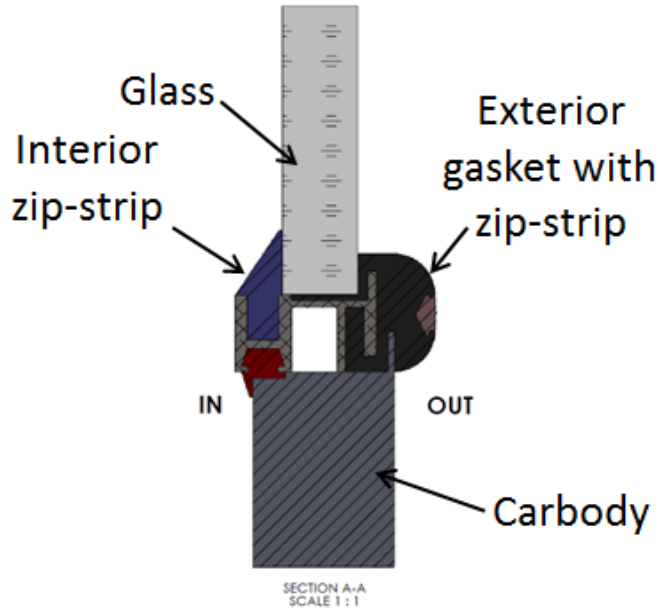
Figure 9. Existing glazing design

Figure 9 presents the current design, which uses outer and inner zip-strips. As can be seen, the outer gasket – especially the zip-strip – is exposed and susceptible to being torn off during an accident.

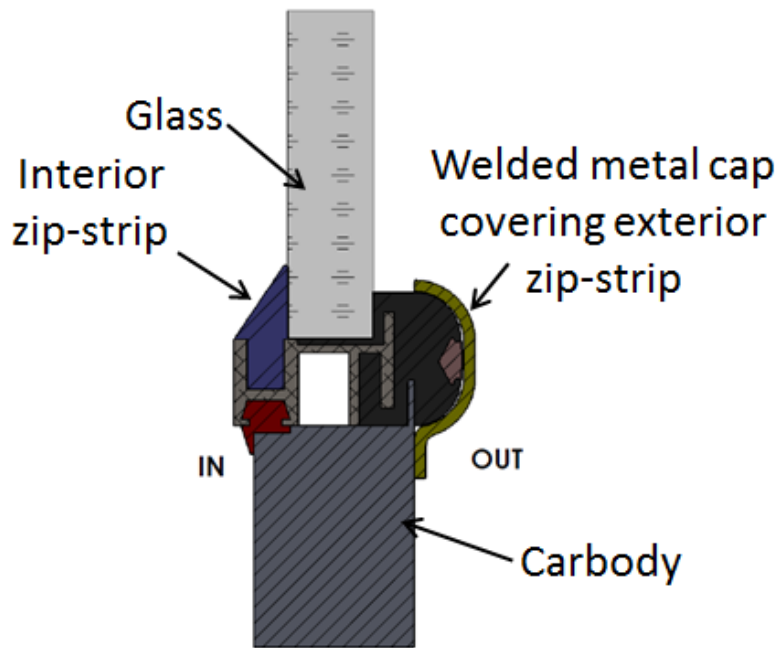
Figure 10. Concept 1 – welded zip-strip cap

Concept 1 (Figure 10) uses a metal cap welded to the carbody to protect the gasket and zip-strip during a rollover. It may be possible to choose the material for the cap in such a way that it crumples around the zip-strip during an accident and further increases safety performance.

Two of the highest-rated concepts presented in Section 5 were selected for prototyping and physical testing. Notated here as Concept A (derived from Concept 1 in Figure 10), the first is a thin sheet metal cover over the gasket that is welded/fastened to the carbody intended to help protect the external gasket and zip-strip from abrasive ballast as shown in Figure 20. Two versions of Concept A, one with a 20-gage sheet (0.0359" thick) and another with a 24-gage sheet (0.0239" thick) were evaluated. The objective is to apply sheet metal covers that are thin enough to be easily pried open by emergency responders, while also providing sufficient protection against abrasion.

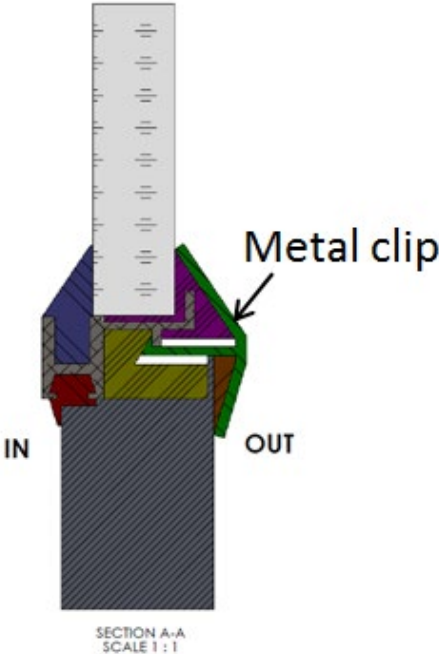
Figure 11. Concept 2 – hubcap-style clip

Concept 2 involves the use of a clip similar to what is used on car hubcaps (seen in green in [Figure 11](#)). The clip is made of metal and would protect the outer gasket during an accident. Emergency personnel can easily pry it loose, when needed.

Concept B is a clip-in style cover over the gasket, wherein the cover replaces the external zip-strip. This design is a derivative of the hubcap-style Concept 2 shown in Figure 11. It is not mechanically fastened to the car and is simply held in place by the zip-strip groove. Again, the intent is to provide abrasion resistance to the gasket, while also being easy to pry open by emergency responders. As shown in Figure 21, achieving the design intent requires specialized tooling to create profiles with sharp radii and specific shapes, which was not practical for a low volume prototype. Hence, Concept B? was prototyped as a two-piece design as shown in Figure 21, with the solid metallic zip-strip being spot welded to the outer cover.

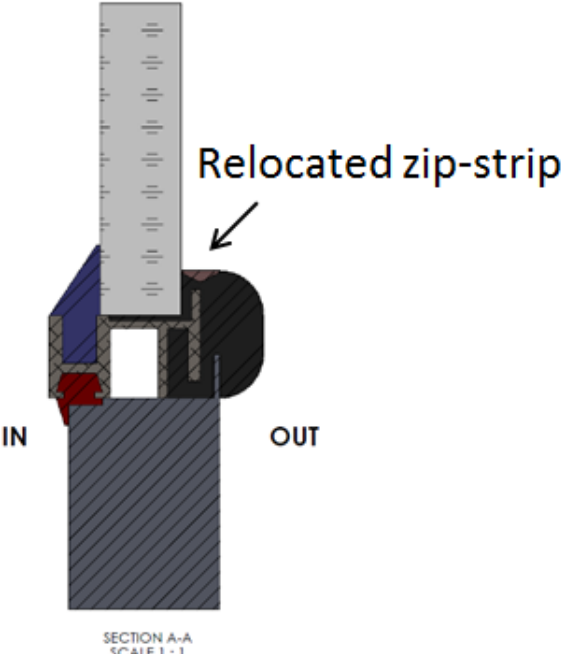
Figure 12. Concept 3 – revised zip-strip location

Concept 3 uses the existing design but relocates the outer zip-strip to a more favorable position. In this configuration, the zip-strip is subjected – in theory – to lower shearing forces during an accident. See [Figure 12](#); the zip-strip sits on the top part of the gasket.

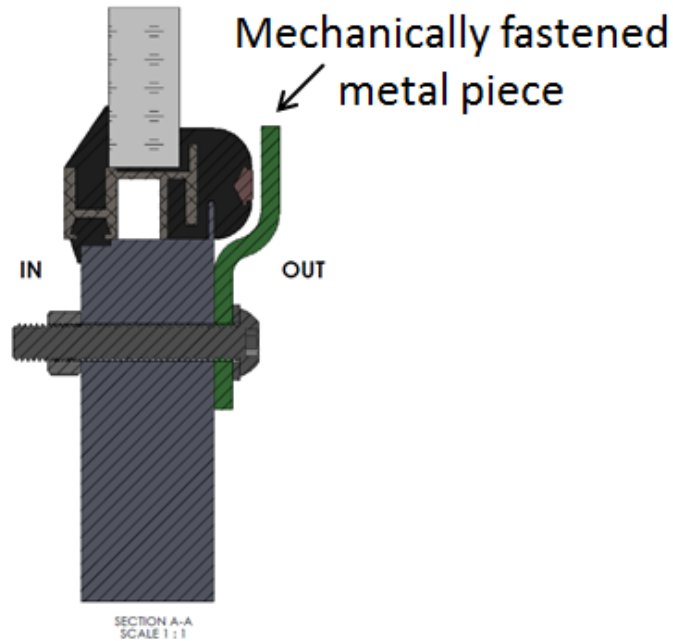
Figure 13. Concept 4 – mechanically fastened

Concept 4 involves mechanically fastening a metal piece over the outer gasket and zip-strip. This way, there is less chance of the zip-strip ripping out during an accident. One of the main benefits of this design is the ease of retrofitting existing railcars. See [Figure 13](#).

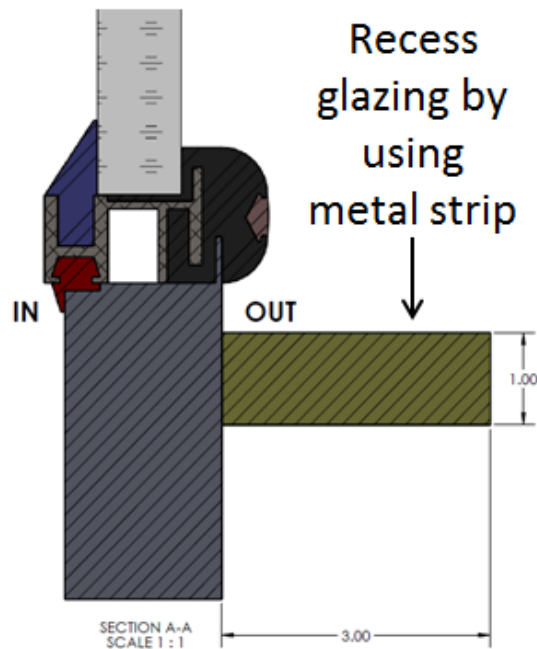
Figure 14. Concept 5 – recessed glazing system

Concept 5, as seen in [Figure 14](#), is to effectively recess the glazing system within the carbody slightly by installing a metal sheet surrounding the glazing system. During a rollover accident, the gasket and zip-strip are likely to experience lower forces and are more likely to remain in place.

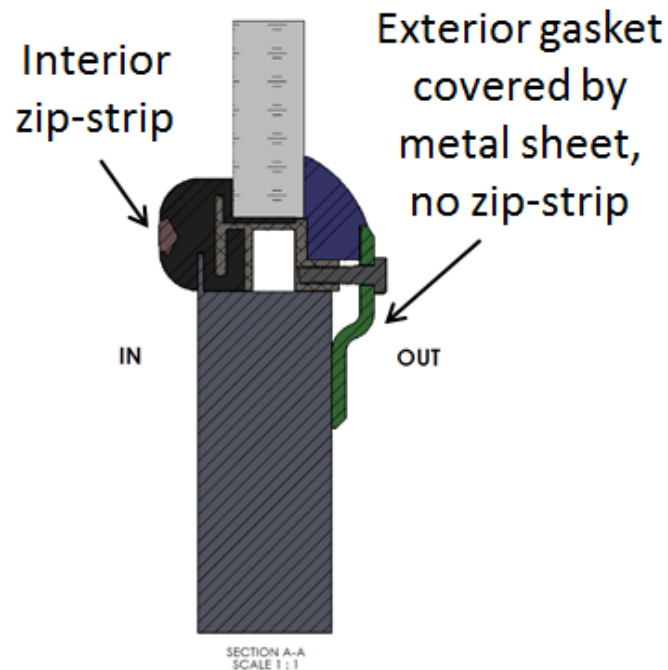
Figure 15. Concept 6 – inner zip-strip with protected outer gasket

Concept 6 utilizes an inner zip-strip with an outer gasket protected by a mechanically fastened metal sheet. Emergency personnel can pry the gasket open. The inner zip-strip can be removed by passengers. See [Figure 15](#).

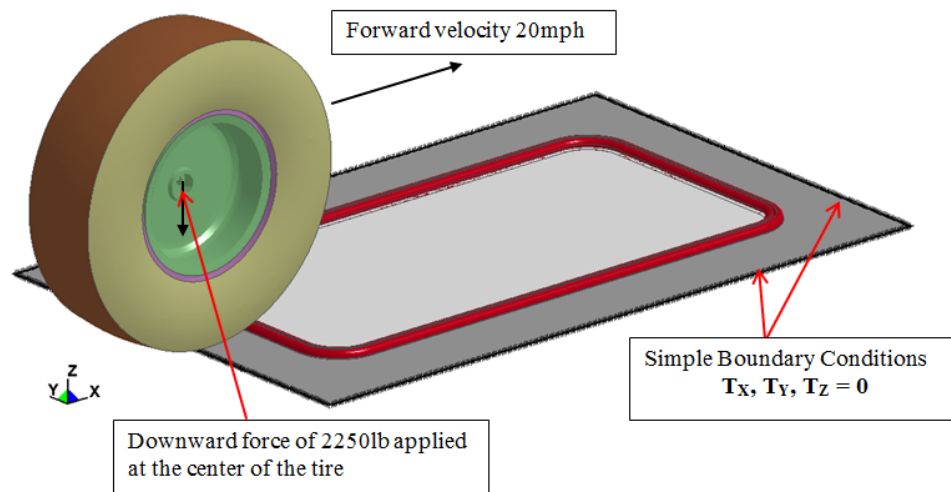
Figure 16. Abrasive rolling wheel concept – not currently implemented

As discussed below, three of the above concepts (inward push, pry test, and ballast drag) were developed further and implemented for this test effort. The abrasive wheel test (see [Figure 16](#)) was not pursued; the ballast drag test was deemed more realistic, but could be reconsidered in the future.

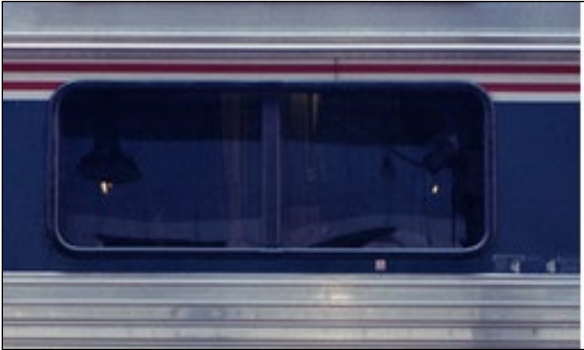
Figure 17. Superliner window

The initial intent called for the test specimen to be cut out from an Amtrak Superliner passenger railcar ([Figure 17](#)). However, this proved challenging for a variety of reasons, and instead, a specimen frame was fabricated using carbon steel plates and angles to best represent the skin and supporting elements used on the Amtrak car. The frame is designed to accommodate the glazing and gasket elements used on the Amtrak cars. In other words, the window opening dimensions and the skin thickness were kept the same as the Superliner car to ensure correct fitment. In addition, the bracing elements (z-sections and perforated angles), with dimensions and

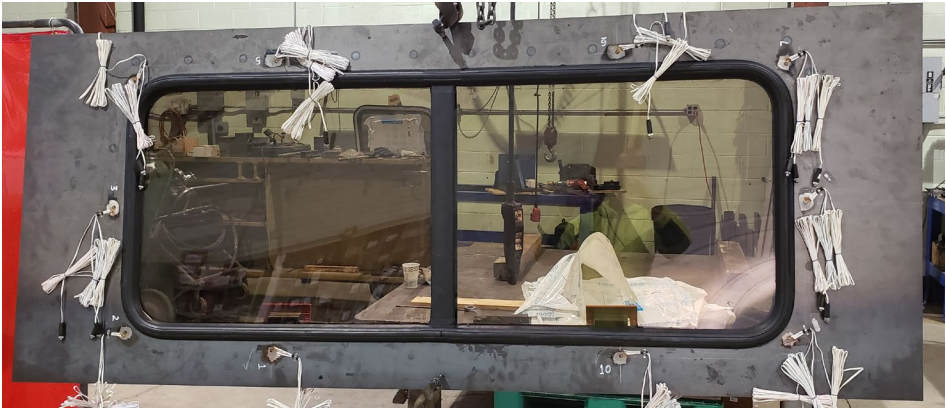
Figure 18. Test specimen – outside view

thicknesses approximating measurements on the Amtrak car, were added to ensure the structure of the test frame was not a factor in glazing performance. Multiple glazing and gasket samples in new condition were acquired from Amtrak for testing. [Figure 18](#) and [Figure 19](#) present images of the outside and inside of the test specimen.

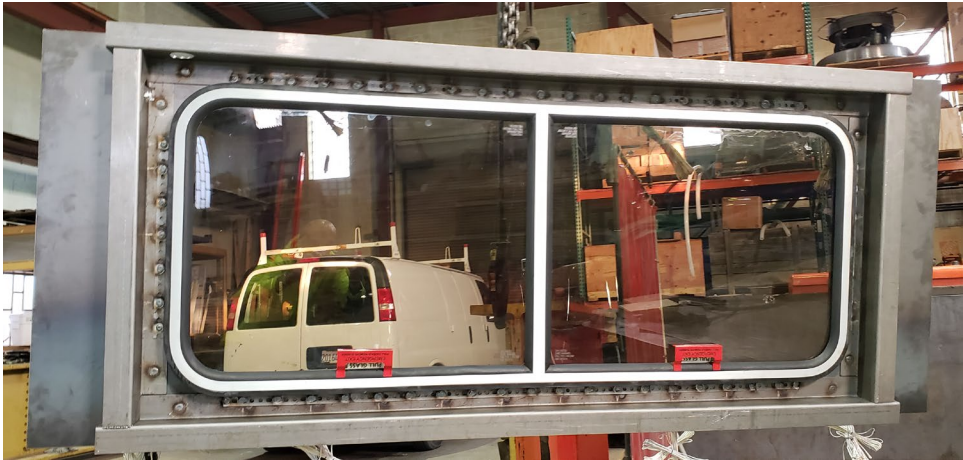
Figure 19. Test specimen – inside view

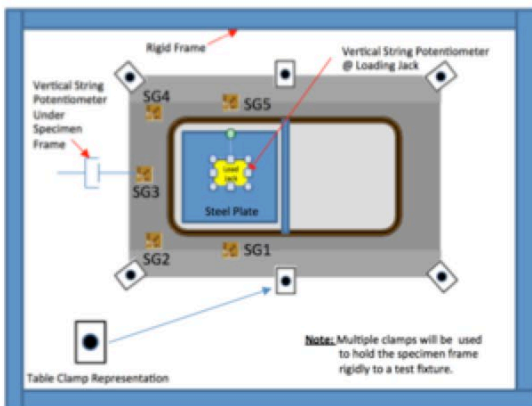
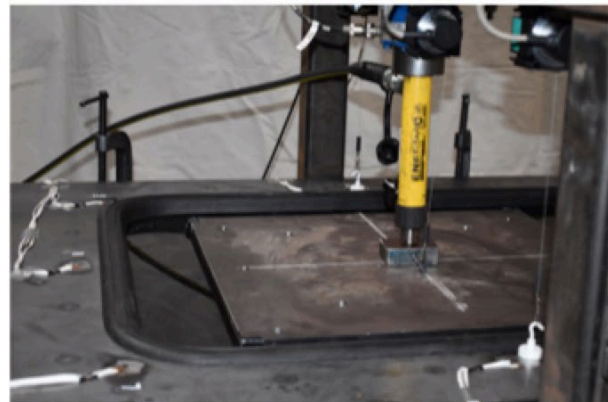
Figure 22. Push-through test – schematic and implementation

- Peak load on jack for the push-through test: 5,000 lbs (Keep increasing until failure, anticipated failure load is less than 5,000 lbs.)
- Loading rate: Manual
- Loading steel plate dimensions: Approximately 20" x 22" x 0.5"
- Vertical location of loading: Centered on the half-window pane

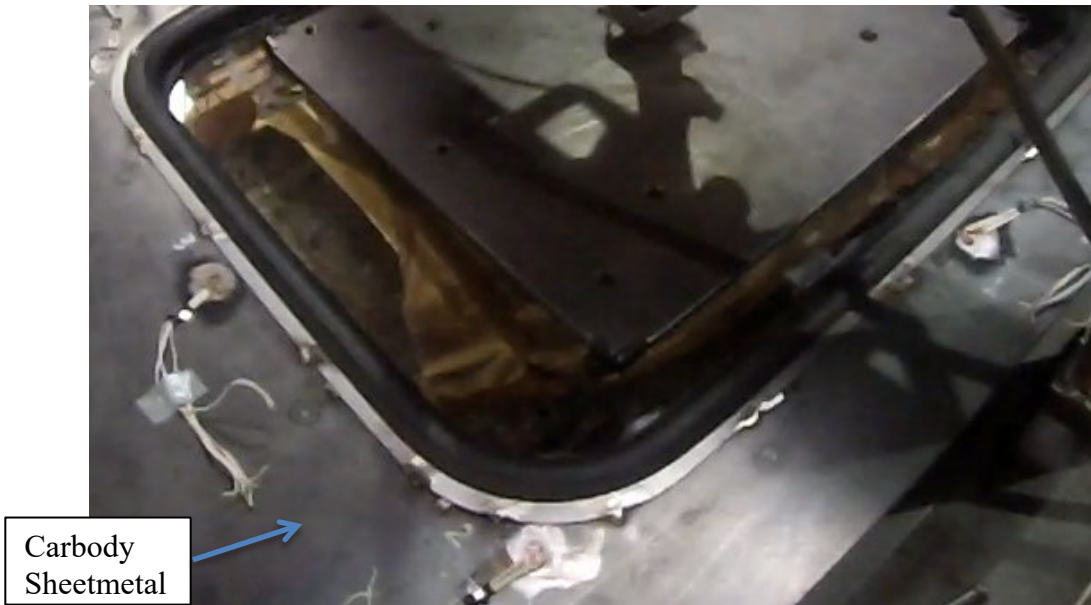
Figure 23. Close-up of shims added to specimen

When a reused specimen, i.e., one that had detached in a prior test and had been reinstalled, was tested, the load needed to separate the glazing was even lower, at only 750 lbs. To improve retention capacity, the research team increased the effective thickness of the carbody sheetmetal that the gasket connects to, by adding shims that brought up the thickness of the plate from 0.25” to 0.3” for New Specimen 5 (see [Figure 23](#)). This improved the retention capacity by about 200–300 lbs, or about 17–25 percent. Shimming also increased the capacity of Reused Specimen 5 by a similar percentage.

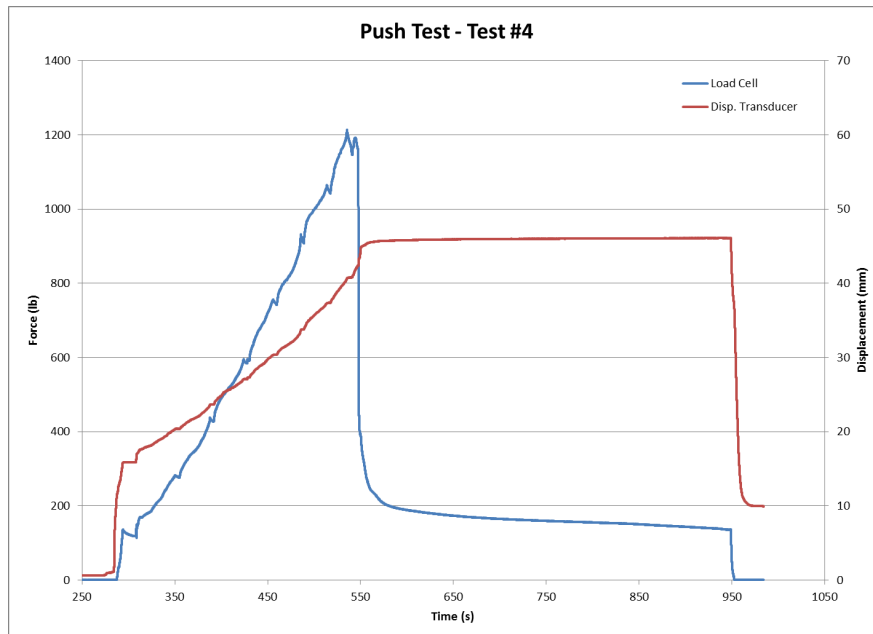
Figure 24. Push-through test – Specimen 4 – force and displacement

Representative force and deflection data from Specimen 4 is shown in [Figure 24](#), and the corresponding post-test image can be seen in [Figure 25](#).

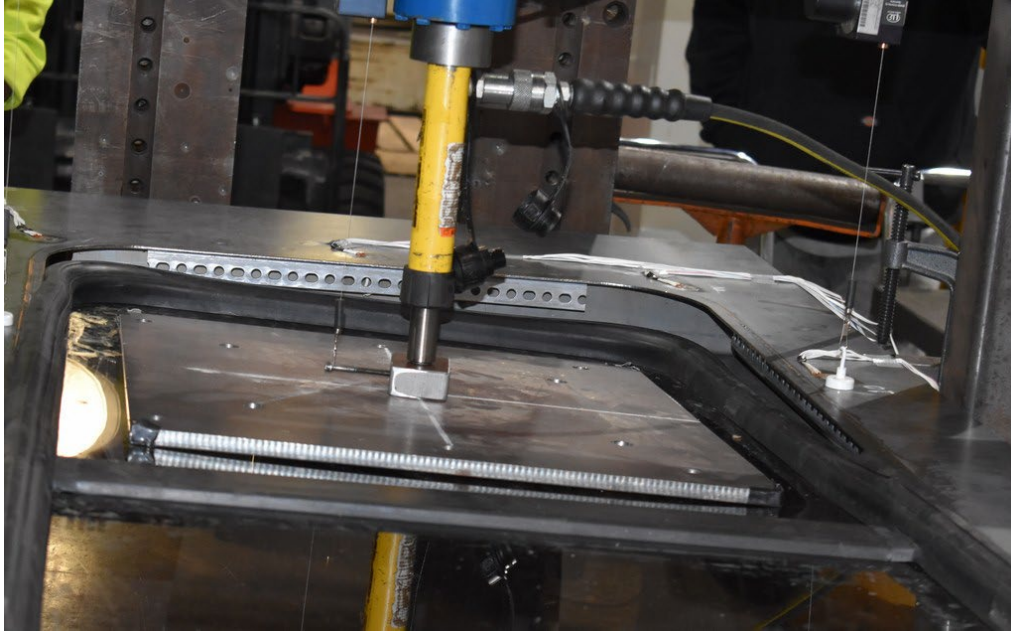
Figure 25. Push-through test – Specimen 4 – showing post-test separation

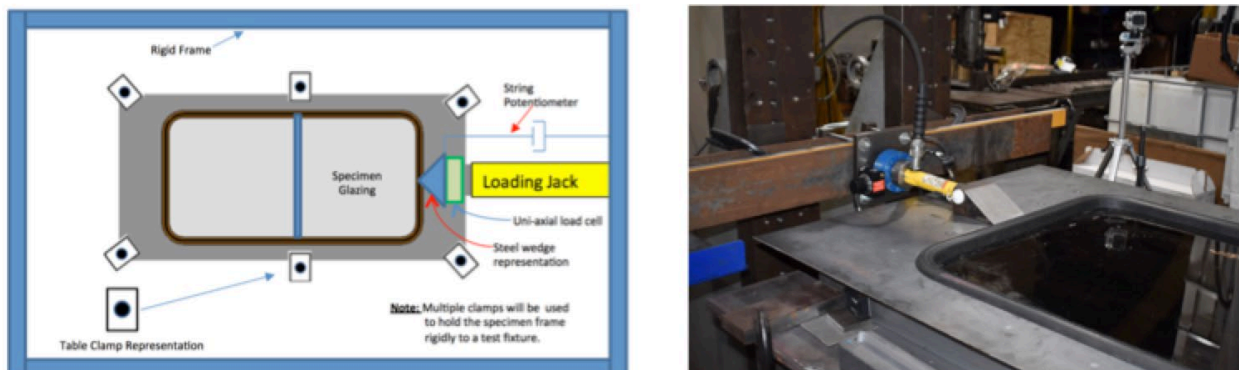
Figure 26. Pry test – schematic and implementation

The pry test quantified the prying force required to detach the glazing from the gasket/frame. A schematic of the test setup and a picture showing the implementation are presented in [Figure 26](#). For this test series, a complete glazing test specimen was mounted to a rigid fixture, and a load parallel to the glazing pane was applied through a wedge, to generate a prying force until either the gasket or the glazing pane separated from the frame. The load was increased until separation was observed.

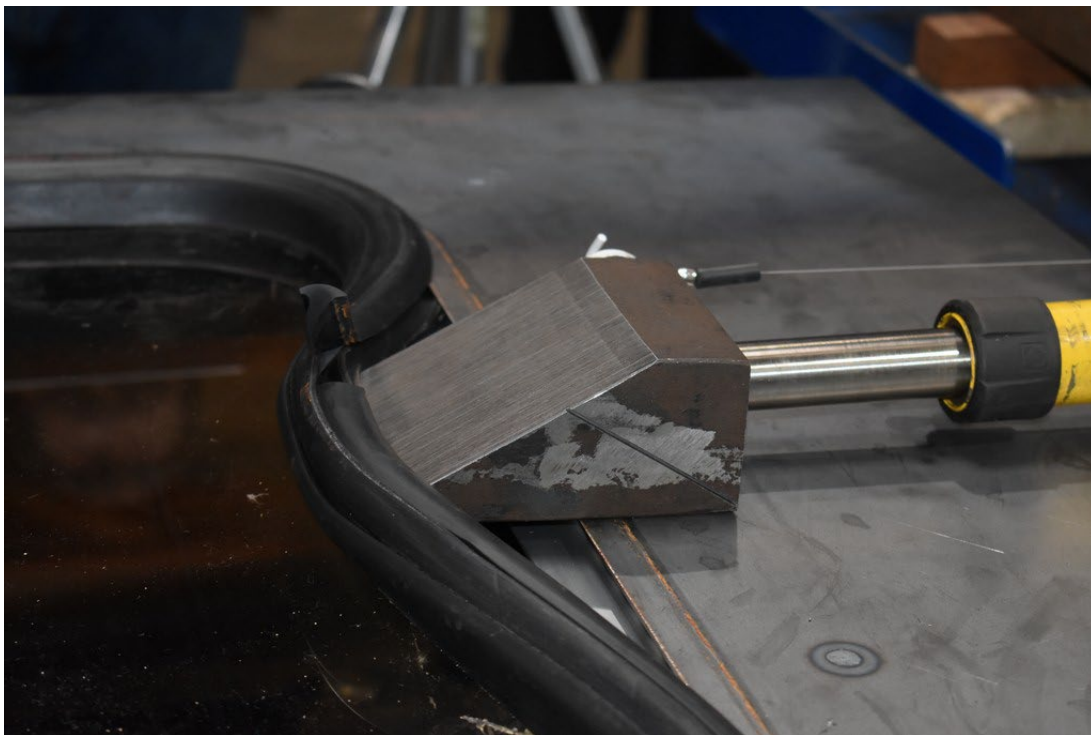
Figure 27. Pry test – Specimen 3 – separated gasket

The test results are presented in [Table 6](#). As seen in the table, for the base case (no protection of the gasket), only a small load (less than 200 lbs) was needed to separate the gasket from the frame (see [Figure 27](#)); given the low magnitude of the prying load for the base case, no additional restraint in the vertical direction was needed to keep the wedge movement (stroke) aligned with the longitudinal axis of the test specimen. For both concepts, the wedge rode over the sheet metal cover, and there was no damage to the gasket; this was in spite of an additional

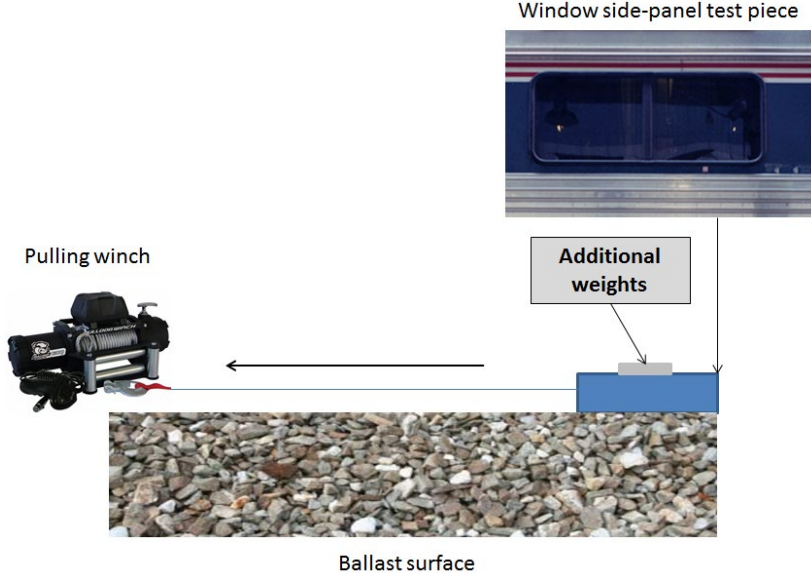
Figure 28. Schematic of ballast drag test

using a winch, and the travel distance required to achieve gasket separation was noted as a measure of the retention capacity of the system.

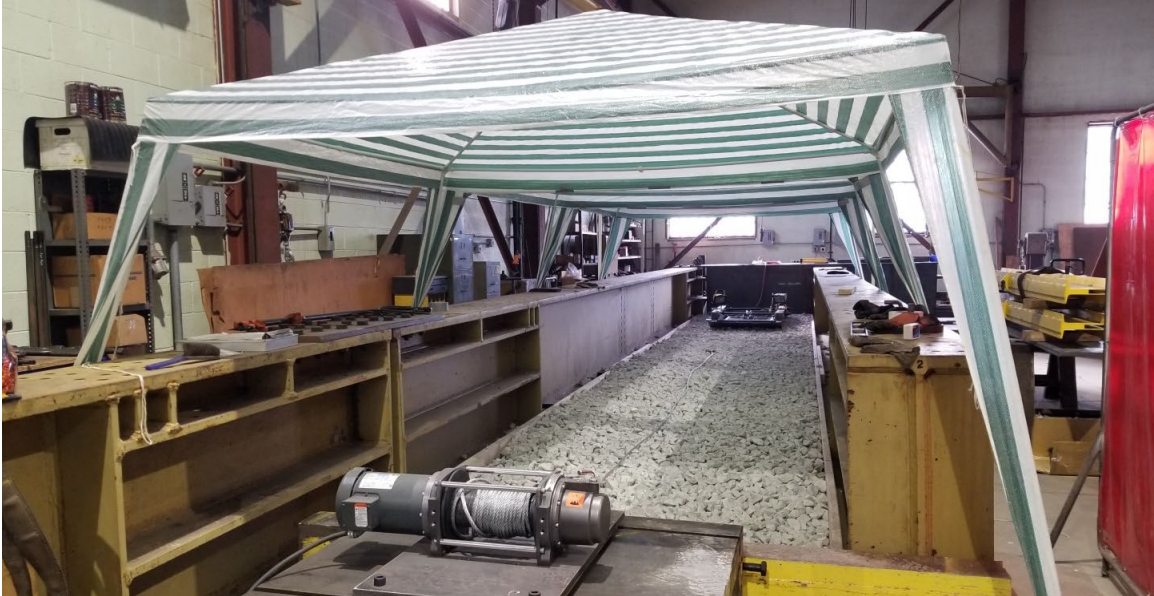
Figure 29. Ballast test setup

This test simulated a passenger car, post-rollover derailment, being dragged through ballast. For this test, a large “sandbox” was constructed and filled with railroad ballast. The dimensions of the box are 6’ wide x 40’ long with a ballast depth of 12” (see [Figure 28](#) and [Figure 29](#)). The test specimen representing a window section (see [Figure 30](#)) was dragged across the ballast box,

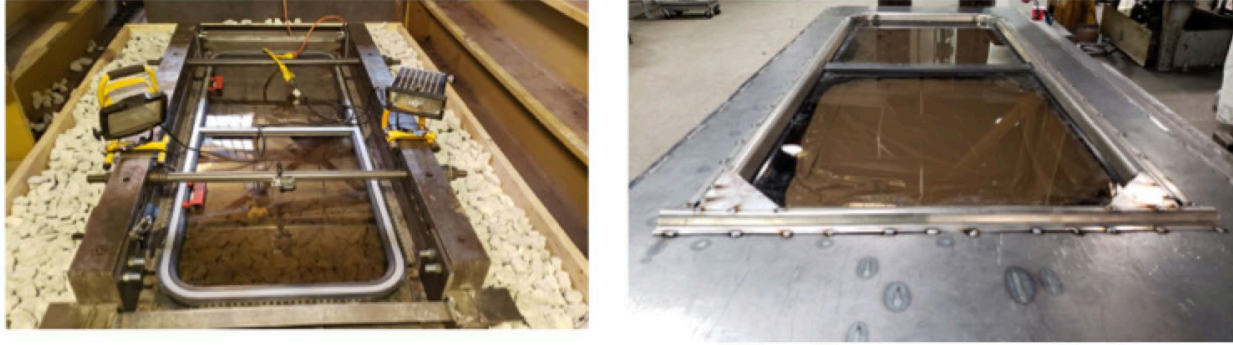
Figure 30. Test specimen and prototype of Concept 1

Lights and cameras were added to the test specimen (see [Figure 30](#)) to allow both the leading and trailing edges of the specimen to be observed and recorded while being dragged, permitting an estimate of the distance dragged before failure. Key test results are presented in [Table 7](#) below. As before, specific specimens were reused to maximize what could be learned; the number of specimens was limited.

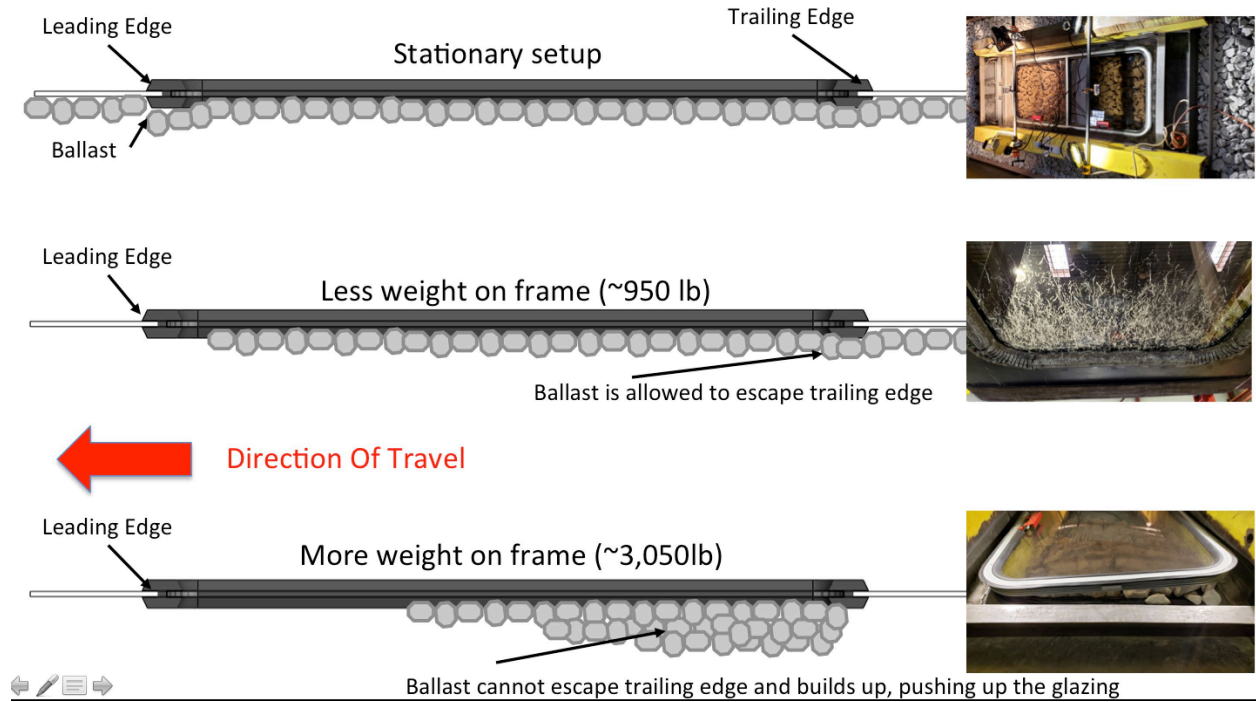
Figure 31. Failure modes during ballast drag test

still protected the gasket from tearing, but the ballast pile-up at the trailing end pushed the glazing inward, increasing the load normal to the glazing, causing separation.

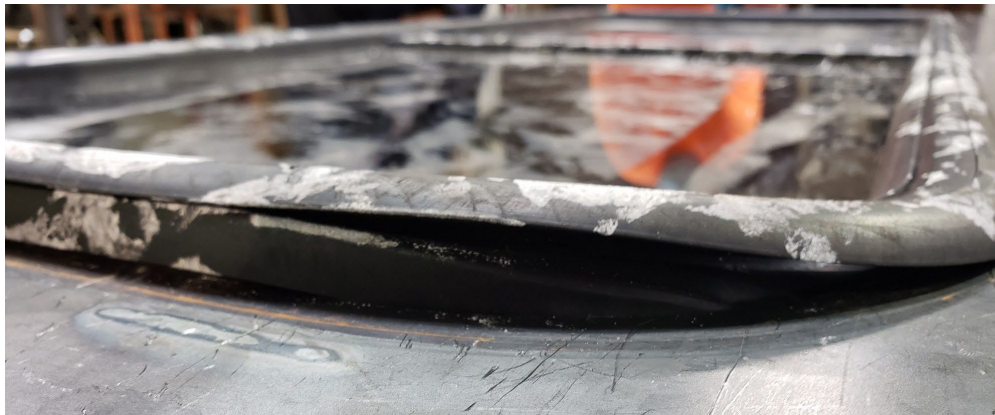
Figure 32. Drag test Specimen 6 – base case – gasket separation at leading edge

Figure 32, Figure 33, and Figure 34 present additional images highlighting some of the test results.

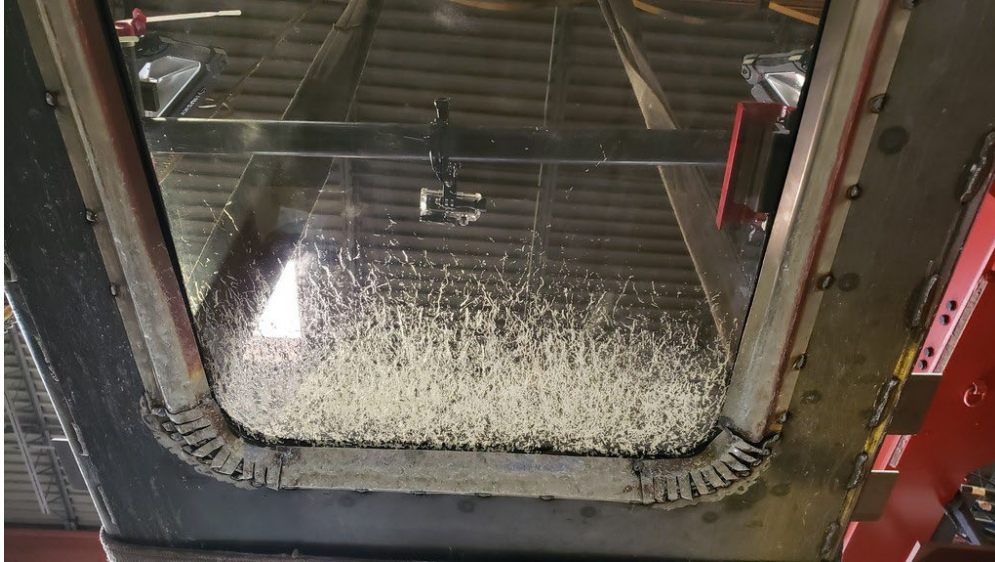
Figure 33. Drag test Specimen 8 – glazing intact after 86' of drag @ 950-lb load

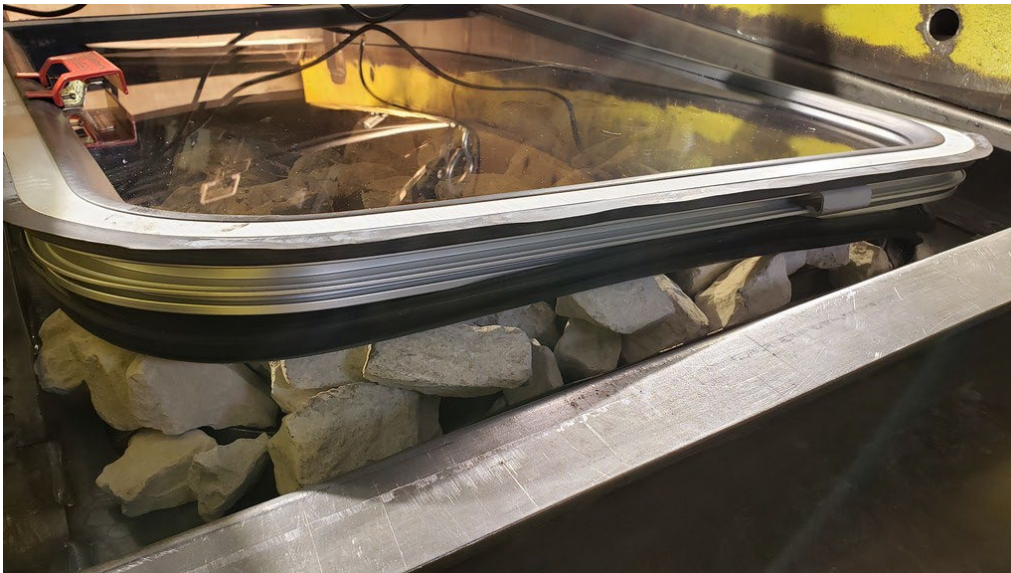
Figure 34. Drag test Specimen 10 – push-through failure at trailing edge

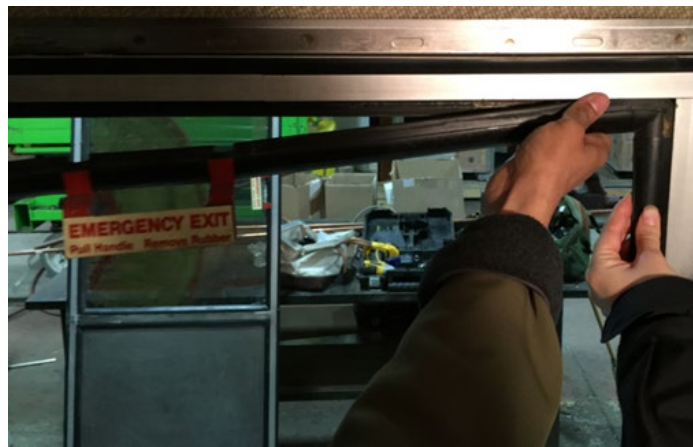
Figure 35. Example of the interior zip-strip being removed

When the zip-strip was removed from the inside, the window pane was easily removed to inside the car. When the zip-strip was removed from the outside the window, the gasket could be pushed into the car with the use of a pry bar or some other tool. The following pictures document the different steps.

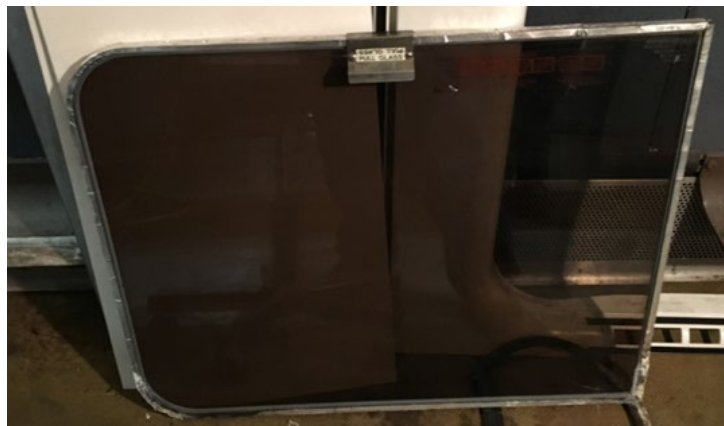
Figure 36. Window pane pulled into the car after the interior zip-strip was removed

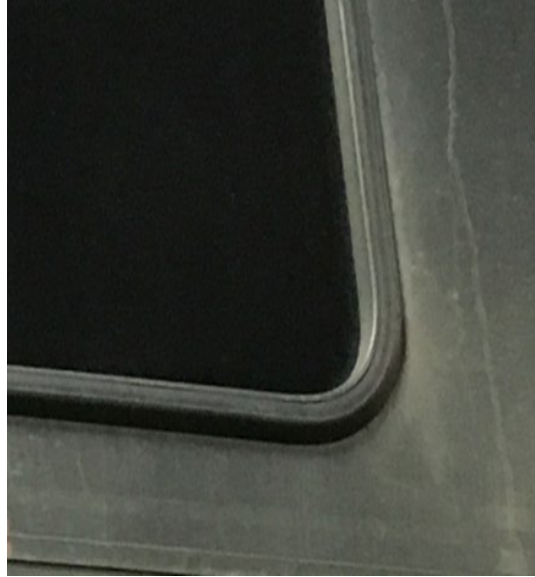
Figure 37. Exterior window with zip-strip in place

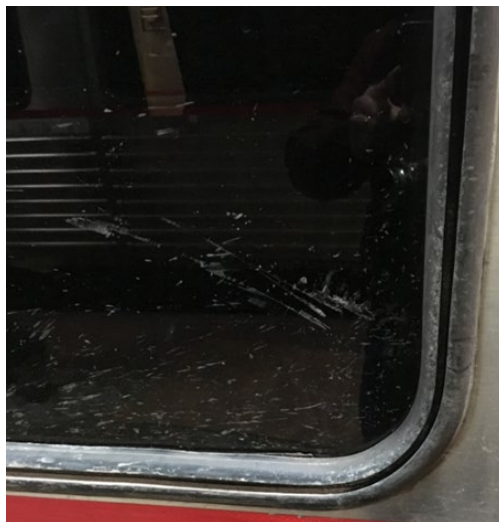
Figure 38. Exterior window with zip-strip removed

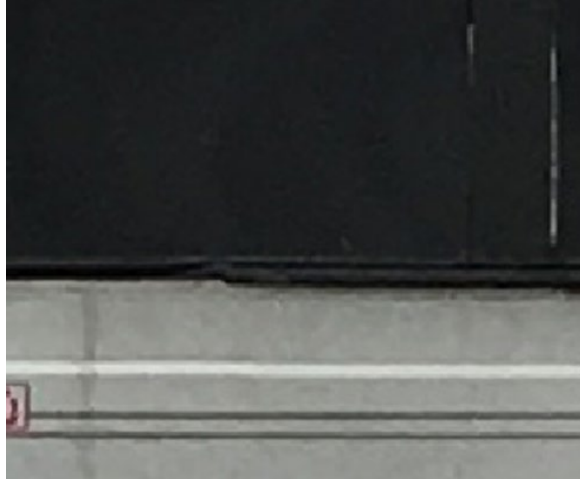
Figure 39. With the exterior zip-strip removed, the gasket can be pried up into the car
