U.S. Department
of Transportation
Federal Railroad
Administration

Integrity of Rail Passenger Equipment Glazing Systems

11. SPONSOR/MONITOR'S REPORT NUMBER(S) DOT/FRA/ORD-22/21	
12. DISTRIBUTION/AVAILABILITY STATEMENT This document is available to the public through the FRA website .

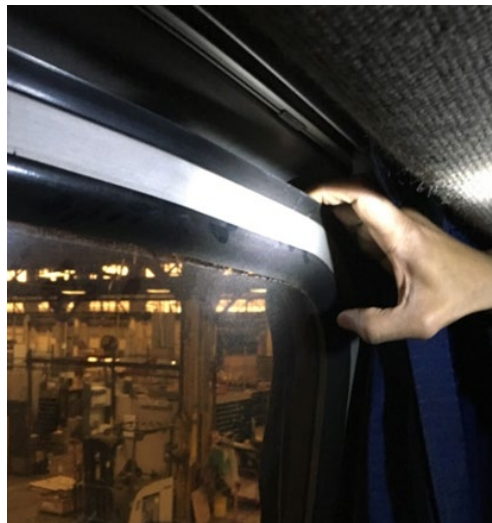
Figure 40. A demonstration of window and gasket system being pulled into the car

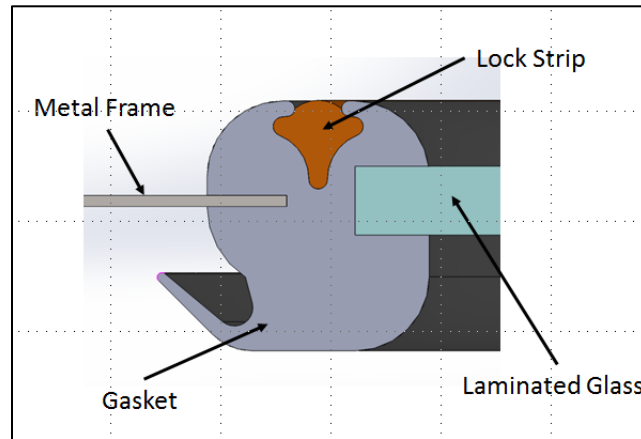
Figure 41. Components of the FE model

- Metal frame representing the outside sheet of the passenger car
- Rubber gasket
- Lock strip (zip-strip)
- Laminated glass

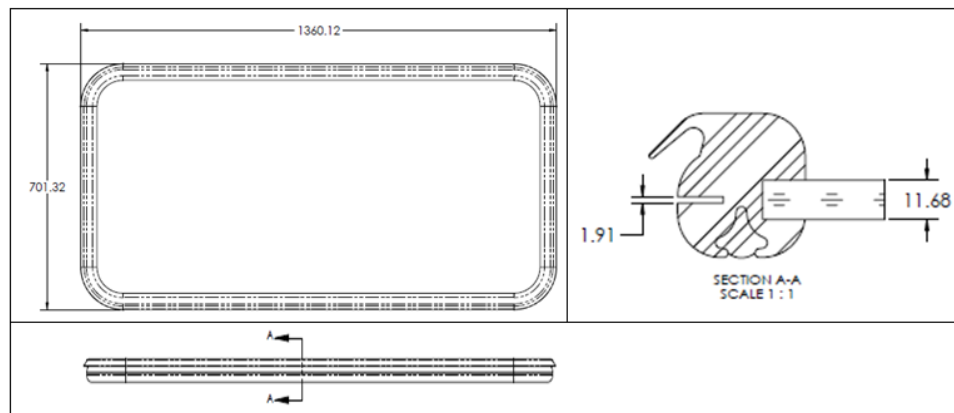
Figure 42. CAD geometry of window glazing

Representative dimensions of a laminated glass pane 27.6” wide by 53.55” long and 0.46” thick were used. The laminated glazing was based on CAD geometry presented in Figure 42.

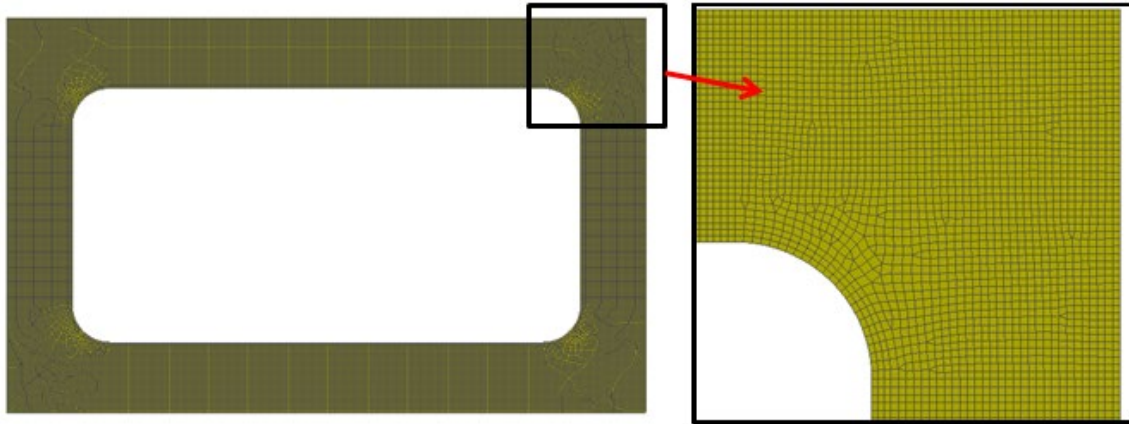
Figure 43. Metal frame shell elements mesh

Typical LS-DYNA element types were used to construct the glazing models. The metal frame was modeled with Belytschko-Tsay (BT) shell elements. These are four-node shell elements with a single integration point in the plane of the shell element, but multiple through-thickness integration points could be used to calculate stress variations. Typically, four integration points are specified through the thickness of the shell for each element to accurately capture the bending response. The shell elements of the metal frame are shown in [Figure 43](#).

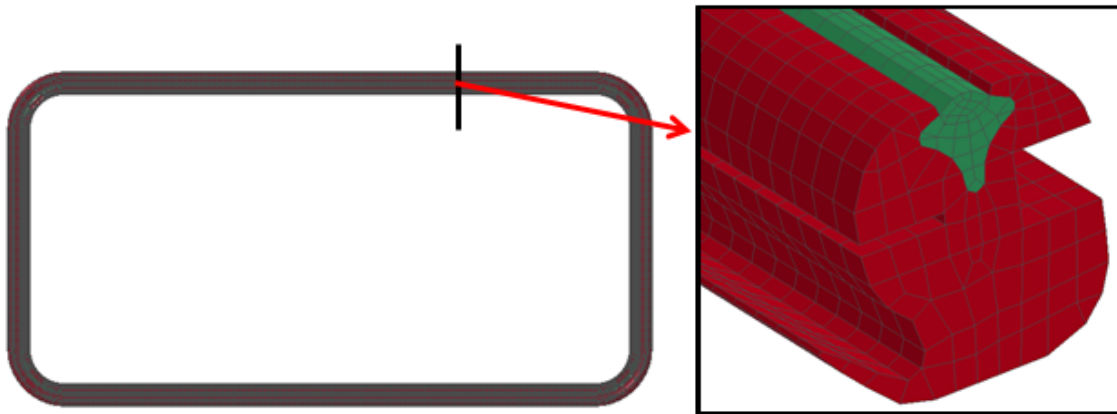
Figure 44. Rubber gasket and lock strip (zip-strip) solid elements mesh

For the lock strip (zip-strip) and the rubber gasket, and 8-node, solid hexahedron elements with single-point integration were used. This is a commonly used solid-element type in LS-DYNA due to its balance of computational efficiency and accuracy. The solid-element components are shown in [Figure 44](#), laminated glass elements in [Figure 45](#), and the integrated model in [Figure 46](#).

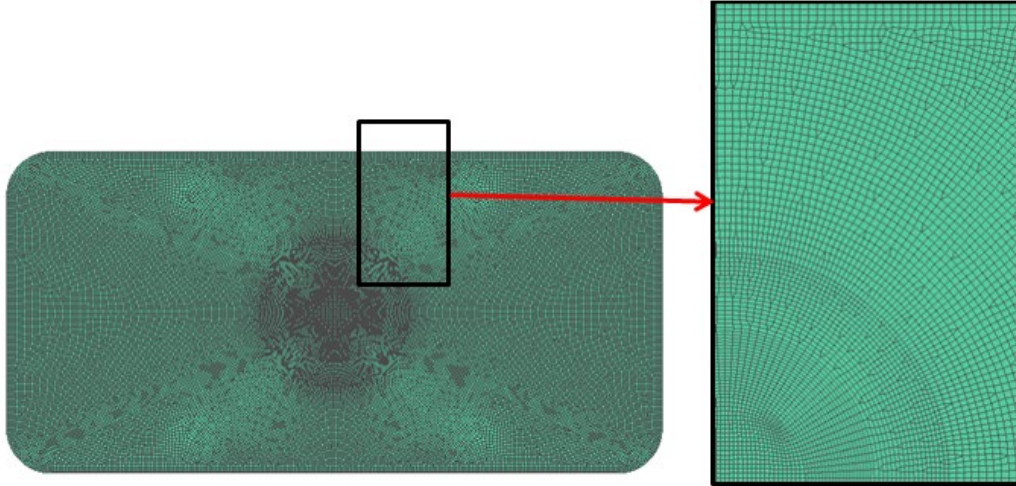
Figure 45. Laminated glass shell elements mesh

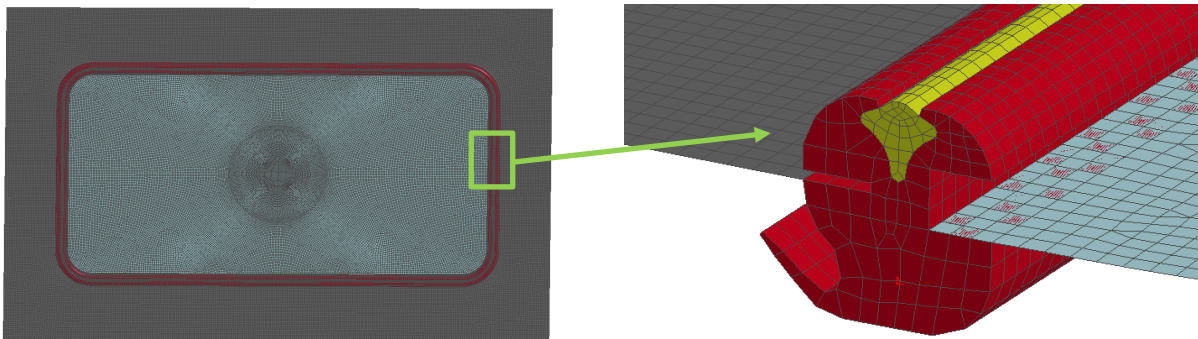
Figure 46. Details of integrated FE model

Figure 46 shows the FE mesh details of the glazing structure used first to characterize the strength of the glass, and then to analyze the mounting method.

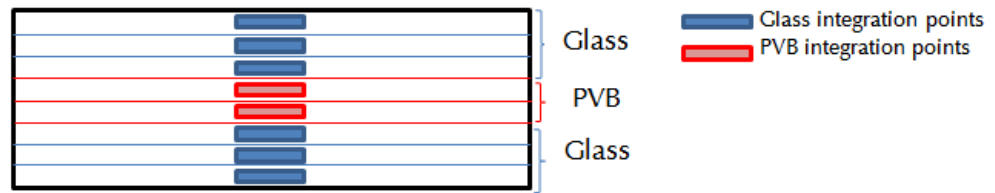
Figure 47. Cross-section of the laminated glass model

The team found that there are different ways to model laminated glass in LS-DYNA. Research findings [15] demonstrated the 3D laminated glass model provides more accurate results and enables the user to investigate the influence of controlling parameters and support conditions. The 2D laminated glass model (material model 32) gives results with reasonable accuracy using less computational time, and hence can be used to investigate the global behavior of laminated glass panels. Since the scope of this project is related more with the mounting method of the current glazing systems and not necessarily with the glass itself, the use of the 2D laminated glass model was deemed an acceptable approach (see Figure 47).

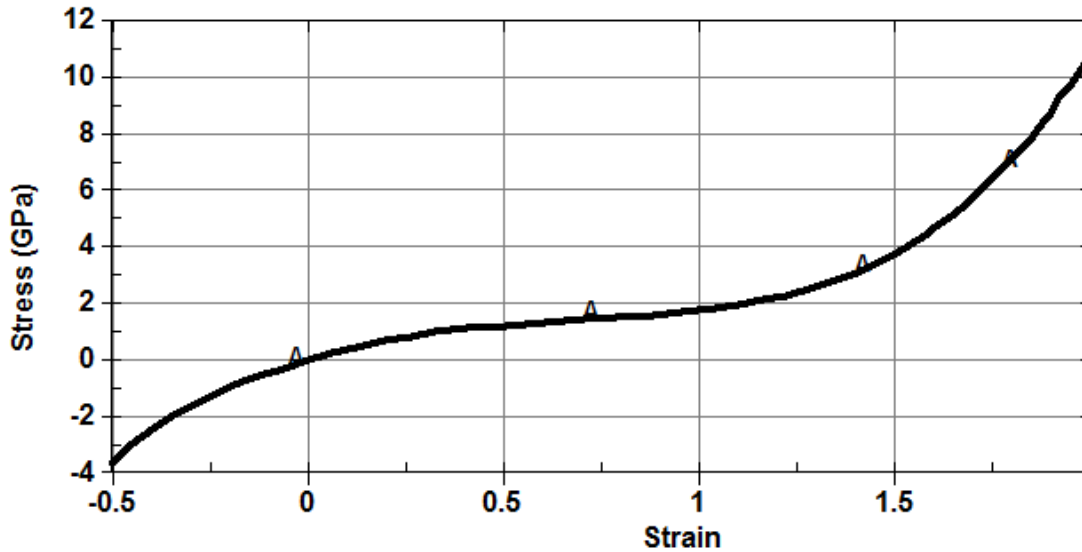
Figure 48. Stress vs. strain curve for rubber/elastomer material

Regarding the rubber/elastomer components, there are multiple material models that LS-DYNA has implemented. The choice of material model depends on the availability of material properties and experimental data. Ogden_Rubber material model (MAT77) was chosen to model rubber sealant joints. This material can be fit to uniaxial or biaxial data. Data need to be provided in both the compression and tension regimes to ensure proper fit. The stress vs. strain curve for the rubber material used in this model is presented in [Figure 48](#), and the material properties are presented in [Table 10](#).

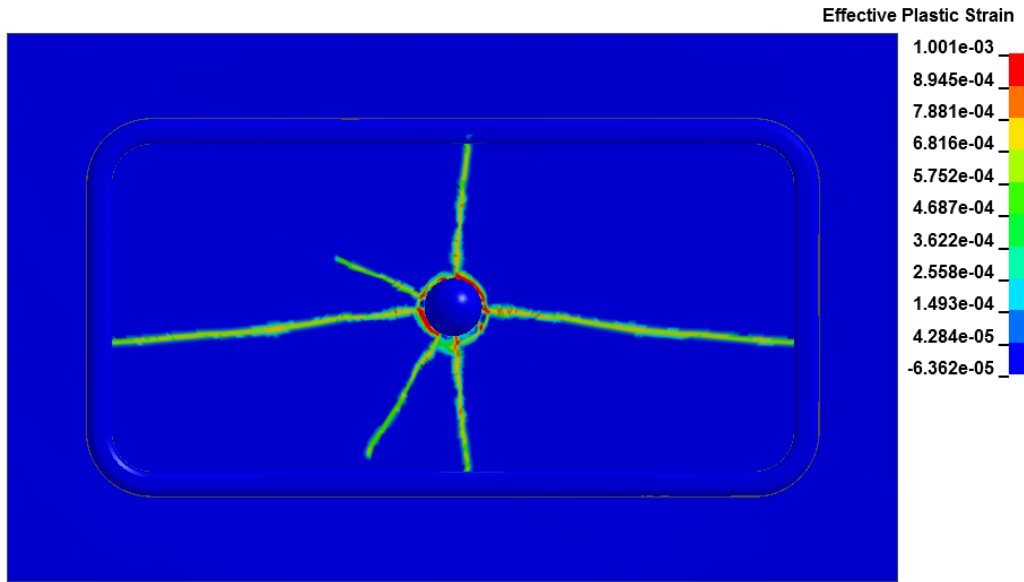
Figure 49. Result of steel ball impact test

Since failure criteria for the PVB interlayer cannot be defined for MAT32, the failure is defined qualitatively by observing the area of the damaged zone and the effective plastic strain from the simulations. The deformation patterns and general behavior observed from these simulations gave the team confidence the material model behaved as intended.

The results are shown in [Figure 49](#) and [Figure 50](#).

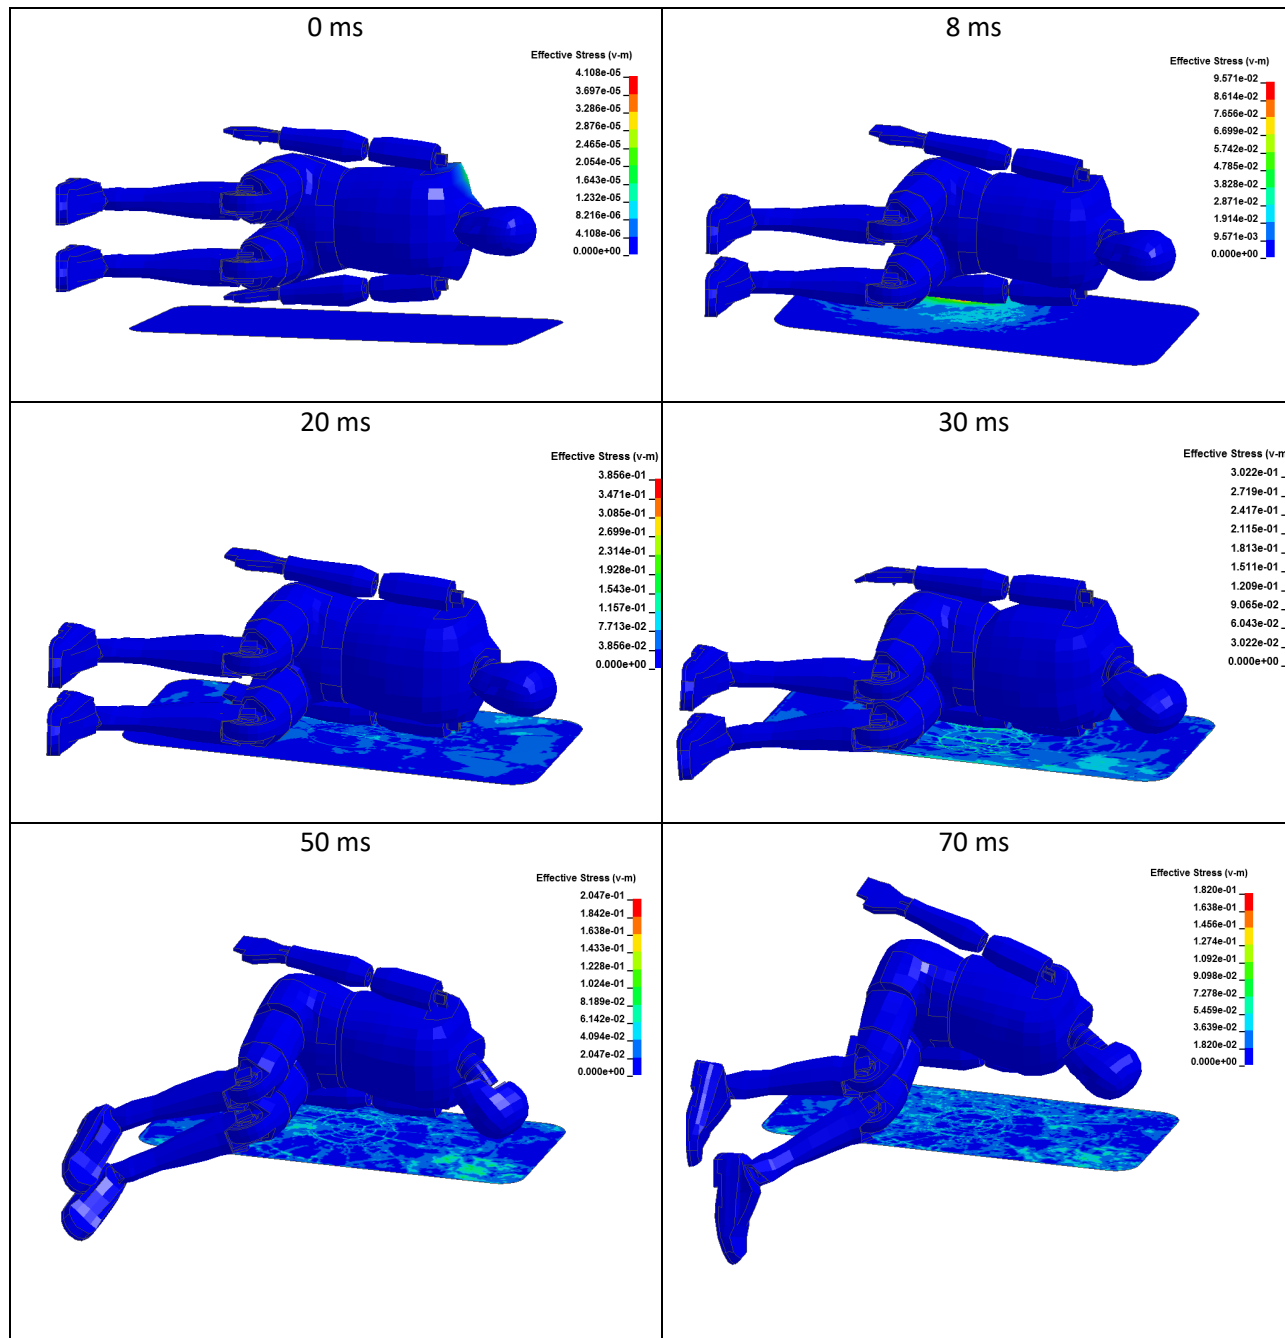
Figure 51. Time-lapse of internal impact test

A model was developed to estimate the forces which could be generated from passengers striking the window glazing during an accident. A Hybrid III 95th percentile male anthropomorphic test device (ATD) was simulated falling and accelerating through a distance equal to the width of the railcar onto the window glazing. At the time of impact, the 100-kg ATD was traveling at 6.67 m/s. The peak force experienced by the window from the impact with the ATD was 21.7 kN. This was a very short duration pulse with a duration of about 50 ms; for comparison, the standard triangular pulse used for vehicle interior fixture strength evaluations has a duration of 250 ms. The nominal load over the 50 ms duration is about 11 kN. A time-lapse of the simulation is shown in [Figure 51](#).

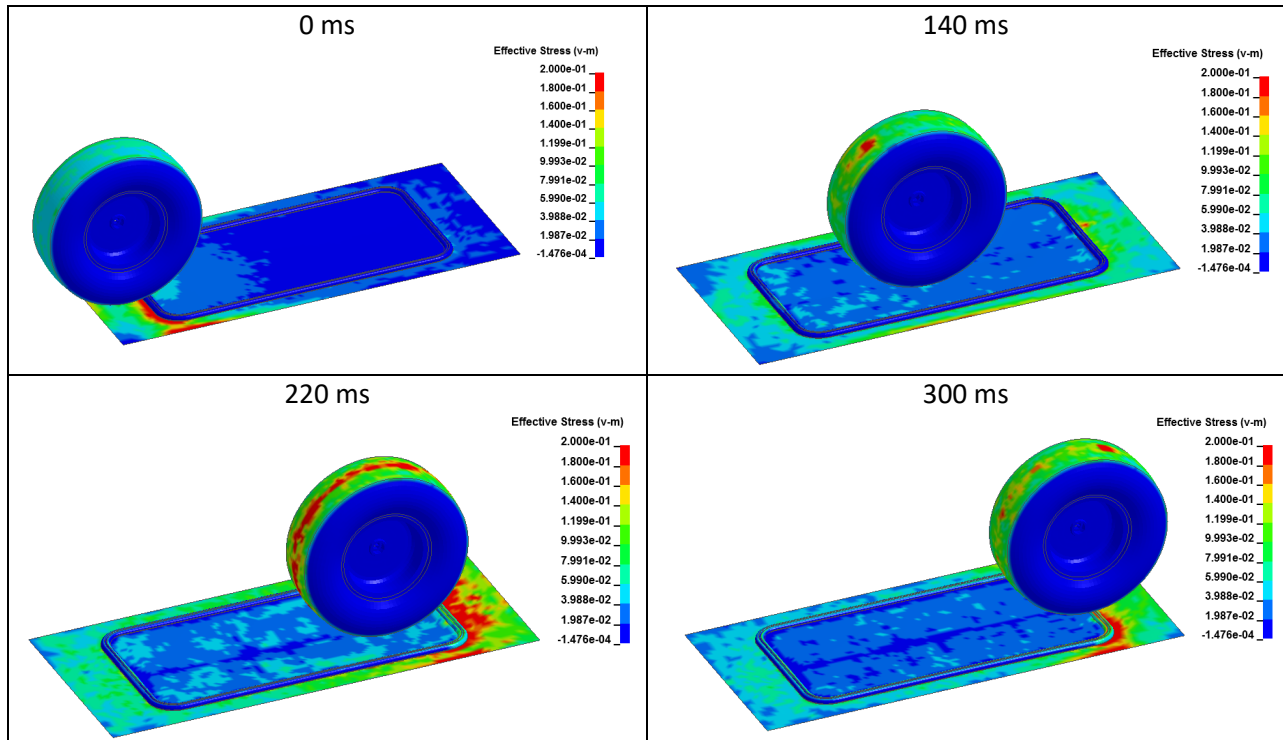
Figure 52. Time-lapse of rolling tire test

A simulation involving rolling a tire with an applied load over the glazing was performed to replicate what might be seen in a rollover-type accident (see [Figure 52](#)).

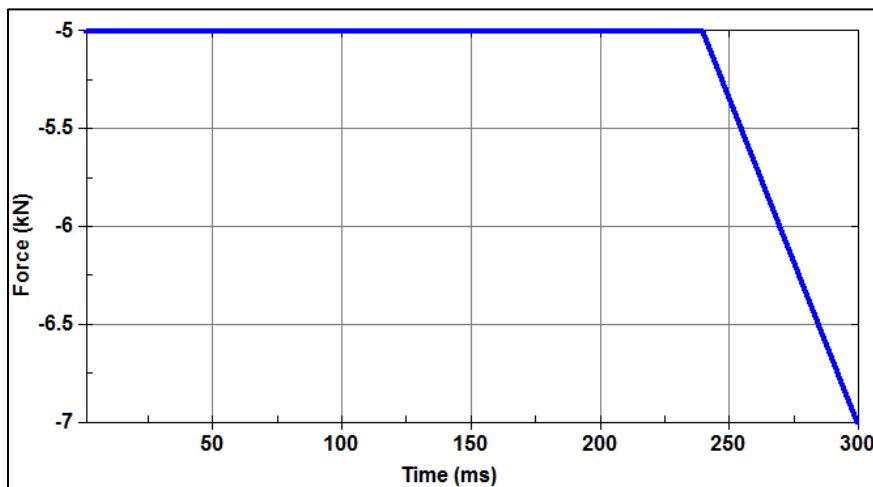
Figure 53. Load applied by the rolling tire

The tire weighed 50 kg; a plot of the applied load is shown in [Figure 53](#). Preliminary runs were made with the load held constant at 5 kN until near the end of the simulation, when it was increased linearly to 7 kN (1,100 lbs to 1,500 lbs). The simulated glazing system survived with no signs of detachment or fracture.
