**Federal Railroad
Administration**

Memorandum

Reply to Att. of: MP&E 98-42

Subject: TTX "National Uni-Truck" (single-axle)

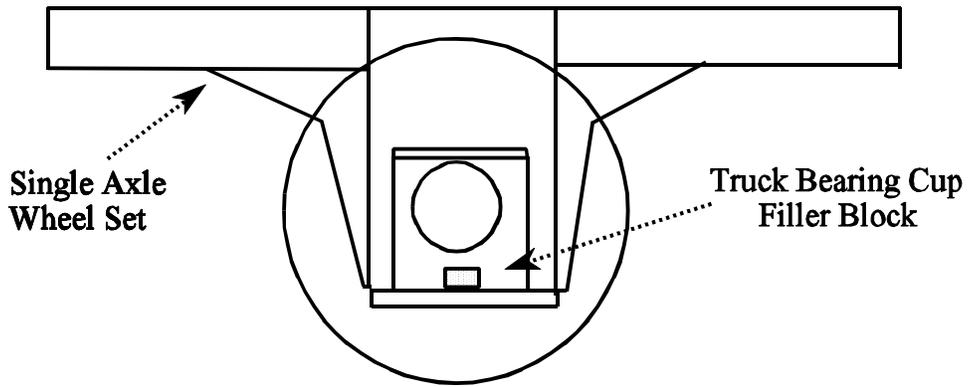
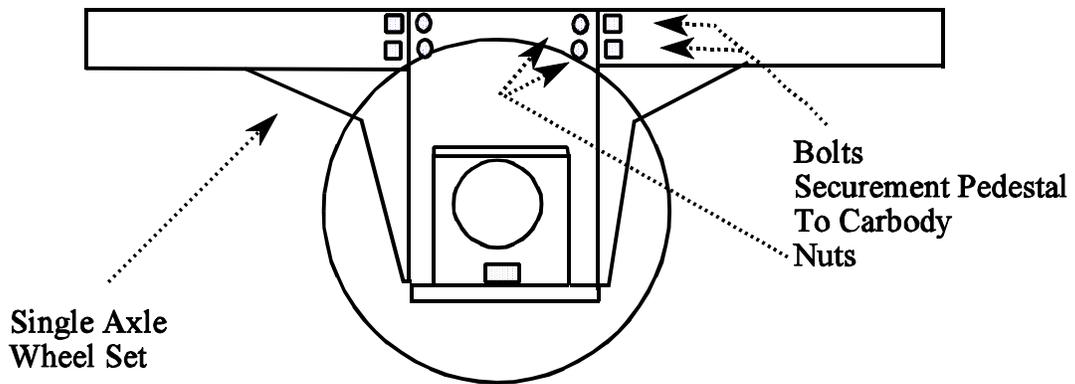
Sketches attached.

The TTUX cars are of special design with a single axle wheel set at each end. The adapter blocks are located beneath the roller bearing rather than on top of the bearing, as found on conventional freight car equipment, and are secured in place by a single bolt or pin and cotter key. When the adapter block is missing the adapter may become unseated from its designed location, or be missing completely.

Each side of the pedestal is attached to carbody by four bolts measuring 4 and f -inch each. Bolts have been found loose, broken and missing.

When this condition is detected, take appropriate action, and report the condition as set forth in CFR 49 Part 215.117 (roller bearing adapters).

This non-complying condition can be reported on the appropriate inspection report using code 215.121(F)(1).
