U.S. Department
of Transportation
Federal Railroad
Administration

Illinois High-Speed Rail Four-Quadrant Gate Reliability Assessment

1. AGENCY USE ONLY (Leave blank)		2. REPORT DATE October 2009		3. REPORT TYPE AND DATES COVERED September 2004 - September 2008
4. TITLE AND SUBTITLE Illinois High-Speed Rail Four-Quadrant Gate Reliability Assessment			5. FUNDING NUMBERS RR97/EG081 RR97A1/EG222

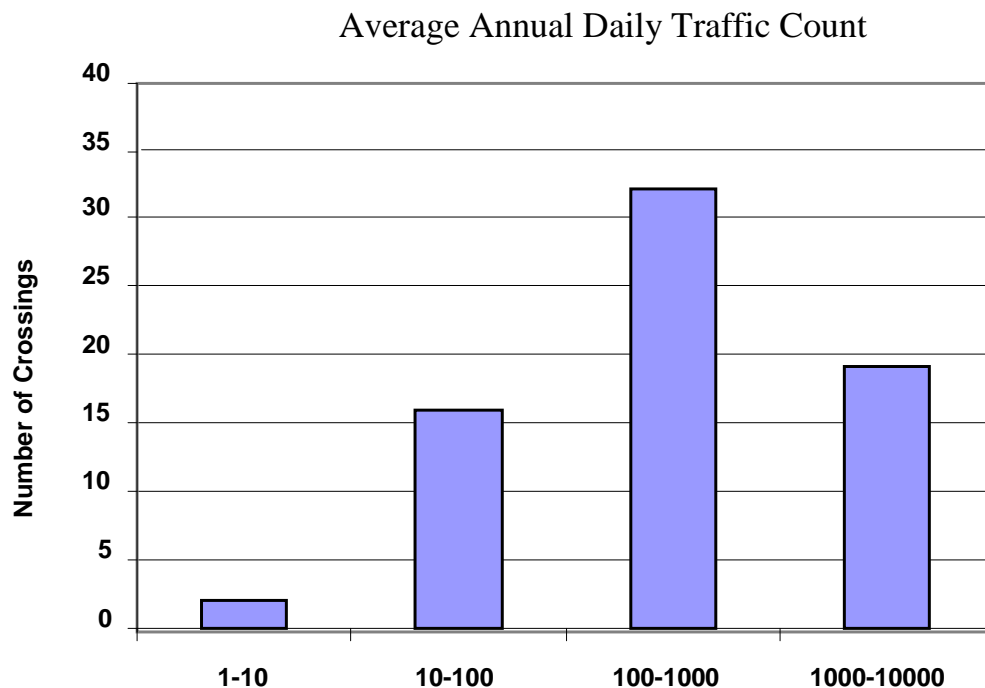
Figure 3. AADT Distribution of the 69 Four-Quadrant Gate Crossings

Of the 69 four-quadrant gate crossings, 62 were classified as rural and seven were classified as urban. As depicted in Figure 3, average annual daily traffic (AADT) at more than two-thirds of the crossings is less than 1,000.¹ This type of low-motor vehicle traffic environment lends itself particularly well to the implementation of four-quadrant gate crossing operations at speeds between 90 and 110 mph (145–177 km/h).

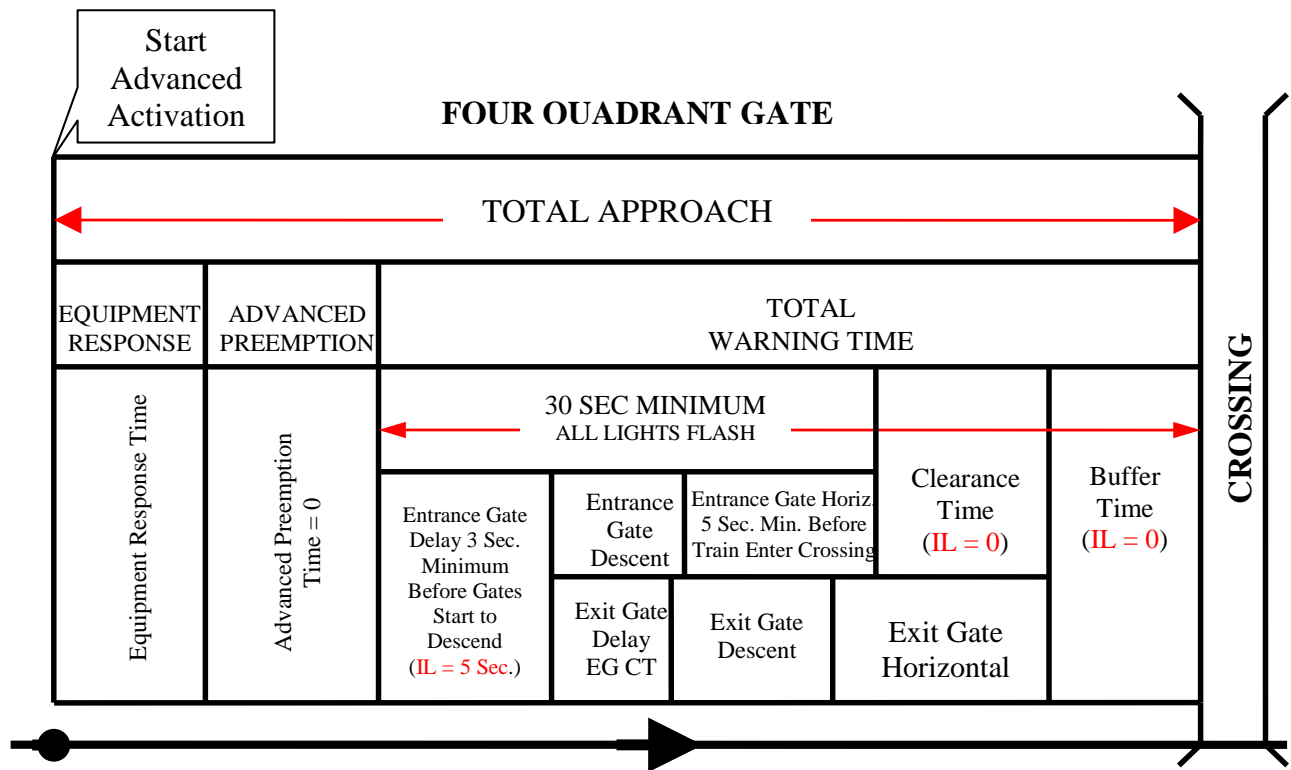
Figure 5. Four-quadrant Gate Crossing System Timing

The four-quadrant gate crossings are designed for a 30-second minimum warning time for passenger and freight trains operating at 79 mph (127 km/h) and 60 mph (97 km/h), respectively.

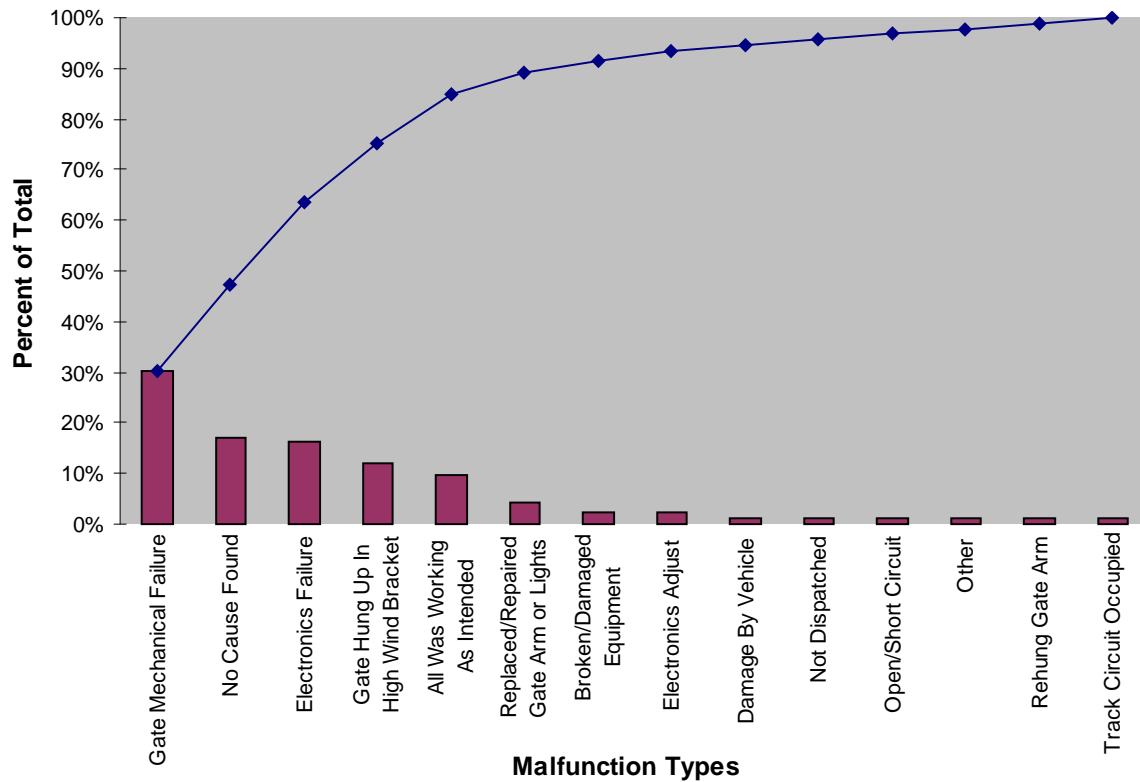
Figure 6. Pareto Distribution of Malfunctions from Data Set I by Reported Cause

Data Set I refers to the 93 trouble ticket records for the time period from May 9, 2003, to May 3, 2005. This data set, collected over 726 days, reflects 14 different malfunction types, as shown by the Pareto distribution in Figure 6. Analysis of the data showed that four malfunction types contributed to 75 percent of the total number of trouble tickets, and the remaining 10 types were responsible for the other 25 percent.

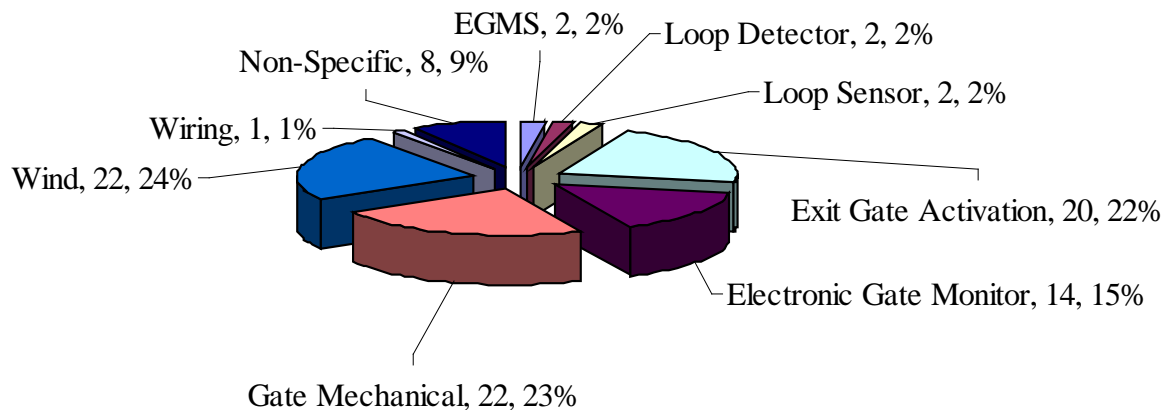
Figure 7. Exit Gate Trouble Ticket Distribution from Data Set I

The 14 malfunction types were reclassified into the nine categories related to grade crossing equipment reliability shown in Table 4. As shown in the Figure 7 pie chart, four malfunction types, totaling 28 percent of the trouble tickets—EGMS, loop detector, loop sensor, and exit gate activation—were specific to exit gate equipment. Exit gate activation issues, mostly arising from oversensitive loop sensors and detectors, accounted for 22 percent of the trouble ticket reports. This condition was typically resolved by decreasing detector sensitivity, but maintaining it above the motor vehicle detection threshold.

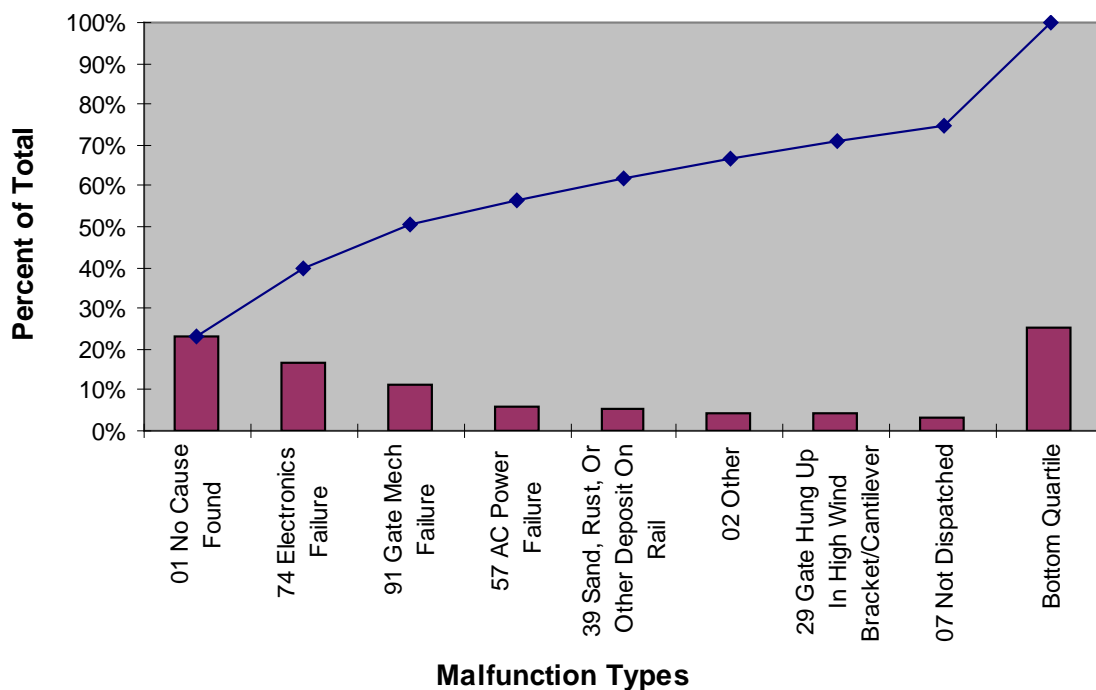
Figure 8. Pareto Distribution of Malfunctions from Data Set II by Reported Cause.

Data Set II entrance and exit gate malfunction data were used to analyze the impact of the four-quadrant gate/vehicle detection system on the HSR corridor timetable. The data collection period spanned 677 days between February 2004 and December 2005. In total, 889 unique trouble tickets were tabulated, equating to an average of 1.31 malfunctions per day. Altogether, 37 different malfunction types were identified as being specific to the grade crossing equipment. Analysis of the data showed that seven malfunction types, as depicted by the Pareto distribution in Figure 8, contributed to 80 percent of the total number of trouble tickets. The other 30 types accounted for the remaining 20 percent.

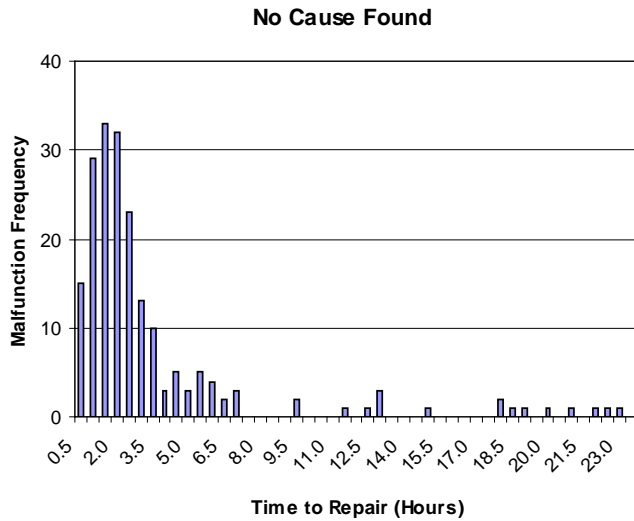
Figure 9. Example of Log-Normal Distribution

For this type of application, the geometric mean, which is related to the log-normal distribution, provides a more realistic average time to fix estimate. Figure 9 shows an example of a log-normal distribution compared to a normal distribution how the data distributions for the *No Cause Found* type responded to the geometric mean.

a) An example of an-adjusted log-normal distribution.

b) An example of a log-normal distribution on log-normal scale.

c) Unadjusted No Cause Found malfunction frequency distribution.

d) No Cause Found malfunction frequency distribution on log-normal (geometric mean) scale.

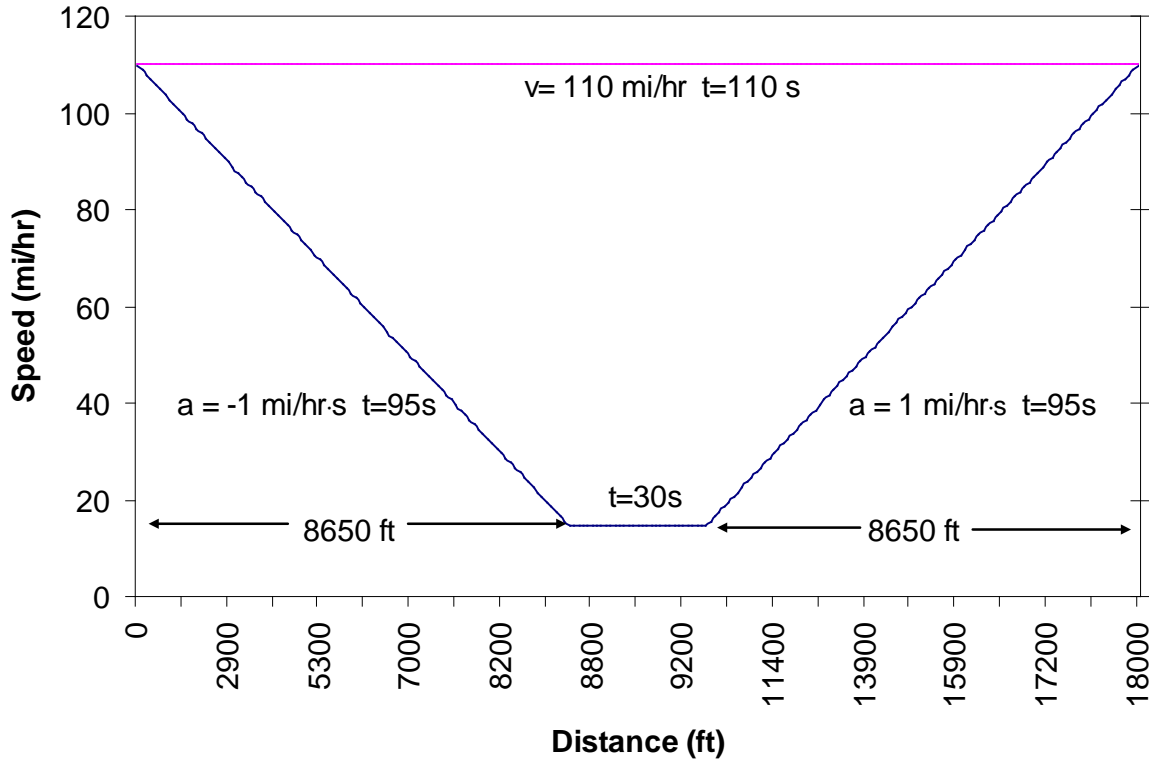
Figure 10. Speed Profile of a 110 mph Train Approaching a 15 mph Grade Crossing

Under these assumptions, a train will require 95 seconds to decelerate from 110 mph (177 km/h) to 15 mph (24 km/h), while covering a distance of 8,650 ft (2,621 m). At 15 mph (24 km/h), the train will require 30 seconds to traverse the crossing and clear the island circuit. The process is then repeated as the train accelerates back to 110 mph (177 km/h), for a total time of 220 seconds (Meyer 2001). This speed profile is illustrated in Figure 10. Conversely, a train that is not required to reduce speed will traverse the entire 17,950 ft (5,440 m) in approximately 110 seconds. The difference between the two times, 110 seconds, is the delay a train will incur due to a single malfunctioning crossing.
