Subj: **Draft Final Report**—Non-Destructive Testing to Replace Hydrostatic Testing of Tank Cars Program

Federal Railroad  
Administration

## **TANK CAR NONDESTRUCTIVE EVALUATION**

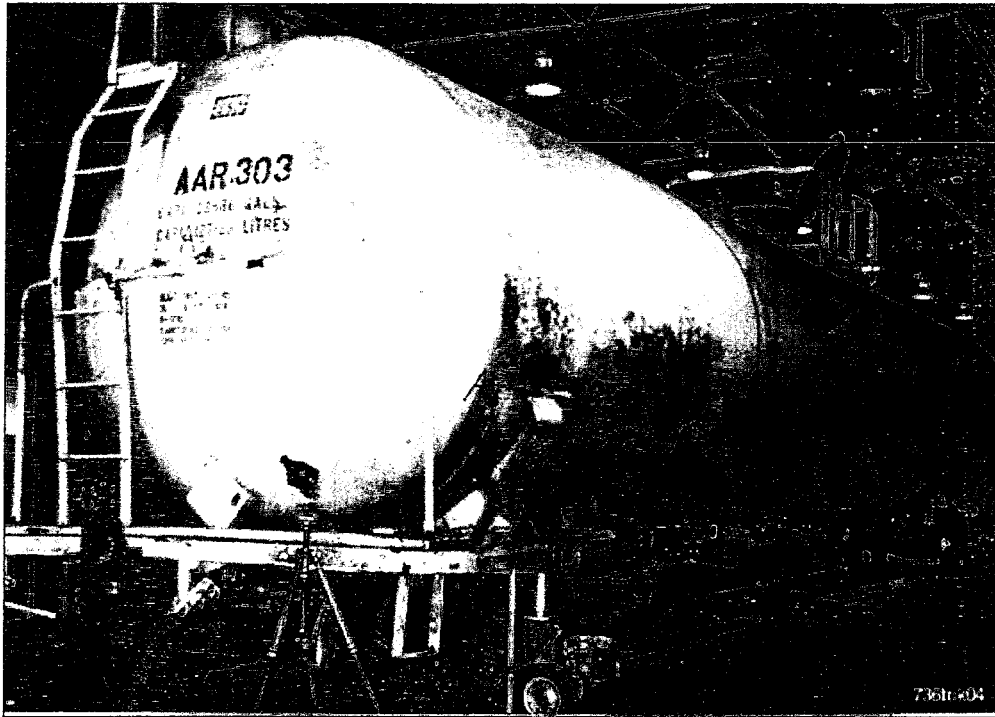
**Figure 3. Non-jacketed General Service Tank Car  
Used in Baseline Evaluations**

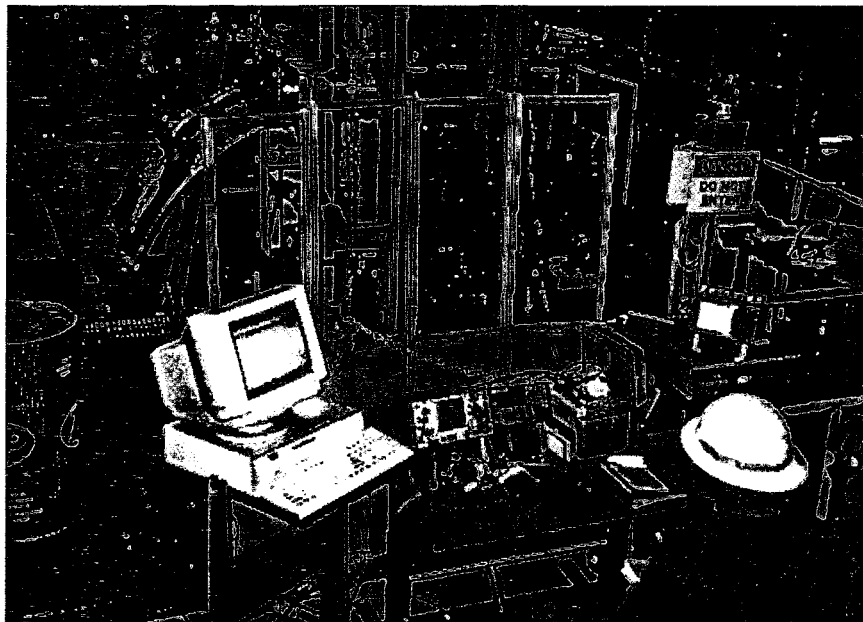
**Figure 16. Instrumentation Used in the Setup for Tank Car Test Panel Dynamic Loading**

The areas around the weld were buffed with an electric grinding brush and diamond scribe marks were placed at various locations at the toe of the weld to provide a starter notch for crack initiation. Crack growth was produced by fixturing a panel into a 150-kip load frame and dynamically loading the panel at the area where the scribe mark was placed. The setup for the panels is shown in Figures 16 and 17.

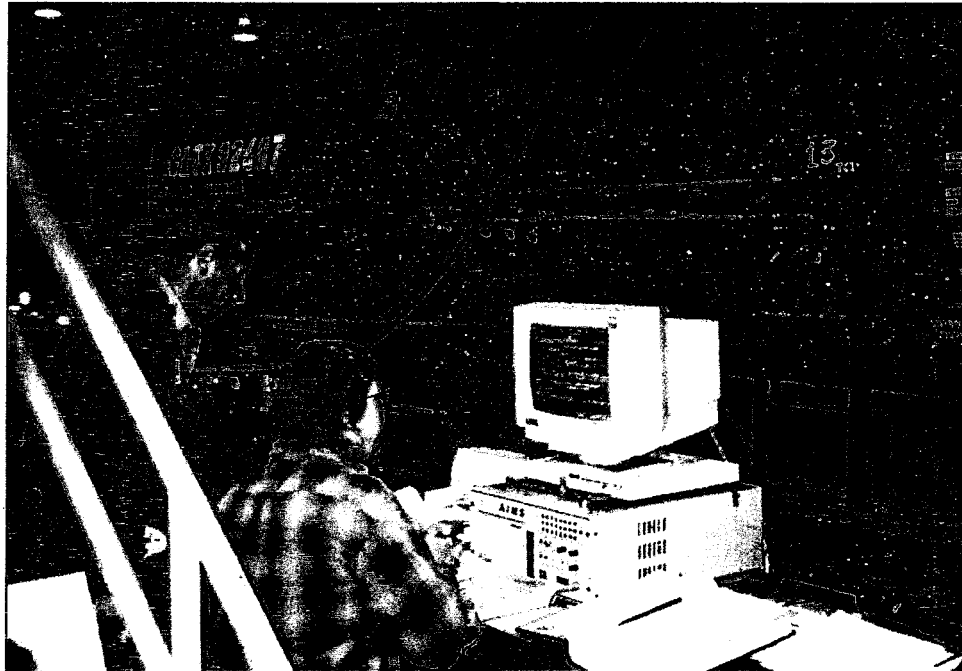
**Figure 32. AE Data Collection and Monitoring System Used in Baseline Evaluations**
