**Federal Railroad  
Administration**

## **Quantification of the Effectiveness of Low Solar Absorptivity Coatings for Reducing Rail Temperature**

1. AGENCY USE ONLY (Leave blank)		2. REPORT DATE  October 2015		3. REPORT TYPE AND DATES COVERED  Technical Report – August 2014
4. TITLE AND SUBTITLE Quantification of the Effectiveness of Low Solar Absorption Coatings for Reducing Rail Temperature			5. FUNDING NUMBERS

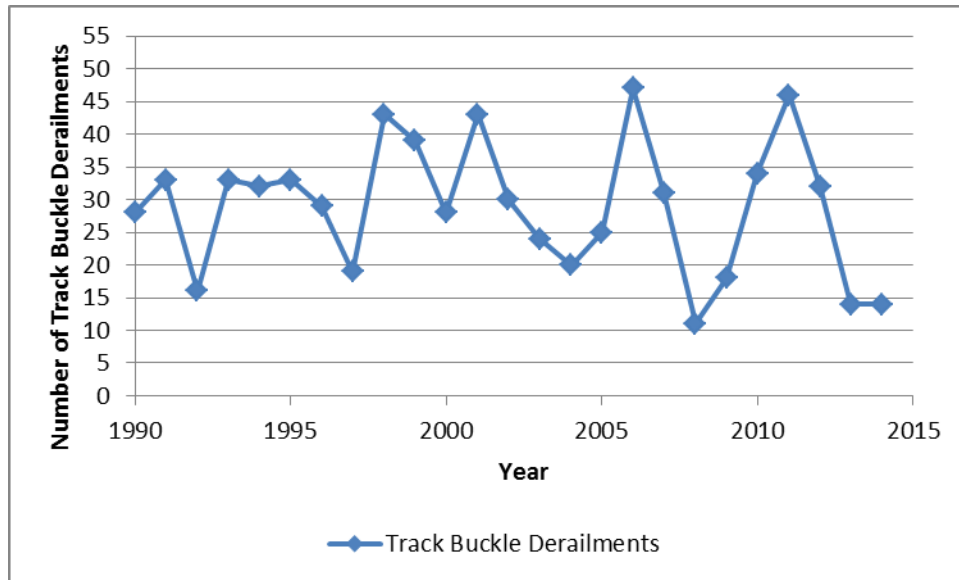
**Figure 1. Number of track buckle derailments per year from 1990 through 2014**

As seen in Figure 1, there are significant variations in the number of track buckles from year to year. The project hypothesized that the variation of summer ambient temperatures from year to year caused the variation in track buckle derailments. To investigate this hypothesis, databases maintained by the National Oceanic and Atmospheric Administration (NOAA) were queried. NOAA maintains over 1200 weather stations throughout the United States in their Historical Climatology Network (HCN). A coding script was written to query the NOAA HCN database and extract the maximum daily temperature for each weather station for every day in July and August from calendar years 1990 through 2014. All the days from July and August for each site were averaged and after that, all the sites were averaged together. The result was a single data point for each year that represents the average maximum daily temperature for the contiguous United States. The red plot in Figure 2 shows the resulting average maximum daily ambient temperature, and the blue plot represents the number of track buckles in July and August for each calendar year.<sup>3</sup>

<sup>3</sup> Note that the blue plot in Figure 2 is not equivalent to the blue plot in Figure 1 as the blue plot in Figure 1 represents all the track buckles in the calendar year, whereas the blue plot in Figure 2 only represents the track buckles that occurred in July and August of the respective calendar year.

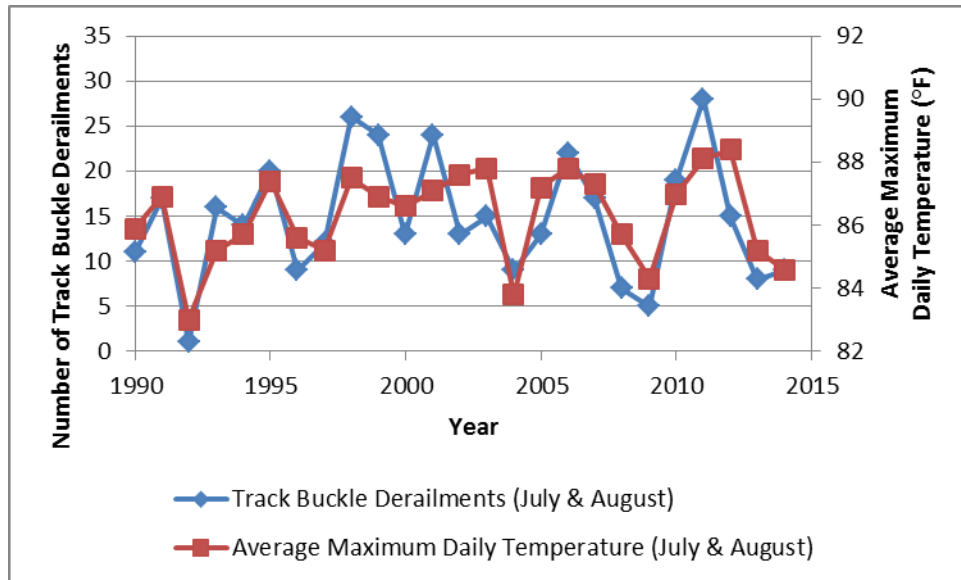
**Figure 2. Number of track buckle derailments and the average maximum daily temperature for the contiguous United States for July and August of each year from 1990 through 2014**

Figure 2 shows a strong correlation between the red and blue plots. The correlation coefficient was calculated and was found to be 0.77. Using a paired student's t-test, it can be shown that this correlation value is statistically significant given that there are 25 pairs of data points (one pair of data points for each year from 1990 through 2014). Figure 3 shows the same data presented in a scatter plot form. In scatter plot form, the correlation is evident as there is a clear linear trend line that can be fitted to the data points.

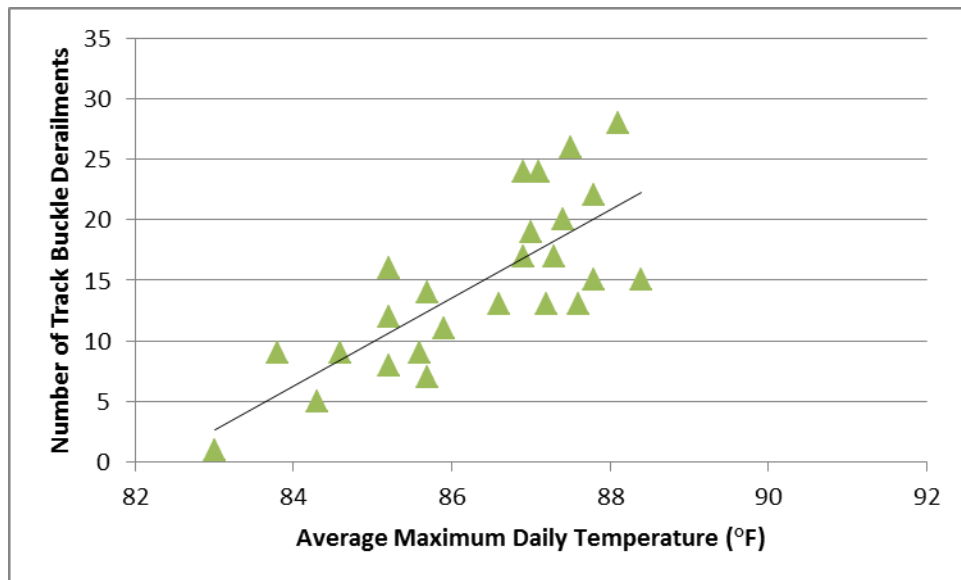
**Figure 3. Average maximum daily temperature in the contiguous United States for July and August versus the number of track buckle derailments in July and August from 1990 through 2014**

In Figure 3, it is evident that when the summer months of July and August have an average maximum daily ambient temperature in the low 80s, there are a low number of buckle derailments. Conversely, there are a significantly larger number of buckle derailments in years where the summer months of July and August have an average maximum daily temperature in the upper 80s. This data led to the assumption that the average maximum daily rail temperature increases as the average maximum daily ambient temperature increases. Also, it was hypothesized that a relatively small reduction (for example, 10° F) in maximum daily rail temperature may reduce the number of track buckle related derailments.

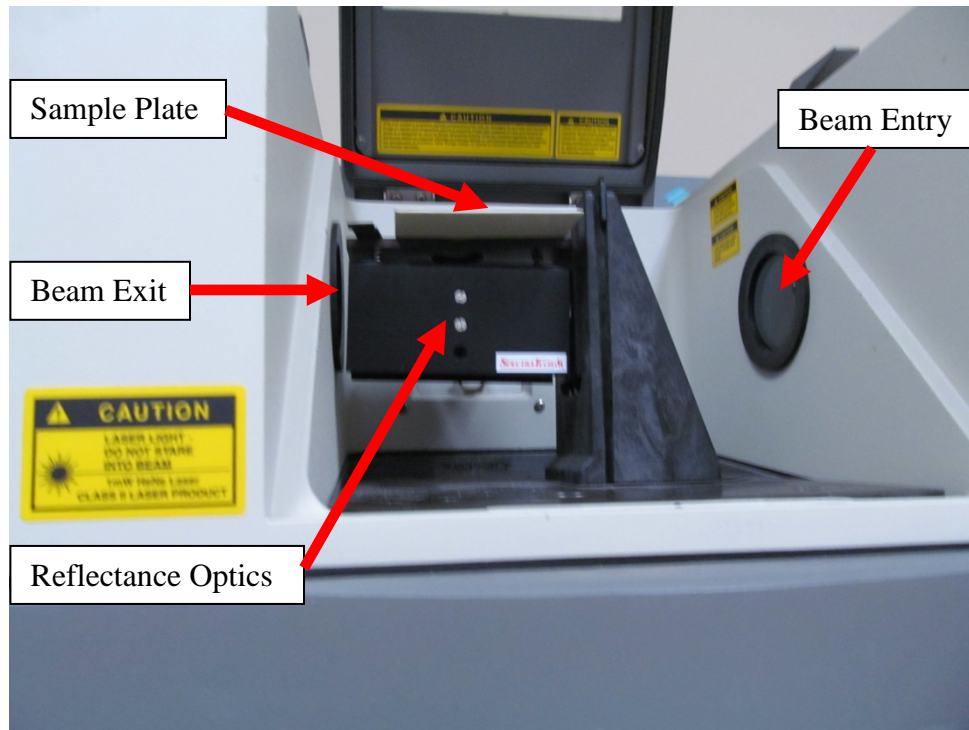
**Figure 4. Inverted sample plate on reflectance optics for IR spectrum**

A photograph of the infrared test apparatus is shown in Figure 4. The infrared beam enters from the port on the right and is deflected by a mirror up onto the inverted, coated plate. The reflected light is gathered and transmitted through the port into the IR measuring devices.

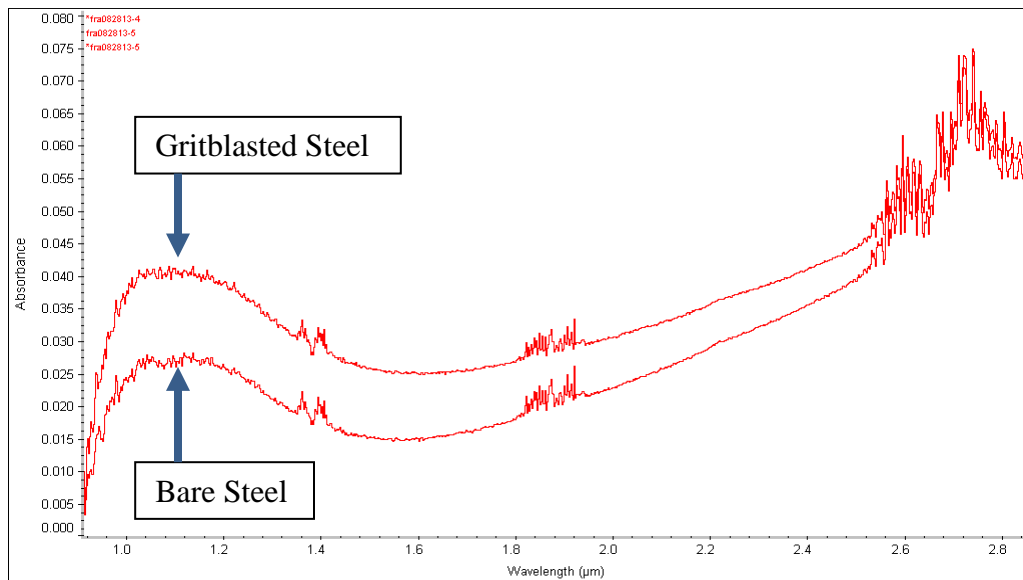
**Figure 5. IR reflectance spectra of gritblasted steel and bare steel**

An example of this anomaly is shown in Figure 5. Bare steel and gritblasted steel were both tested. Their surfaces differed in roughness, with the gritblasted sample expected to have more

diffuse reflectance. As was stated previously, the detector cannot discriminate between diffuse reflectance and absorption, so the gritblasted sample appeared to have greater absorption. However, later testing (see Subsection 3.1.2) showed that the two samples have equivalent thermal performance.

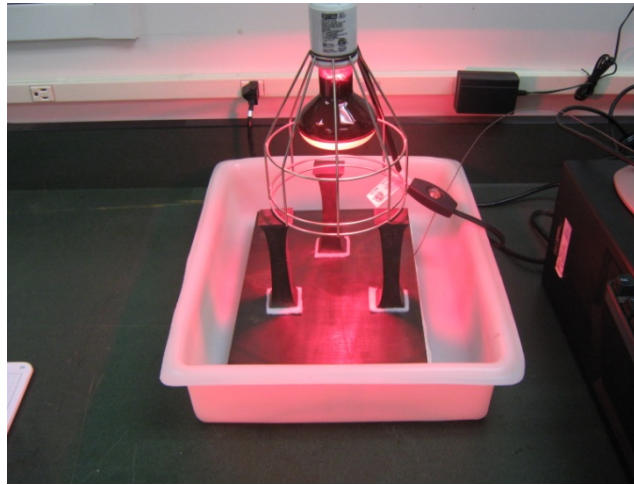
**Figure 6. Lab testing of steel plate heat gain under an IR heat source**

In these tests the steel plates were scaled up to 8 inches by 12 inches by 0.75 inches. These plates were coated on one side with the subject material. When they had dried for several days, they were irradiated for 24 hours using a sun-spectrum heat lamp (ExoTerra PT2144) which provided the “natural” infrared distribution of sunlight that had travelled through the atmosphere.

The samples were irradiated at a standoff distance of 6.75 inches, which corresponds to an irradiance of about 120W over the surface of the steel plate. The temperature in the bottom center (opposite the side being irradiated) was measured for approximately 24 hours. The test setup is shown in Figure 6.

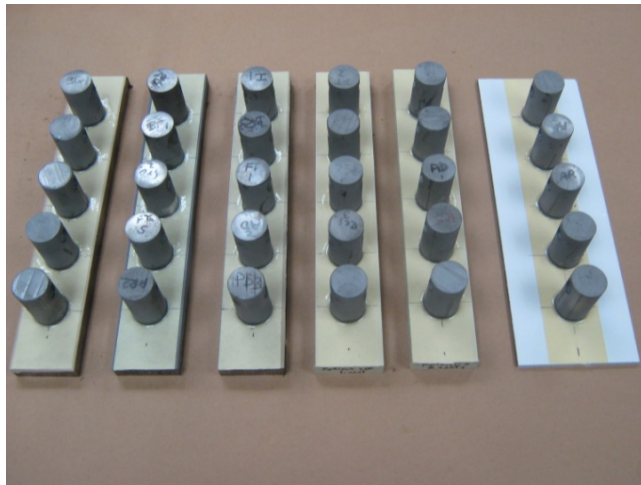
**Figure 7. Masked steel plates with rods bonded in place**

The test used bonded pull rods, which were directly attached to the coating surface with a bonding adhesive. The rods were 1.125 inches in diameter and produced a circular attachment area very close to 1.0 square inches. Adhesive squeeze onto adjoining areas of coating was minimized by using masking tape with circular cutouts. Once cured, the excess adhesive was scored around the base of the attached rod, as is shown in Figure 7. Five tests were performed on each system and the pull tests were performed at 0.05 inches per minute.

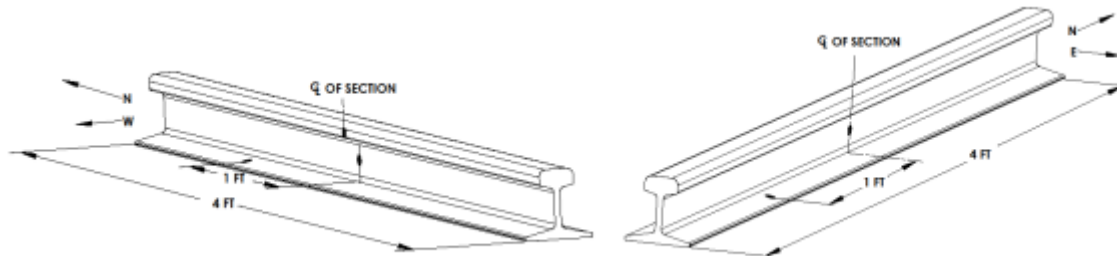
**Figure 8. Placement of thermocouples on rail segments for outdoor testing**

Five thermocouples were affixed to each rail prior to coating; they were placed into small drilled holes and secured with epoxy adhesive. The epoxy adhesive was modified with boron nitride filler to improve thermal conductivity. In total, there were 30 thermocouples placed on the six rails, and a thirty-first thermocouple was used for monitoring ambient air temperature. The placement of the thermocouples on a rail section is shown in Figure 8.

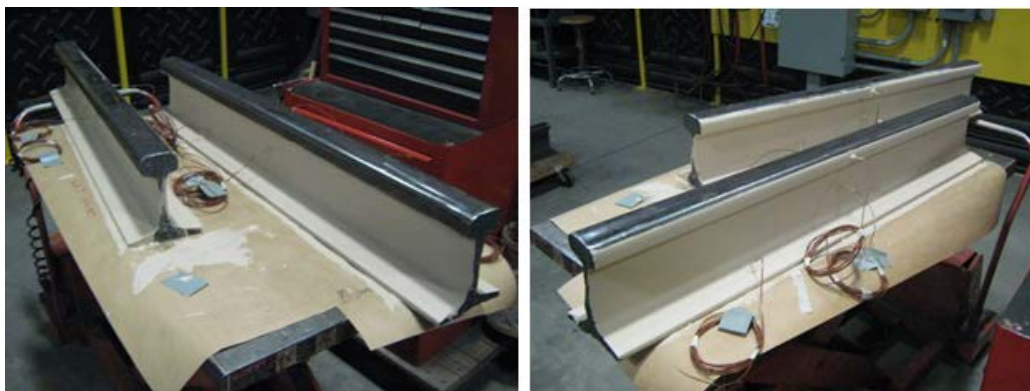
**Figure 9. Rails coated for outdoor testing**

The rails were coated on both sides of the base and web. In addition, one side of the head was coated. The second side of the rail head and the top of the rail head were *not* coated because it was assumed that wheel-wear would remove the coatings quickly from the areas. The coatings were applied at Edison Welding Institute (EWI) except for EonCoat® which was applied by the vendor. The plain Sherman-Williams® tan paint and the Sherman-Williams® tan paint with Hytech® microballoons were both roller-applied. The Precision Coating® Reflect 3000 and the RailShield® Alkyd were spray-applied.

Figure 9 shows a prepared rail with the masking removed. The thermocouples were attached before the coating was applied, so the rail steel temperature underneath the coating would be measured (rather than the coating's temperature).

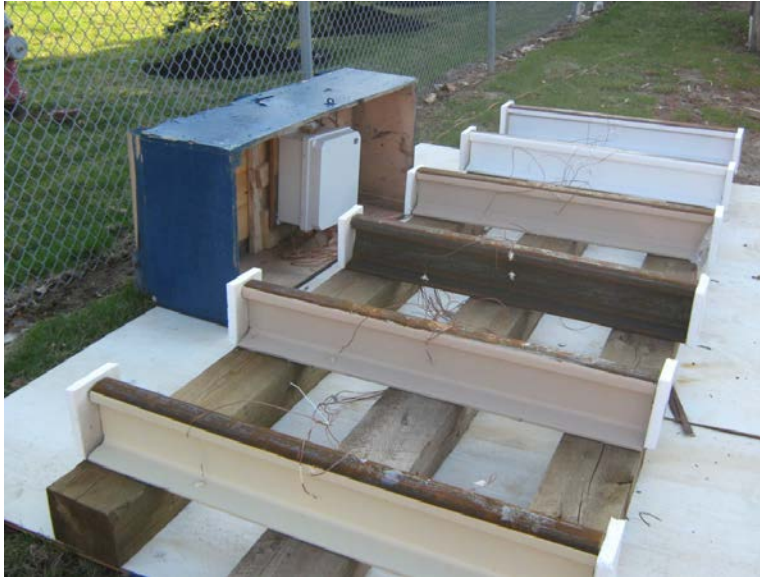
**Figure 10. Placement of rails on test platform**

Ultimately, the rails were placed on a platform where they could be exposed to direct sunlight much of the time. The setup of the rails is shown in Figure 10. The order of the rail samples starting from the bottom in Figure 10 and moving towards the top is as follows:

- Precision Coatings® Reflect 3000
- Sherwin-Williams® tan paint

- Uncoated rail
- Sherwin-Williams® tan paint with Hytech® microballoons
- EonCoat®
- RailShield® Latex

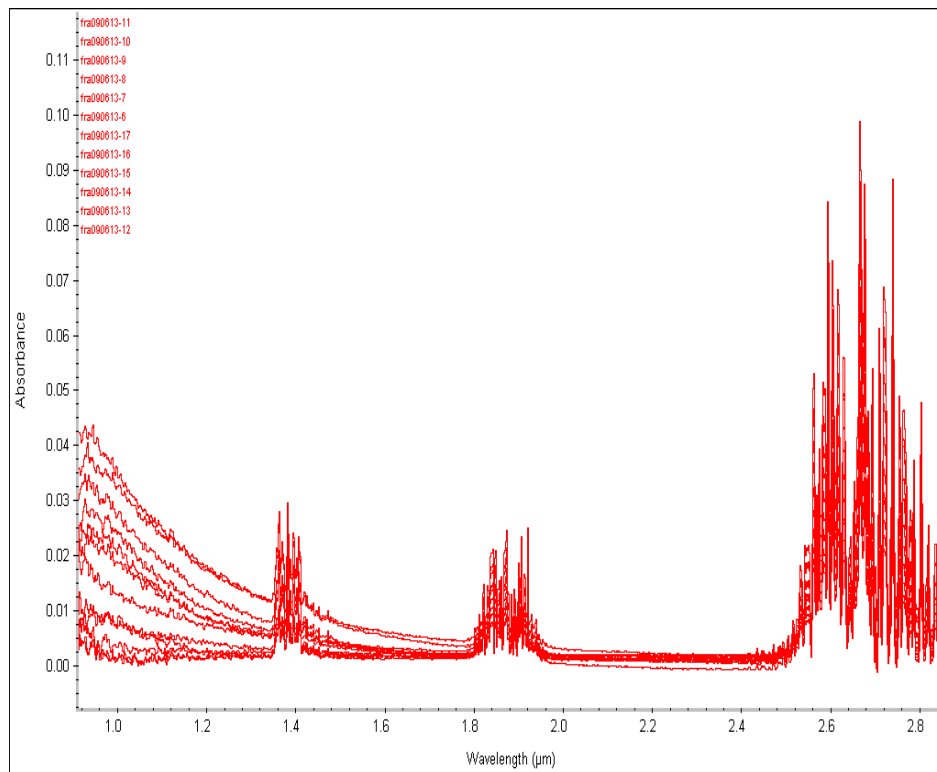
**Figure 11. Composite spectral comparison of IR reflectance of coatings and surfaces**

Figure 11 shows a composite overlay of the spectra measured for the coating systems. The plots with larger values represent higher absorbance and hence are lower performance materials, and the plots with lower values represent lower absorbance and hence are better performing materials.

The plots shown in Figure 11 from bottom (better performing) to top (lesser performing) are listed in order as follows:

- Precision Coatings® Reflect 3000 (one coat with primer)
- Bare steel
- Rusted steel
- EonCoat®

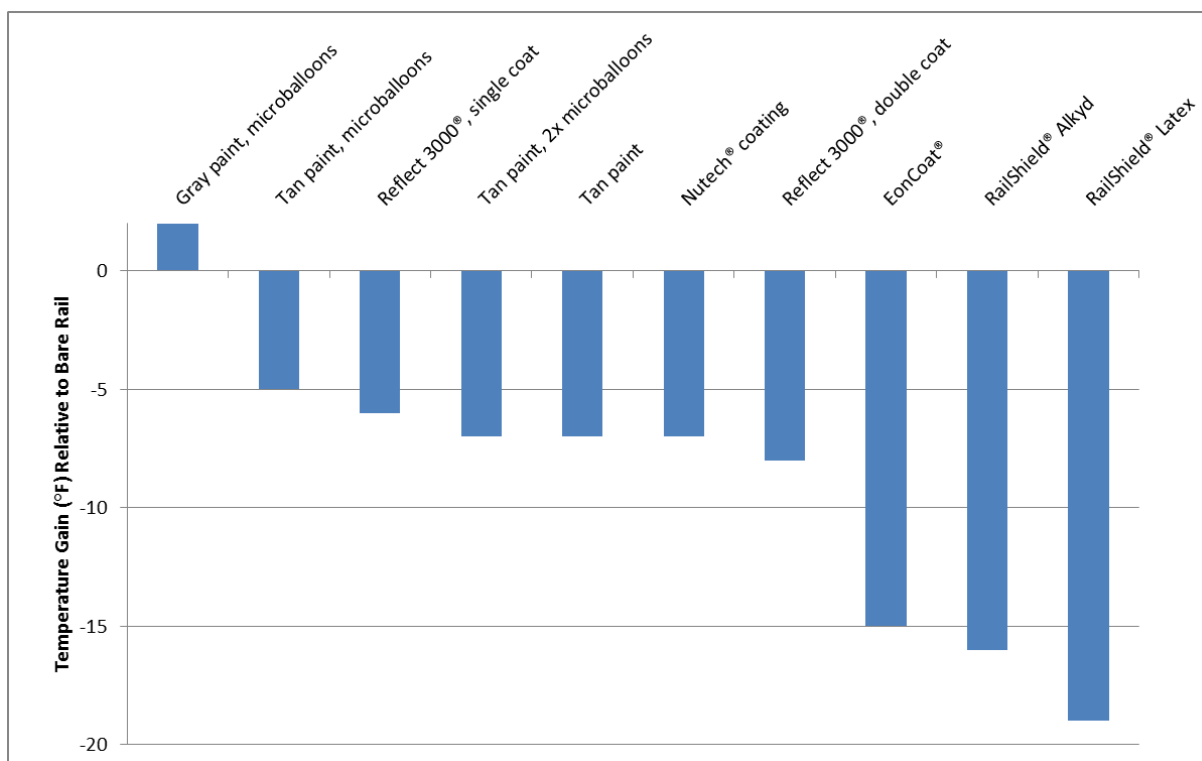
**Figure 12. Temperature gain relative to uncoated rail**

The measurement metric used to quantify performance was the temperature gain which is the final temperature (after approximately 24 hours of exposure to the IR heat source) minus the initial temperature (before exposure to the IR heat source). This metric is shown in Figure 12 for the coatings tested.

The data presented in Figure 12 indicates that most of the coatings provided some resistance to temperature gain under the IR heat source.<sup>6</sup> The data shows that EonCoat® and the two RailShield® products were the only coatings that provided a reduction of greater than 10° F relative to the uncoated rail.

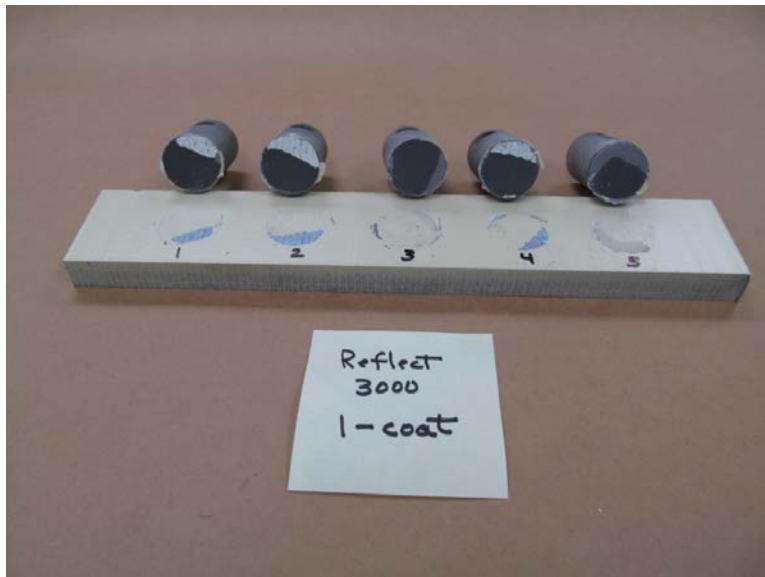
**Figure 13. Results of pull-off tests for Precision Coatings® Reflect 3000**

The Sherman-Williams® paints and Nutech® coating were largely pulled off the steel surface. The adhesive being used did not bond well to the Precision Coatings® Reflect 3000 coating, which resulted in the coating remaining mostly intact as shown in Figure 13. This was unforeseen but suggests the coating has a slippery surface, which may help to shed dirt and water. EonCoat® experienced a cohesive failure mode as shown in Figure 14, which suggests that EonCoat® may be susceptible to mechanical failure in service. RailShield® Alkyd showed a mix of adhesive and cohesive failure but appears to have a fairly high internal strength.

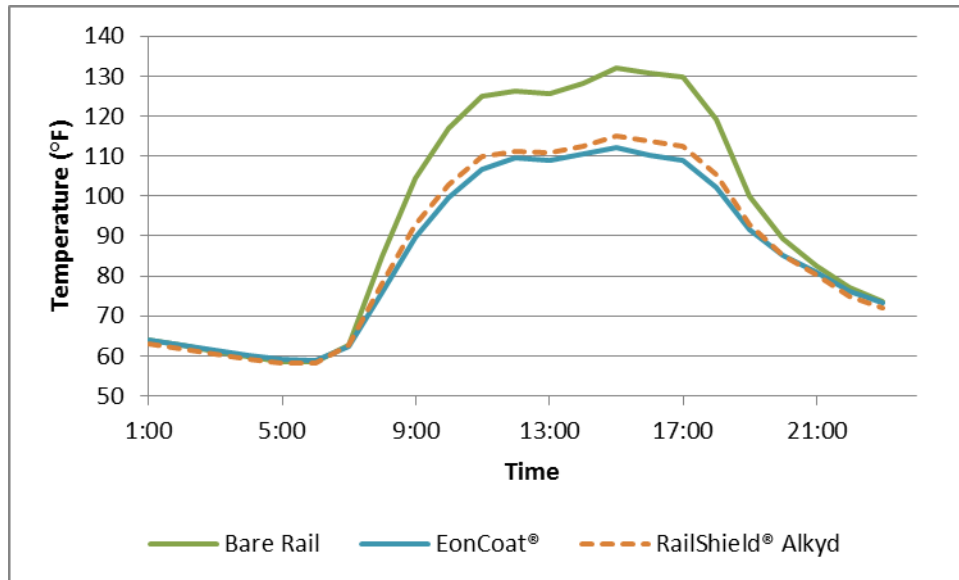
**Figure 15. Rail temperatures from July 11, 2014**

Figure 15 is a complete day of data (not just the maximum daily temperature) for the uncoated rail and the rails that were coated with EonCoat® and RailShield® Alkyd. This data was recorded on July 11, 2014 and represents one of the hottest days during the data collection period.

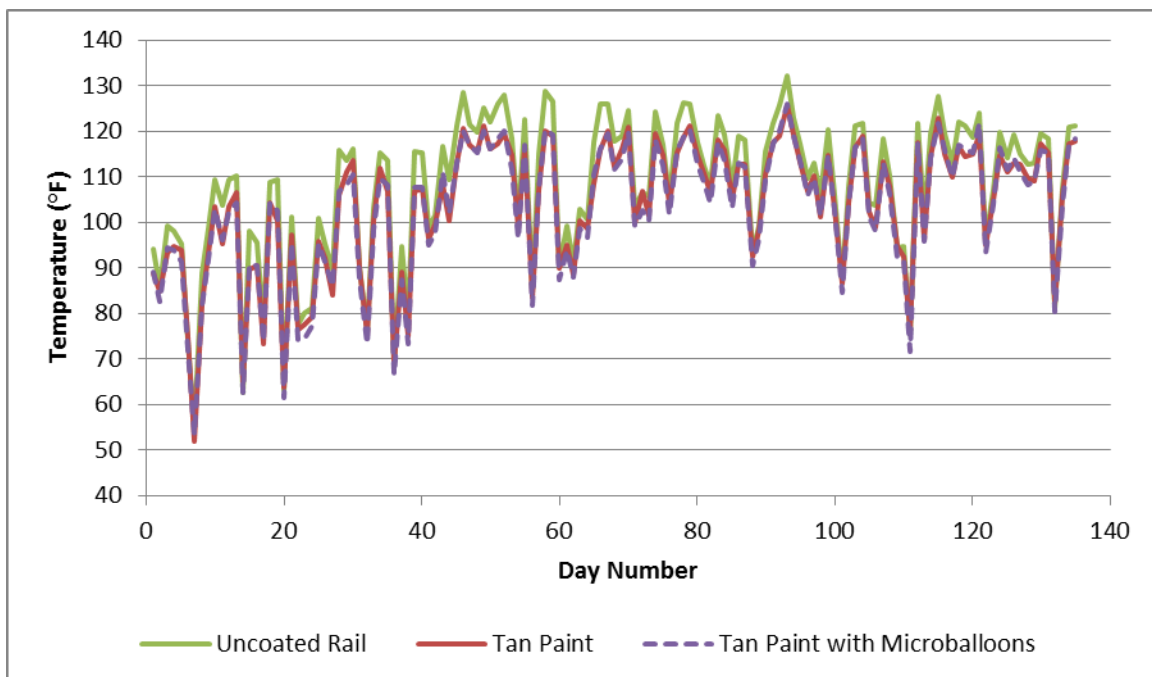
**Figure 16. Maximum daily temperature for rail coated with Sherman-Williams® tan paint and rail coated with Sherman-Williams® tan paint including Hytech® microballoons**

- Figure 16 shows the maximum daily temperature for the rail coated with Sherman-Williams® tan paint and the rail coated with Sherman-Williams® tan paint with Hytech® microballoons.
- Figure 17 shows the same plot for the rail coated with Precision Coatings® Reflect 3000.
- Figure 18 shows a third plot for the rails coated with EonCoat® and RailShield® Alkyd.

The data shown in each of the plots encompasses the entire duration of outdoor testing from April 7, 2014 to August 24, 2014.

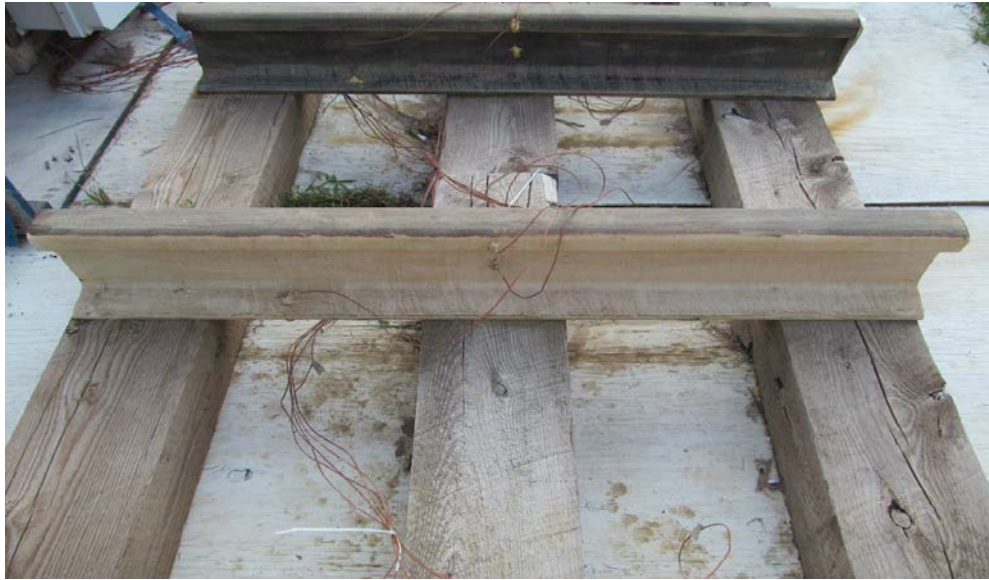
**Figure 19. Rail coated with Sherman-Williams® tan paint at conclusion of outdoor testing**

The photographs in this appendix were taken after 135 days of outdoor exposure and were taken of the west-facing side of each coated rail.
