U.S. Department of  
Transportation

**Federal Railroad  
Administration**

## **Full-Scale Tank Car Rollover Tests – Survivability of Top Fittings and Top Fittings Protective Structures**

1. AGENCY USE ONLY (Leave blank)		2. REPORT DATE May 2016		3. REPORT TYPE AND DATES COVERED Final Report – January 2013
4. TITLE AND SUBTITLE Full-Scale Tank Car Rollover Tests – Survivability of Top Fittings and Top Fittings Protective Structures			5. FUNDING NUMBERS

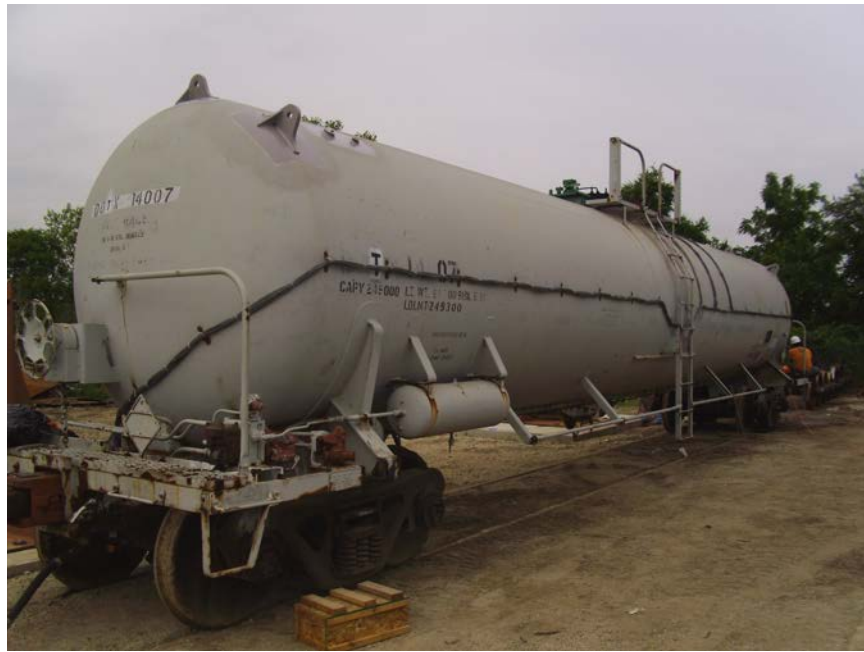
**Figure 1 Base Test Article**

Except for the modifications mentioned above, the only changes made to the base case car body were removing the ladder and the platform from the impact side of the car. Figure 1 shows the non-impacting side of the base case car after modification. Figure 2 shows a close-up of the top fittings.

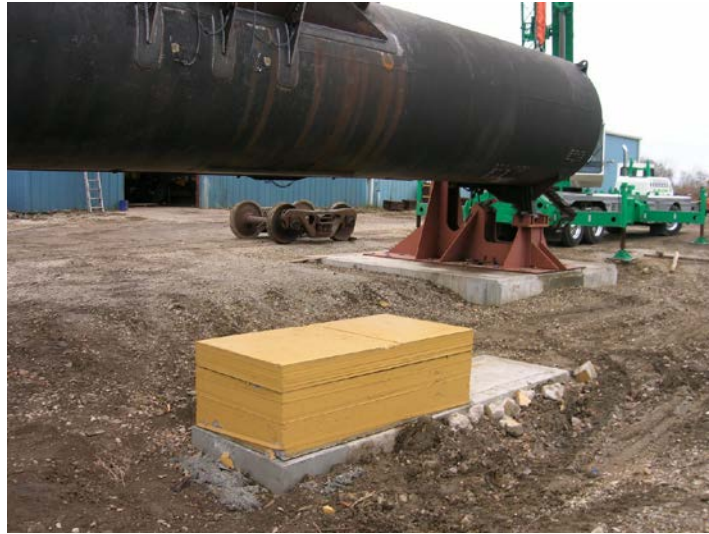
**Figure 12. Concrete Target Pads – Skid Case**

The next test was performed on a car which was identical to the base case car except it had a deflective skid attached. Prior to performing this test, FRA decided that an impact speed of 18 mph was appropriate for this case, which meant that a stack of sacrificial concrete target blocks with a total height of 28 inches was placed above the target foundation. One 20 -in block and another 8-in block were used; the 8-in block on top received an impact similar to the base case test. The resulting angle of impact was 27 degrees between the tank vertical plane and the target surface (see Figures 12 and 13).

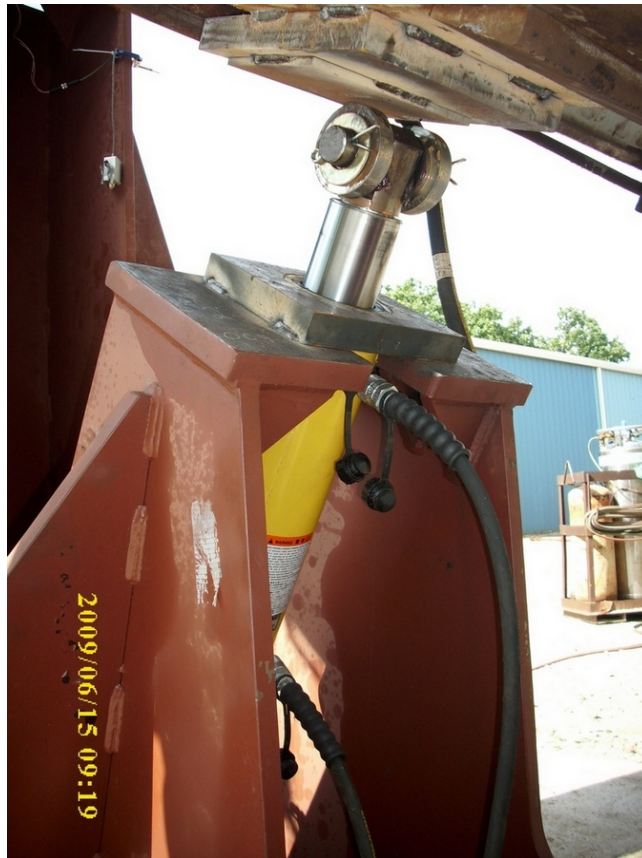
- An electric induction pump (20L)
- Two 75-ton double acting cylinders
- Two 2½-inch pressure gauge, 0-10,000 psi ½
- Appropriate high pressure piping, including valves, hoses, couplers, etc.

The single pump powered both cylinders through a setup of manifolds and valves. The symmetry of the tank car body provided for uniform cylinder extension speed.

**Figure 18. Hydraulic Cylinder and Rollers**

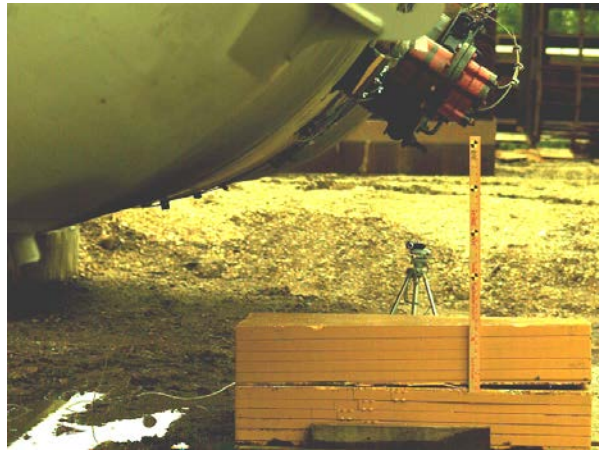
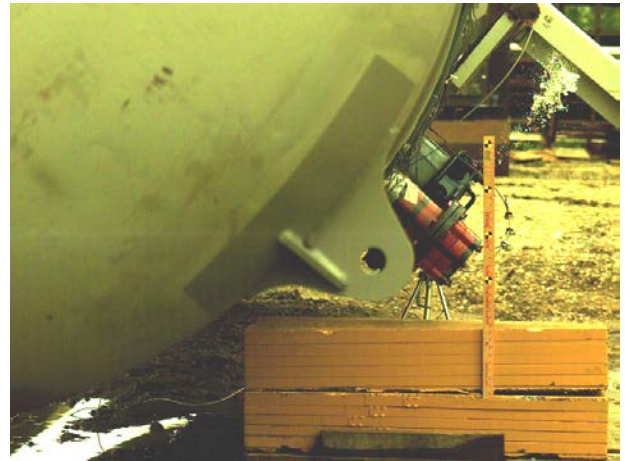
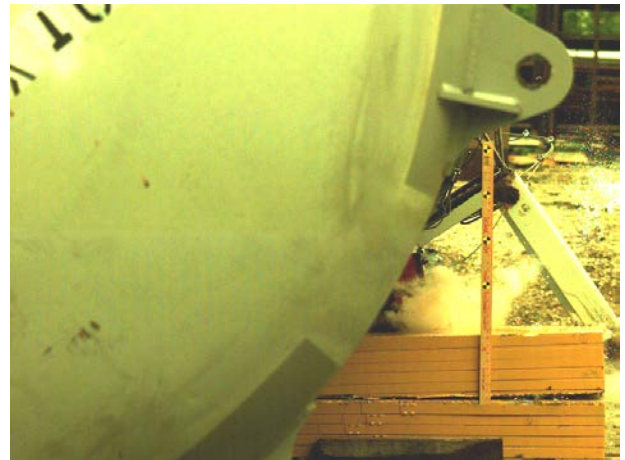
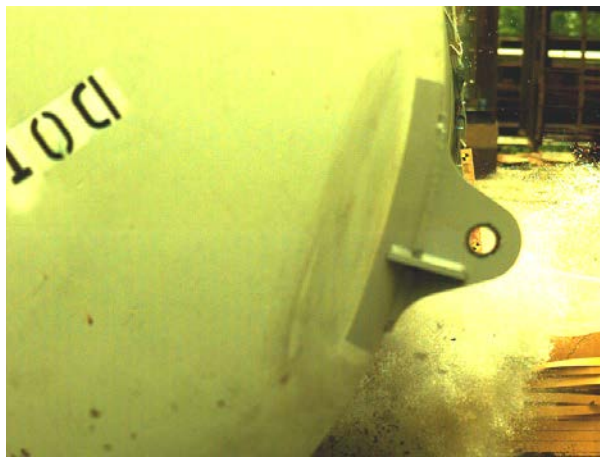
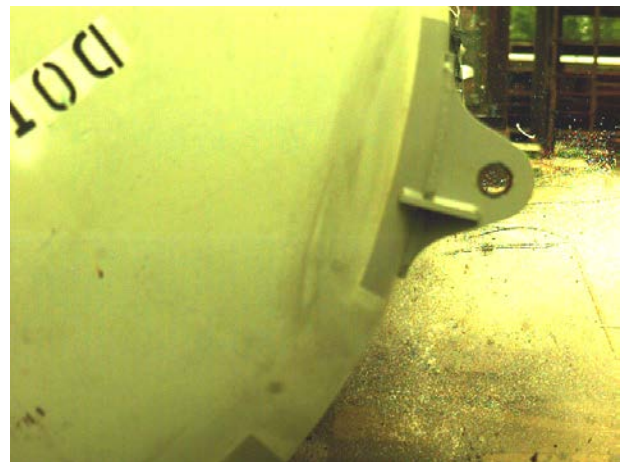
**Figure 24. Views from High Speed Camera – Base Case**

In this test, the initial impact occurred between the safety valve and the top sacrificial concrete block, followed by an impact between the manway and the adjacent single block, and then a final impact between the unloading nozzle and the base pad. The safety valve deformed, bent relative to its attachment on the tank shell, sheared off the tank shell, became momentarily “pinched” between the tank shell and the top concrete block, and then flew outward away from the tank as far as the valve’s tether would allow. The top concrete block was pushed out approximately 15 feet and broken into one large and several smaller pieces. The manway cover was broken off, as was the unloading nozzle (see Figures 24 through 26). The tank shell deformed inward in the vicinity of the fittings varying up to 3½ inches. This damage resulted in a rapid release of the lading (water).

The high-speed video indicated that the impact speed was 24 mph with the accelerometer recording forces of approximately 10 g’s perpendicular to the tank surface and 10 g’s lateral. Sample strain gauge data are presented in Appendix A. Generally, the data agrees in magnitude and shape with the strain data obtained from the LS-Dyna simulation of the scenario.

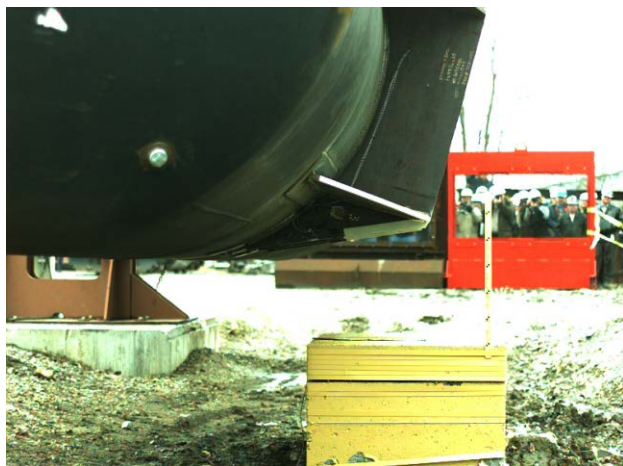
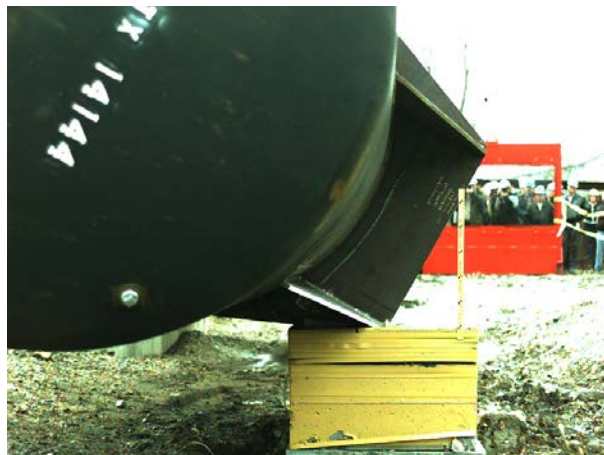
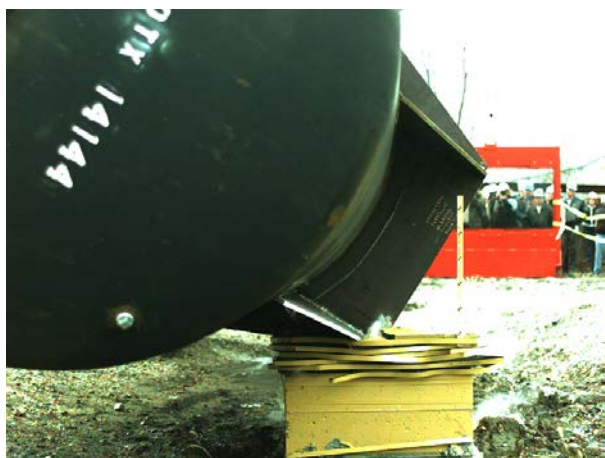
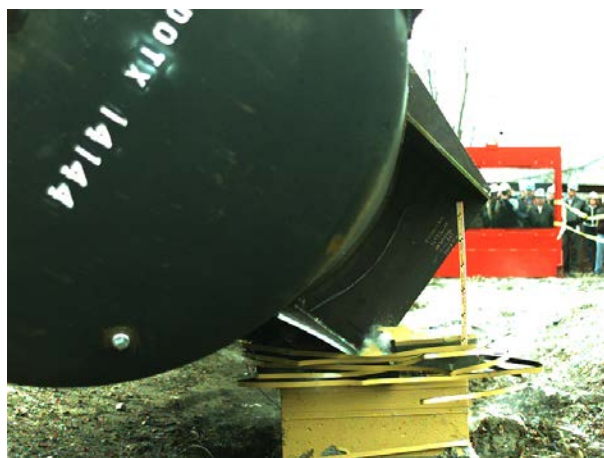
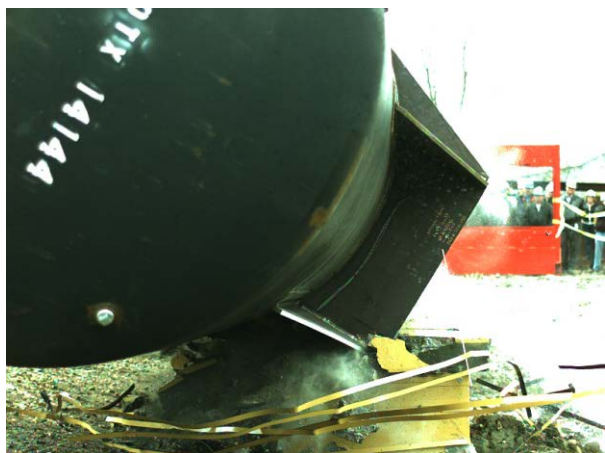
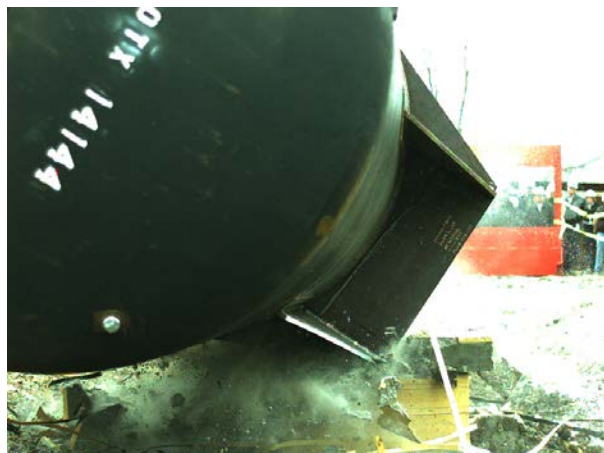
**Figure 27. Views from High-Speed Camera – Skid Case**

When the deflective skid hit the concrete blocks, it crushed the top 8-inch block and cracked the lower 20-inch block (Figure 27). High-speed video indicated that the impact speed was 17.6 mph, while the accelerometers recorded unfiltered maximum impact accelerations of 10 g perpendicular to the tank surface and 12 g lateral. The skid performed as expected in protecting the top fittings. There was no release of lading at the points of interest. However, there was a slight secondary leak due to a seal issue (which was unrelated to the test setup and procedure).

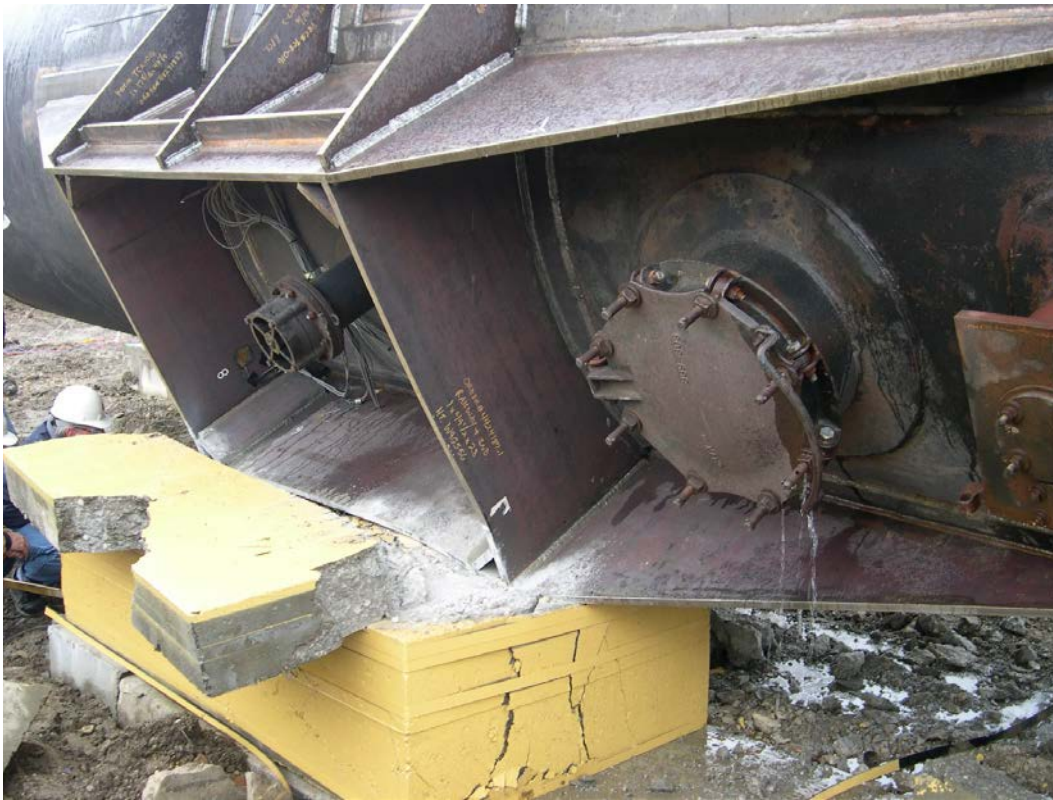
**Figure 28. Skid Case – Post-Test**

The skid saw inward deformation along its longitudinal leading edge, with a maximum deformation of about  $2\frac{7}{8}$  inches toward the tank center perpendicular to the sheet. The B-end (west end) lateral plate buckled slightly. Section 6 provides a comparison of actual test deflection versus deflection from the simulations. The skid itself survived without fracture and succeeded in protecting the fittings from any damage (Figure 28). All horizontal welds were inspected with the magnetic particle method and no cracks were found. The ends of the fillet welds at the impact side gussets had  $\frac{1}{4}$ -inch long cracks due to a very thin amount of parent material ripping off the tank shell pads (see weld inspection report).

It should be noted that the skid was intended to be a sacrificial and protective structure, so deformations or cracking are not considered failures. Sample strain gauge data are presented in Appendix A.

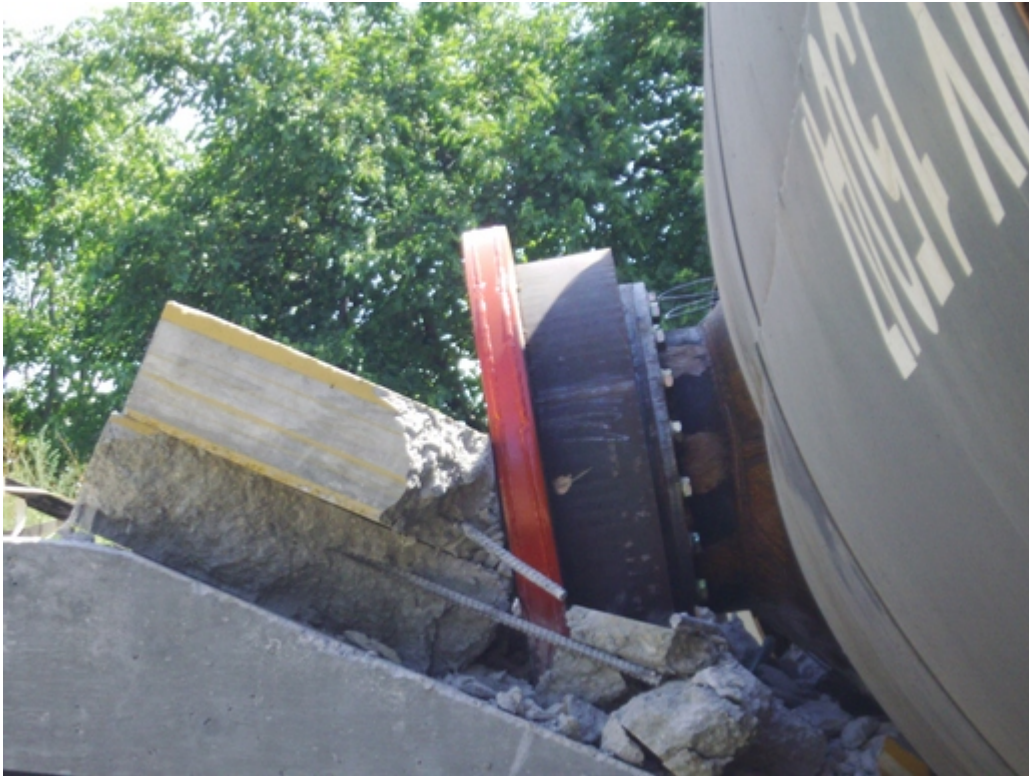
**Figure 29. Sleeve Case – Post-Test (View 1)**

Upon impact, the protective sleeve assembly sheared completely through both 8-inch thick concrete sacrificial blocks (see Figures 29 and 30). The protective sleeve assembly's hollow ½-inch thick buffer feature ("ring") was crushed along the impact side (see Figure 31) and the sleeve deformed inward ⅞ inch at the inner diameter. In the area around the top fittings, the tank shell and pad deformed inward about 5 inches (see Figure 32). The impact speed was 12 mph. Accelerometers recorded unfiltered maximum accelerations of 6 g's perpendicular to the tank surface and 9 g's lateral. The small ⅞-inch deformation of the sleeve indicates that the protective space envelope of the fittings located inside the sleeve would not have been breached. There was a 7-inch clearance between the inside of the sleeve and what would have been the outer fiber of the nearest fitting. No damage was found on the 20 grade-8 bolts or on any welds. No release of lading occurred.

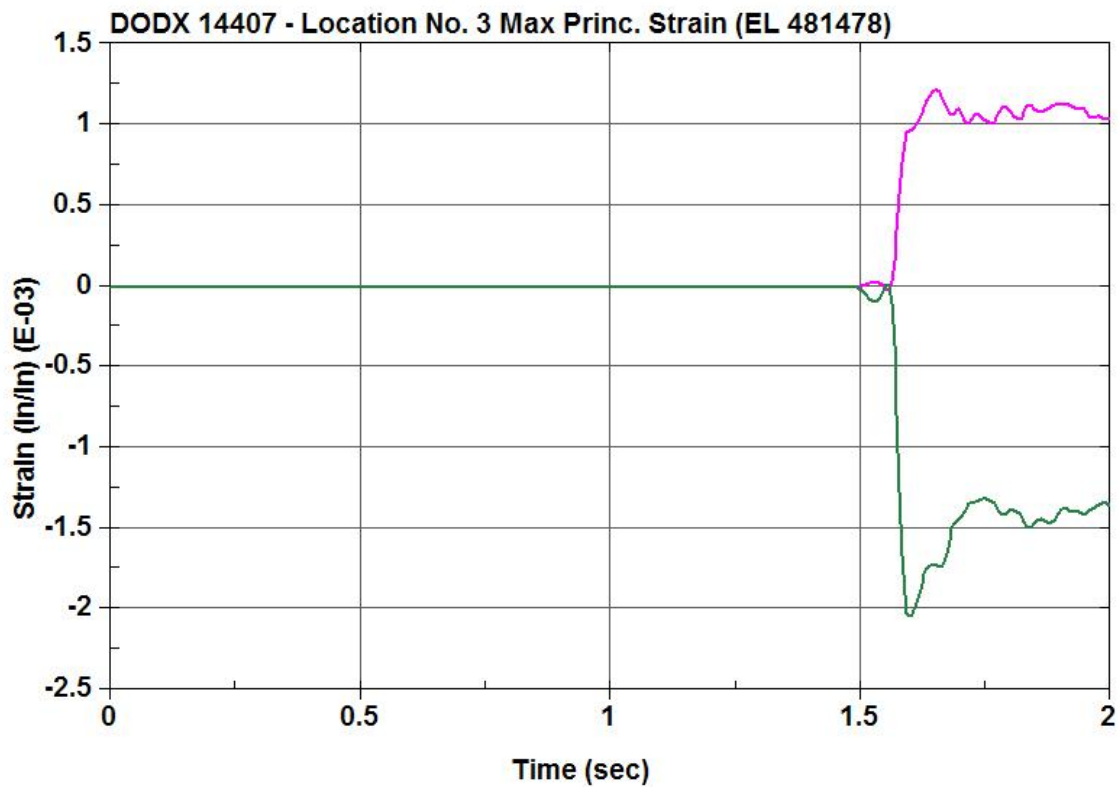
**Figure A-9 Principal Strains from Skid Test and Skid Test Simulation for Location #3**

**Principal Strains from LS-Dyna Skid Case Simulation Location #3**

**Figure 3 - East Gusset - Principal Strains**
