U.S. Department  
of Transportation

Federal Railroad  
Administration

RR 18-13 | August 2018

## RAILROAD RIGHT-OF-WAY VEHICLE INCURSION PREVENTION RESEARCH

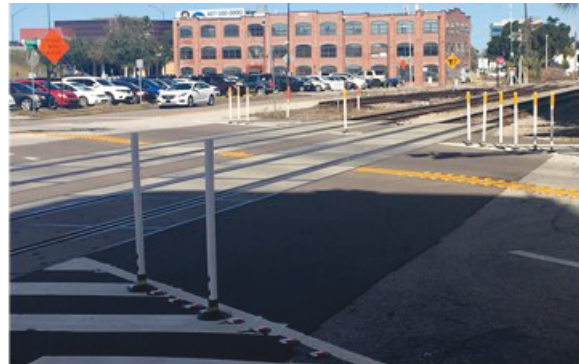
Figure 1. ROW Incursion Treatments Installed at the W. Washington St. Crossing in Orlando, FL

Treatments were installed at two crossings in the City of Orlando, FL, and evaluated through December 2016 to December 2017 after installation. The locations selected for this study were the grade crossings at W. Washington St. (Crossing ID 622188X) and W. Jefferson St. (Crossing ID 622187R) within the city. Volpe research staff developed the treatments for the two crossings. Vehicle ROW incursion data before and after the installation of the treatments was collected by SunRail and analyzed by the Volpe research staff. The ROW incursion treatments, as shown in Figure 1 for the W. Washington St. crossing, were installed on December 19–20, 2016.

The W. Jefferson St. crossing was equipped with the first two treatments (pavement markings only) and the W. Washington St. crossing was equipped with all four treatments. This was done to determine if the addition of reflective markers and delineators provided added safety. The treatments installed at the W. Washington St. crossing were shown previously in Figure 1. Figure 3 shows the pavement marking treatments installed at the W. Jefferson St. crossing.

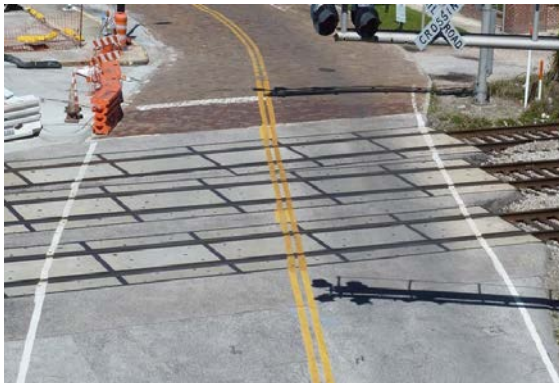
**Figure 3. ROW Incursion Treatments Installed at the W. Jefferson St. Crossing**

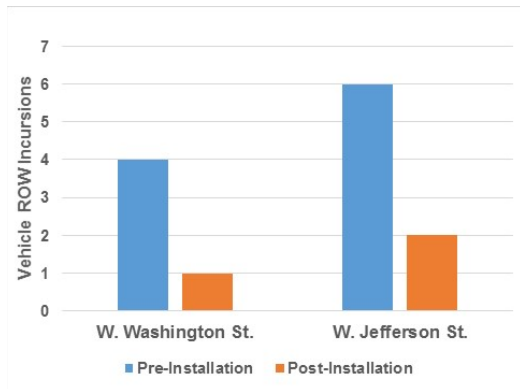
Figure 4. Number of ROW Incursions Before and After the Installation of the Improvements

**Pre-Installation:** A total of twelve months of data was analyzed for both crossings in the pre-installation period from 12/19/15 to 12/18/16. A total of four ROW incursion incidents were reported at the W. Washington St. crossing and six ROW incursion incidents were reported at the W. Jefferson St. crossing. All incidents occurred during nighttime hours between 9:30 PM and 3:00 AM.

**Post-Installation:** The treatments were installed on December 19–20, 2016. A total of 12 months of data was analyzed for both crossings in the post-installation period from 12/21/16 to 12/20/17. A total of one ROW incursion incident was reported at the W. Washington St. crossing and two ROW incursion incidents were reported at the W. Jefferson St. crossing. All incidents occurred during nighttime hours between 12:00 AM and 3:00 AM.

**Comparative Analysis:** As shown in Figure 4, vehicle ROW incursions decreased significantly at both crossings between the two periods. They went down 75 percent at the W. Washington St. crossing (from 4 to 1) and 67 percent at the W. Jefferson St. crossing (from 6 to 2). It appears that the addition of the reflective markers and flexible delineators, although significantly increasing the overall cost, provided an additional safety benefit over the pavement markings.
