Crashworthiness Testing of Amtrak's Traditional Coach Seat

Safety of High-Speed Ground Transportation Systems

DOT/FRA/ORD-96/08
DOT-VNTSC-FRA-96-11

Final Report
October 1996

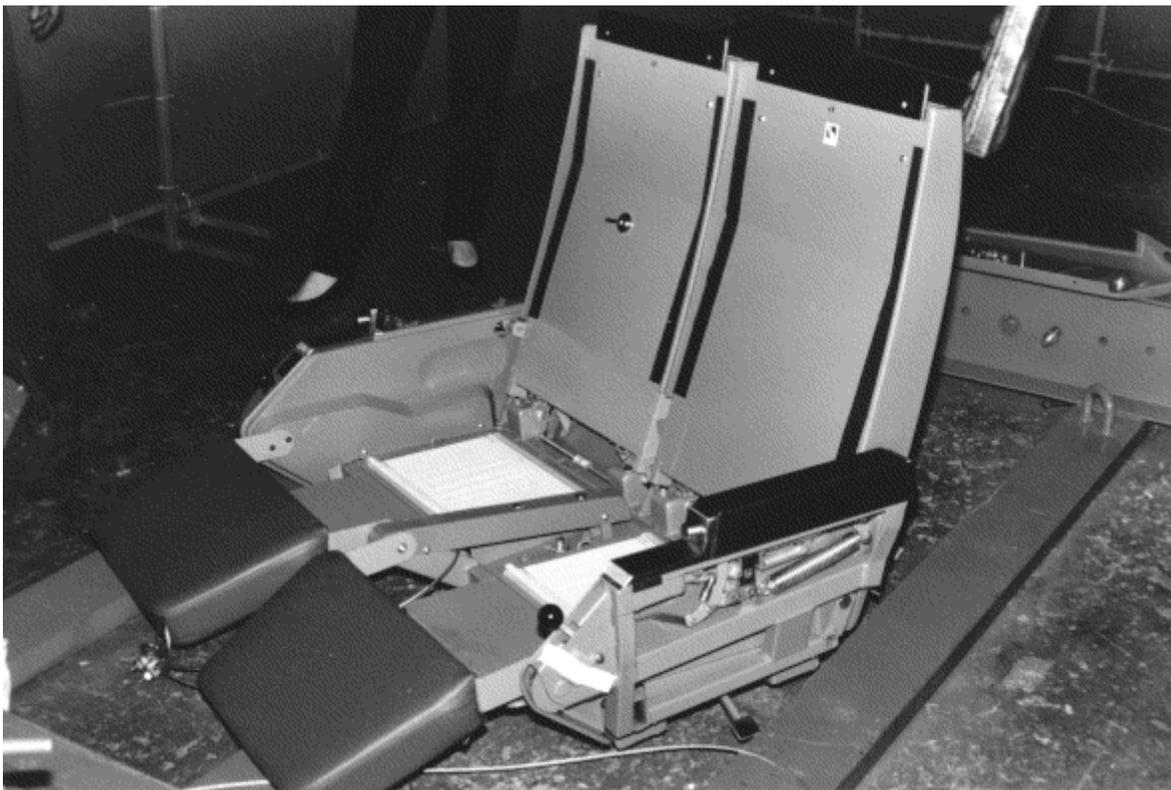
Figure 3-1 shows a photo of Amtrak's traditional seat pair frame, without the cushions or mounting hardware. The seat pair is manufactured by Coach and Car, Inc. of Chicago, Illinois. It carries two passengers, and can rotate 180° about the vertical to face forward or backward. One passenger rides inboard, near the aisle, while the other passenger rides outboard, near the window or wall of the car. There are two mounts for the seat. In the Amfleet cars, one pedestal mount attaches the seat to the floor underneath the inboard seat, and another bracket mount attaches the seat frame to the wall. The mounts attach to floor and side-wall tracks, which allow (longitudinal) positioning of the seat pair in one inch increments. In the Viewliner cars, there are two pedestal mounts, one under each seat, attached to two floor tracks. In the Horizon cars, the seat pair is attached with two floor mounts at fixed locations.

Figure 3-1. Photograph of Frame of Amtrak's Traditional Seat Pair

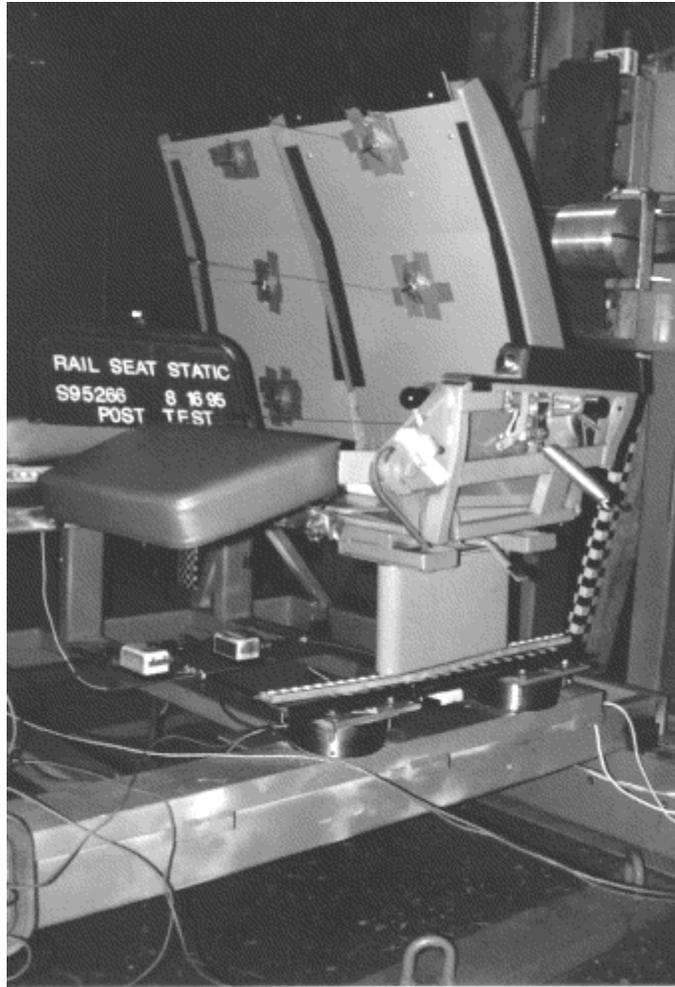
Figure 5-2 shows the seat pair after the head-load quasi-static test. Damage to the seat pair and mounting included failure of the recline mechanism and some permanent deformation of the seat back, as well as the floor track and hat section.

Figure 5-2. Head-Load Quasi-Static Test, Seat Pair Post-test Condition

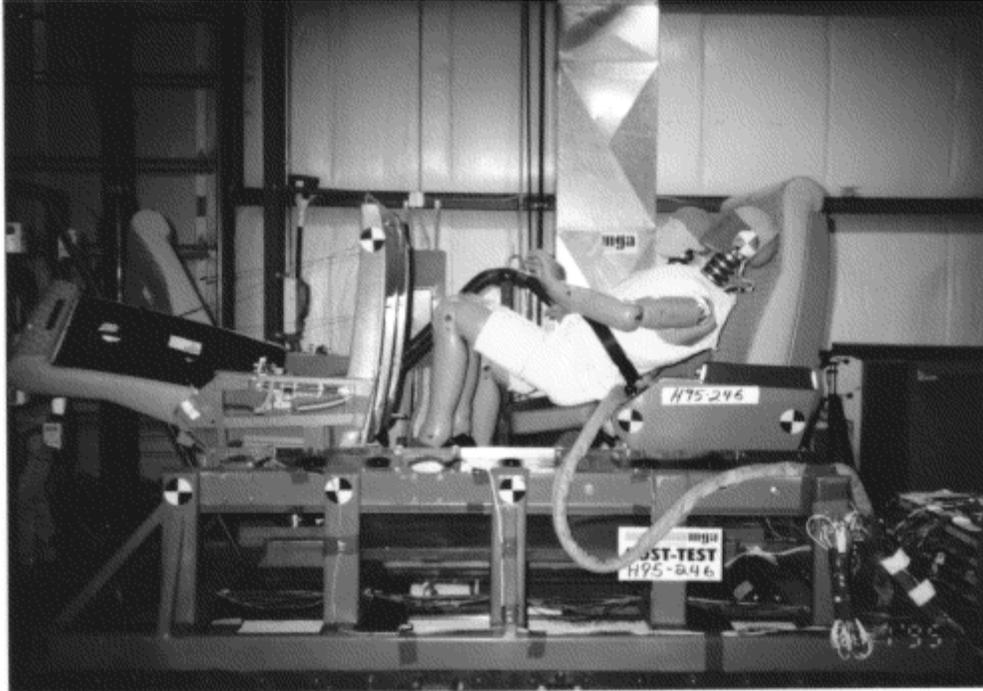
The rear seat pair remained intact, and was not subject to any damage. Figure 5-6 is a photograph of the post-test condition of the test sled and dummies.

Figure 5-6. Dynamic Test 1 (H95246), Post-test Condition

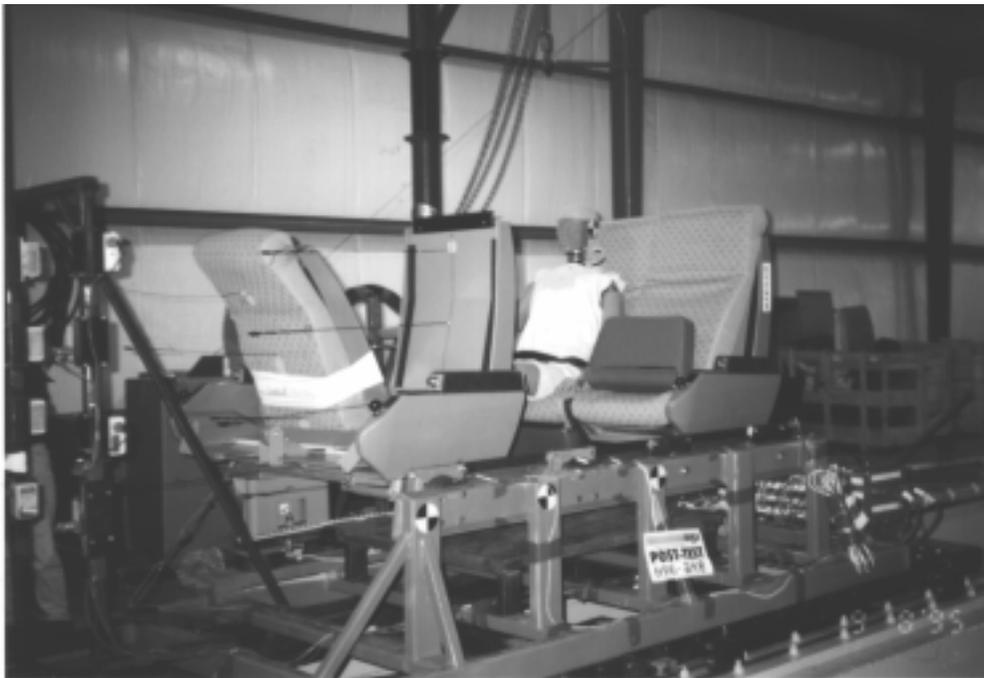
The forces and decelerations experienced by the dummy remained within human survivable limits. The rearward seat pair remained intact during this test. Figure 5-11 shows a photograph of the post-test conditions for dynamic test 3.

Figure 5-11. Dynamic Test 3, Post-test Condition

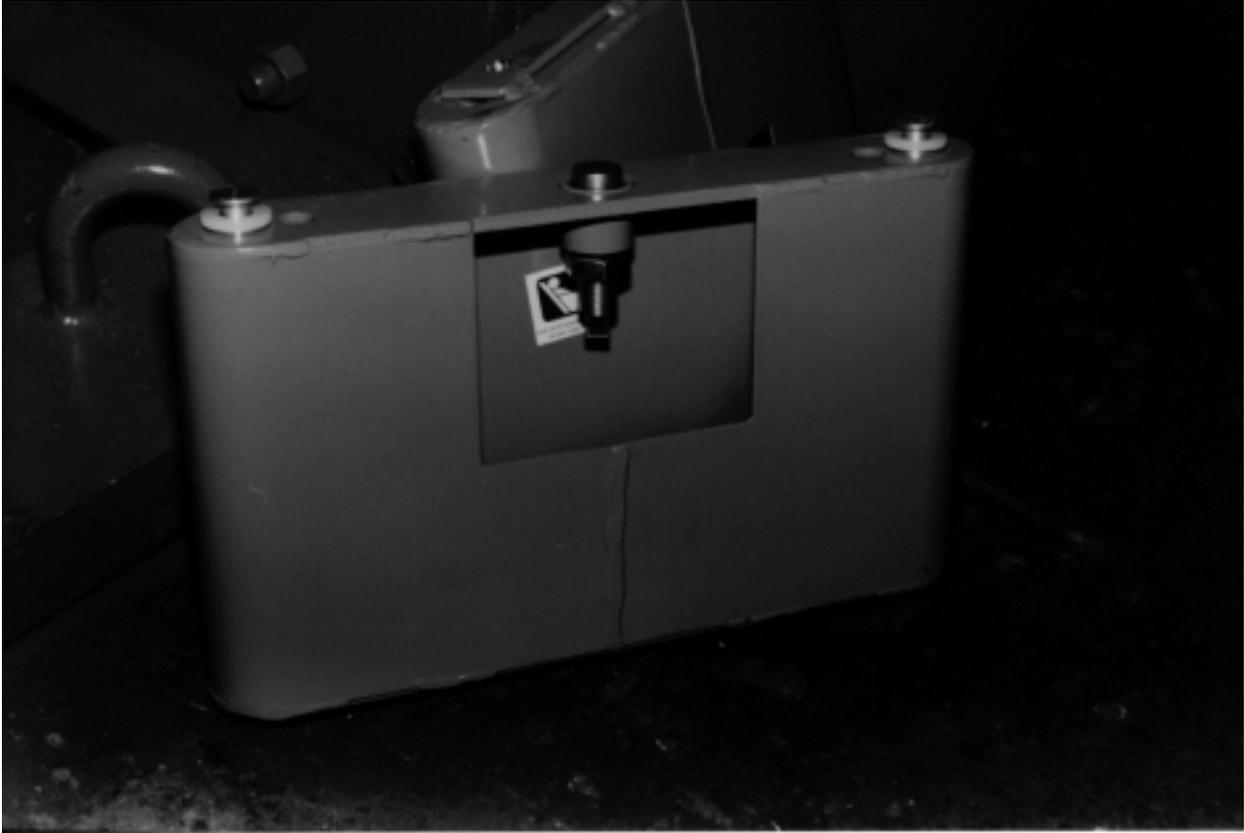
Figure B-4. Floor Pedestal Photograph Showing Access Cutout for Locating/Locking Pin and Bottom Plate

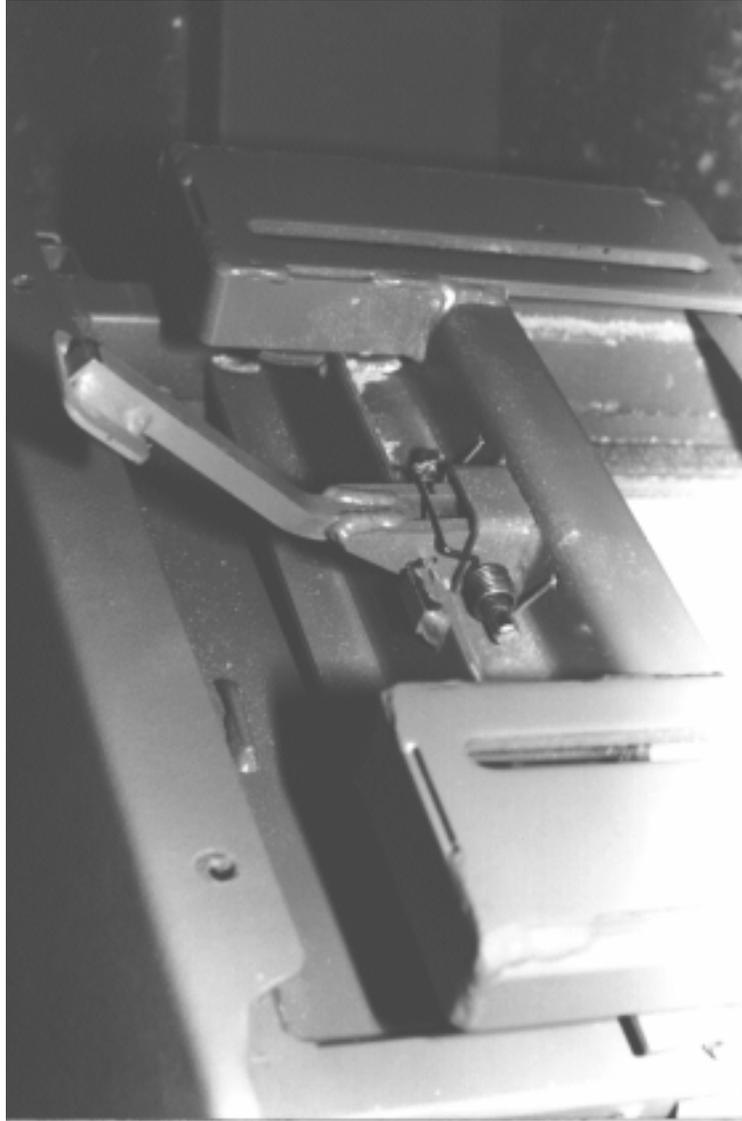
Figure B-10. Locking Mechanism Photograph, Mechanism in the Locked Position

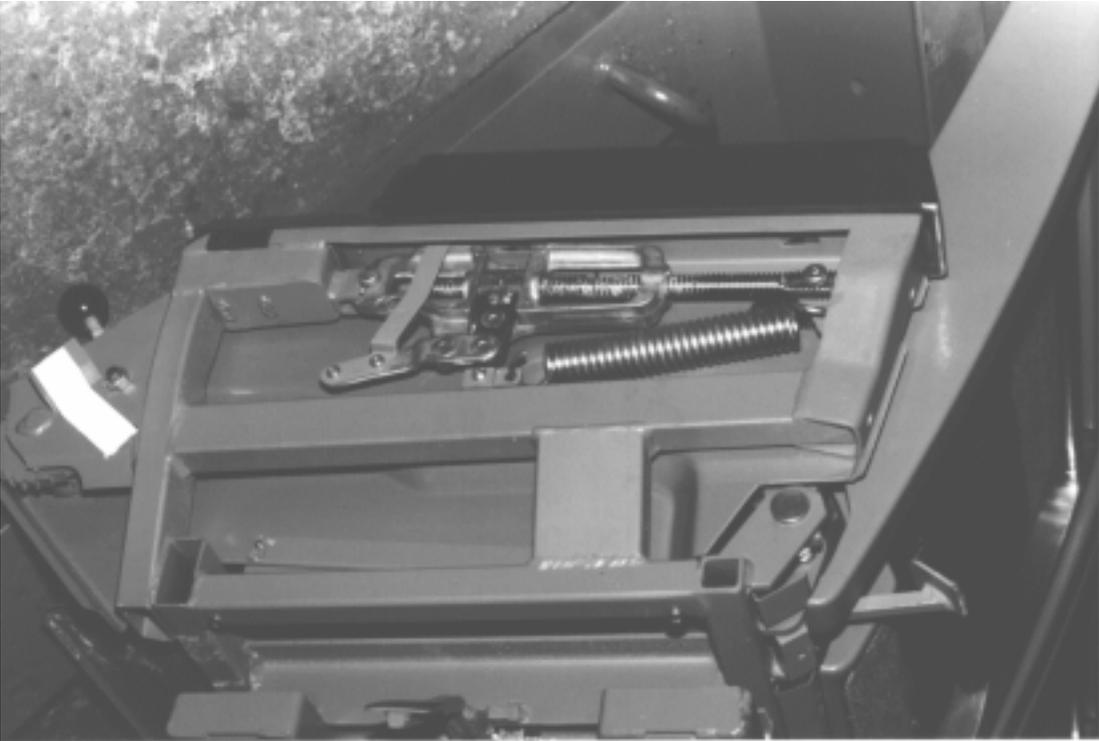
Figure B-12. Recline Mechanism Photograph
