LOCOMOTIVE TO AUTOMOBILE  
BASELINE CRASH TESTS

1. Report No. FRA-OR&D-76-03		2. Government Accession No.		3. Recipient's Catalog No.	
4. Title and Subtitle LOCOMOTIVE TO AUTOMOBILE BASELINE CRASH TESTS				5. Report Date August 1975

6. Performing Orgn Code	
7. Author(s) R. L. Anderson*				8. Performing Orgn Rpt No. DOT-TSC-FRA-75-18	
9. Performing Organization Name and Address Dynamic Science - Division of Ultrasystems 1850 West Pinnacle Peak Road Phoenix AZ 85027				10. Work Unit No. RR502/R6330

11. Contract or Grant No. DOT-TSC-700	
12. Sponsoring Agency Name and Address U.S. Department of Transportation Federal Railroad Administration Office of Research and Development Washington DC 20590				13. Type of Report and Period Covered Nov 1973 - June 1974 Final Report

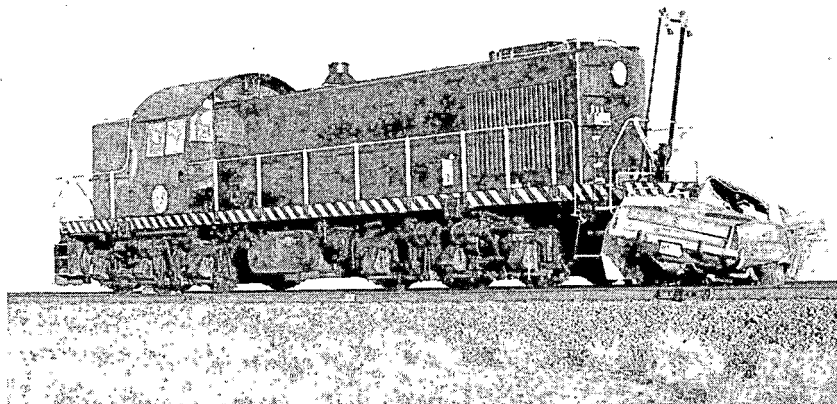
Figures 11 and 12 are overall and close-up views of the pre-test impact orientation for Test TGB-1. Figures 13 and 14 are post-test views of the locomotive and automobile. The coupler penetration is illustrated in Figures 15 and 16. During the impact, the fuel tank was damaged, causing a steady flow of the dyed water from near the top of the tank. The deformed tank is shown in Figure 17. During impact, the rear axle contacted the front plate on the train and was driven against the fender on the opposite side of the car. Figure 18 shows the deformation on the passenger side of the automobile due to the rear axle. The front section of the automobile from the firewall forward was broken loose, as mentioned earlier, but remained connected by the left front fender. Figure 19 shows how the engine compartment was opened up and how the transmission penetrated into the ballast at the side of the track during the stop. The front of the locomotive suffered significant deformation. The front plate was bent back as much as 11 inches at the lower right corner. The locomotive steps, which were part of the support of the front plate, sheared with permanent set are seen in Figure 20. Figure 21 shows a close-up of the broken pipe on the front of the locomotive. The post-test condition of the front of the locomotive is illustrated in Figure 22. The imprint of the left rear wheel can be seen on the lower left-hand side of the plate.

Figure 13. Post-test Orientation of Automobile (Test TGB-1).

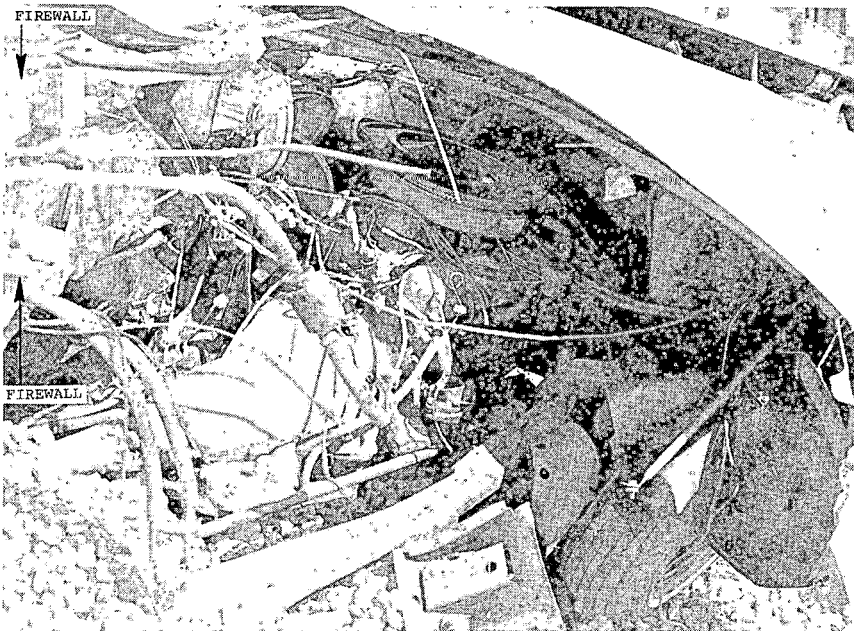
Figure 19. Post-test View of Engine Compartment (Test TGB-1).

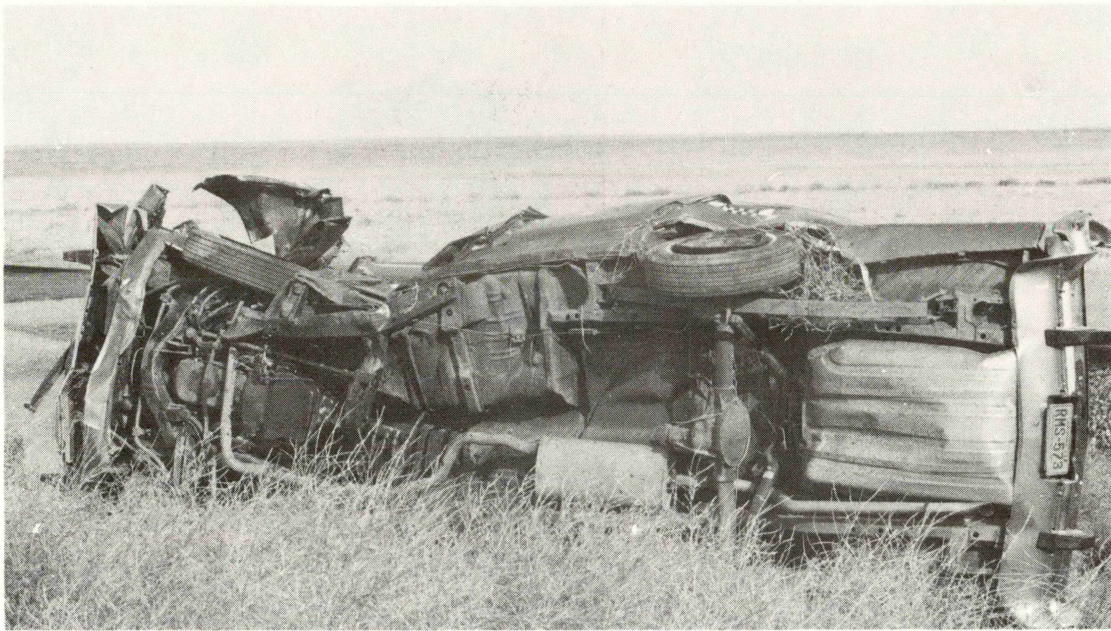
Figures 23 and 24 are overall and overhead views of the pre-test impact orientation. Figures 25 through 29 show the post-test deformation of various sections of the automobile.

Figure 25. Post-test Orientation of Automobile (Test TGB-2).

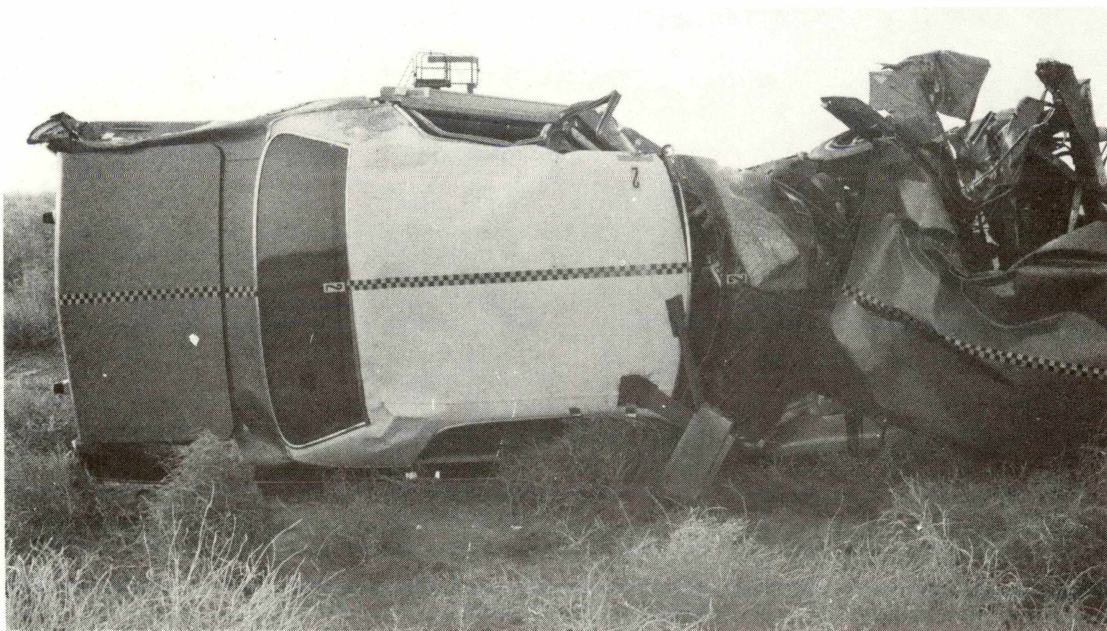
Figure 26. Post-test View of Top of Automobile (Test TGB-2).

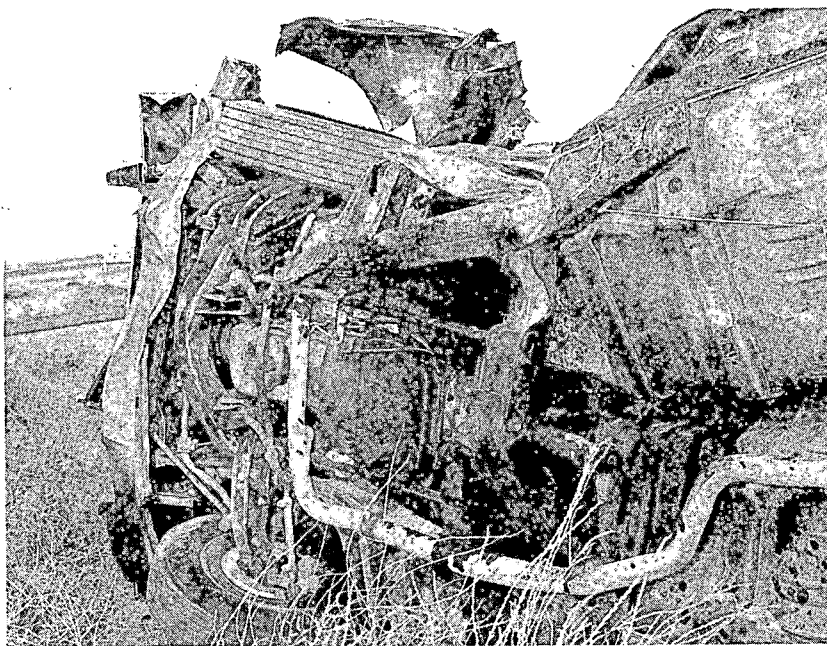
Figure 27. Post-test Underside View of Front Section of Automobile (Test TGB-2).

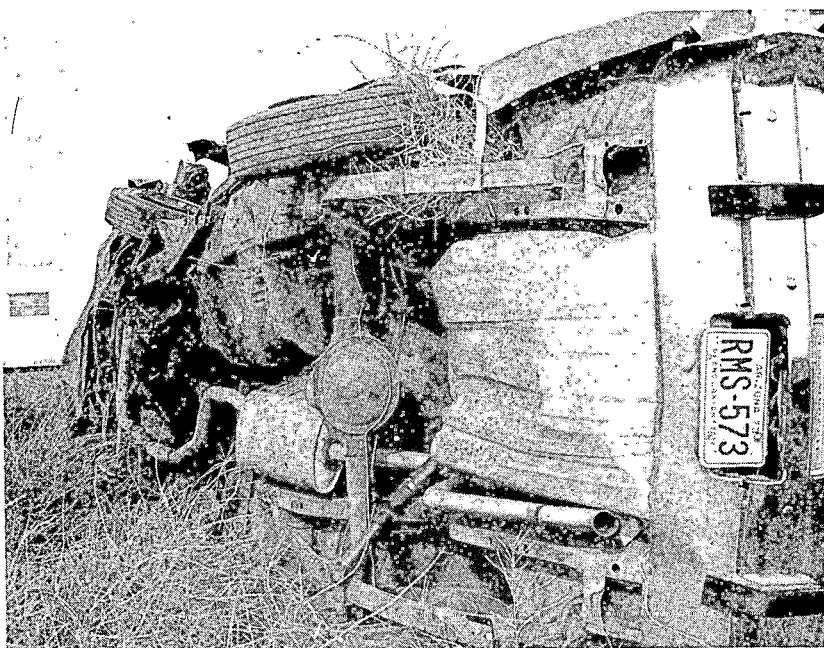
Figure 28. Post-test Underside View of Automobile (Test TGB-2).

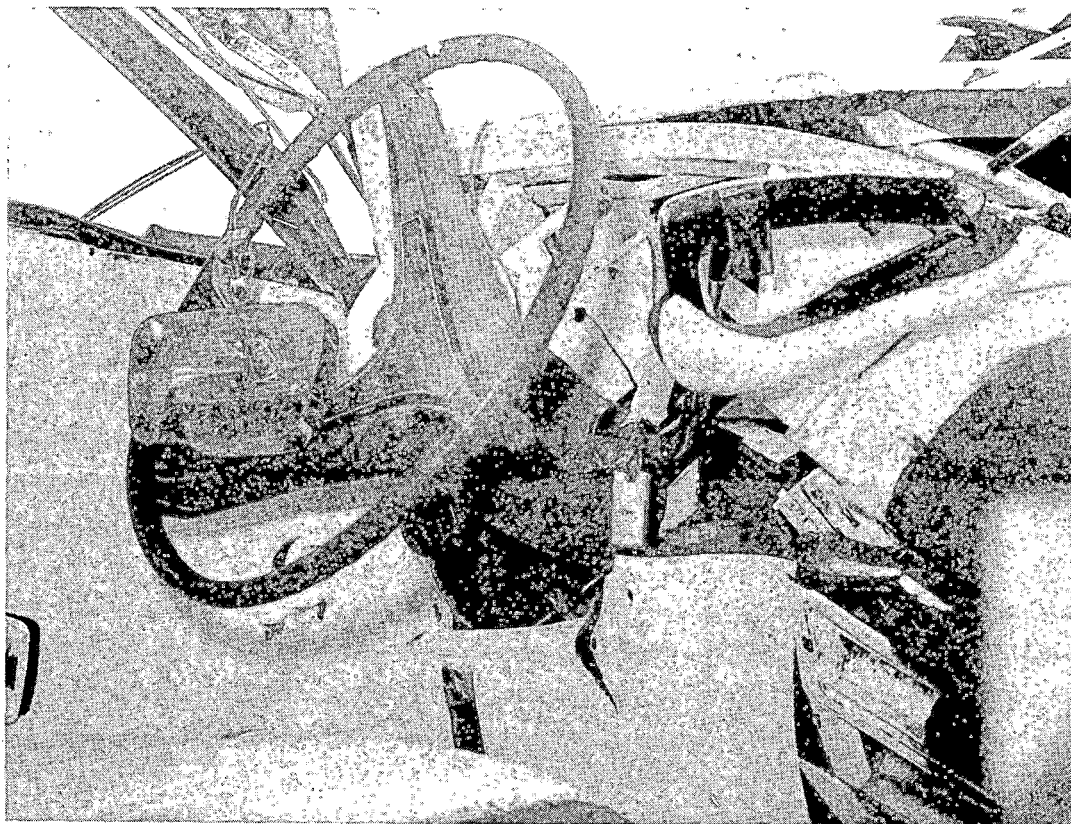
Figure 29. Post-test View of Driver Area (Test TGB-2).

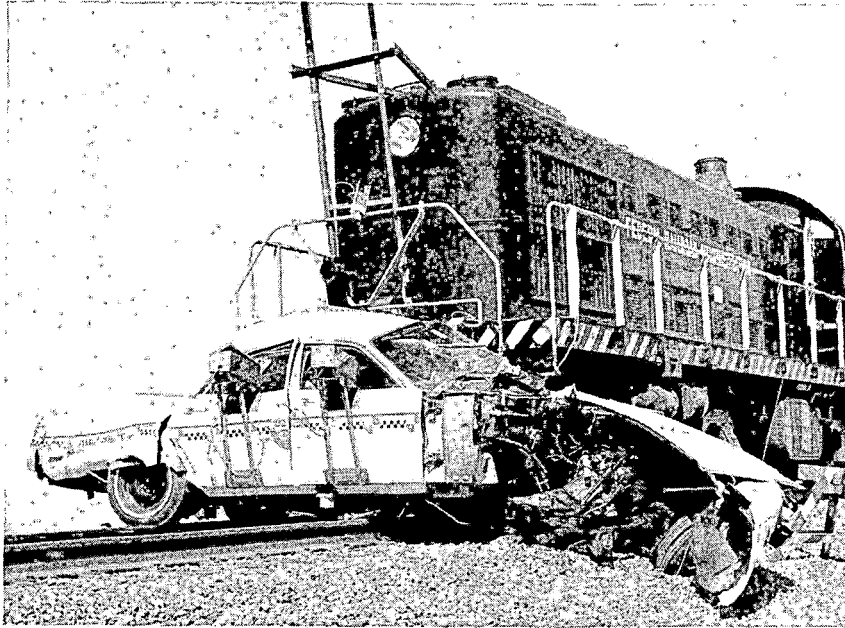
Figures 33 and 34 are overall and close-up views of the pre-test impact orientation of Test TGB-3. Figure 35 is an overall post-test view of the automobile and locomotive which shows the broken front section of the automobile as well as the torn right rear fender and overall condition of the automobile. Figures 36,

Figure 35. Post-test View of Locomotive and Automobile (Test TGB-3).

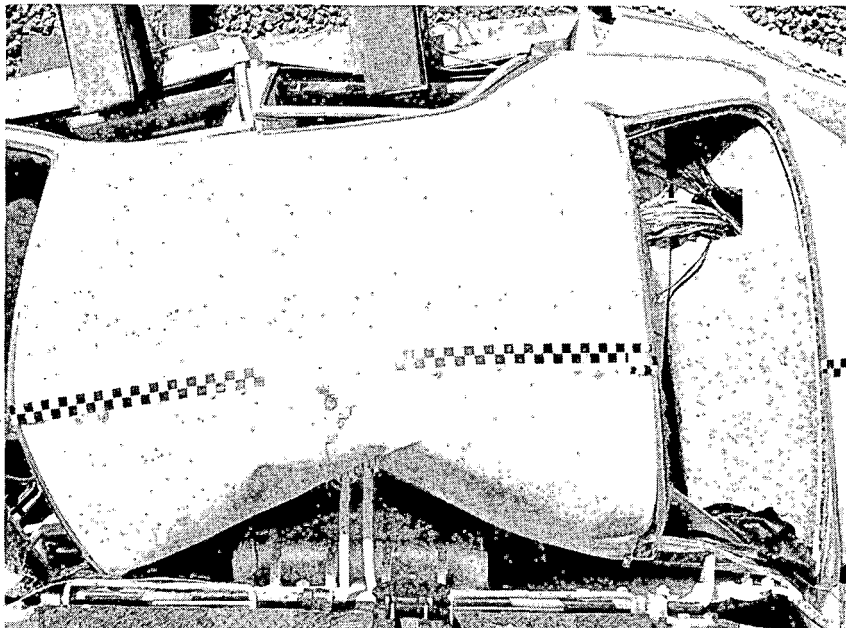
Figure 36. Post-test Overhead View of Center Section of Automobile (Test TGB-3).

37, and 38 are post-test overhead views of the center, front, and rear sections of the automobile showing how the automobile is wrapped around the locomotive front plate and coupler.

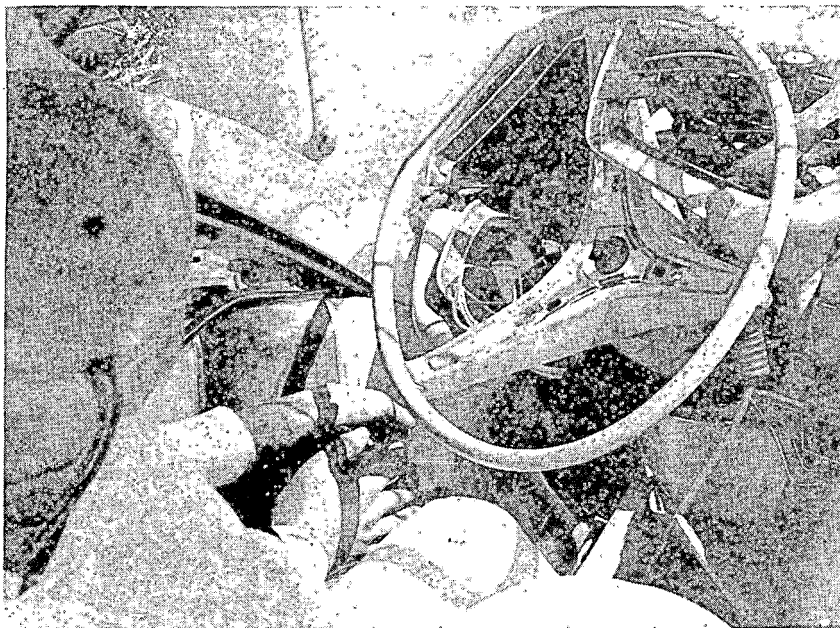
Figure 39 is a view of the coupler through the right rear door, showing the intrusion into the occupant space of the automobile. Figure 40 is a post-test view of the dummy in the driver area. The dummy retained its structural integrity with no apparent permanent damage, even though the loads experienced during the impact would have been fatal for a human, as will be discussed later. After the front section of the automobile was pulled back, the locomotive was simply backed away from the automobile leaving an imprint as shown in Figure 41.

Figure 40. Post-test View of Dummy and Driver Area (Test TGB-3).

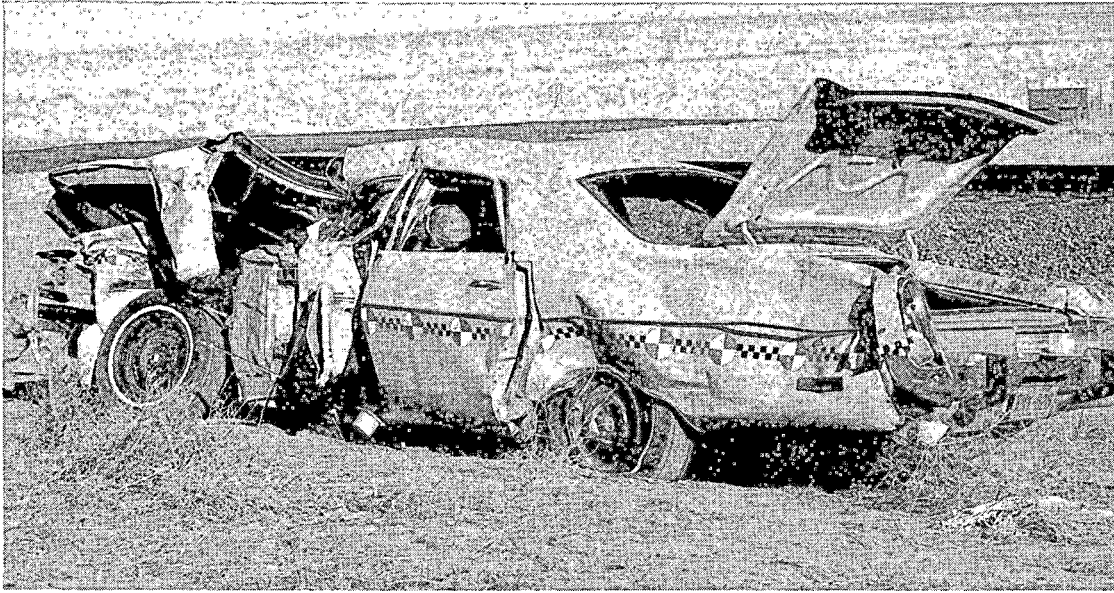
Figure 54. Post-test View of the Left Side of the Automobile (Test TGB-4).

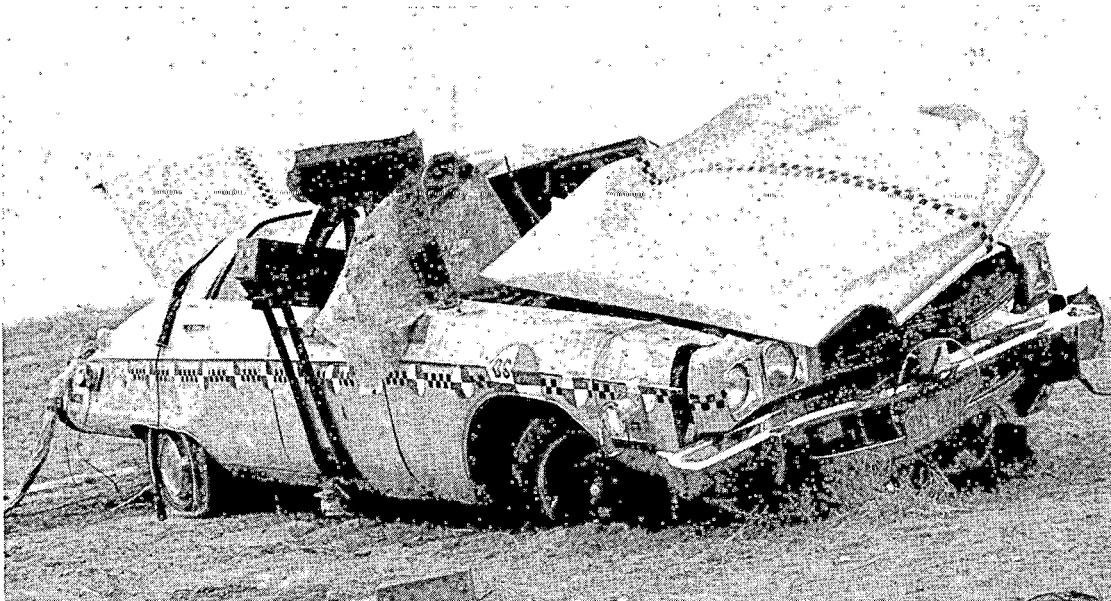
Figure 55. Post-test View of the Right Side of the Automobile (Test TGB-4).

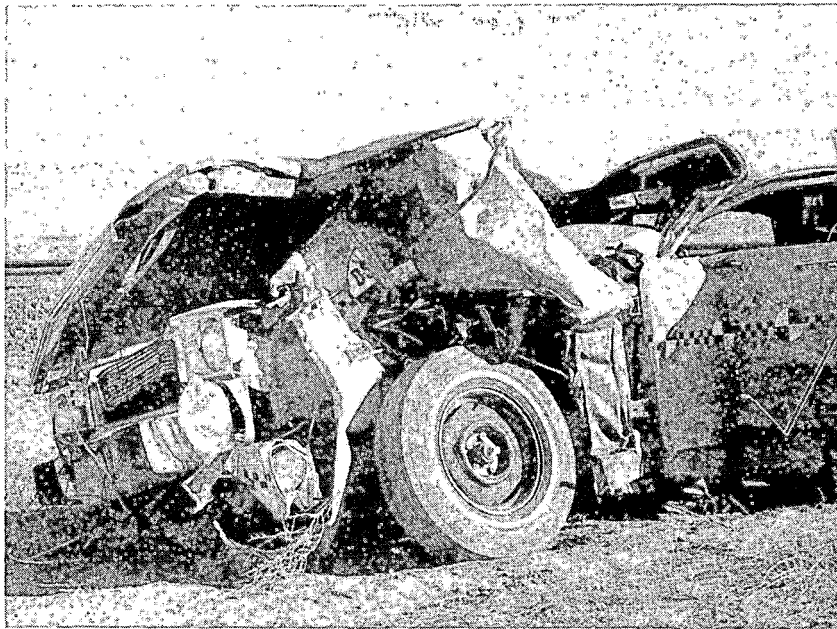
Figure 56 shows the post-test impact point. The coupler contacted the engine head, resulting in a crack in the head.

Figure 56. Post-test View of Impact Area (Test TGB-4).
